Music Bowl Structural Assessment

24 November 2014

R14265

Prepared for Rockhampton Regional Council

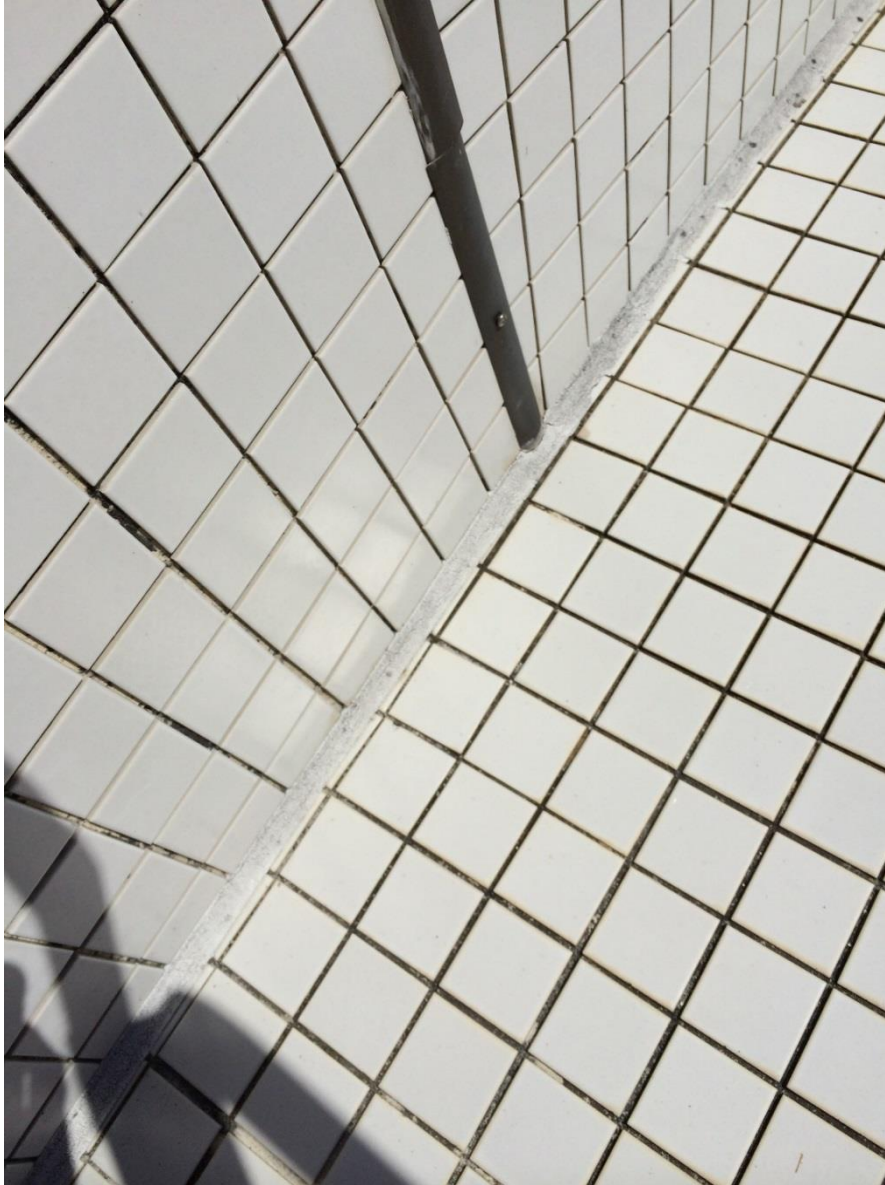
Figure 9 - Vertical and horizontal tiled junction

Junction of vertical tiled and horizontal tiled surface showing sealant. Metal cover capping in vertical surface which appears to cover cut tile junction.

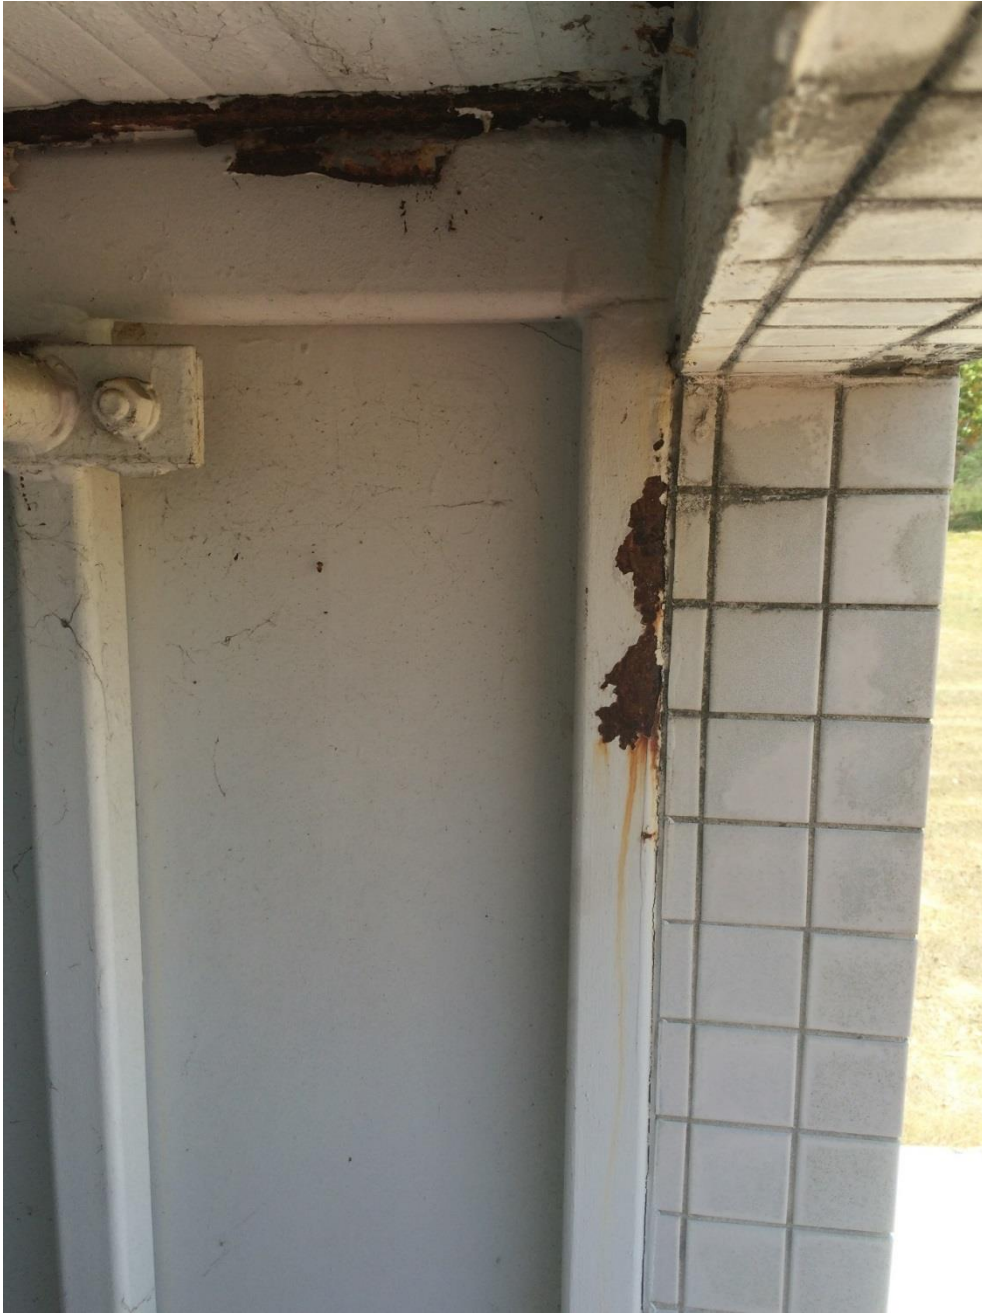
Photo 001 - Corrosion to truss web at end

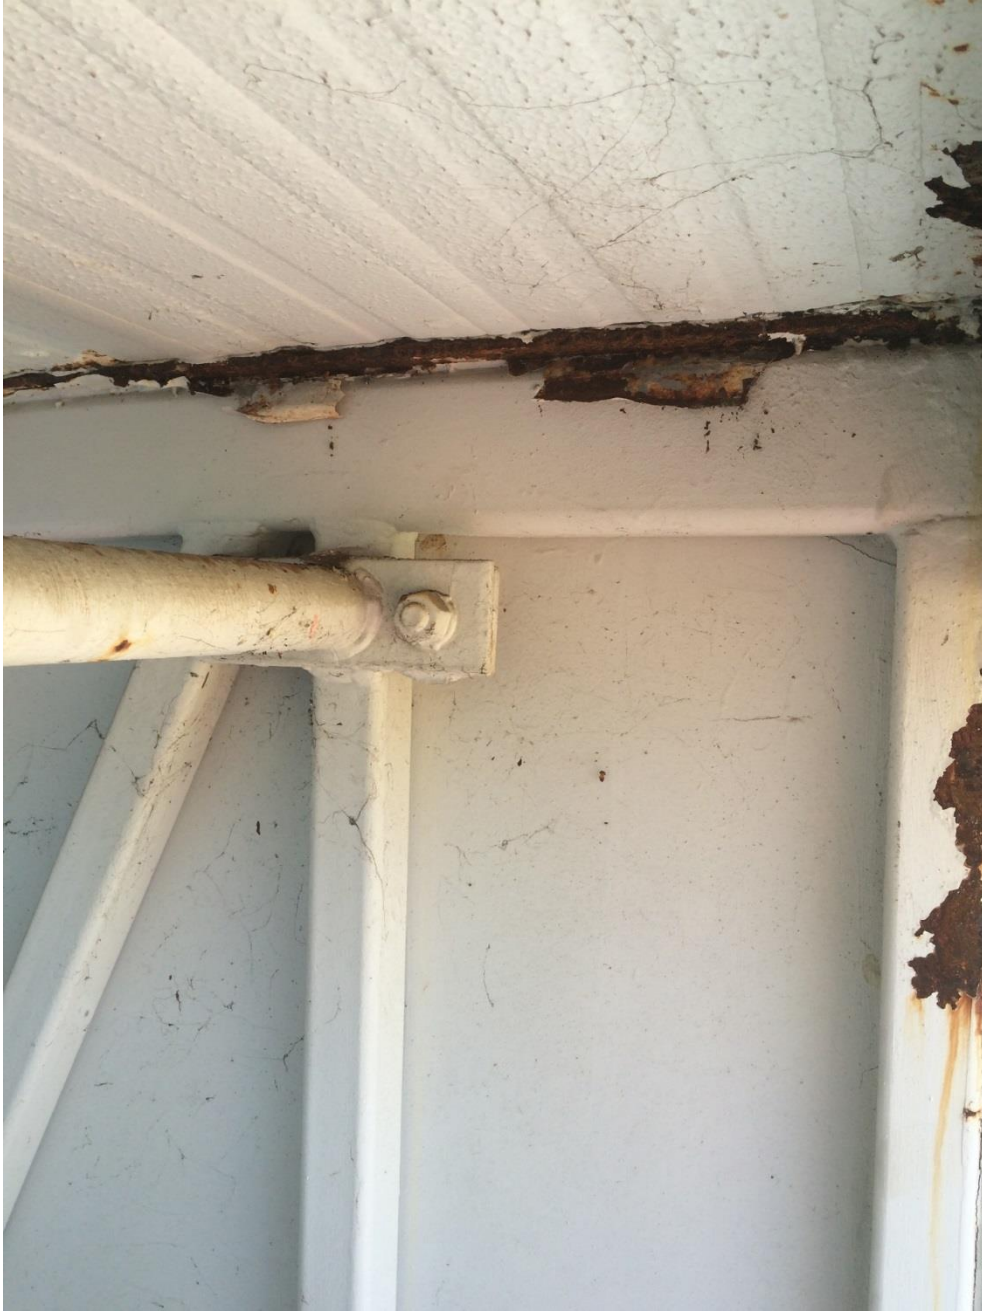
Photo 002 - Corrosion to top plate

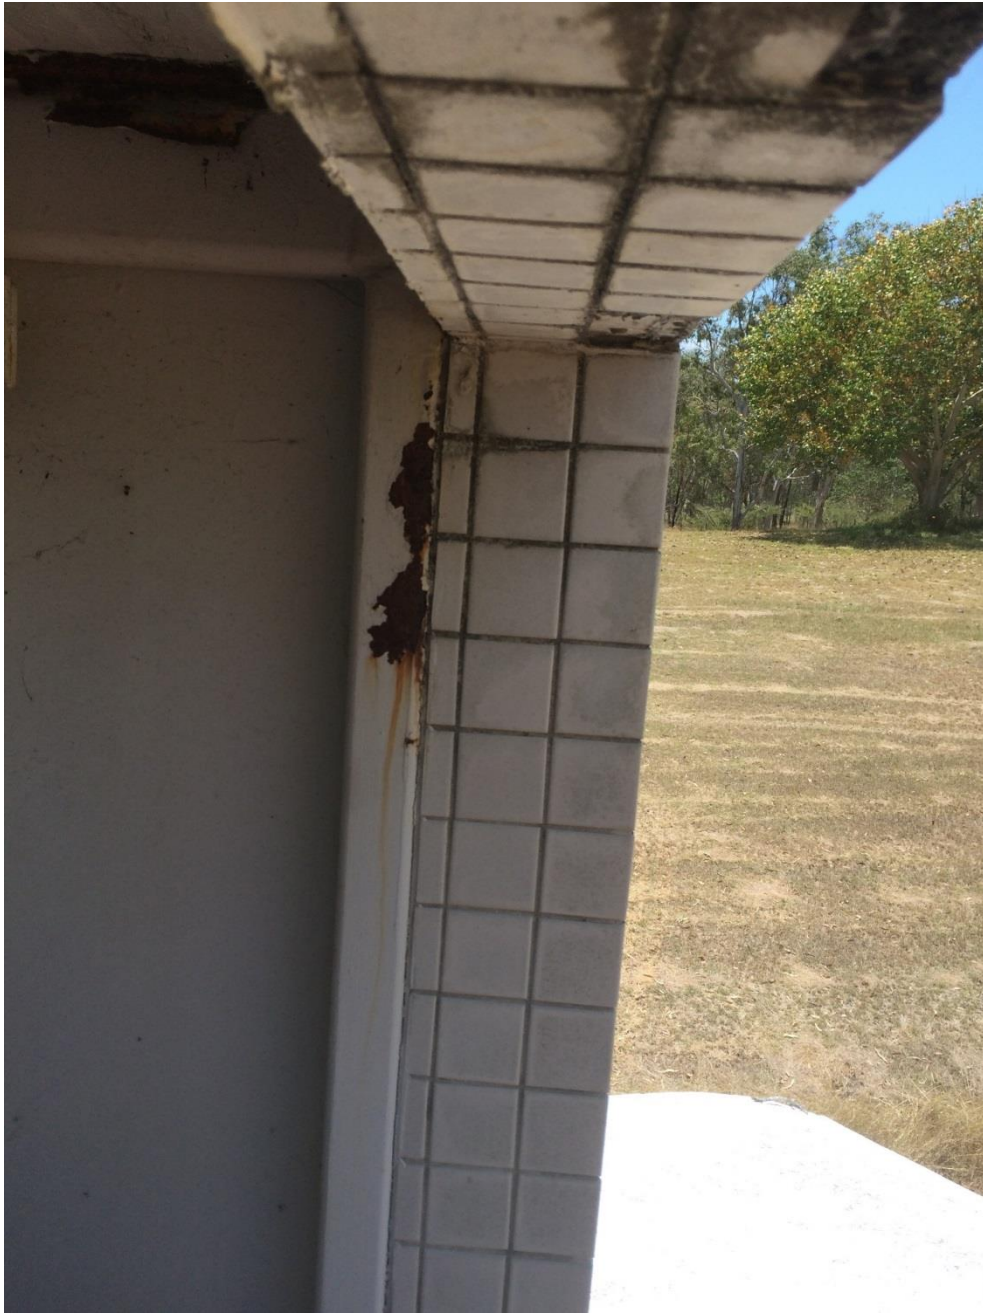
Photo 007 - Corrosion to truss web at end

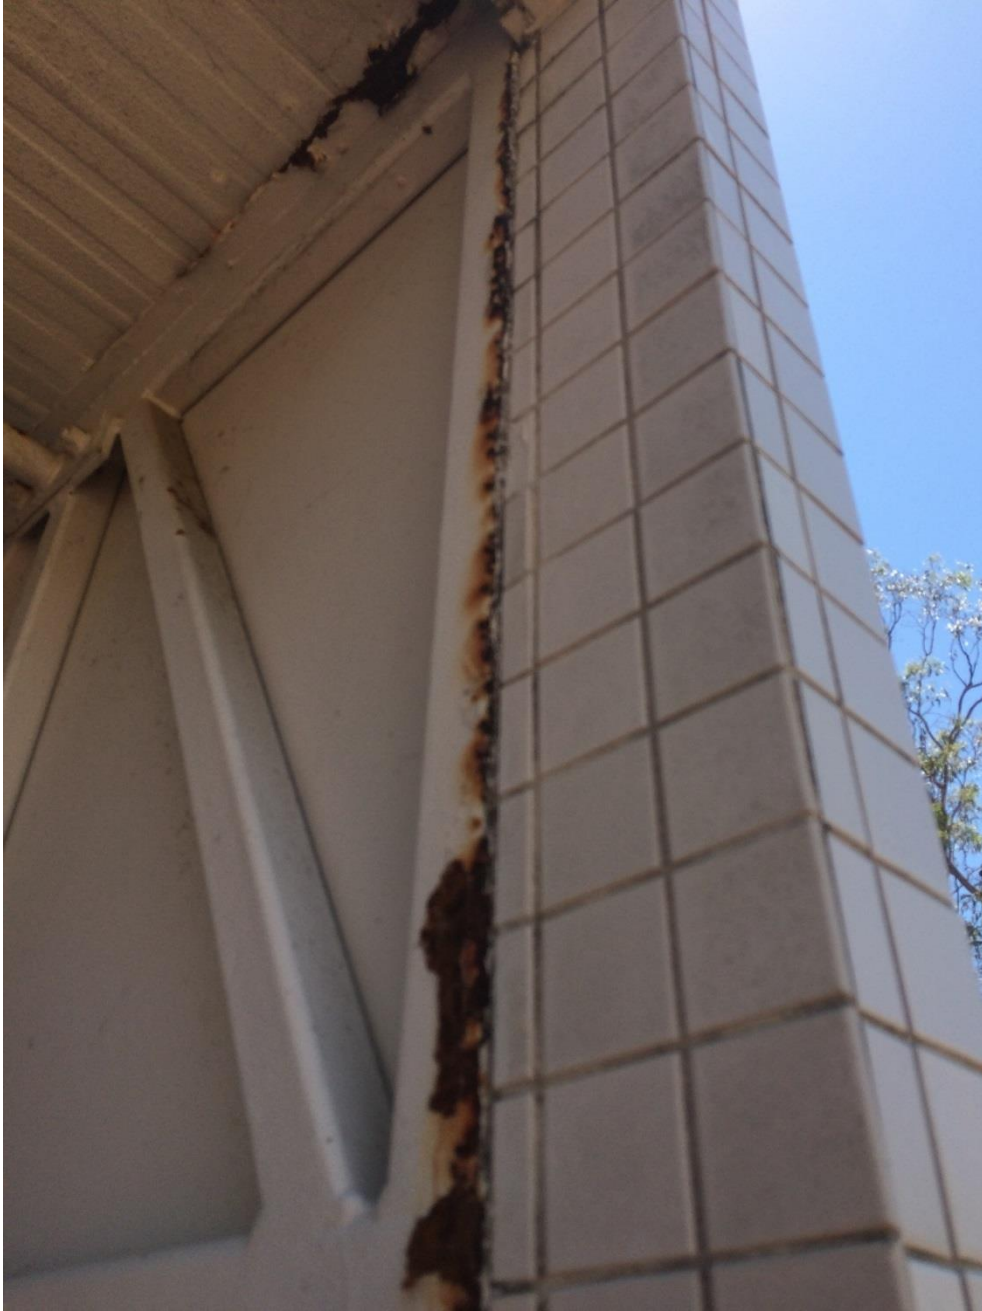
Photo 009 - Corrosion to truss bottom chord and web at end

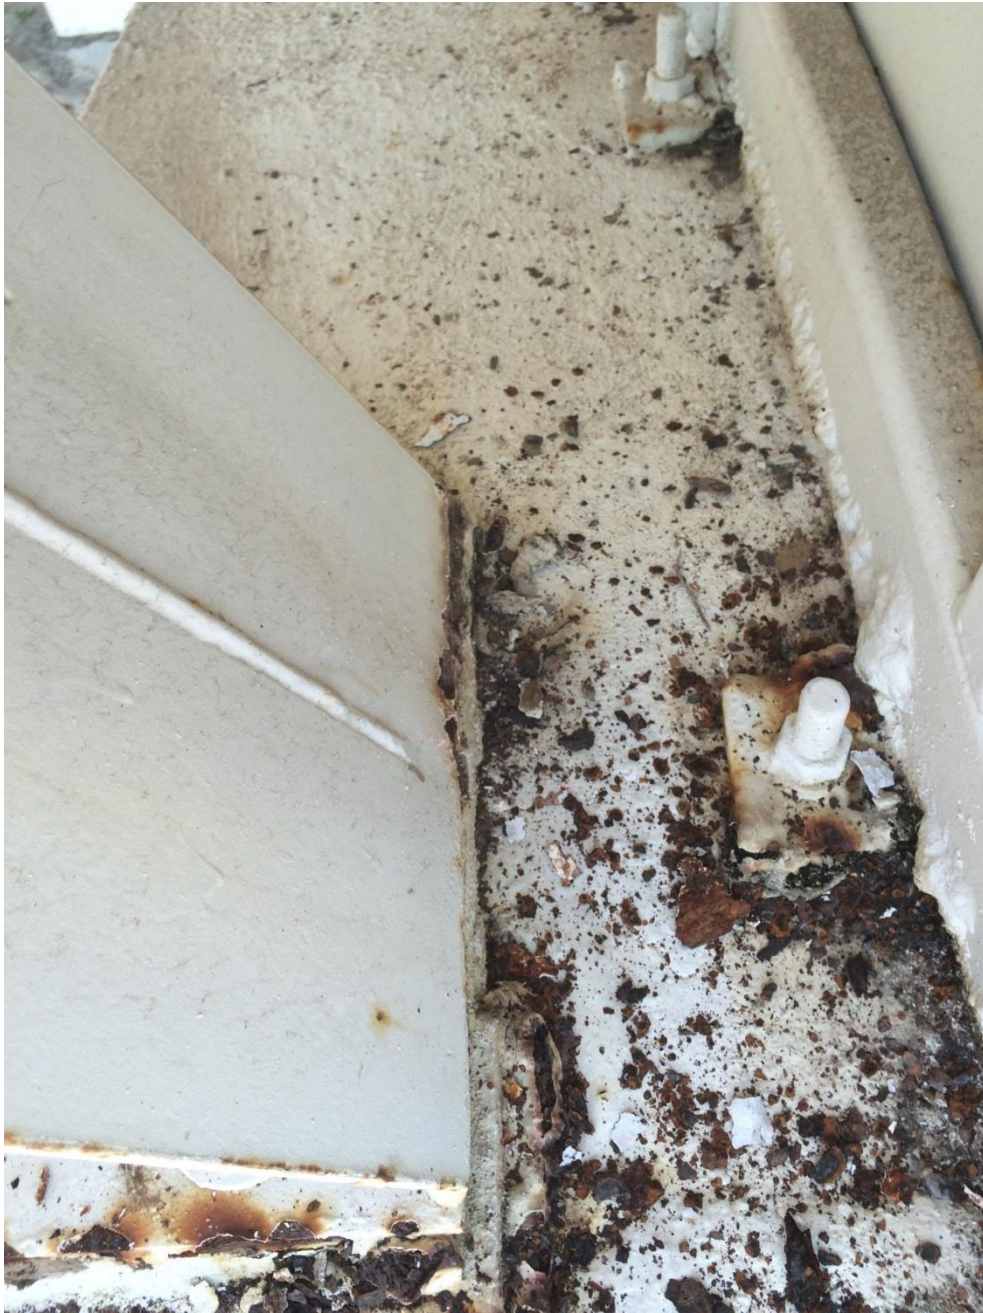
Photo 014 - Minor corrosion to main arch top flange at baseplate

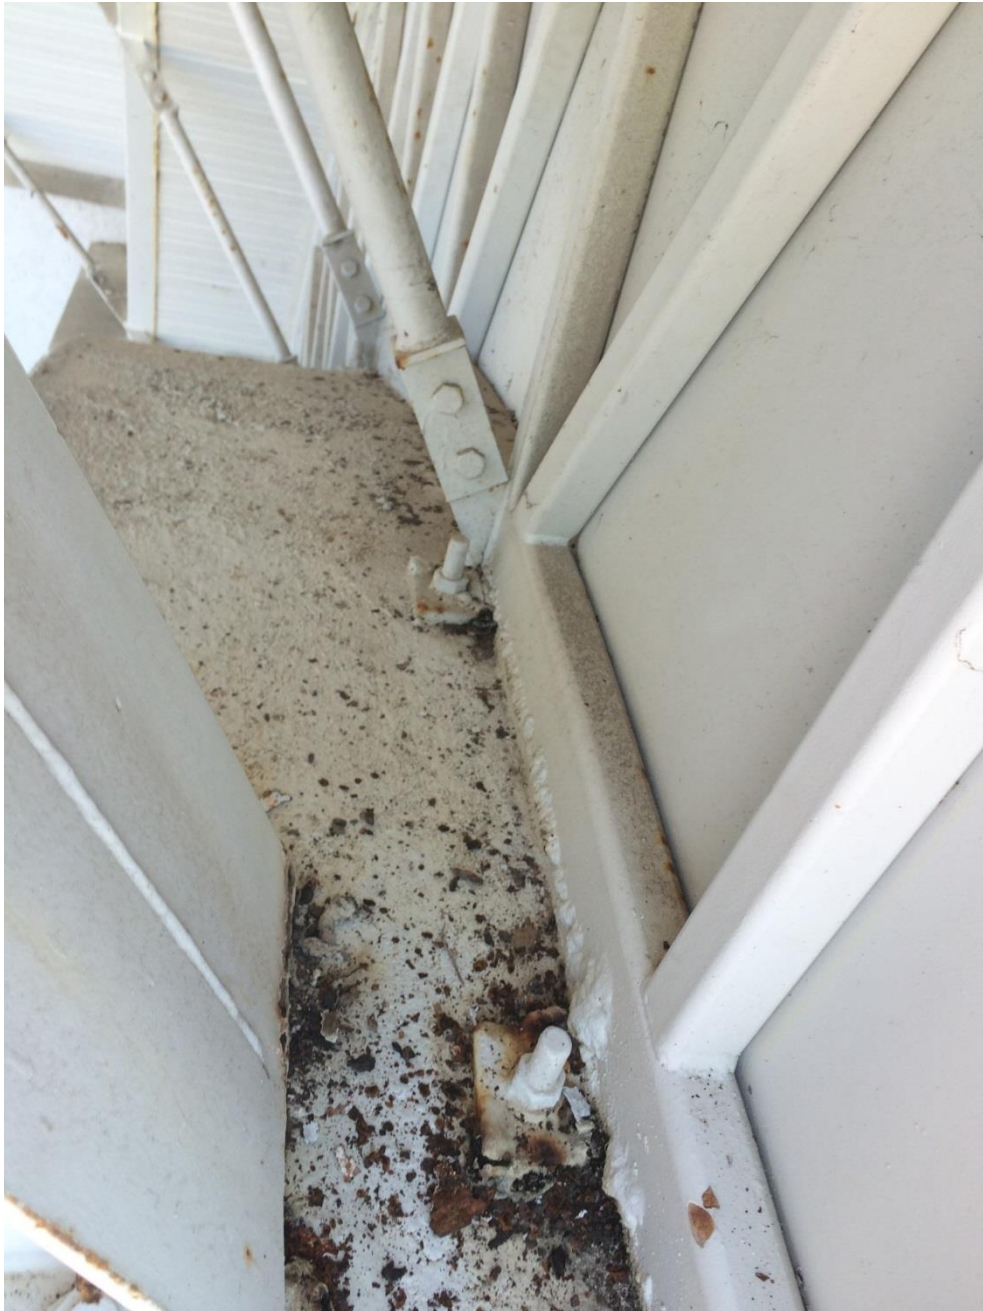
Photo 015 - Minor corrosion to bottom chord along concrete

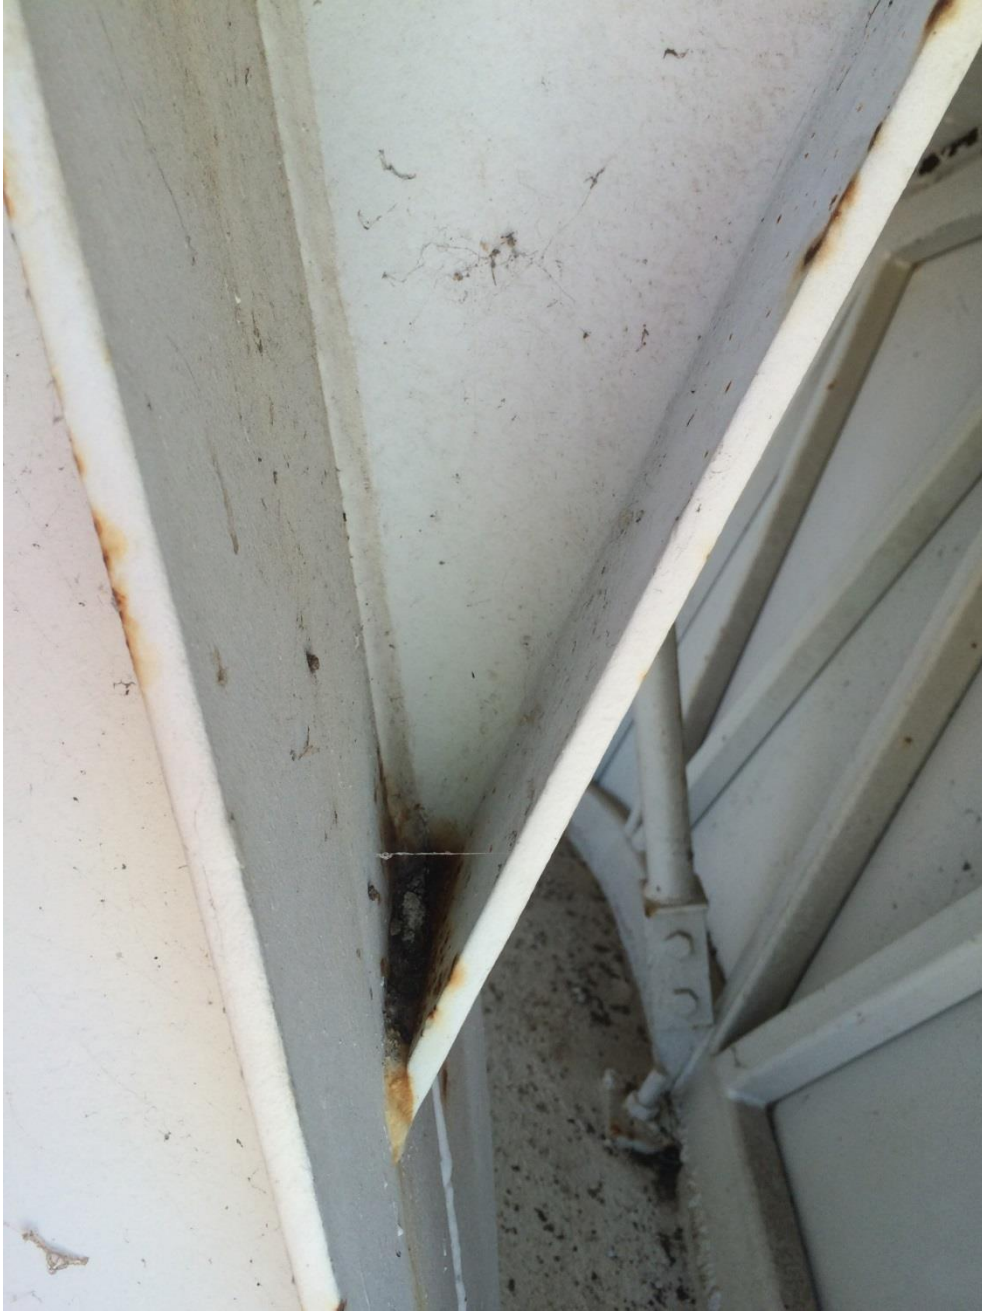
Photo 016 - Minor corrosion in corner of stub

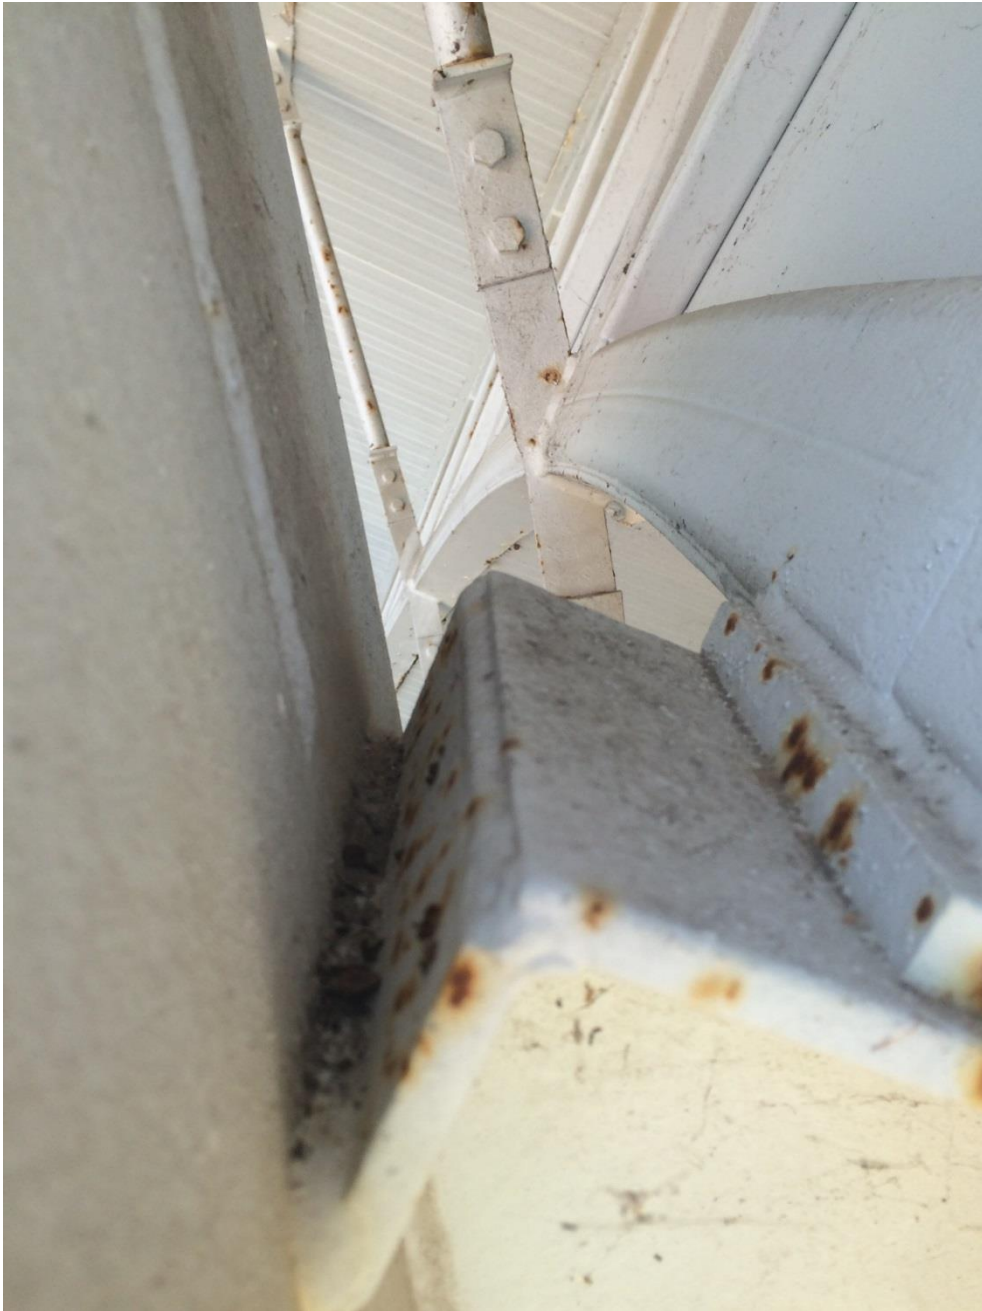
Photo 017 - Minor corrosion in corner of stub

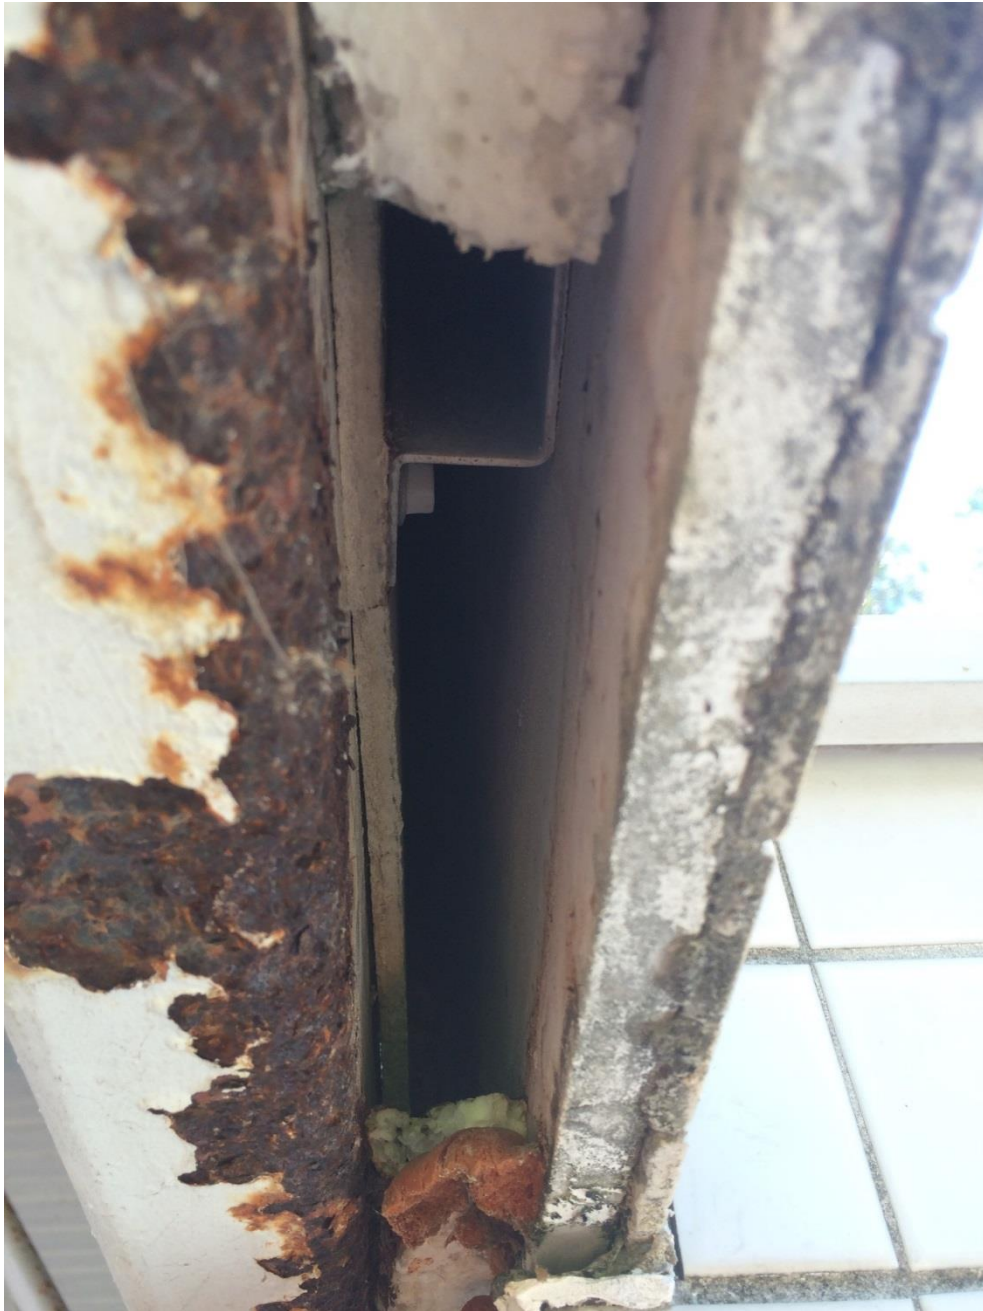
Photo 020 - Heavy corrosion to bottom chord

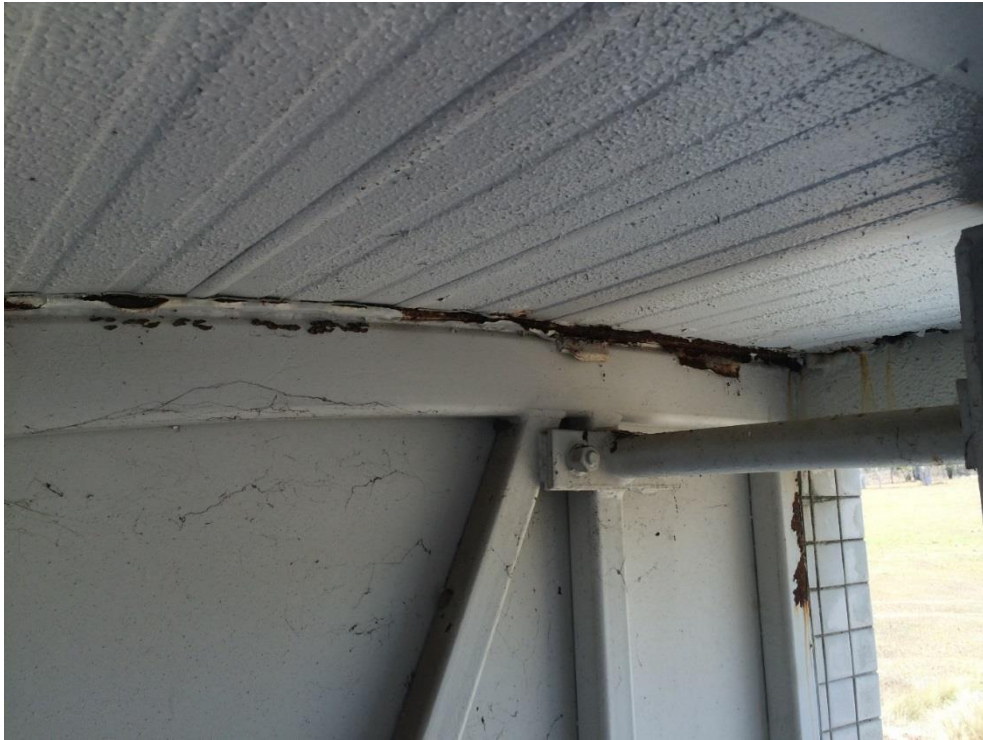
Photo 021 - Heavy corrosion to top plate all along

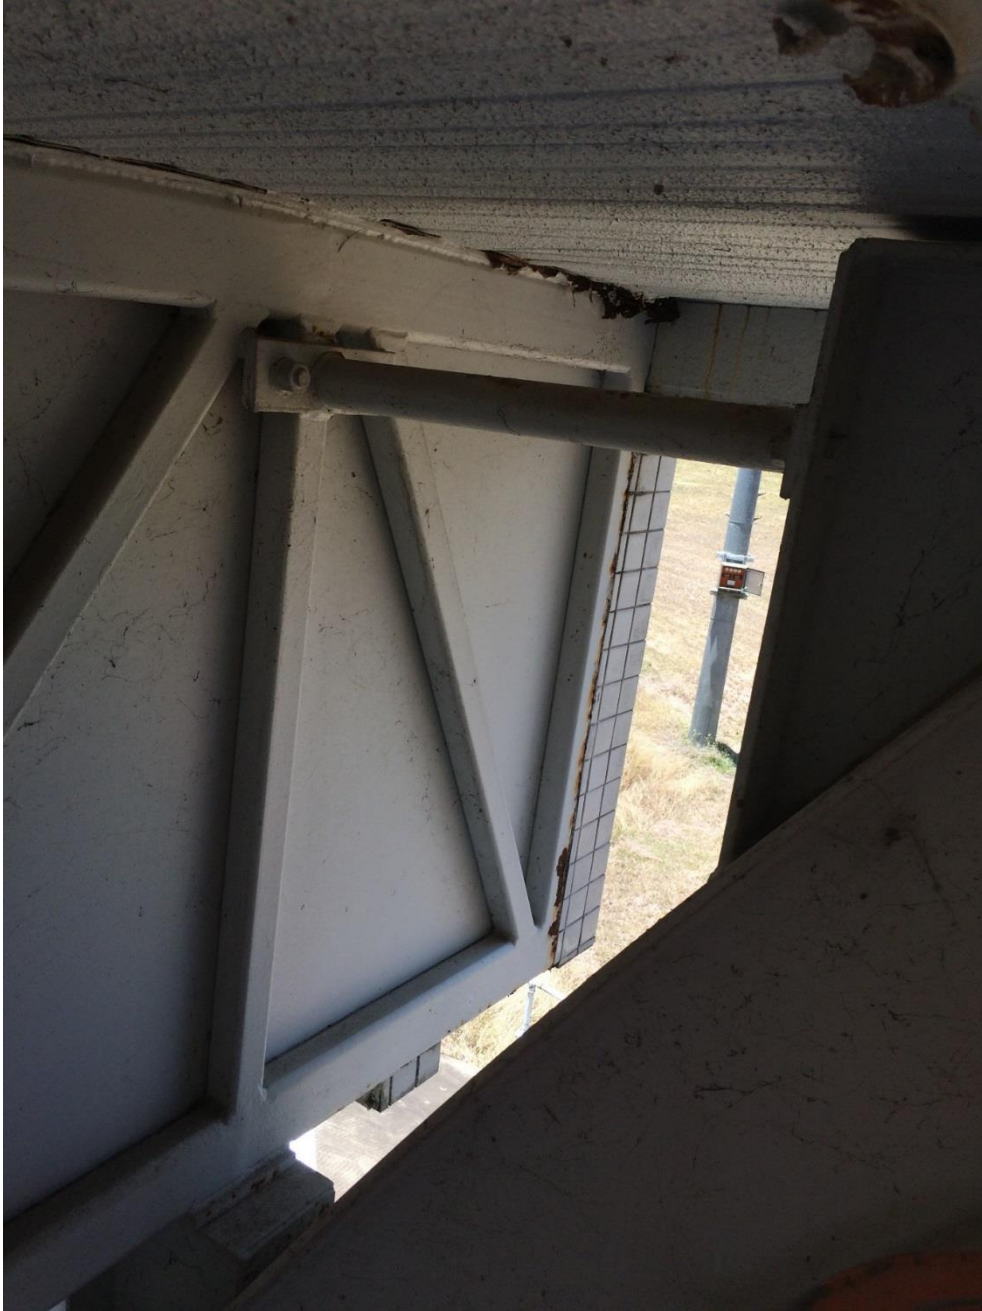
Photo 030 - Heavy corrosion to top plate

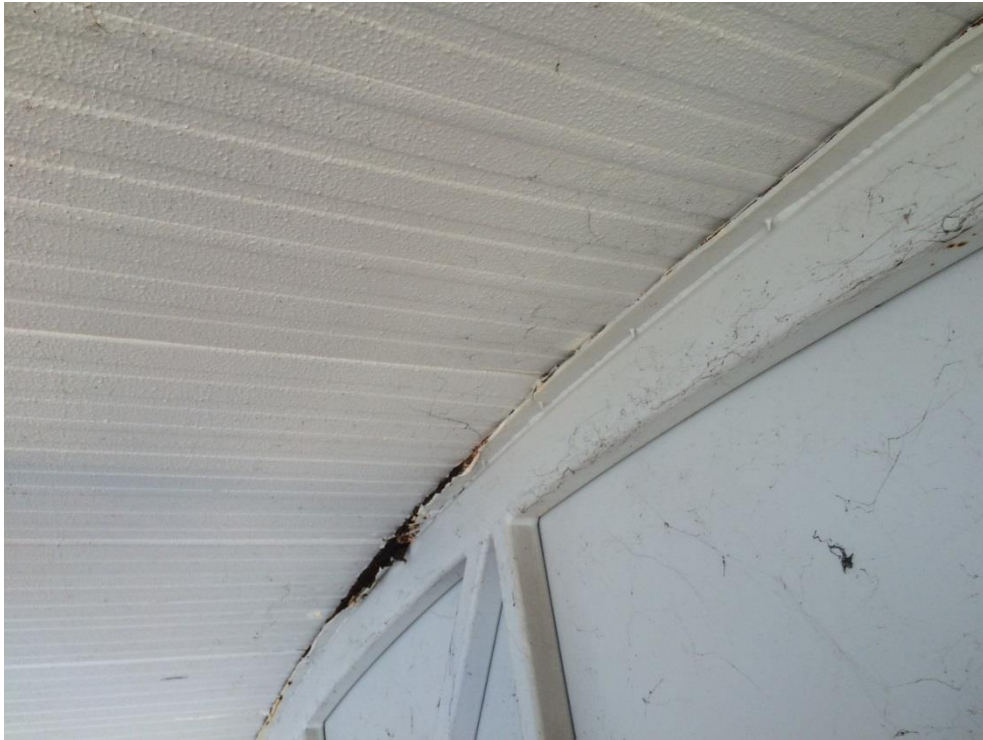
Photo 043 - Heavy corrosion to top plate

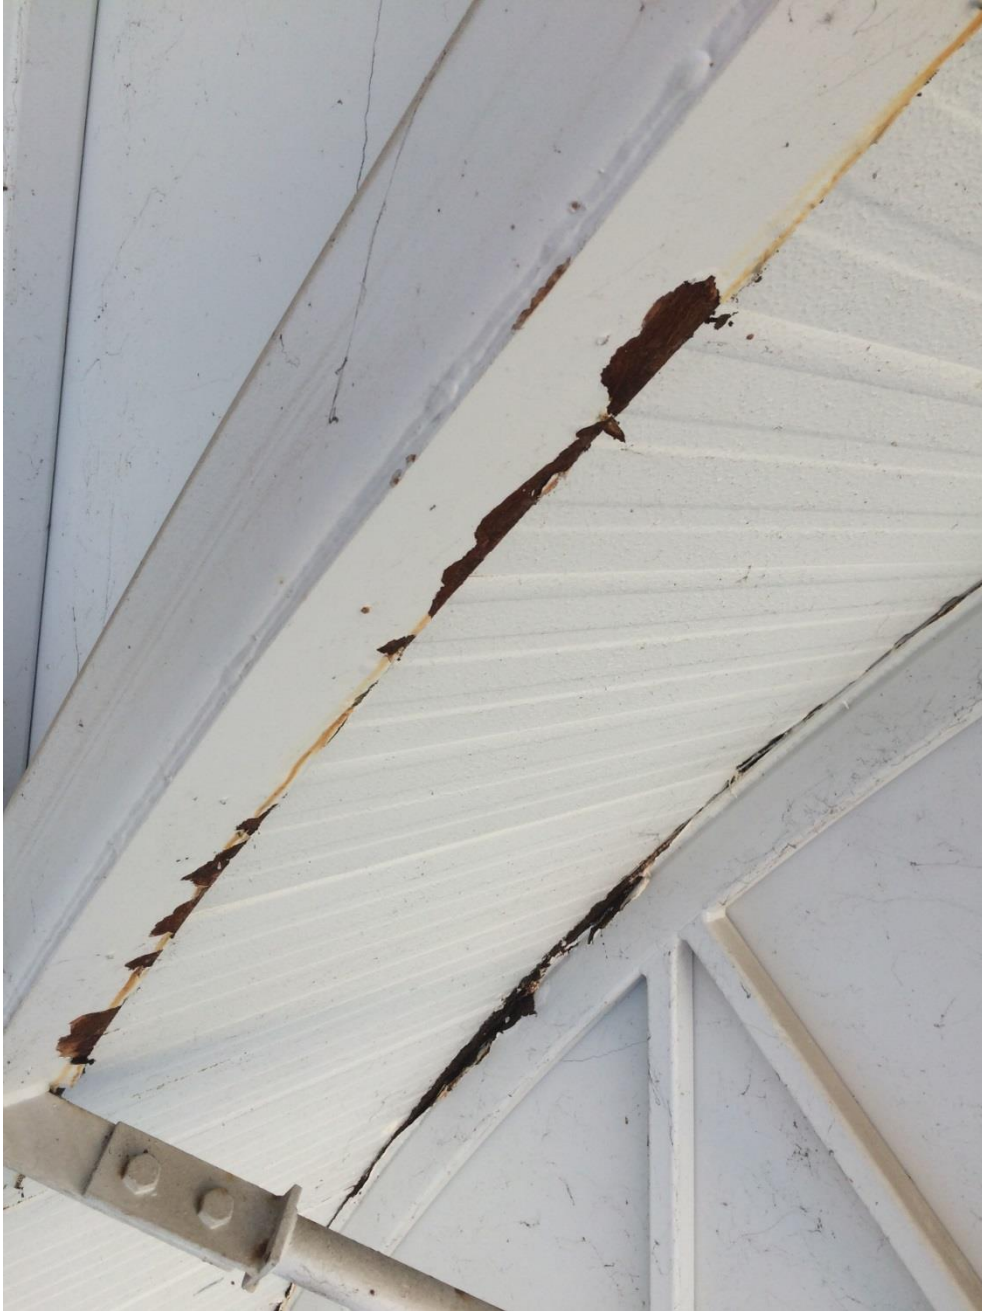
Photo 052 - Minor corrosion to bottom plate

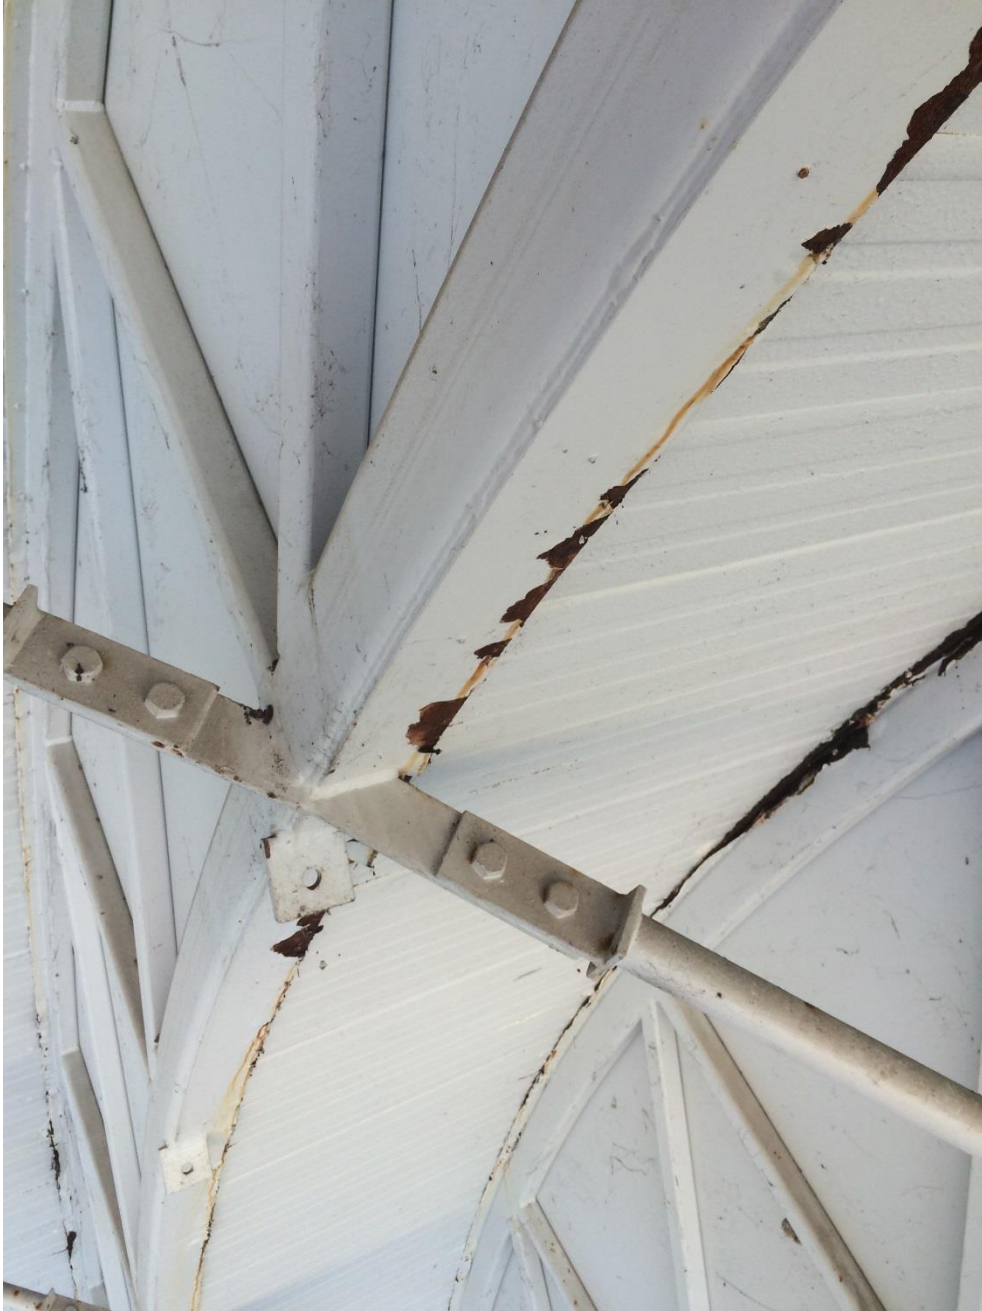
Photo 053 - Minor corrosion to bottom plate

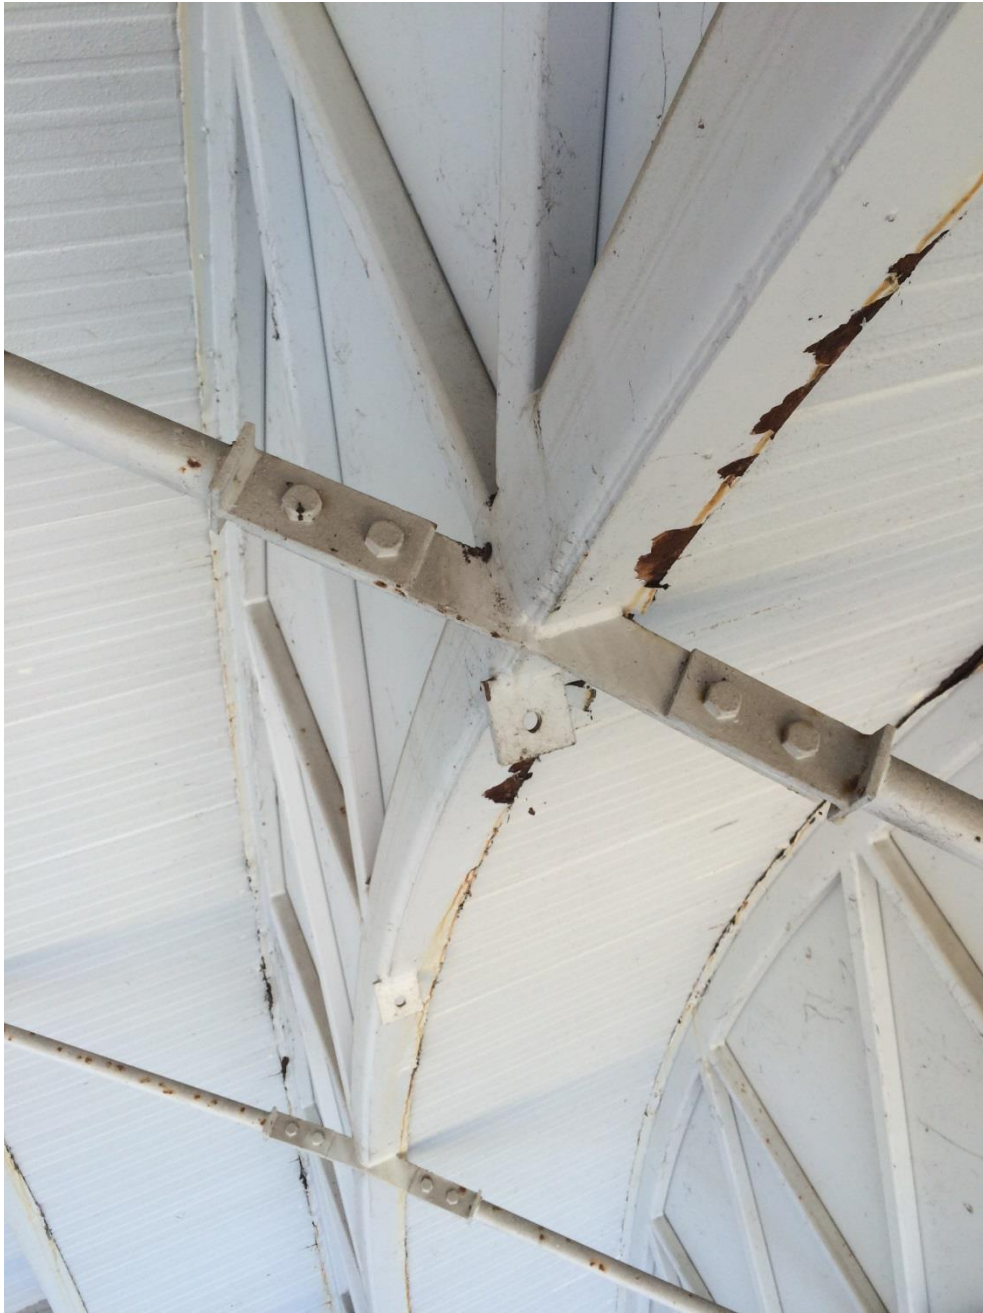
Photo 054 - Minor corrosion to bottom plate

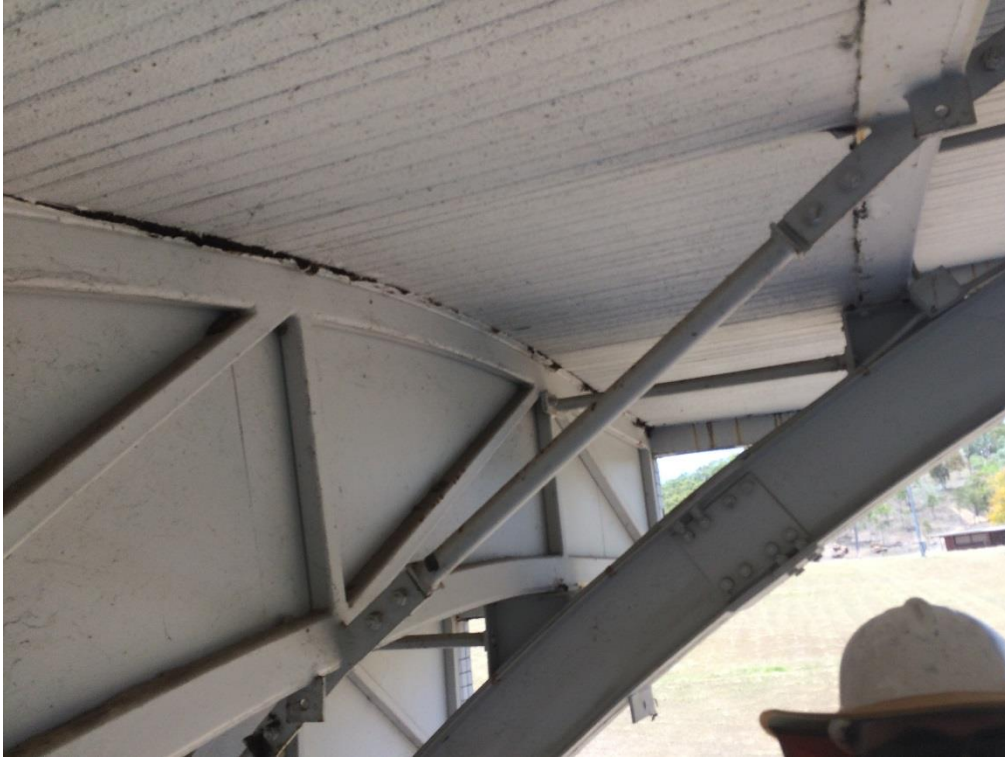
Photo 055 - Heavy corrosion to top plate

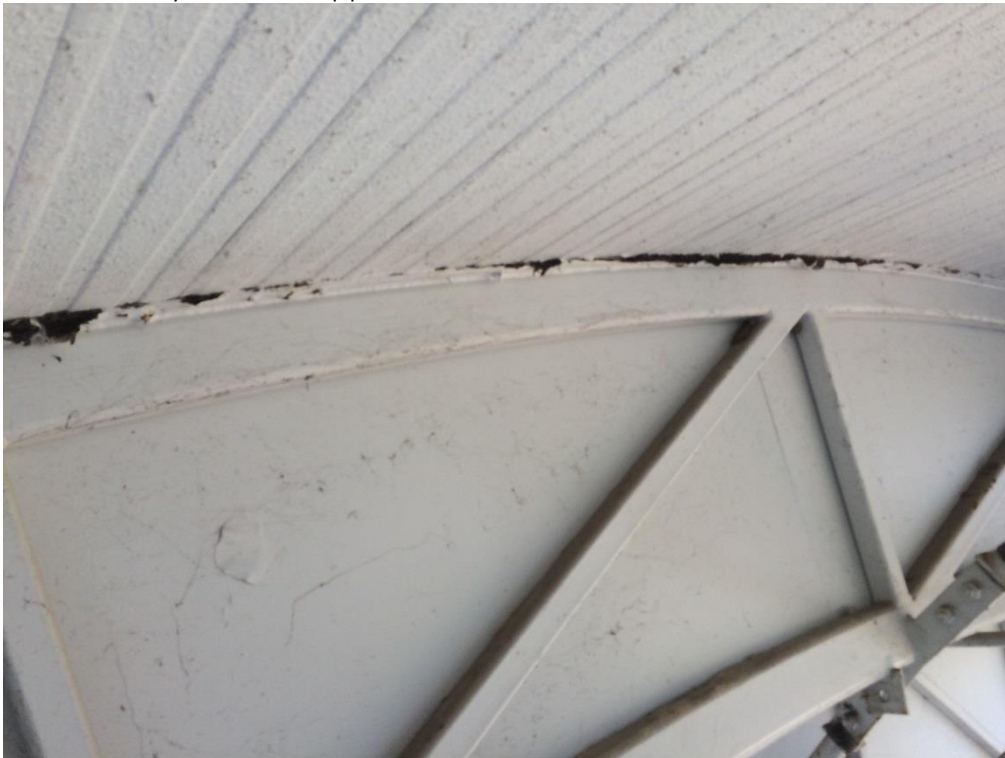
Photo 056 - Heavy corrosion to top plate

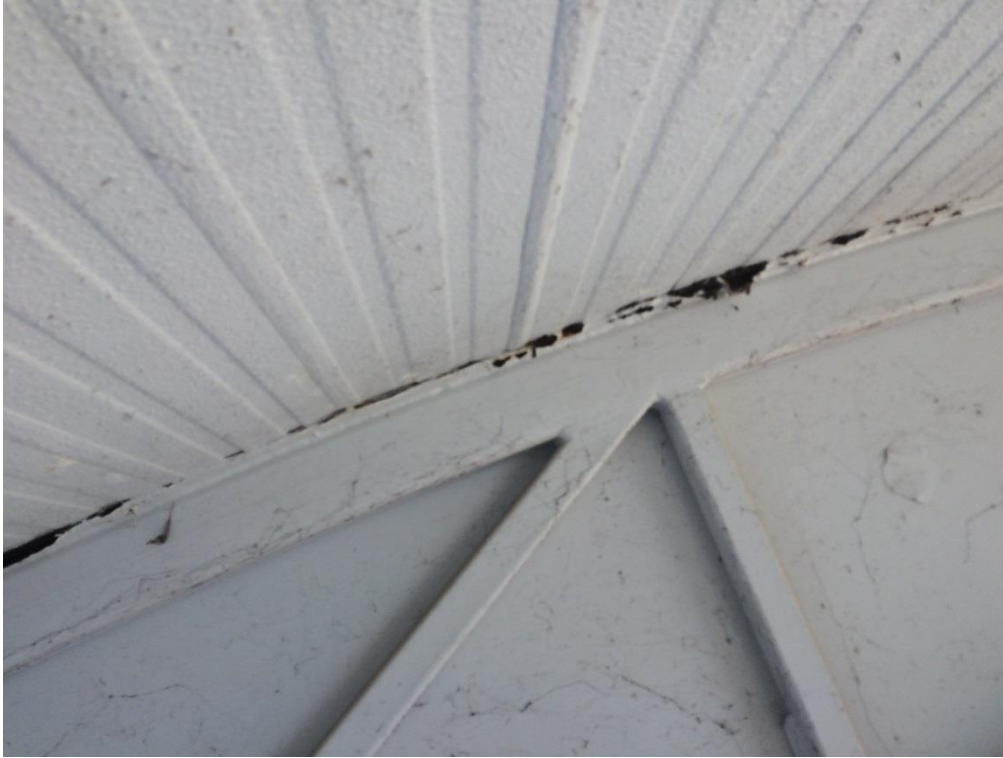
Photo 057 - Heavy corrosion to top plate

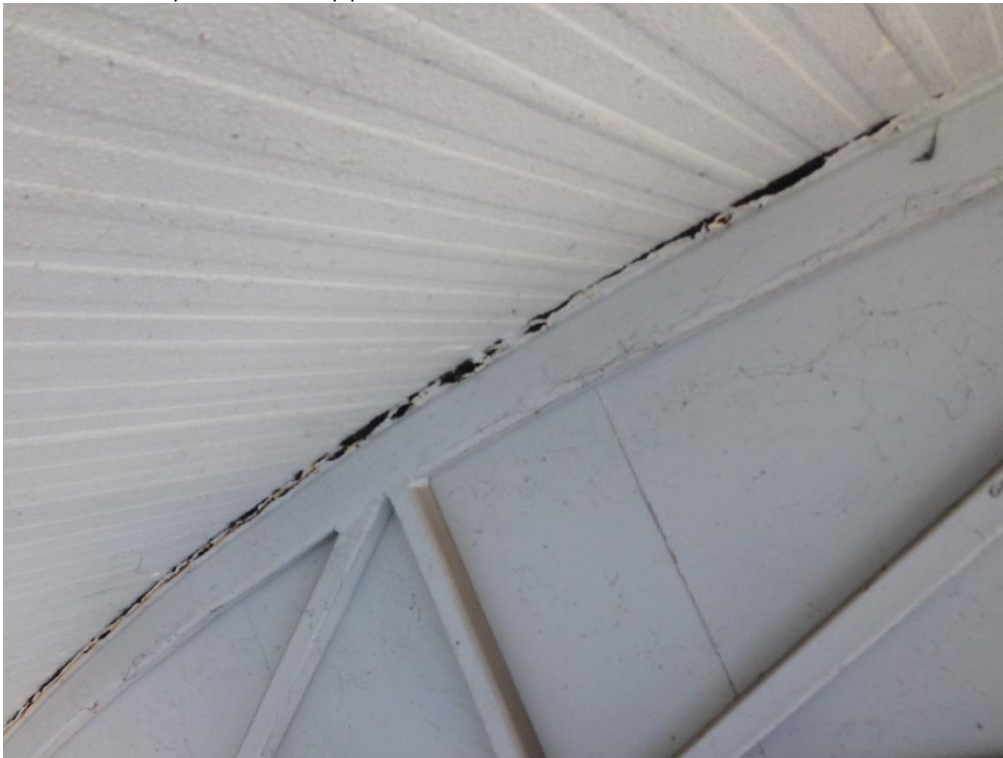
Photo 058 - Heavy corrosion to top plate

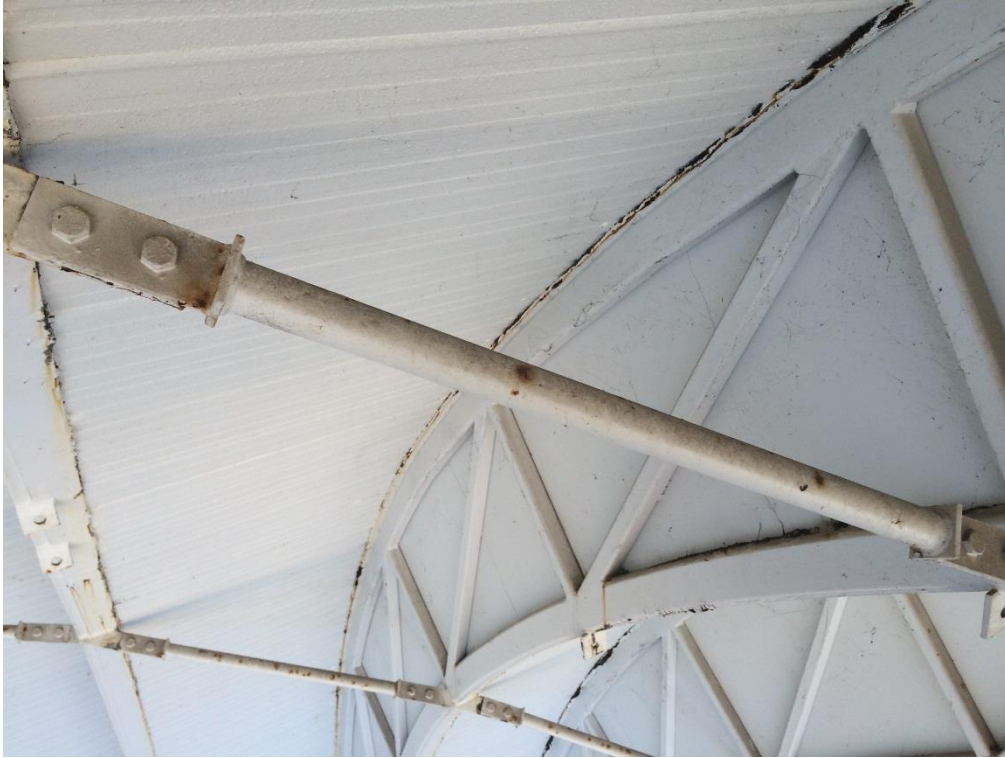
Photo 059 - Heavy corrosion to top plate
