Music Bowl Structural Assessment

24 November 2014

R14265

Prepared for Rockhampton Regional Council

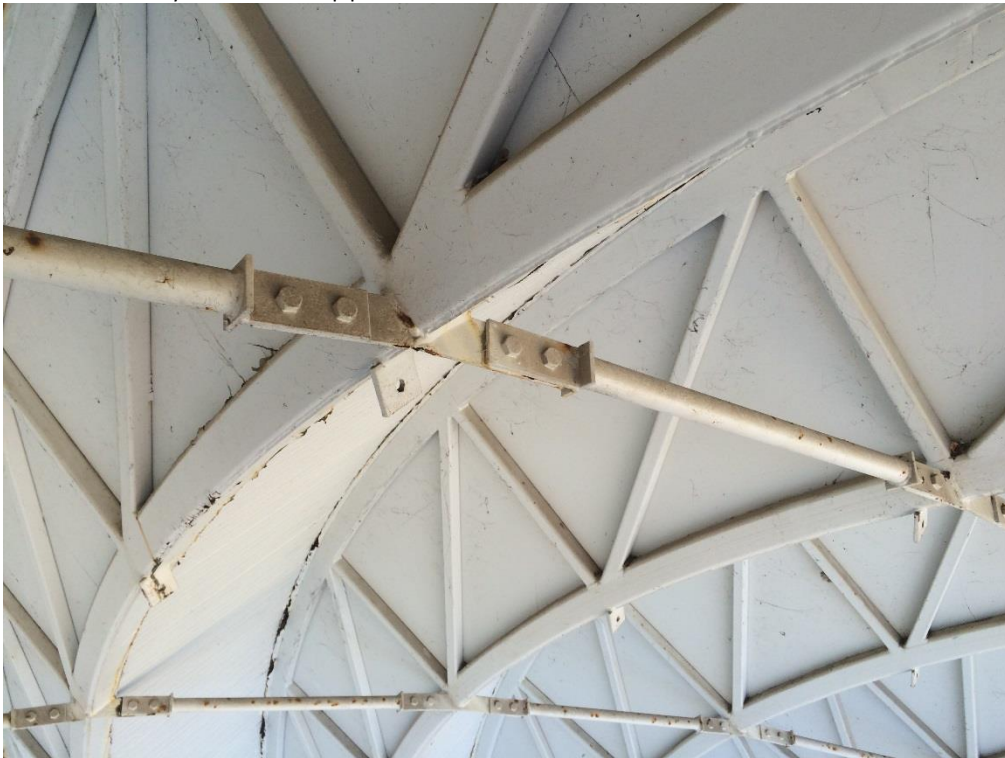
Photo 060 - Minor corrosion to bottom plate

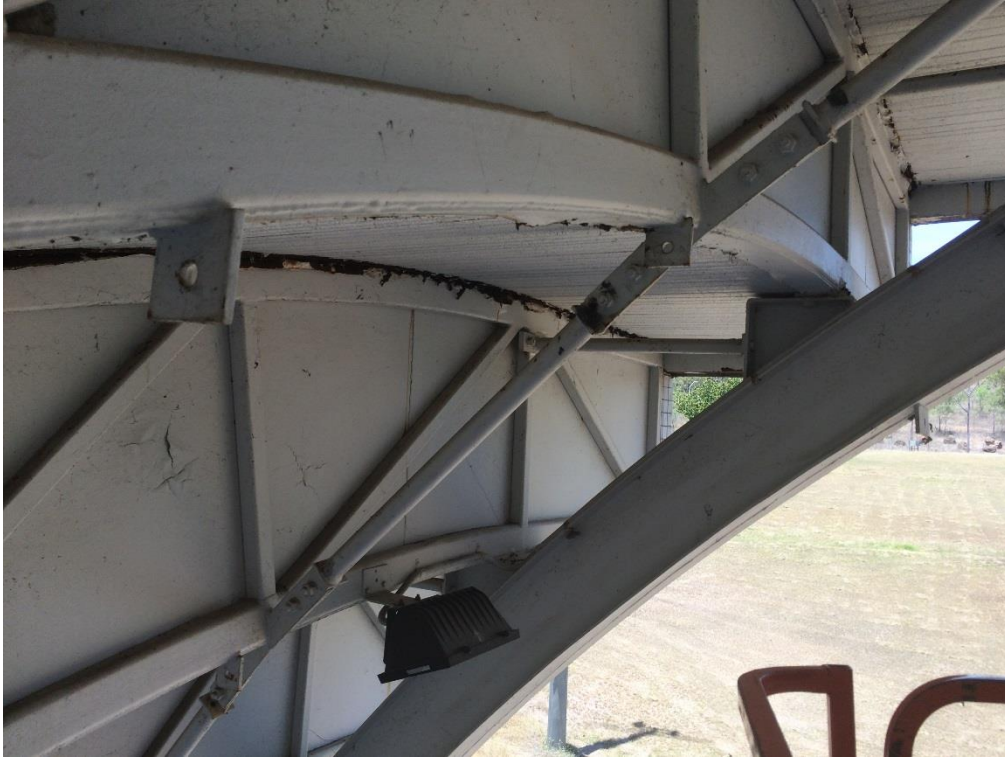
Photo 061 - minor corrosion to bottom plate

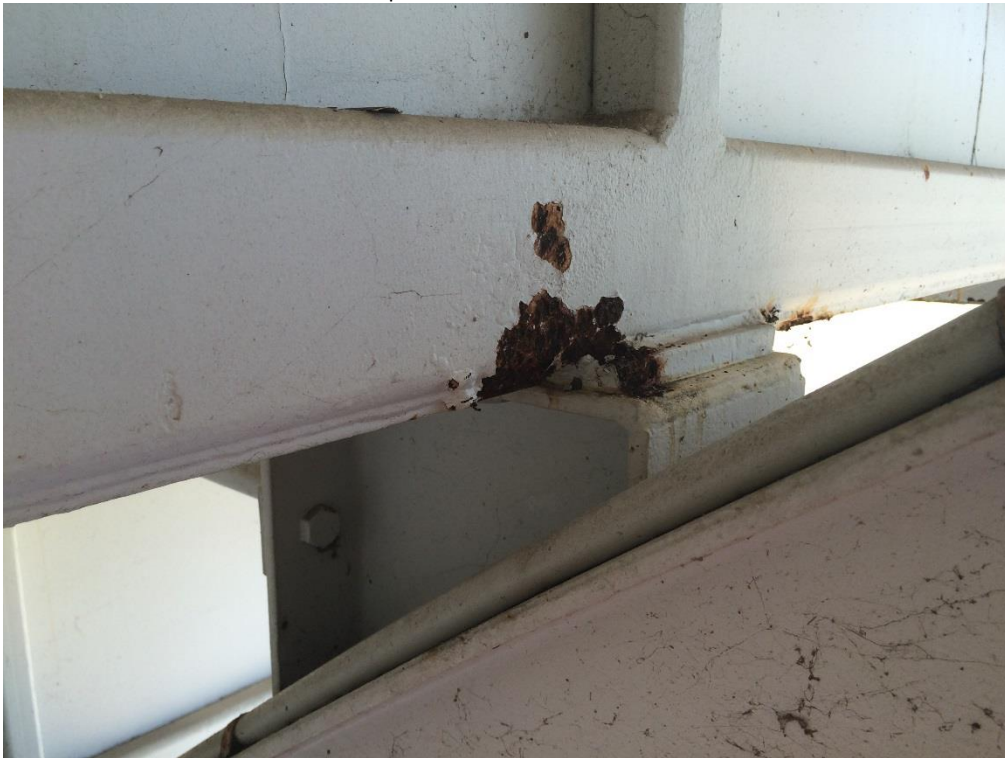
Photo 062 - Minor corrosion to bottom chord at stub

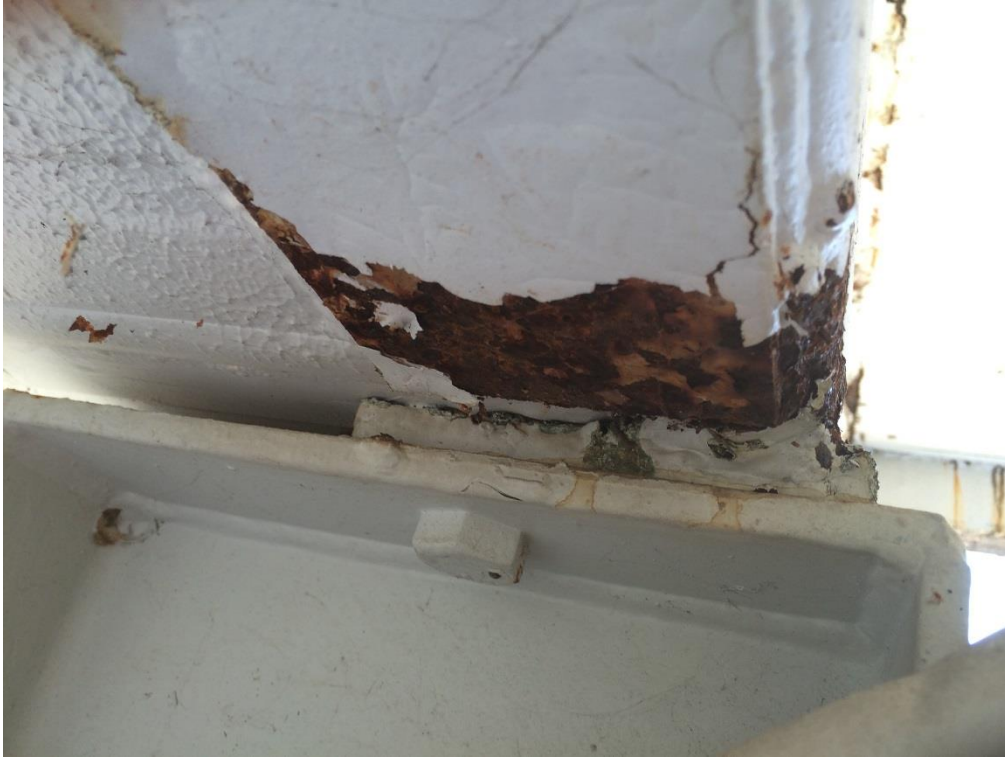
Photo 063 - Minor corrosion to bottom chord at stub

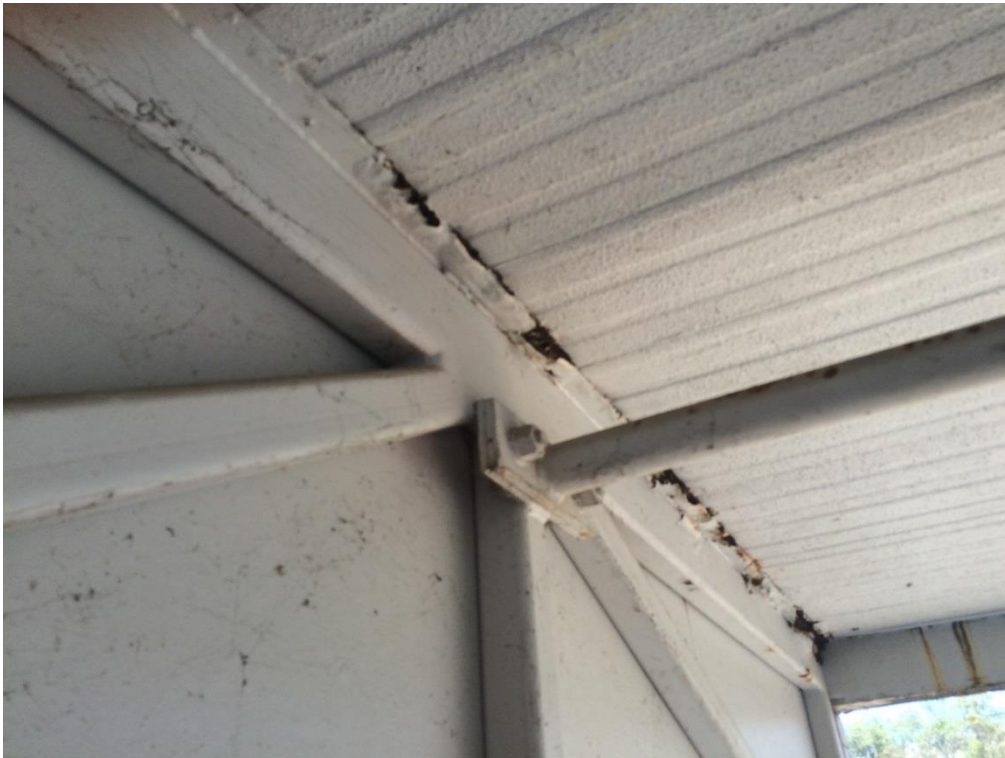
Photo 064 - Heavy corrosion to top plate

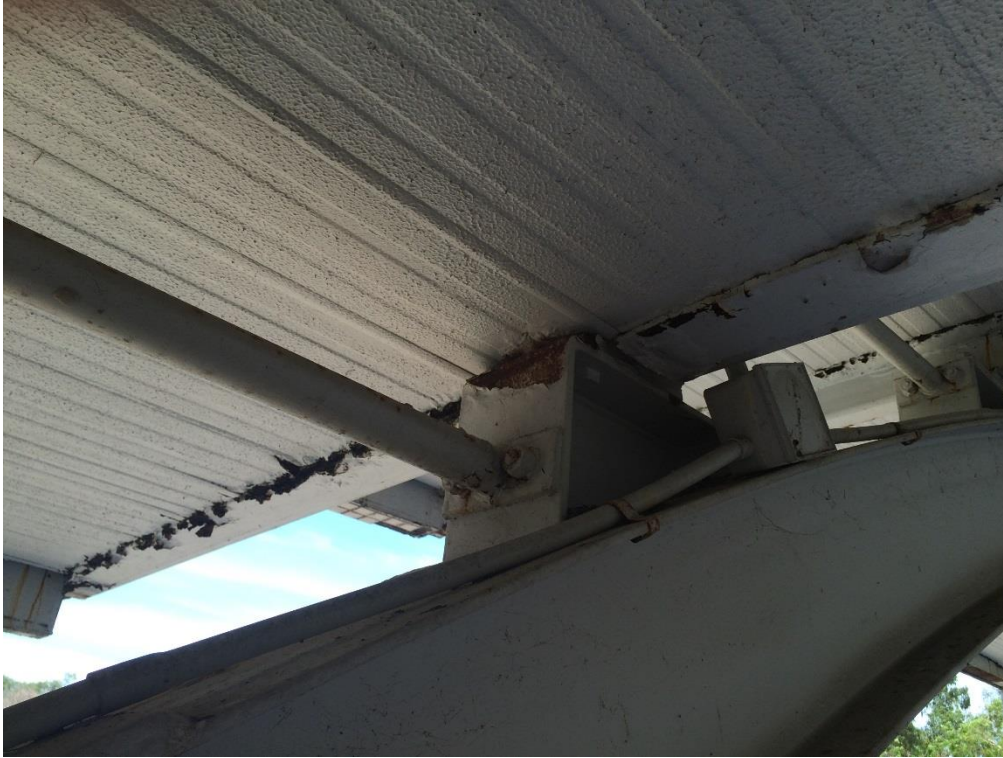
Photo 065 - Minor corrosion to bottom plate and stub

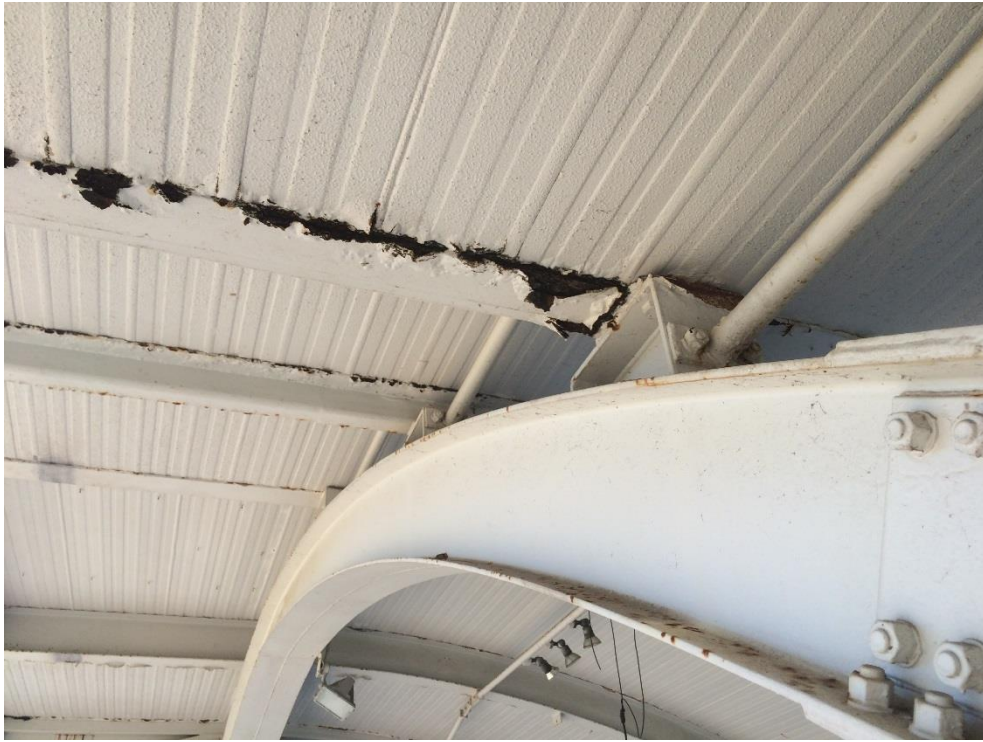
Photo 070 - Heavy corrosion to bottom plate

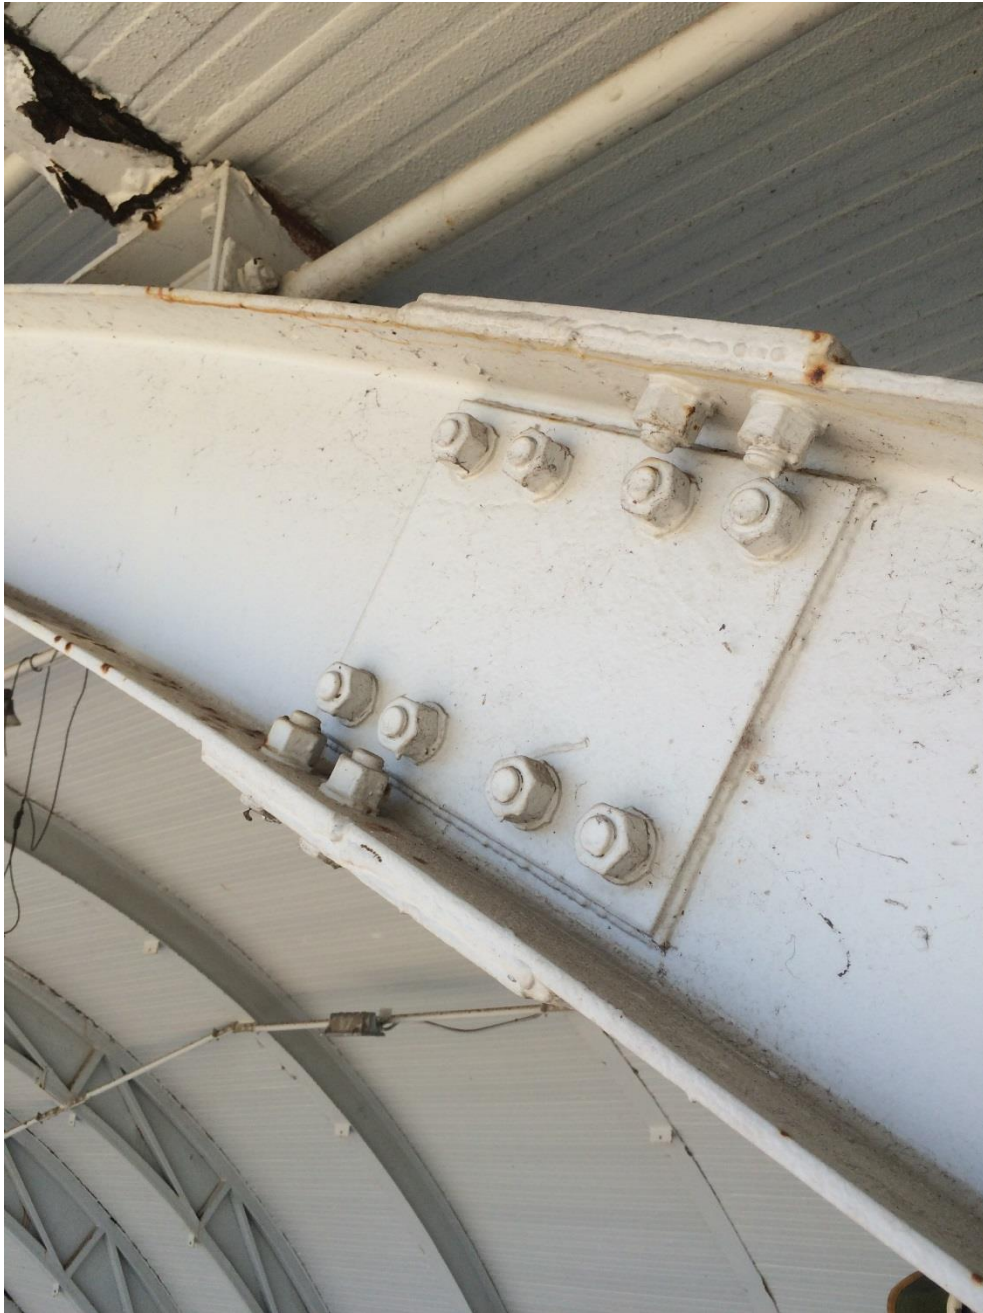
Photo 072 - Splice in good condition

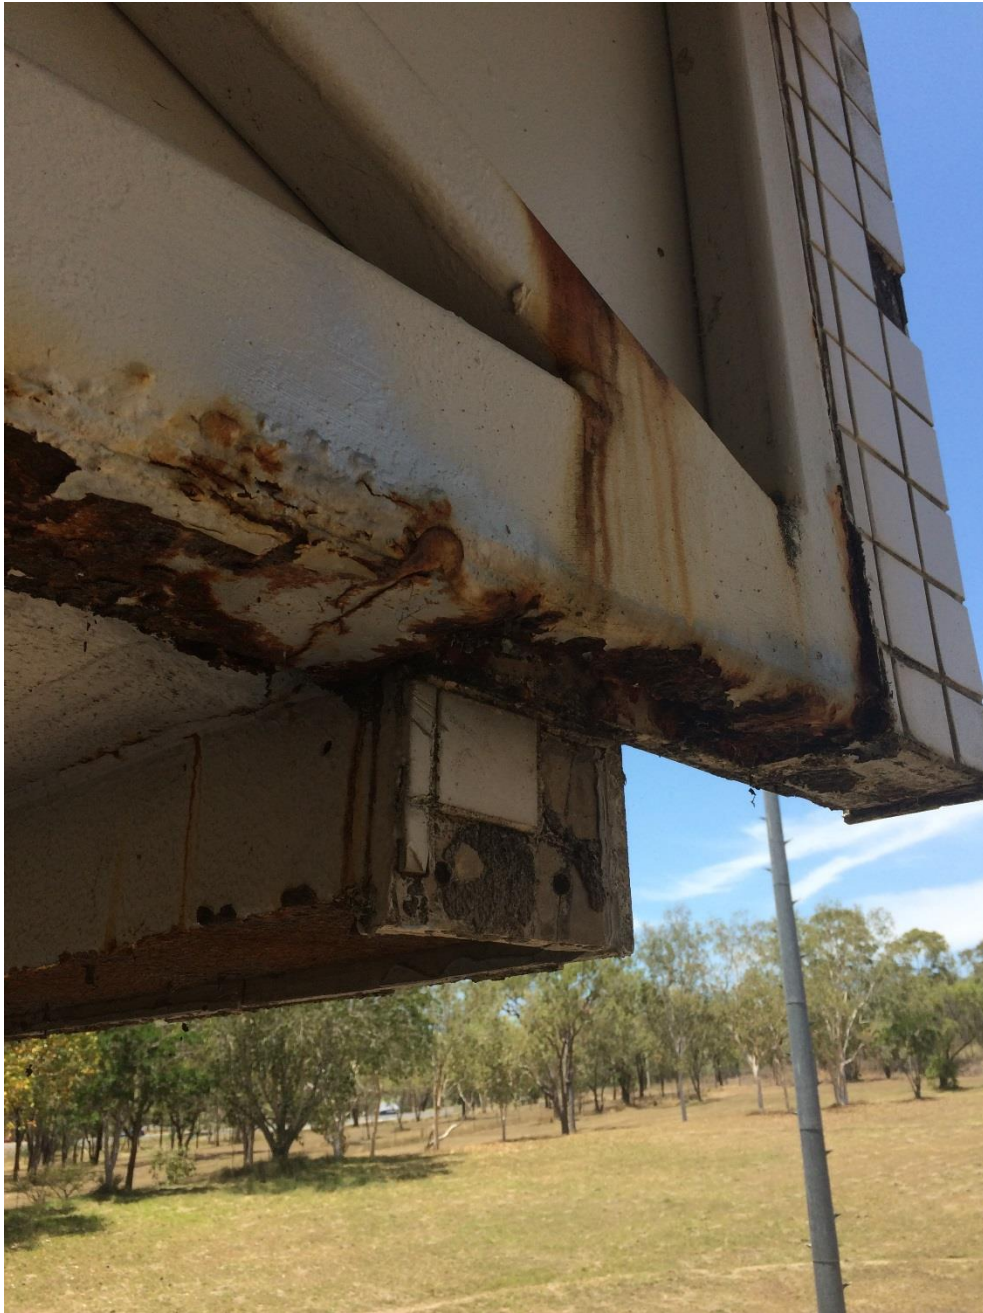
Photo 073 - Heavy corrosion to truss bottom chord at the exterior face of the soundshell

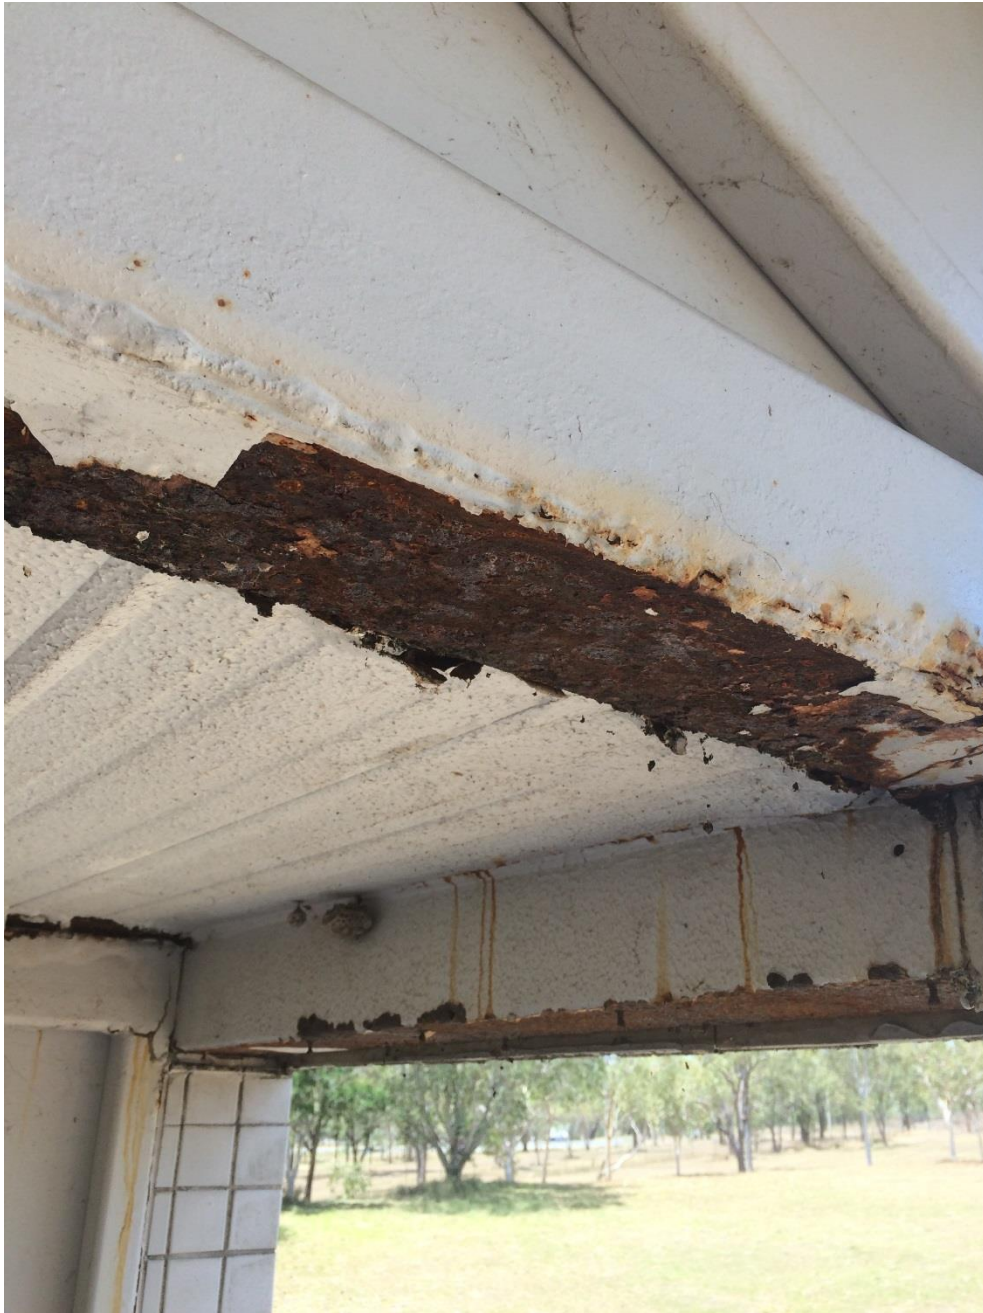
Photo 074 - Heavy corrosion to bottom plate

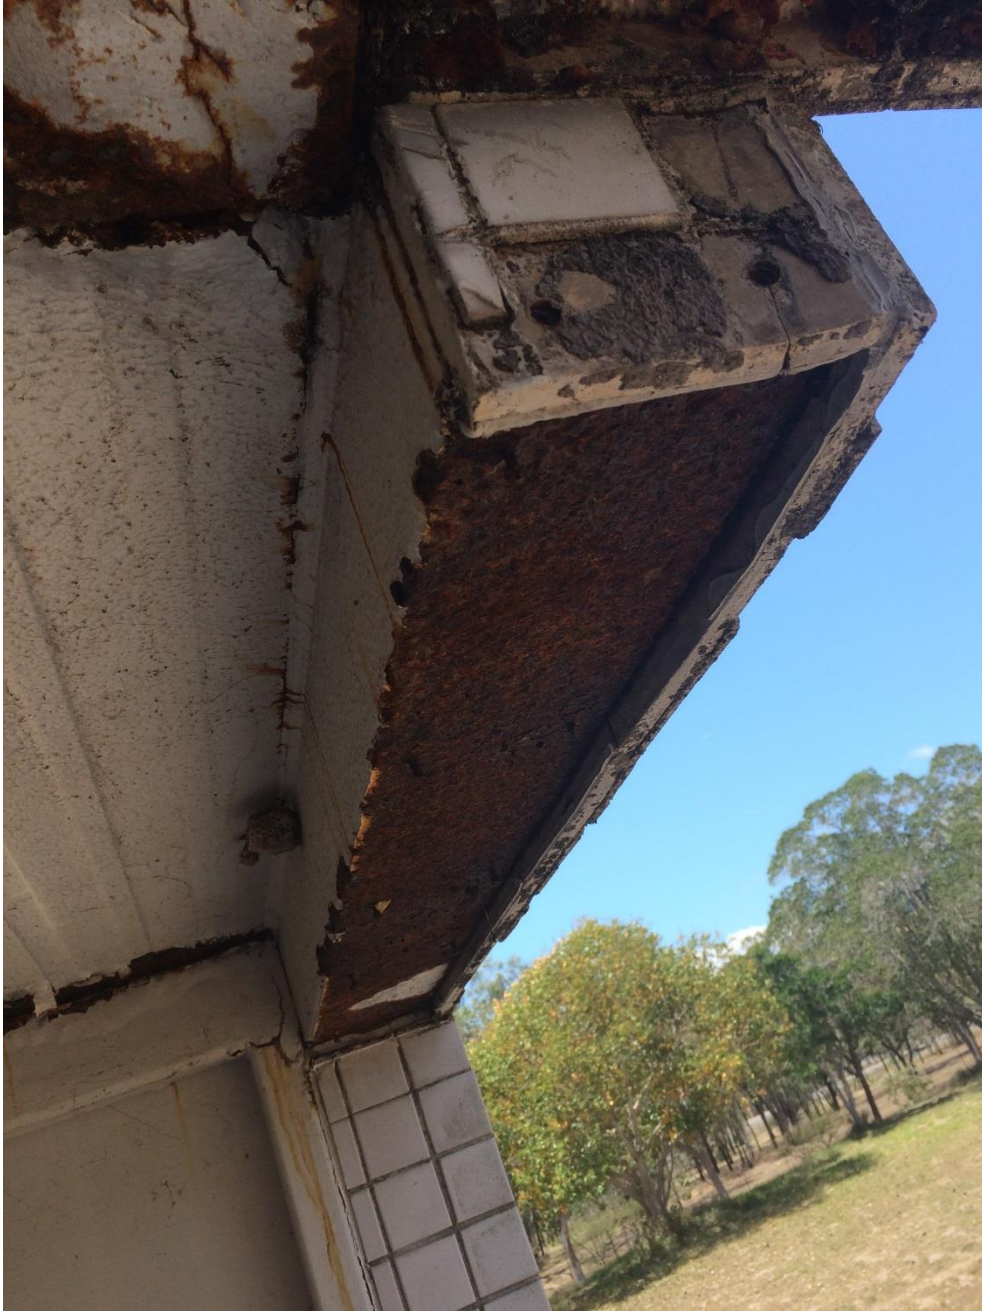
Corrosion has caused holes in the section.

Corrosion of this member is likely to allow further corrosion to the metal formwork.

Photo 075 - Heavy corrosion to steel fascia

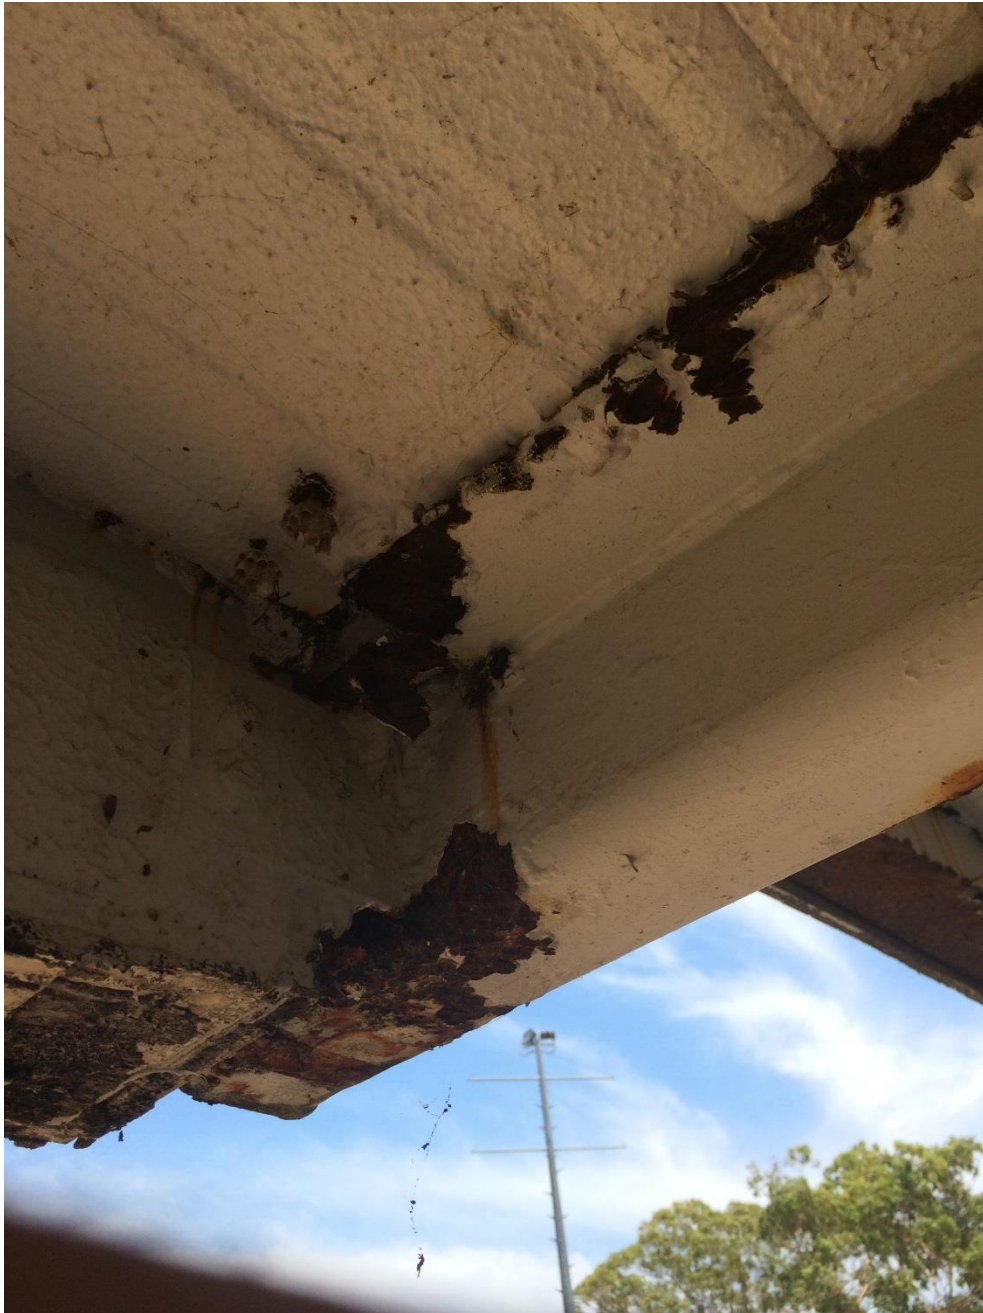
Photo 080 - Minor corrosion to bottom plate

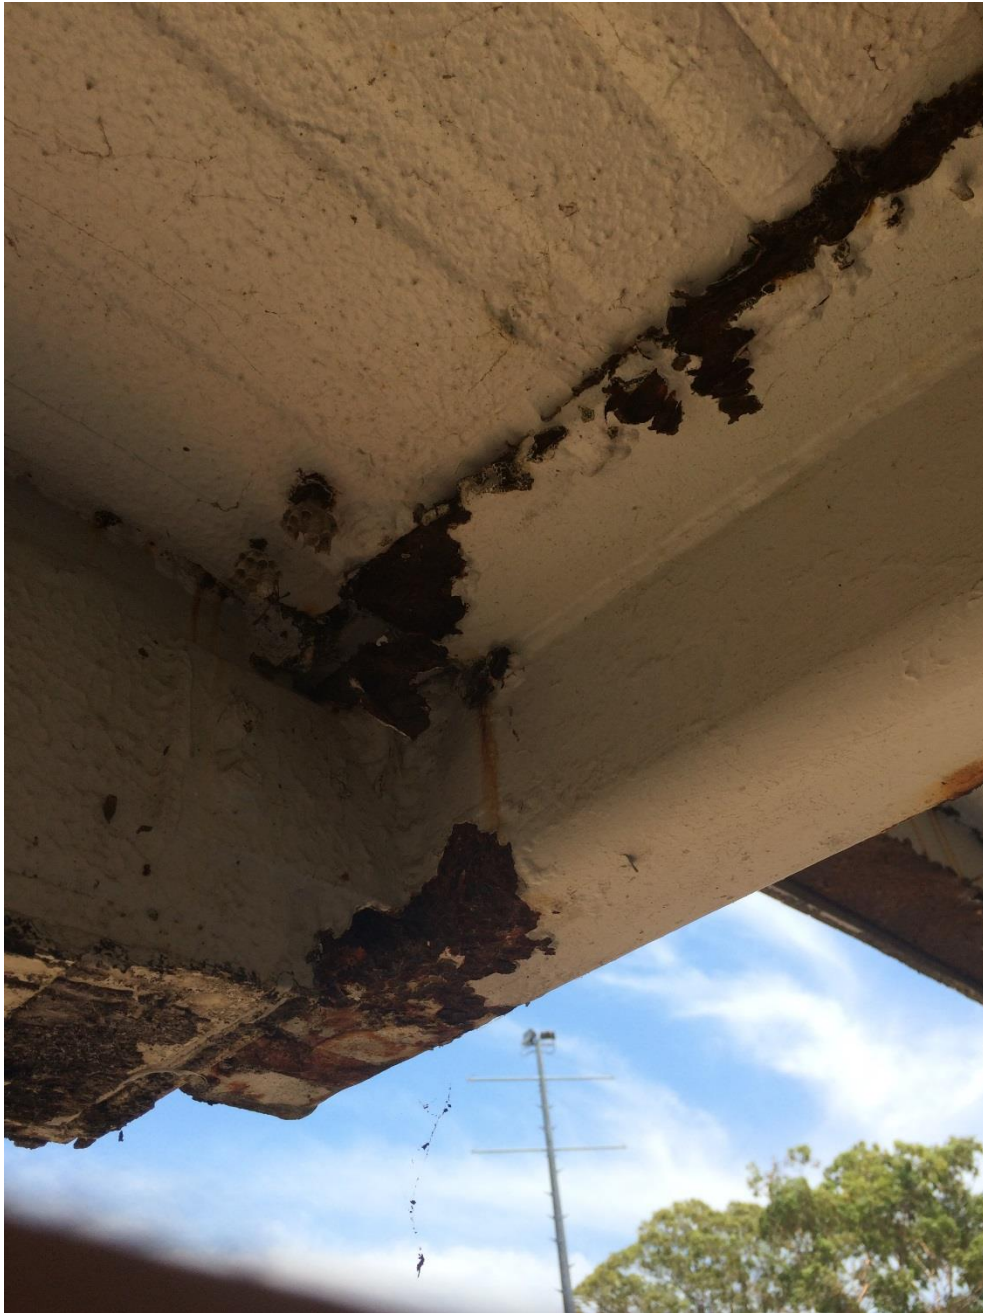
Photo 081 - Minor corrosion to truss bottom chord at the exterior face of the soundshell

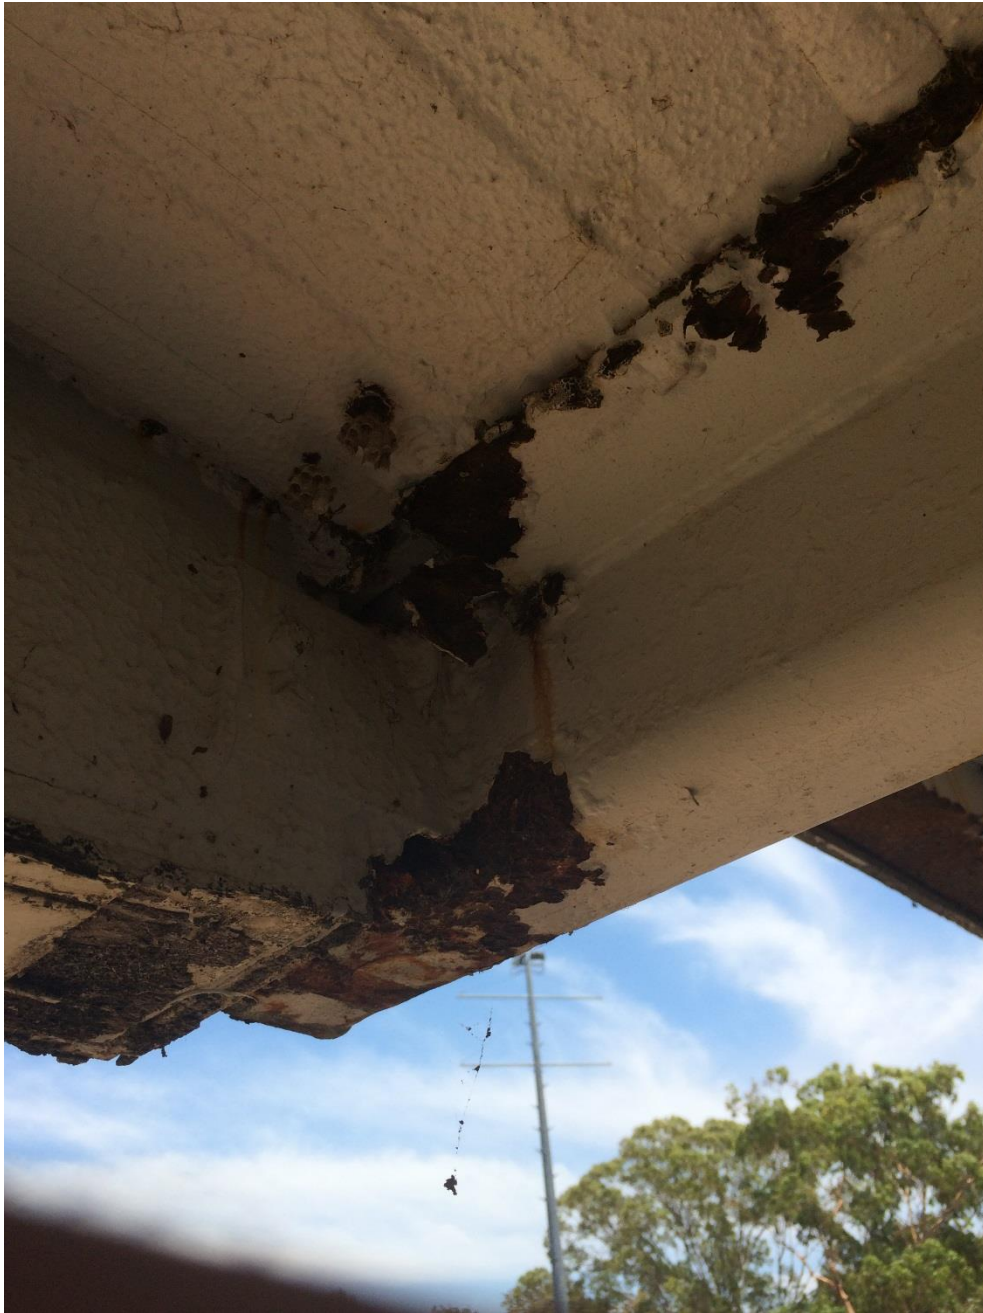
Photo 082 - Minor corrosion to truss bottom chord at the exterior face of the soundshell

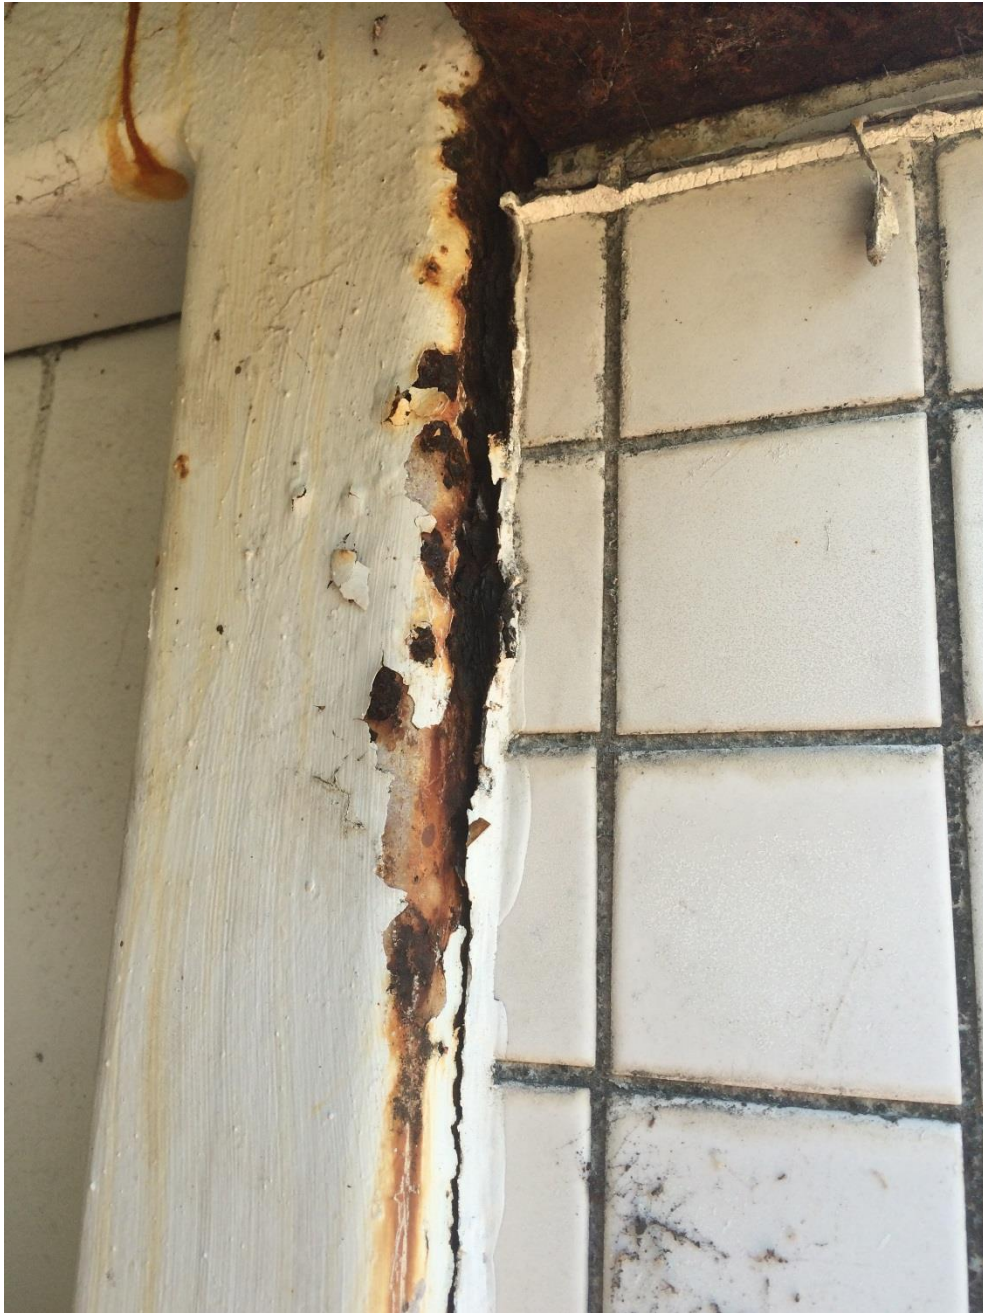
Photo 089 - Heavy corrosion to truss web at exterior face of the soundshell

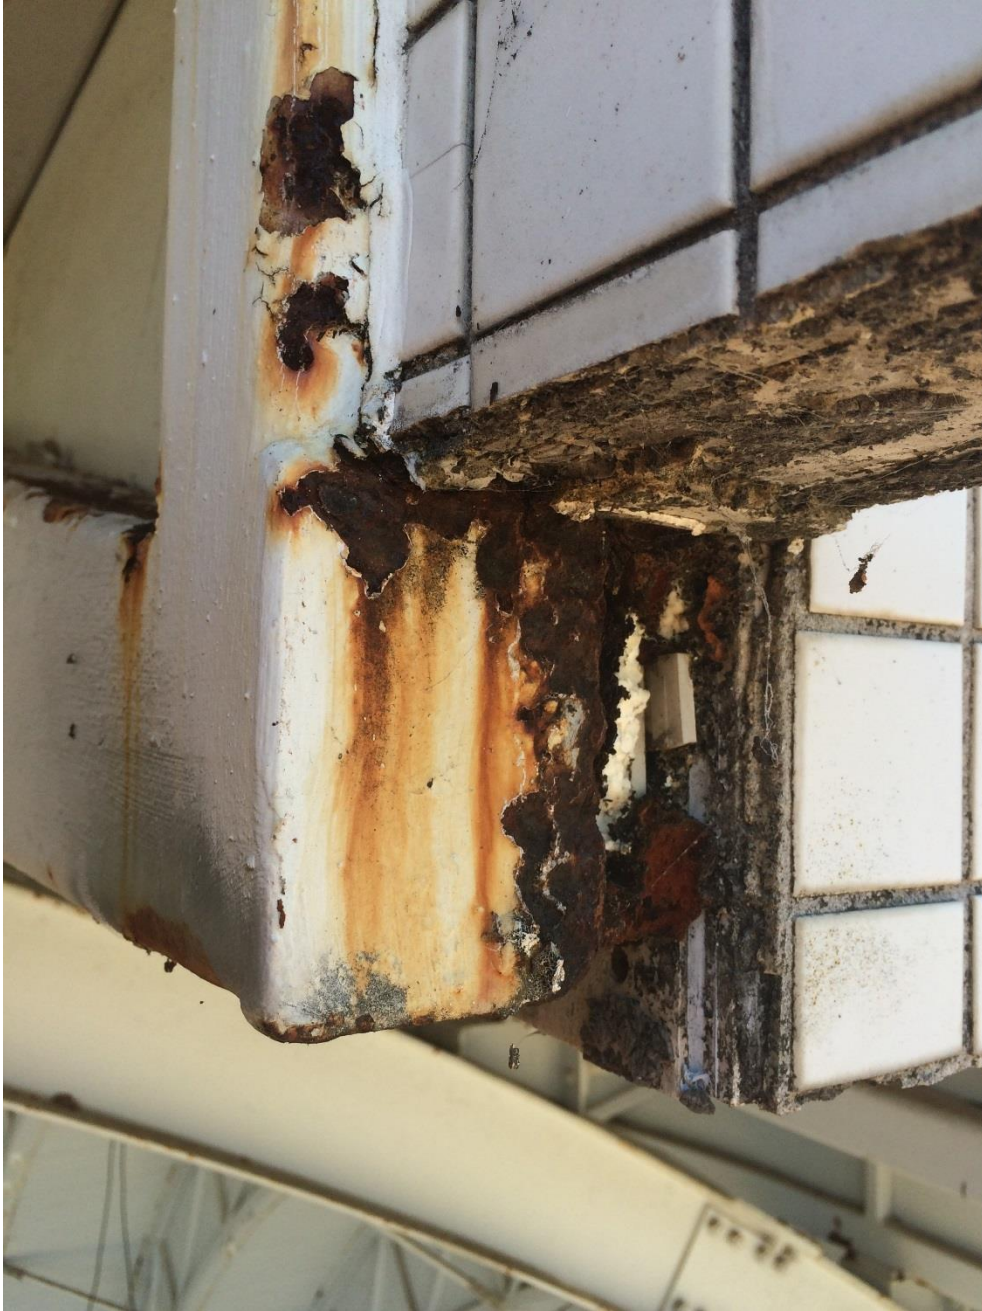
Photo 090 - Heavy corrosion to truss web at exterior face of the soundshell

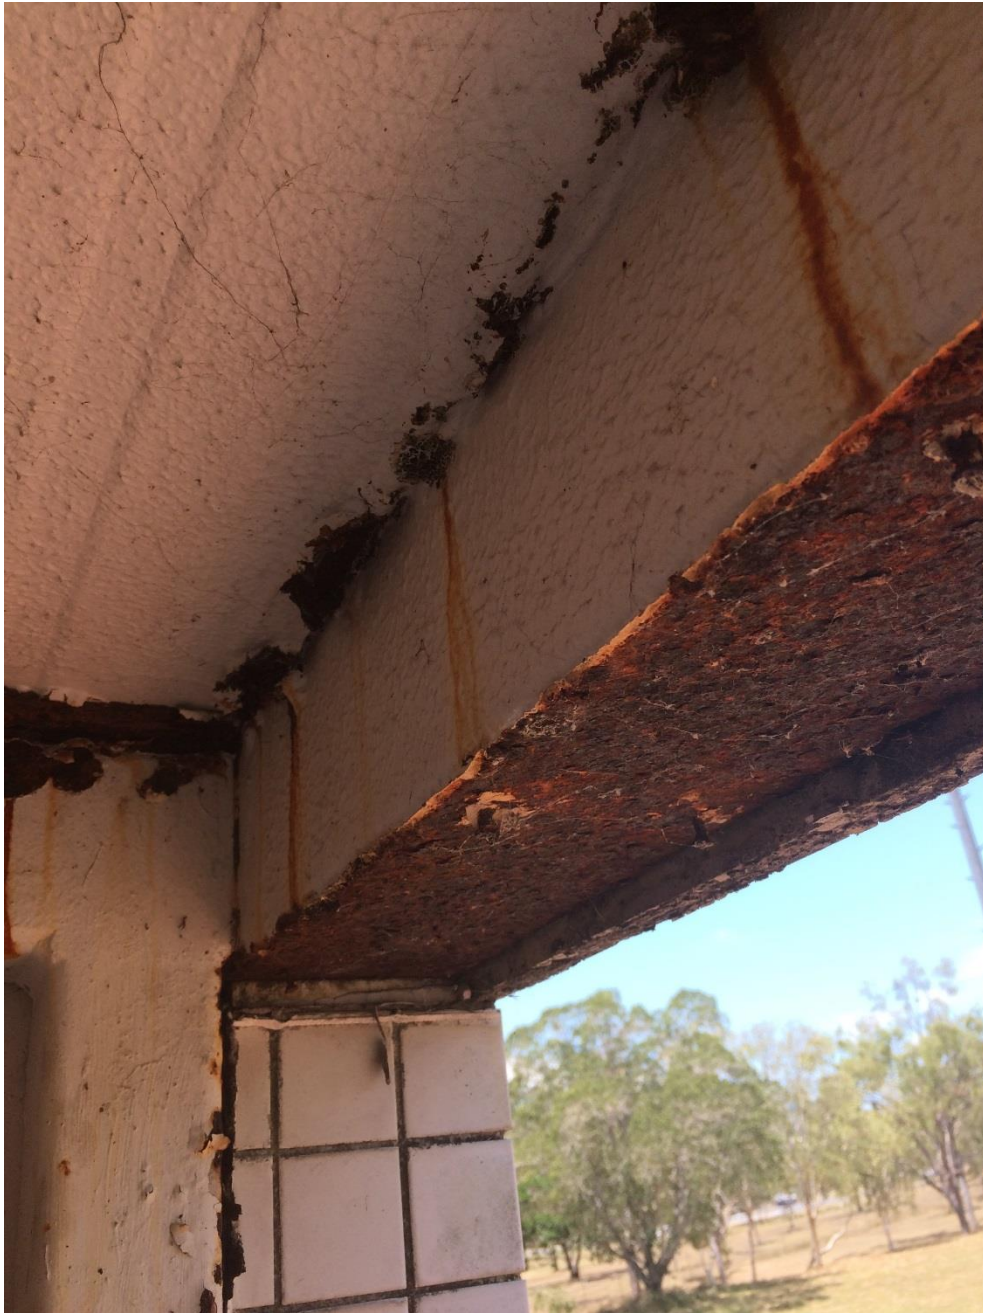
Photo 091 - Heavy corrosion to fascia

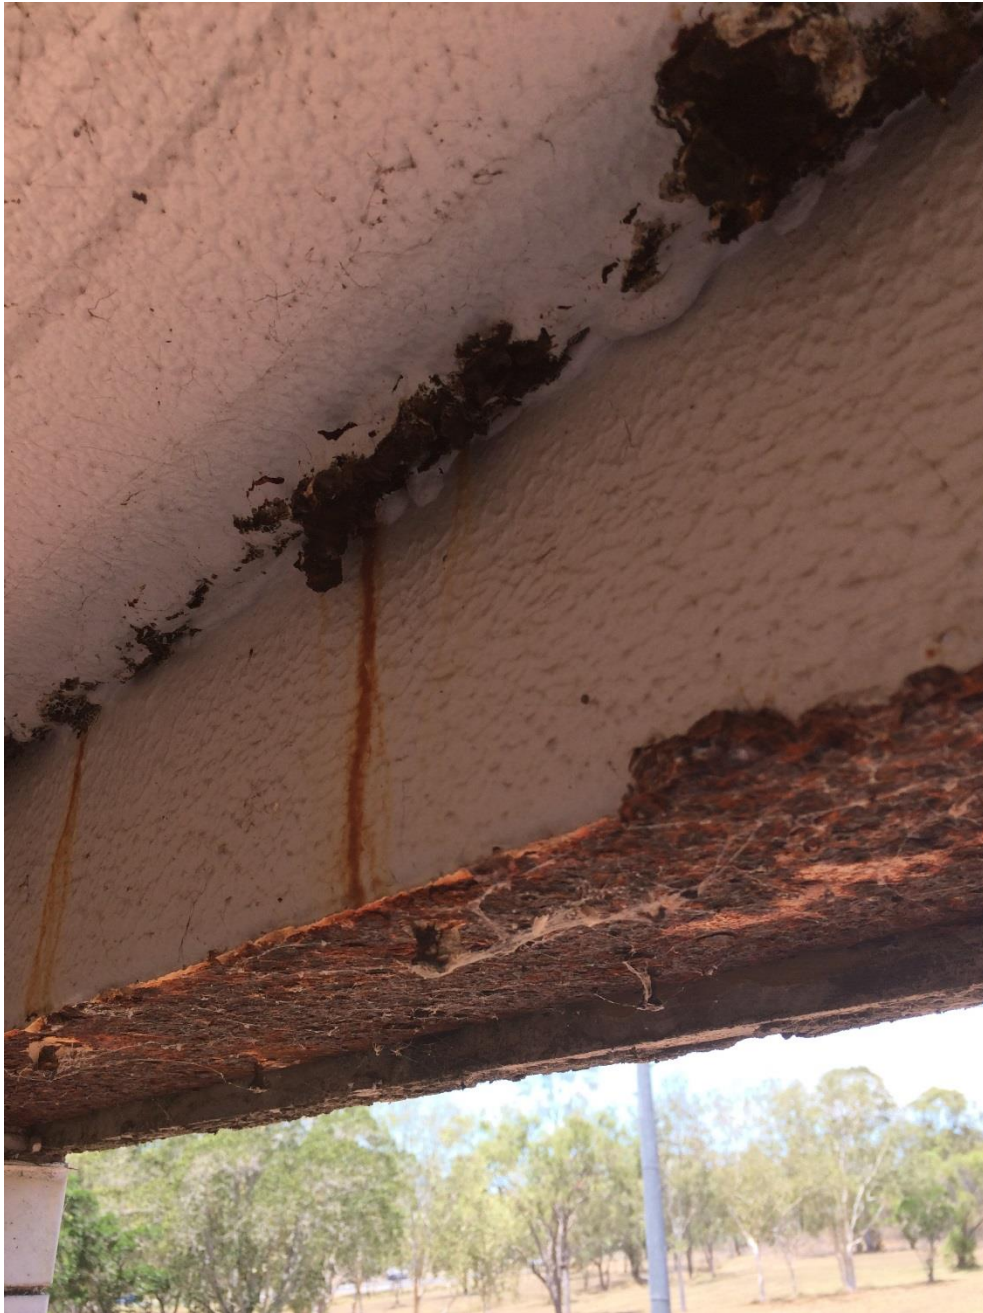
Photo 092 - Heavy corrosion to fascia

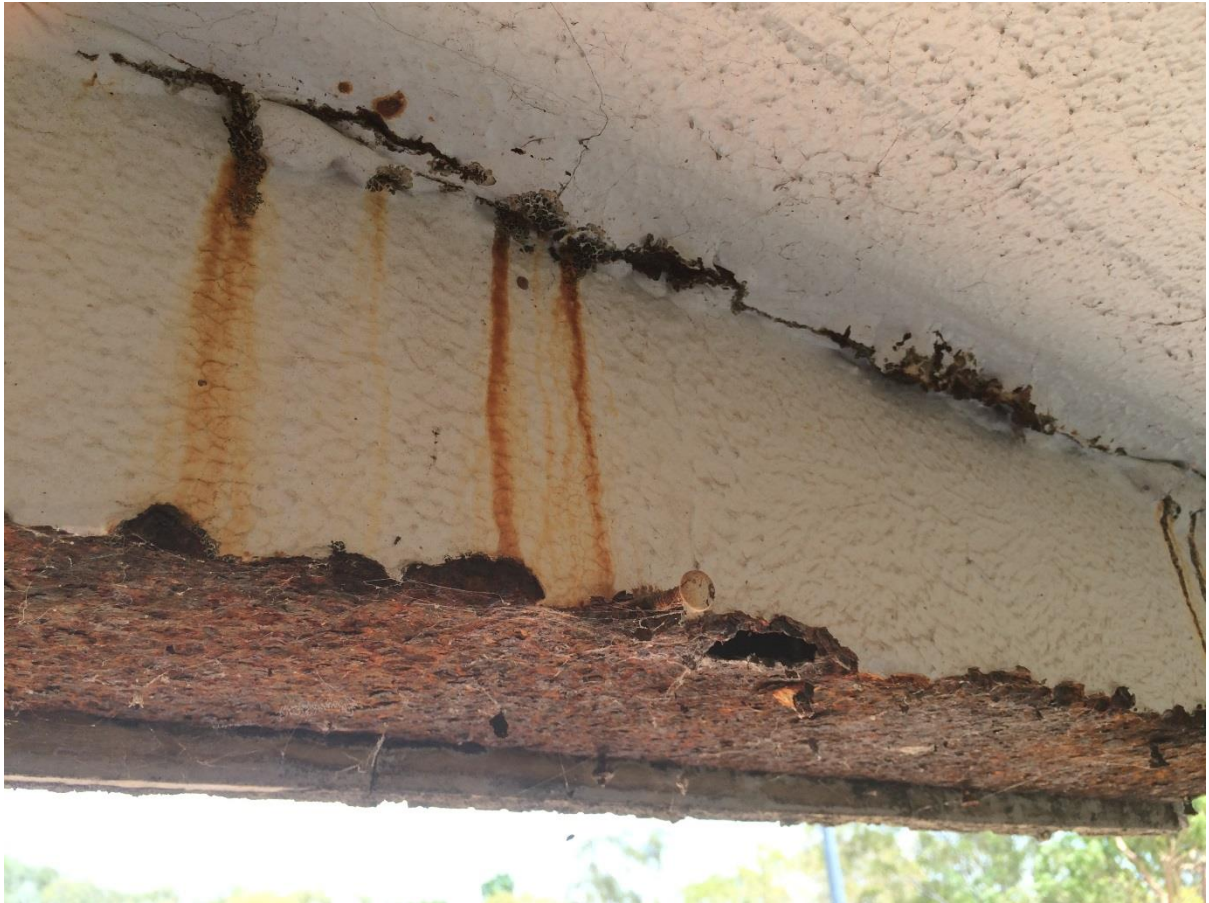
Photo 095 - Heavy corrosion to fascia

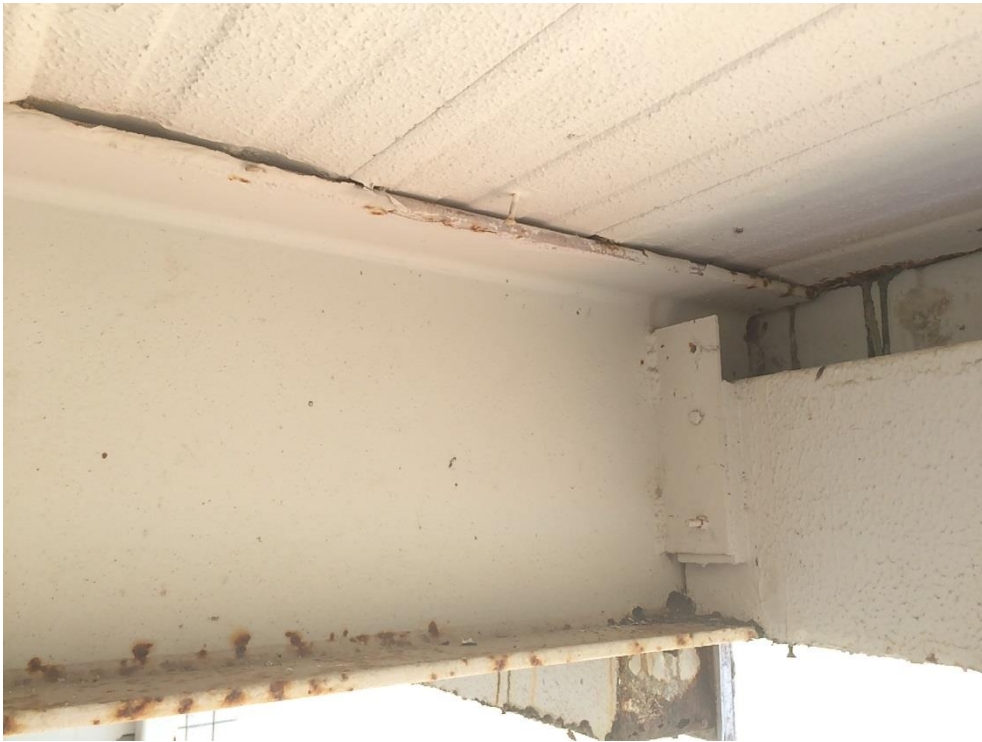
Photo 098 - Minor corrosion to roof beam

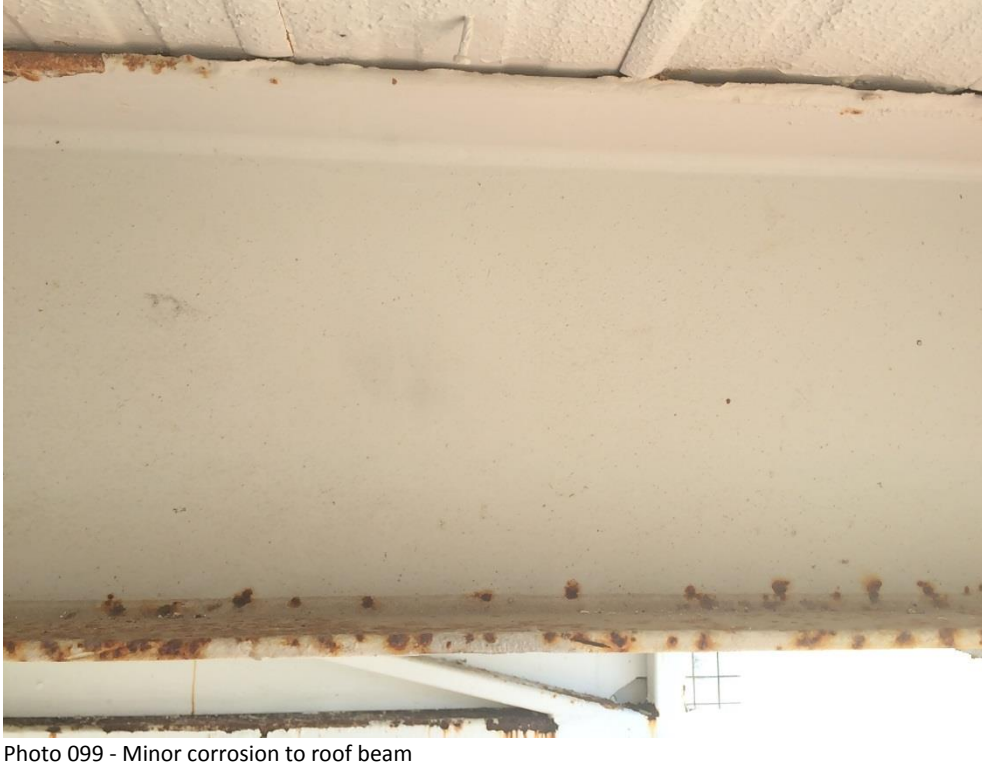
Photo 099 - Minor corrosion to roof beam

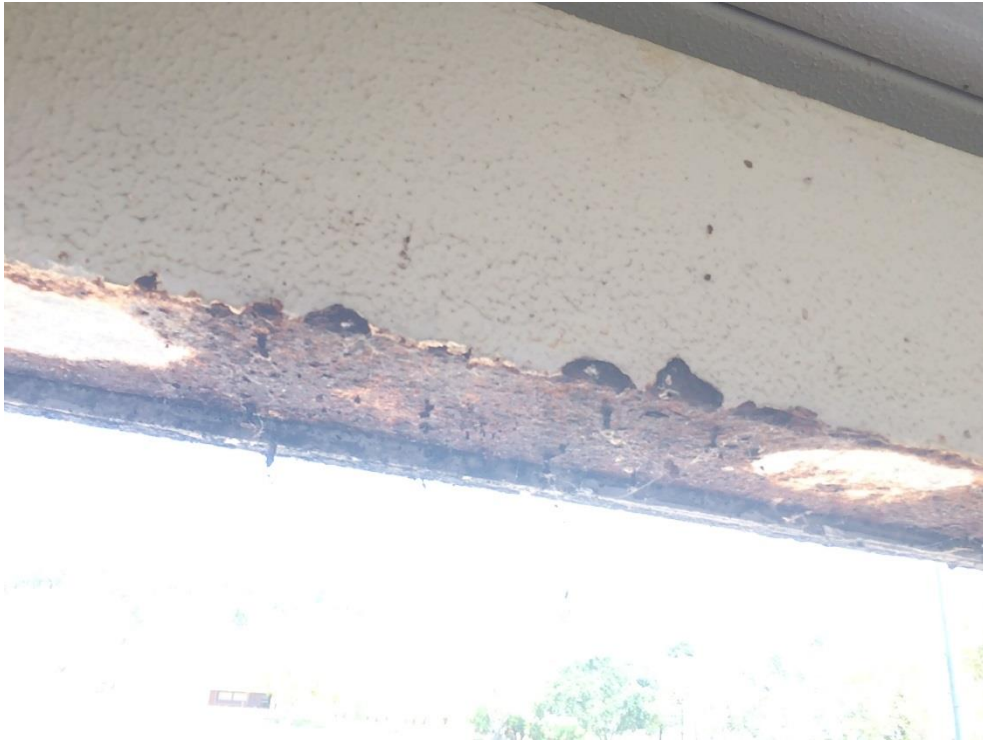
Photo 103 - Heavy corrosion to fascia
