Music Bowl Structural Assessment

24 November 2014

R14265

Prepared for Rockhampton Regional Council

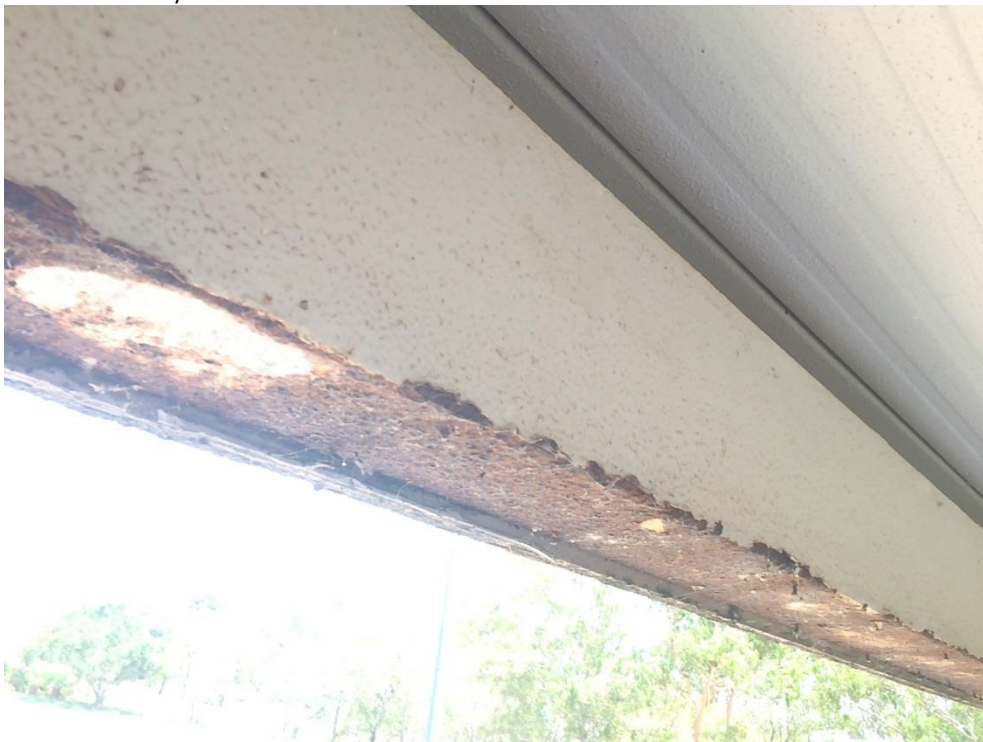
Photo 104 - Heavy corrosion to fascia

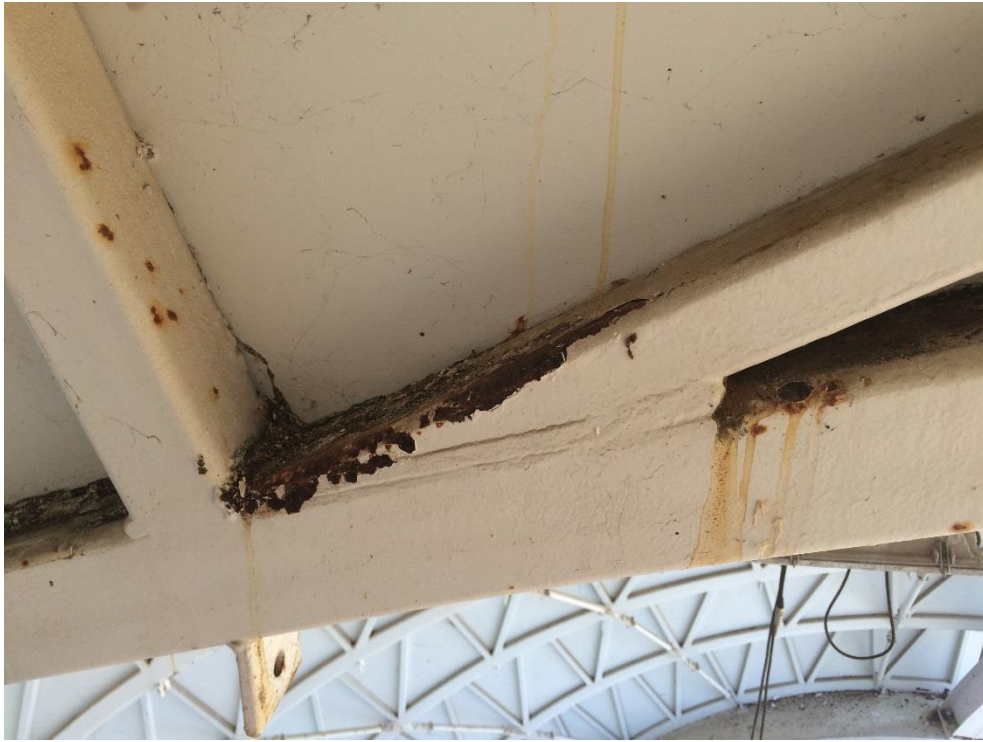
Photo 109 - Minor corrosion to web member

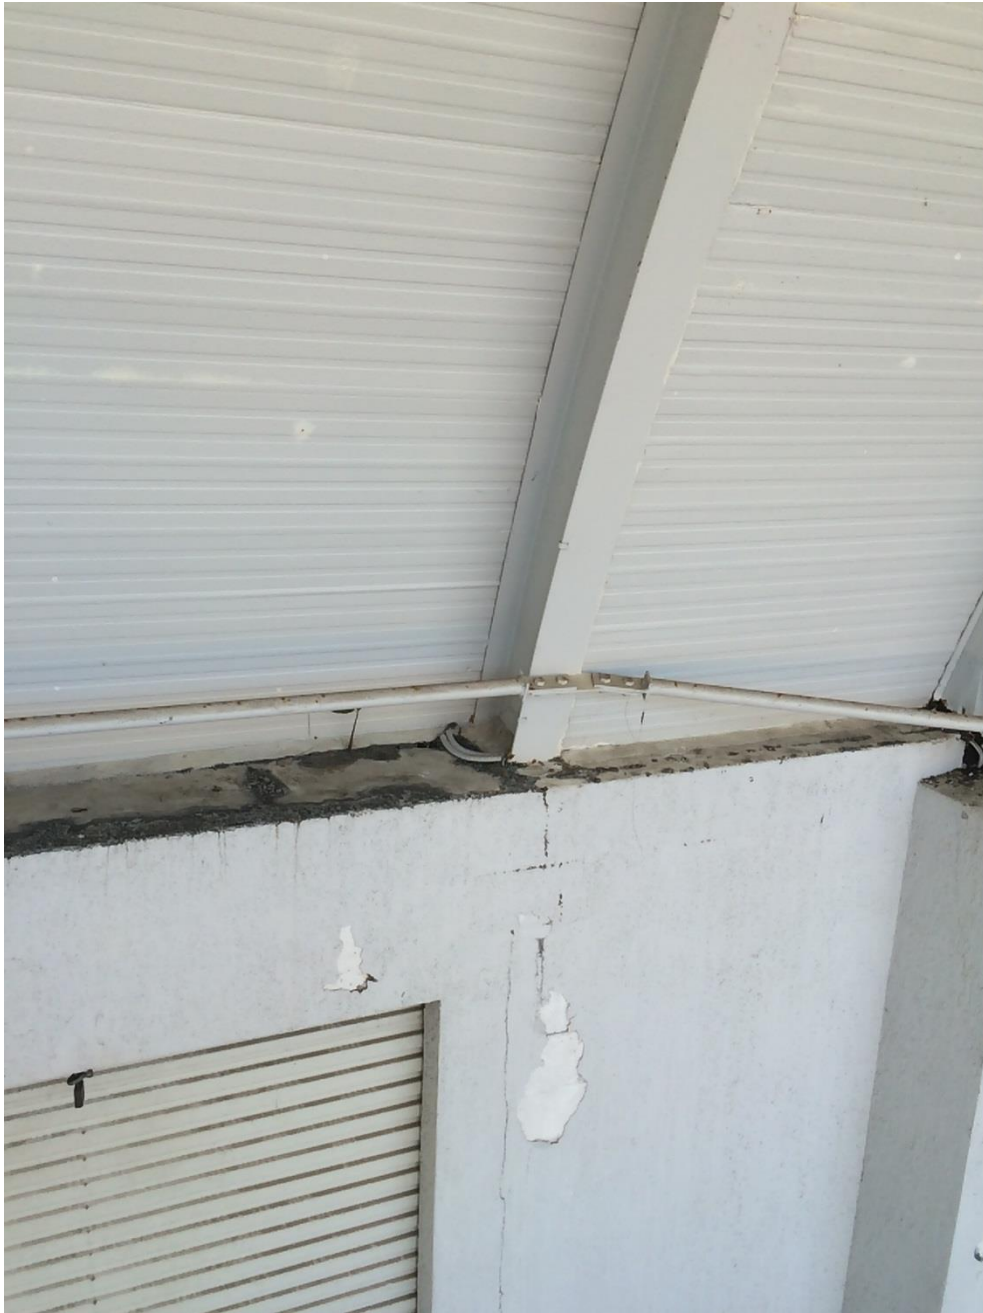
Photo 111 - Minor corrosion to roof beam to concrete interface

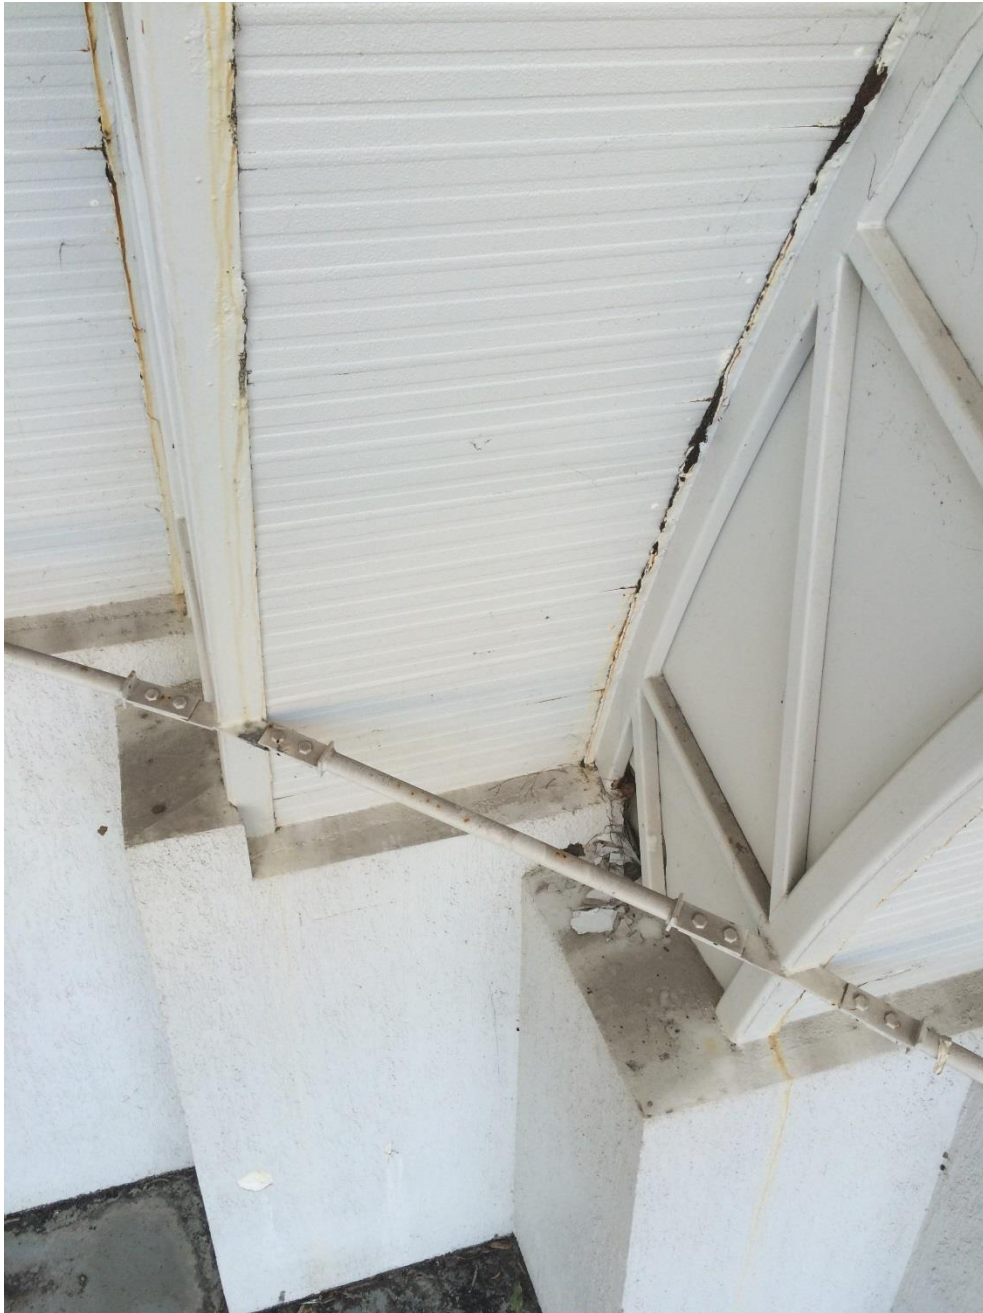
Photo 118 - Minor corrosion to truss to concrete interface

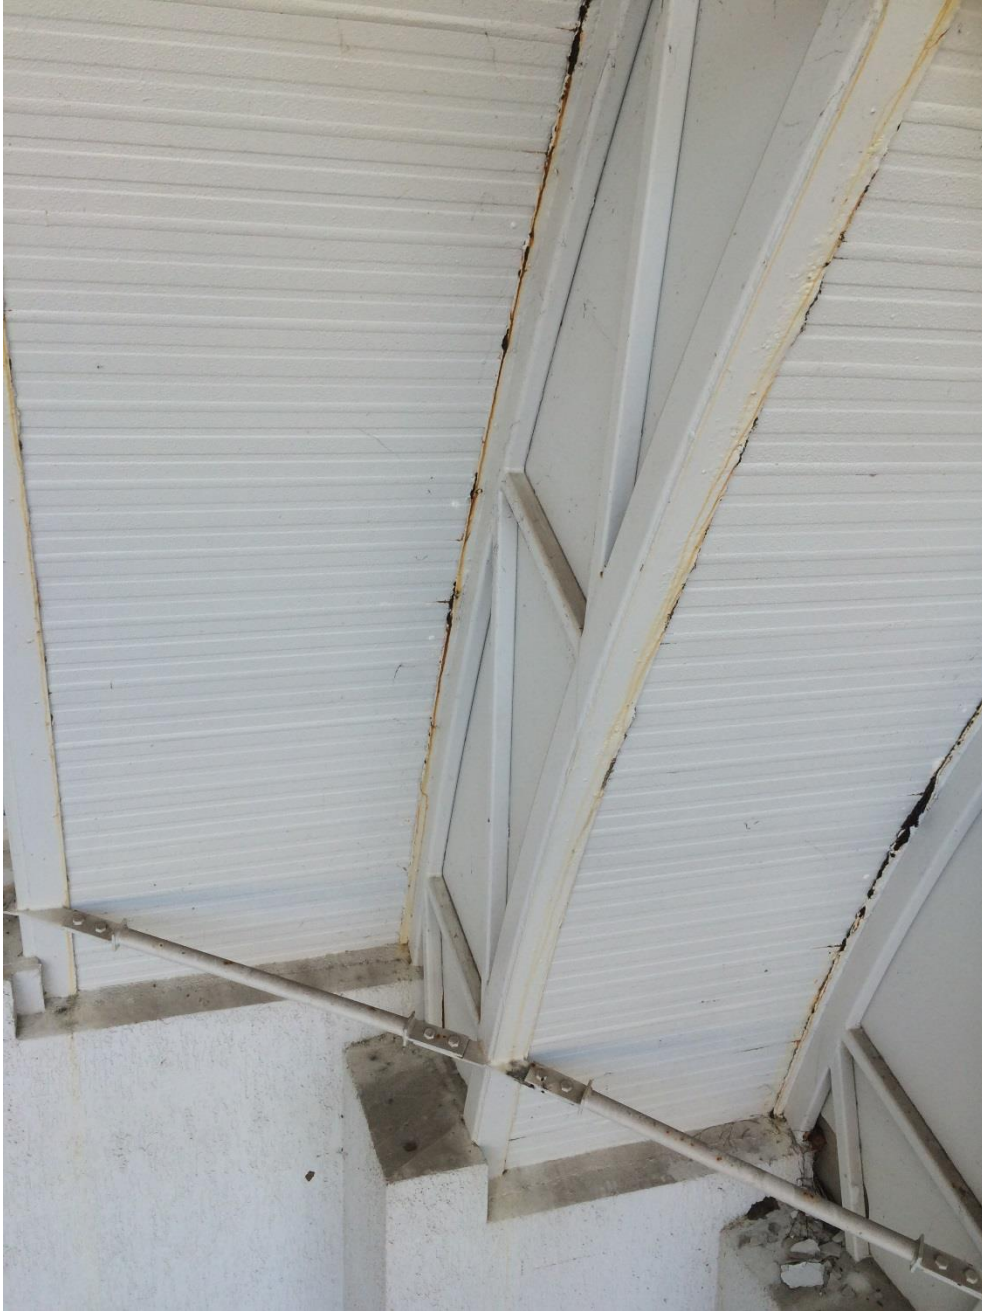
Photo 119 - Minor corrosion to truss top and bottom plate

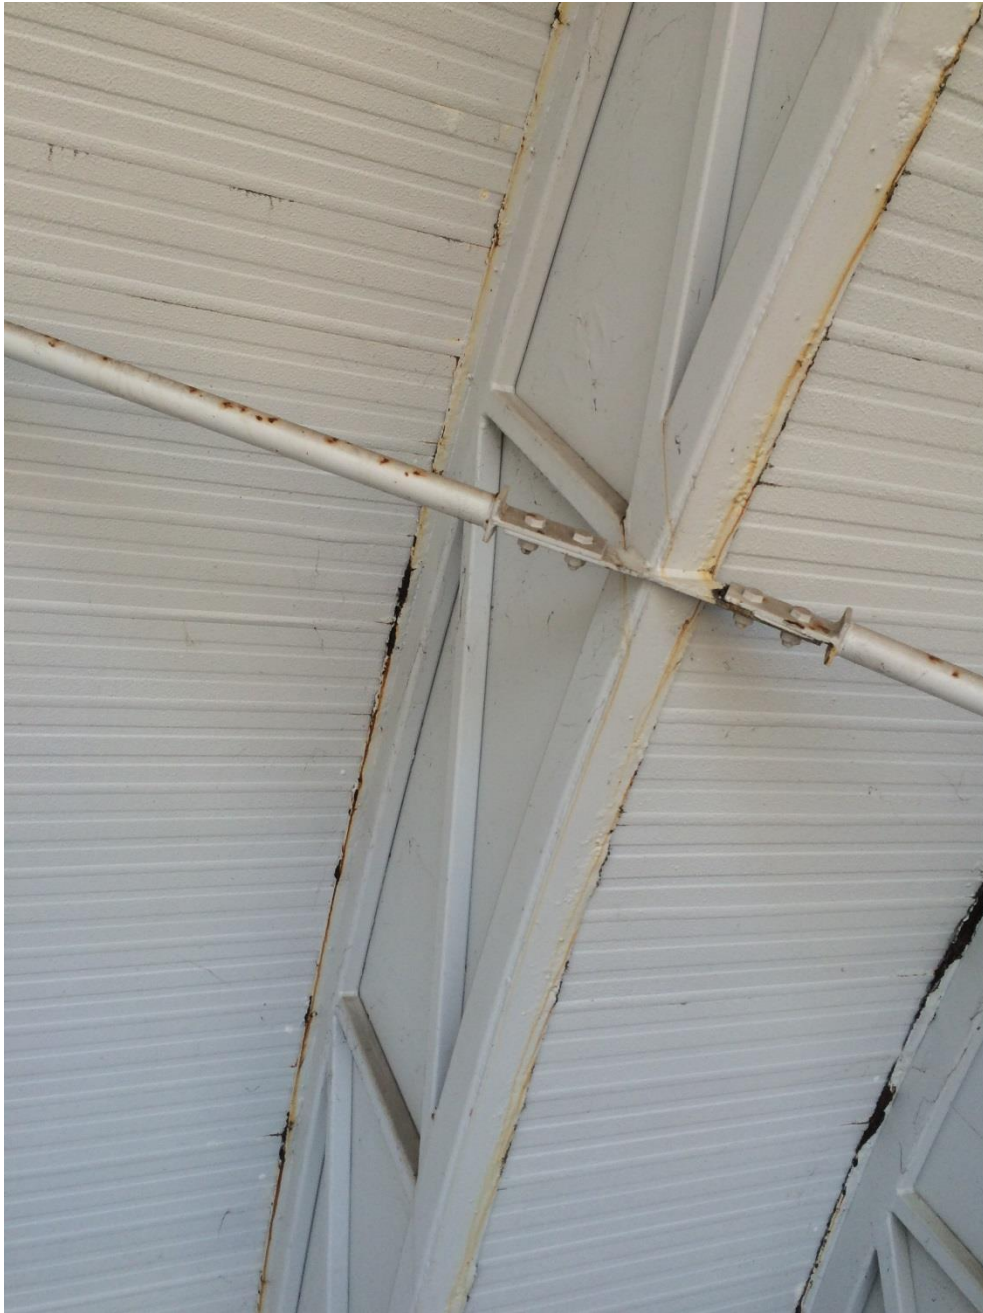
Photo 120 - Minor corrosion to truss top and bottom plate

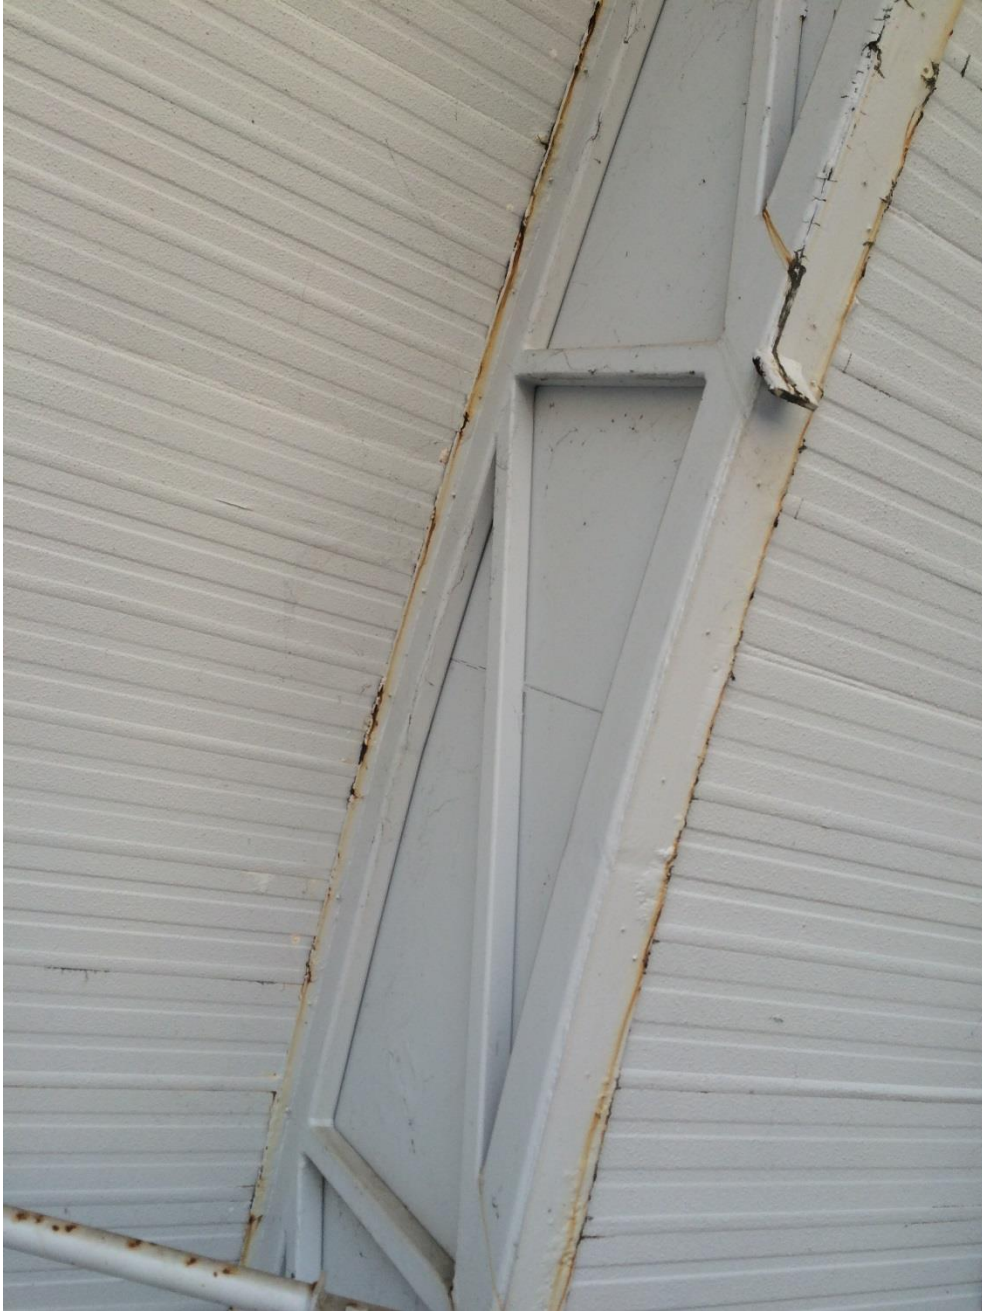
Photo 121 - Minor corrosion to truss top and bottom plate

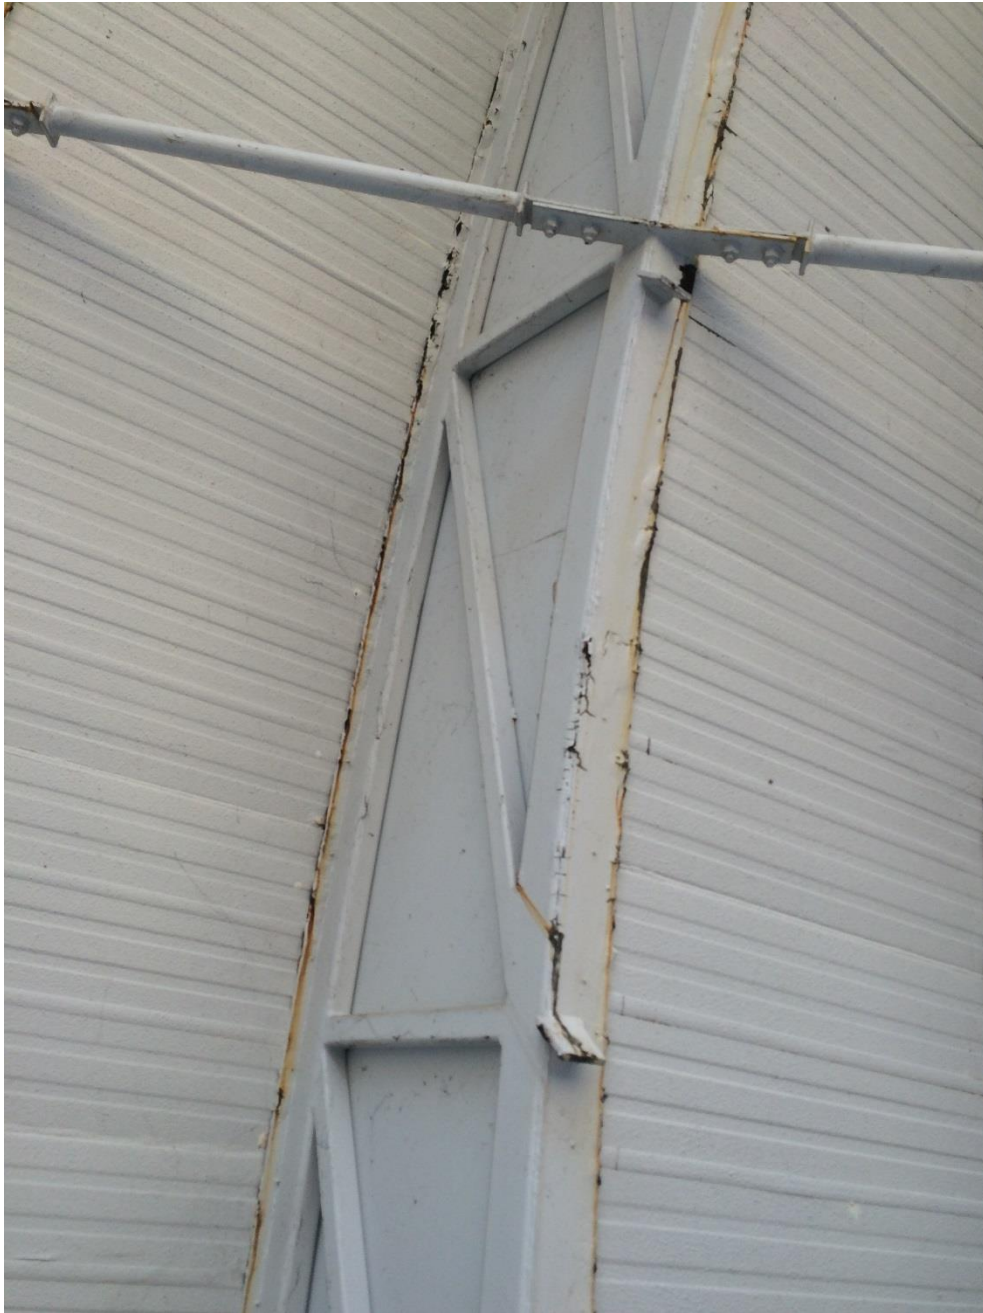
Photo 122 - Minor corrosion to truss top and bottom plate

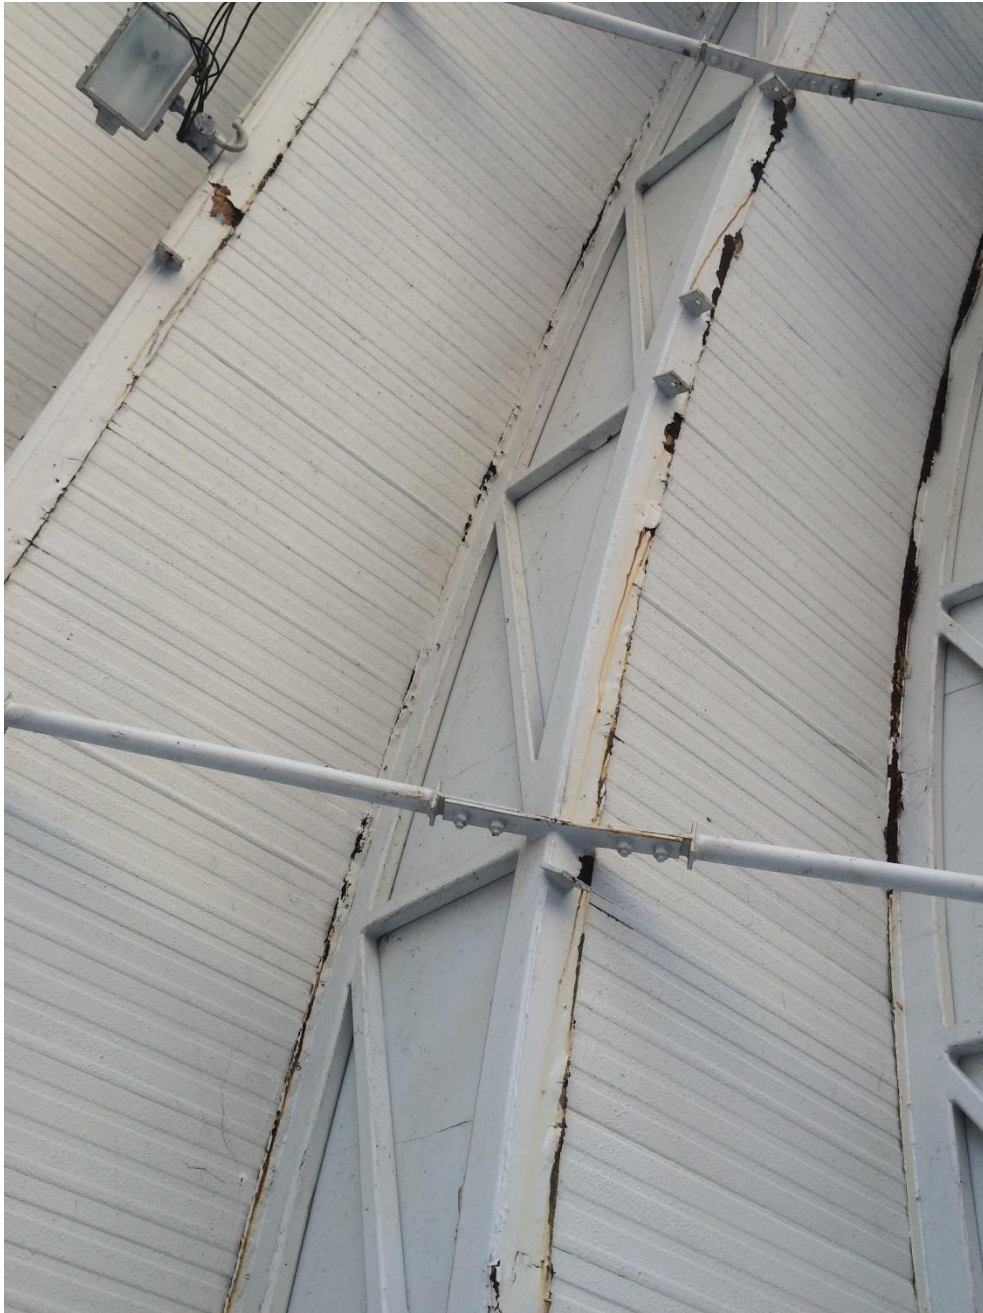
Photo 123 - Minor corrosion to truss top and bottom plate

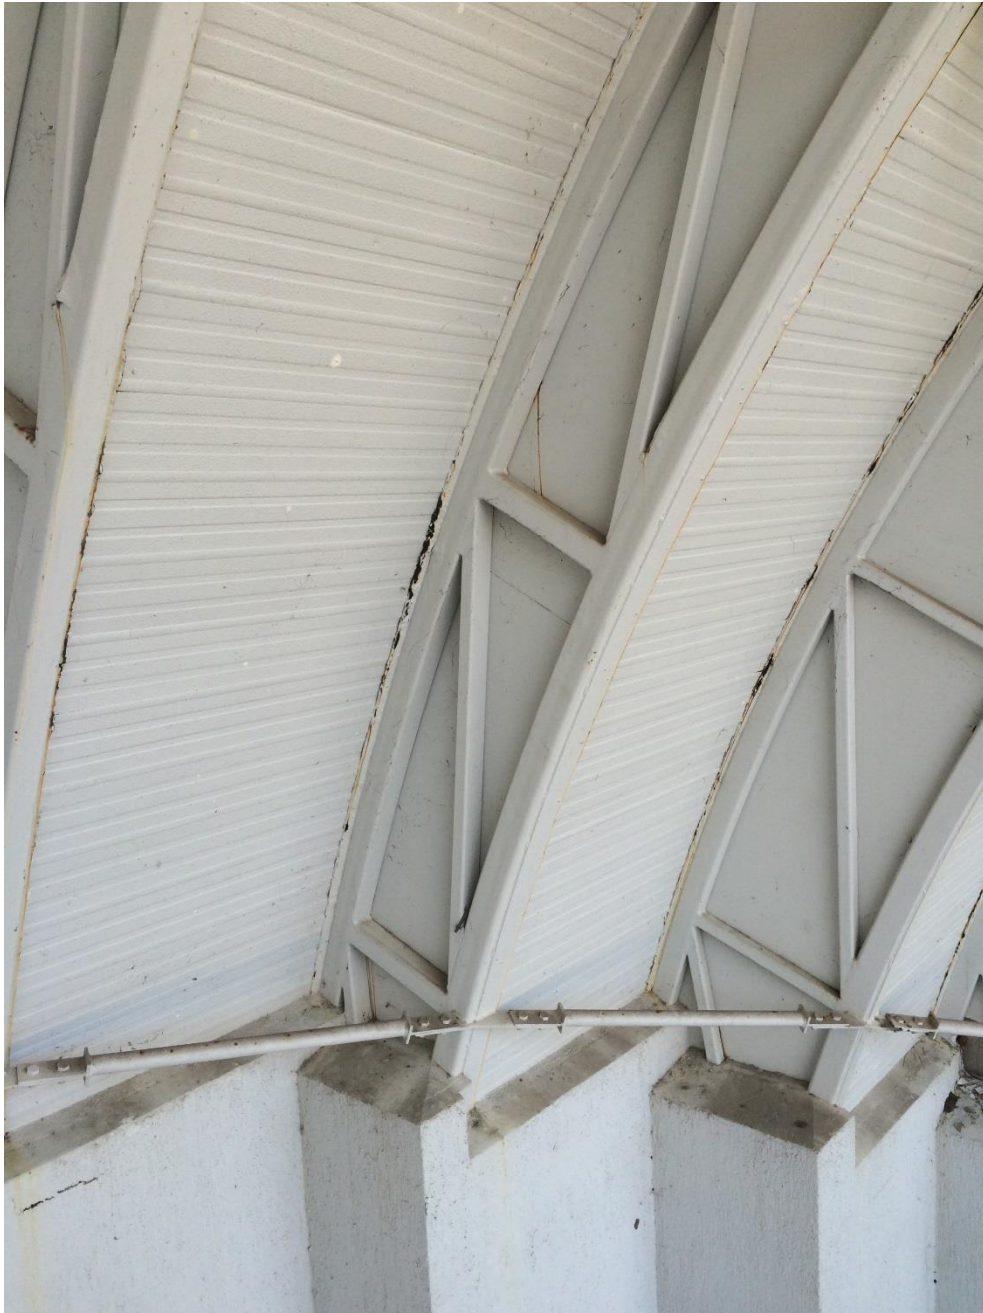
Photo 125 - Minor corrosion to truss top and bottom plate

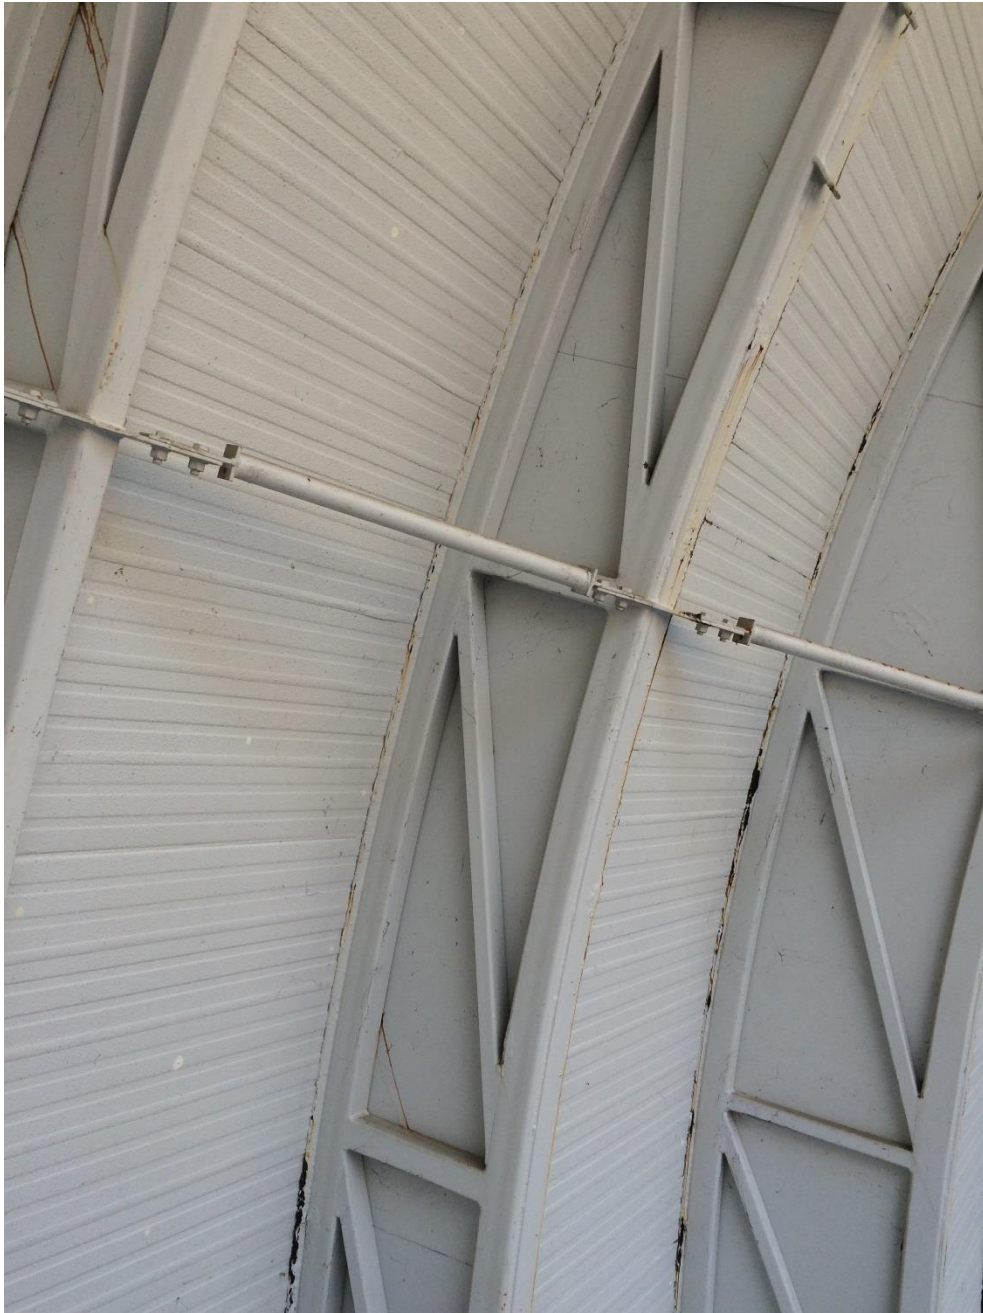
Photo 126 - Minor corrosion to truss top and bottom plate

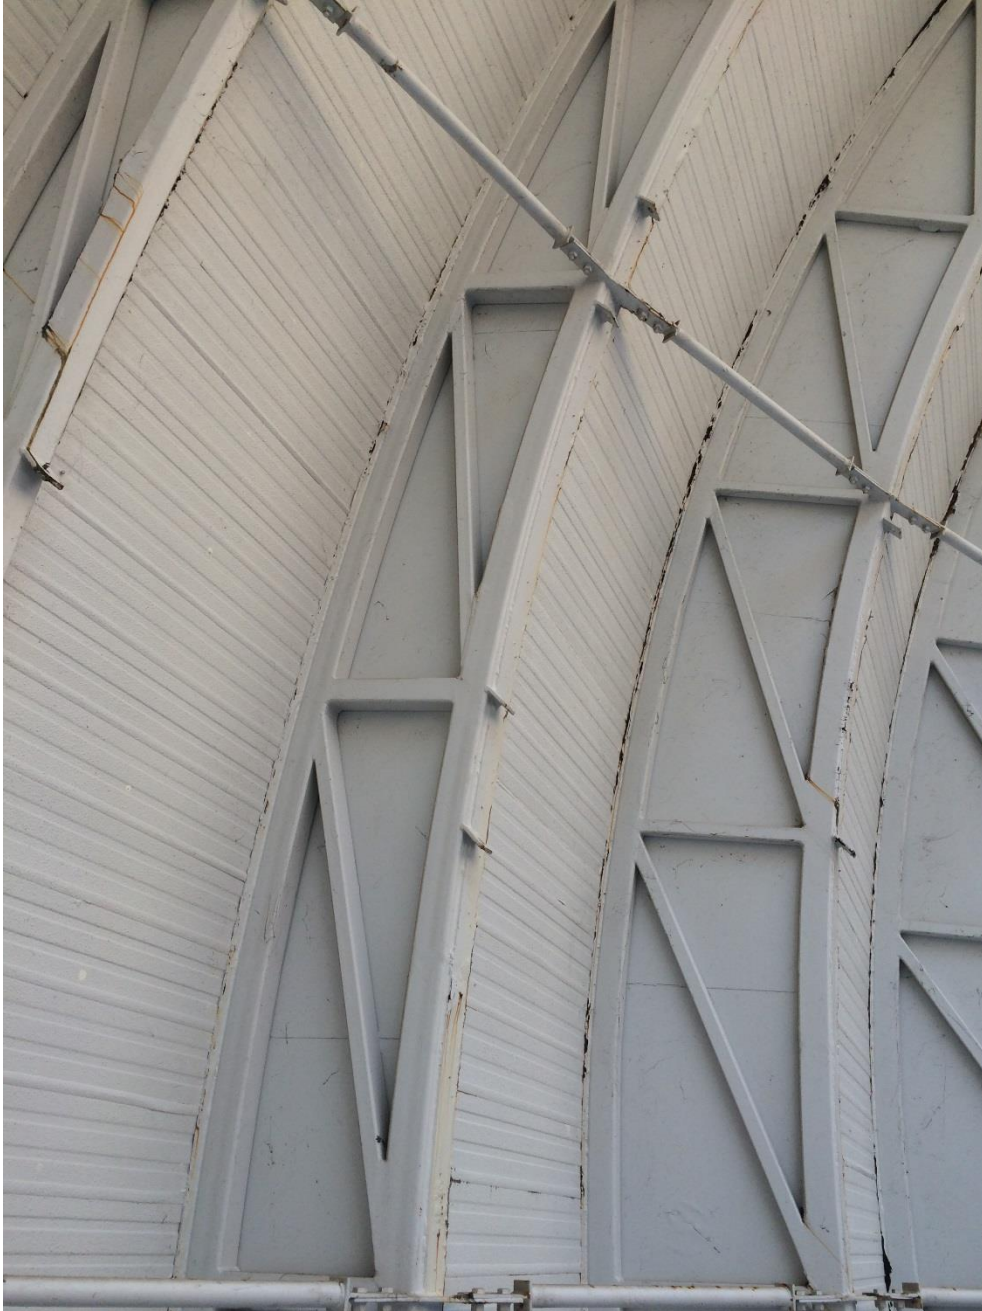
Photo 127 - Minor corrosion to truss top and bottom plate

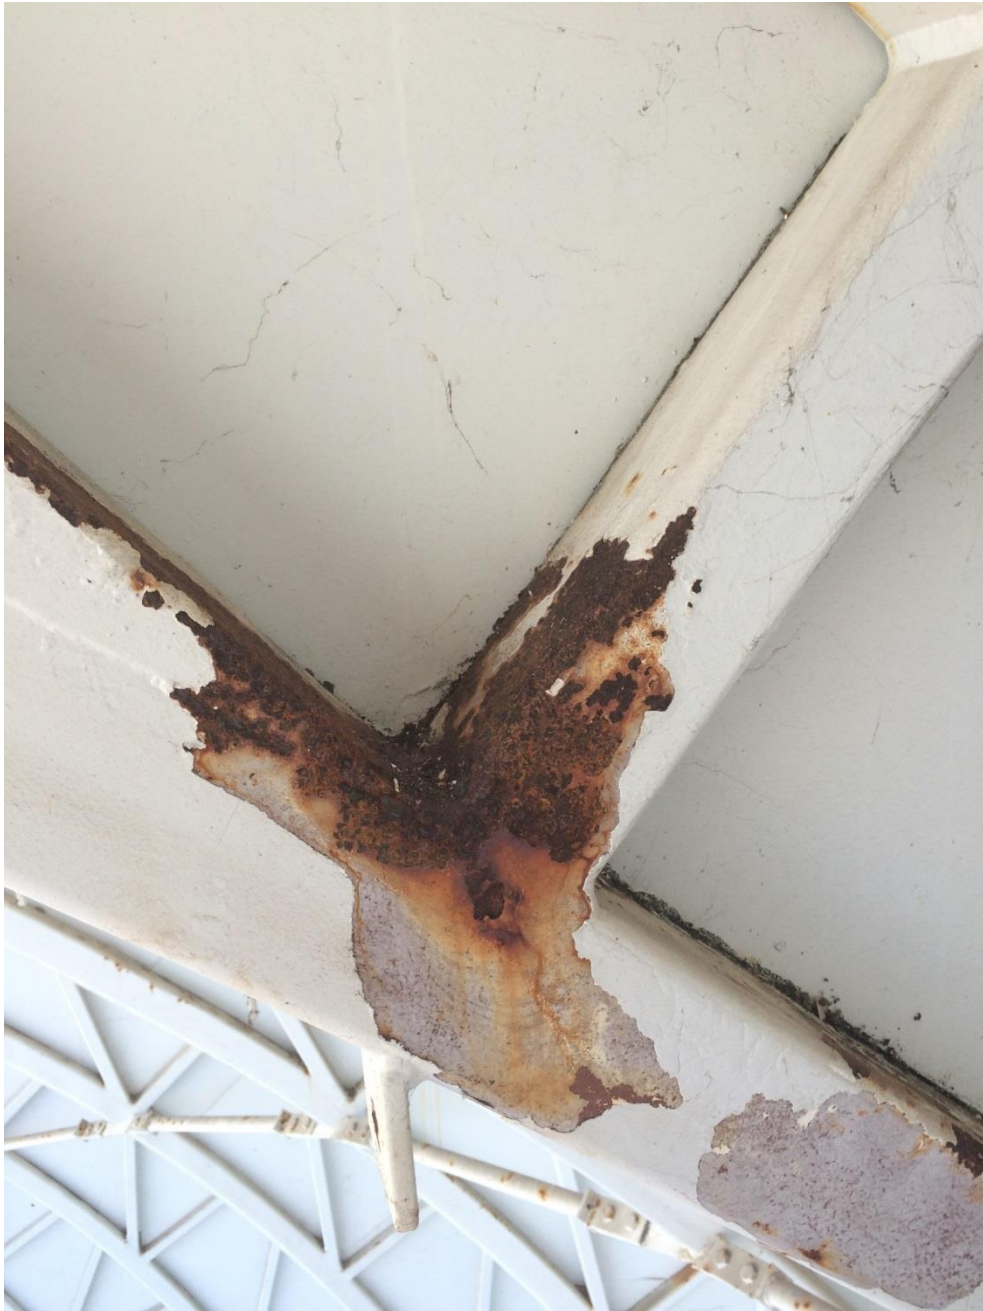
Photo 132 - Minor corrosion to bottom chord and web of truss

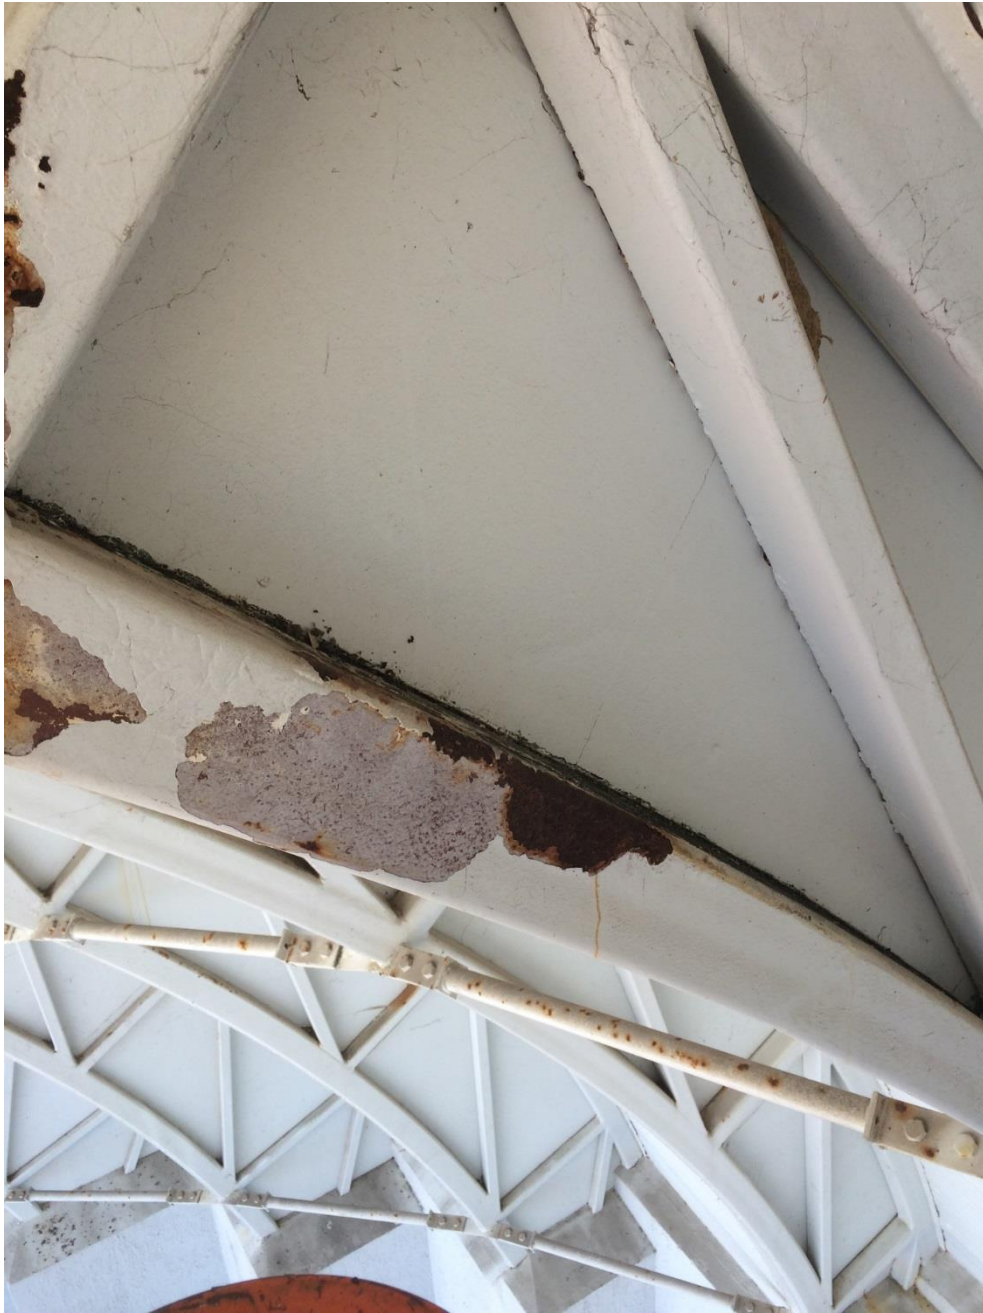
Photo 133 - Minor corrosion to bottom chord

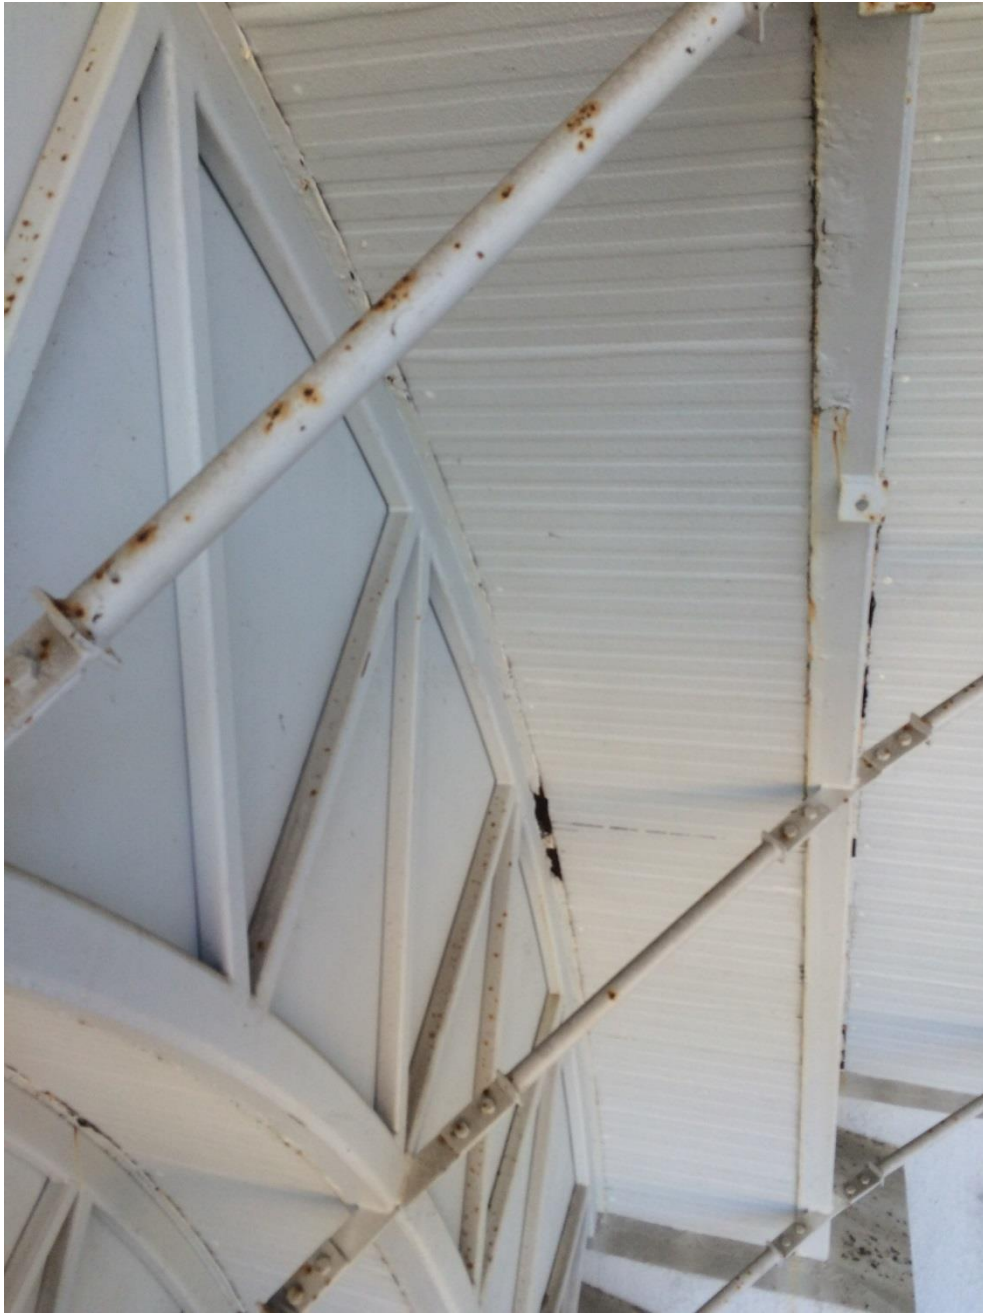
Photo 169 - Minor corrosion to bottom plate and top plate

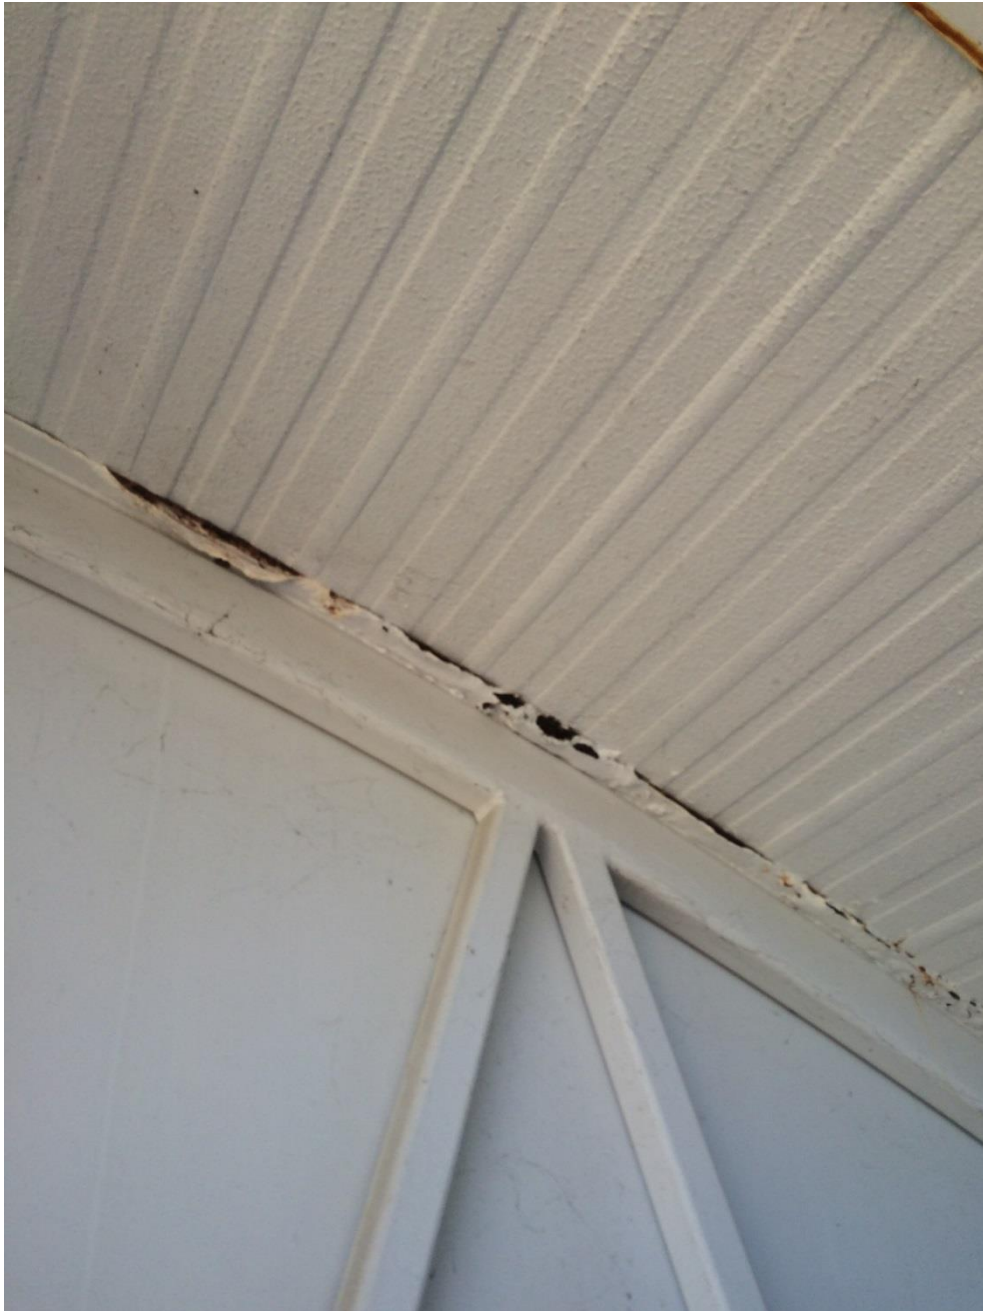
Photo 170 - Minor corrosion to top plate

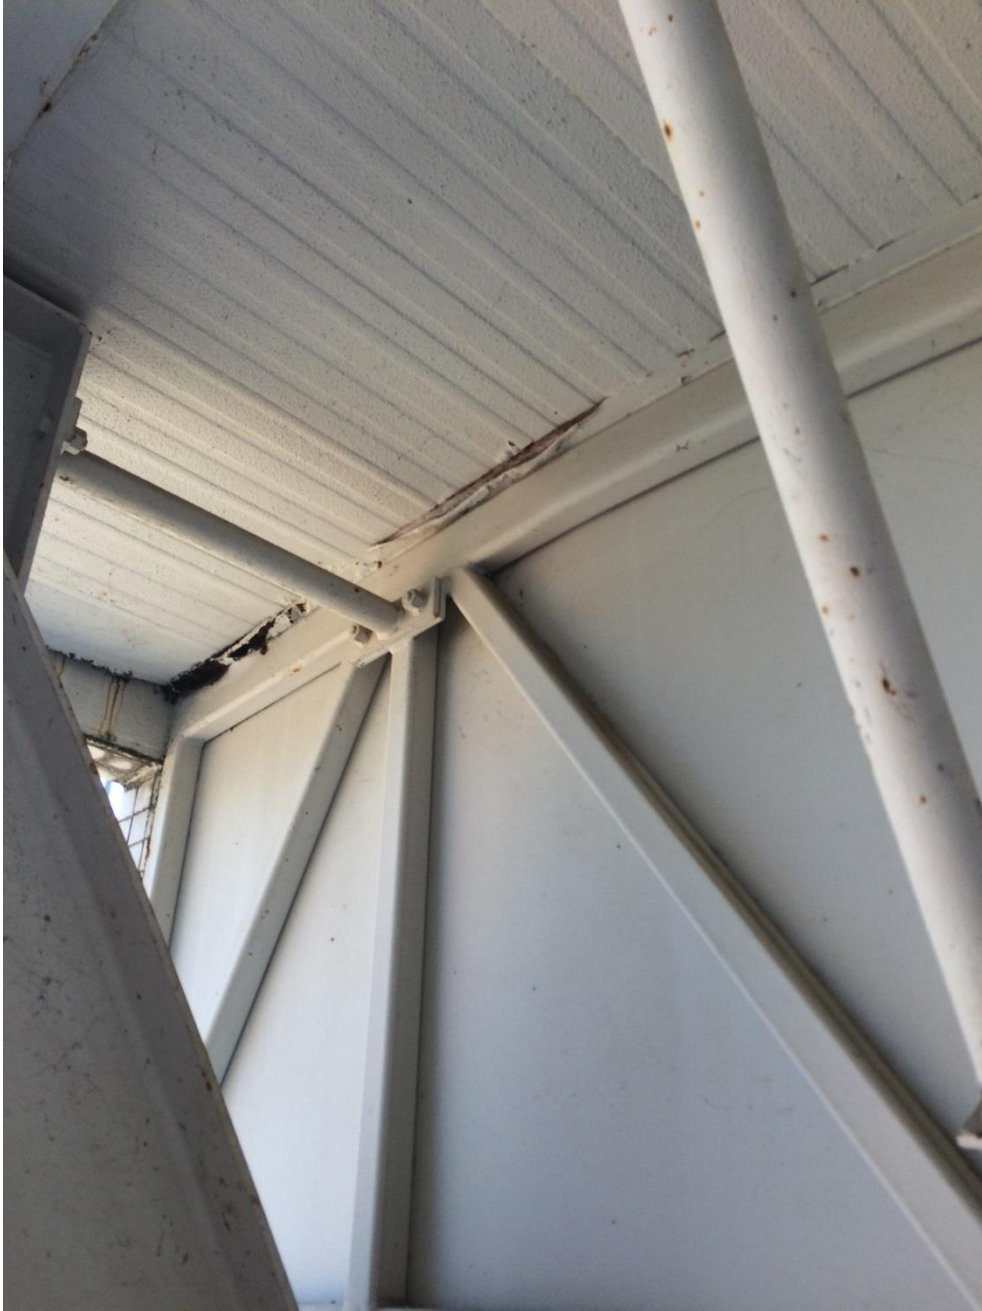
Photo 171 - Minor corrosion to top plate

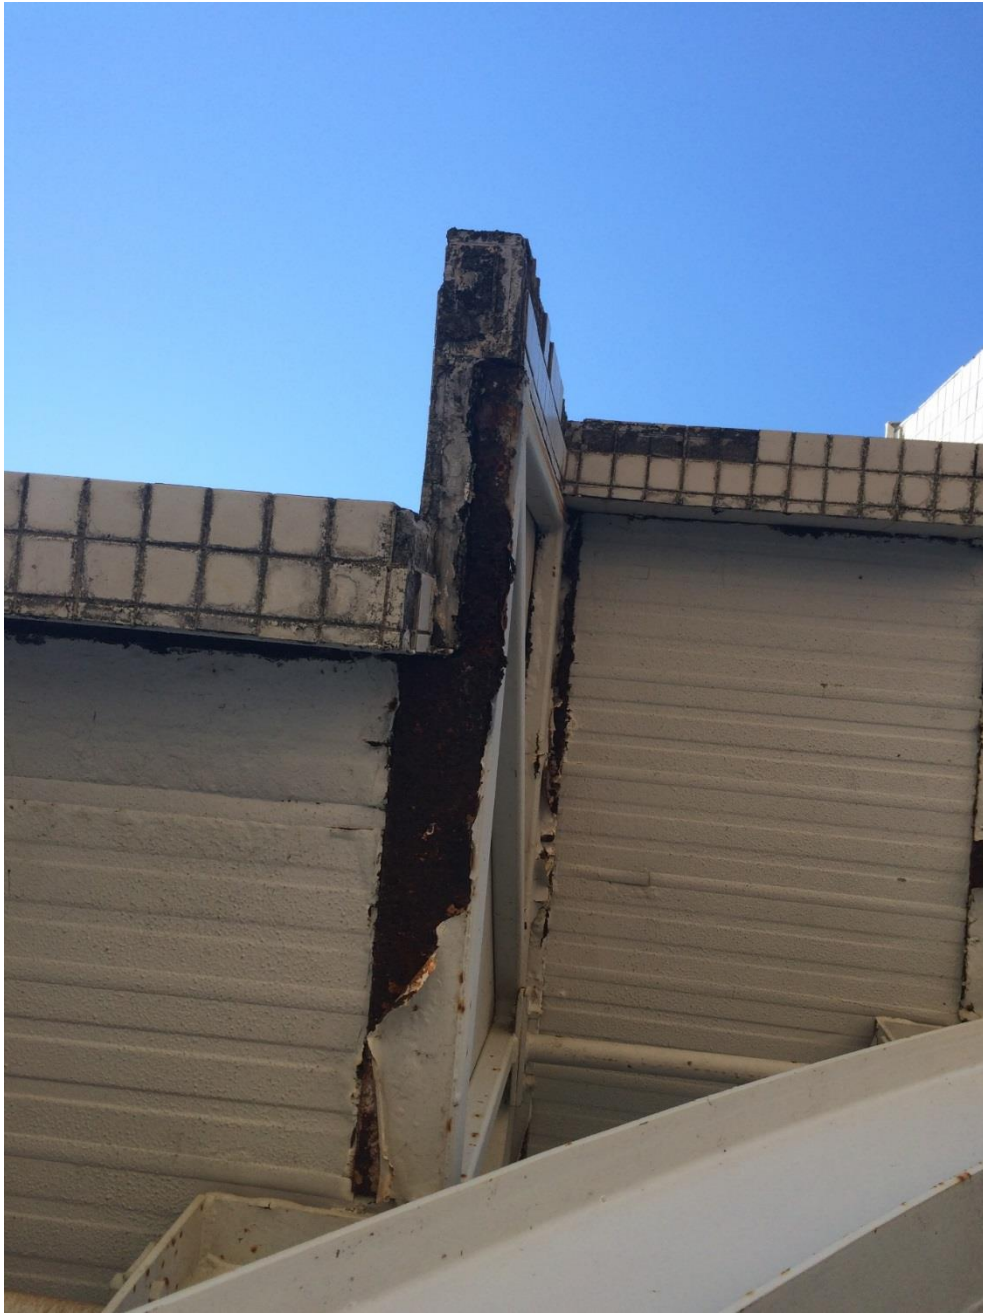
Photo 177 - Heavy corrosion to end web of truss
