Music Bowl Structural Assessment

24 November 2014

R14265

Prepared for Rockhampton Regional Council

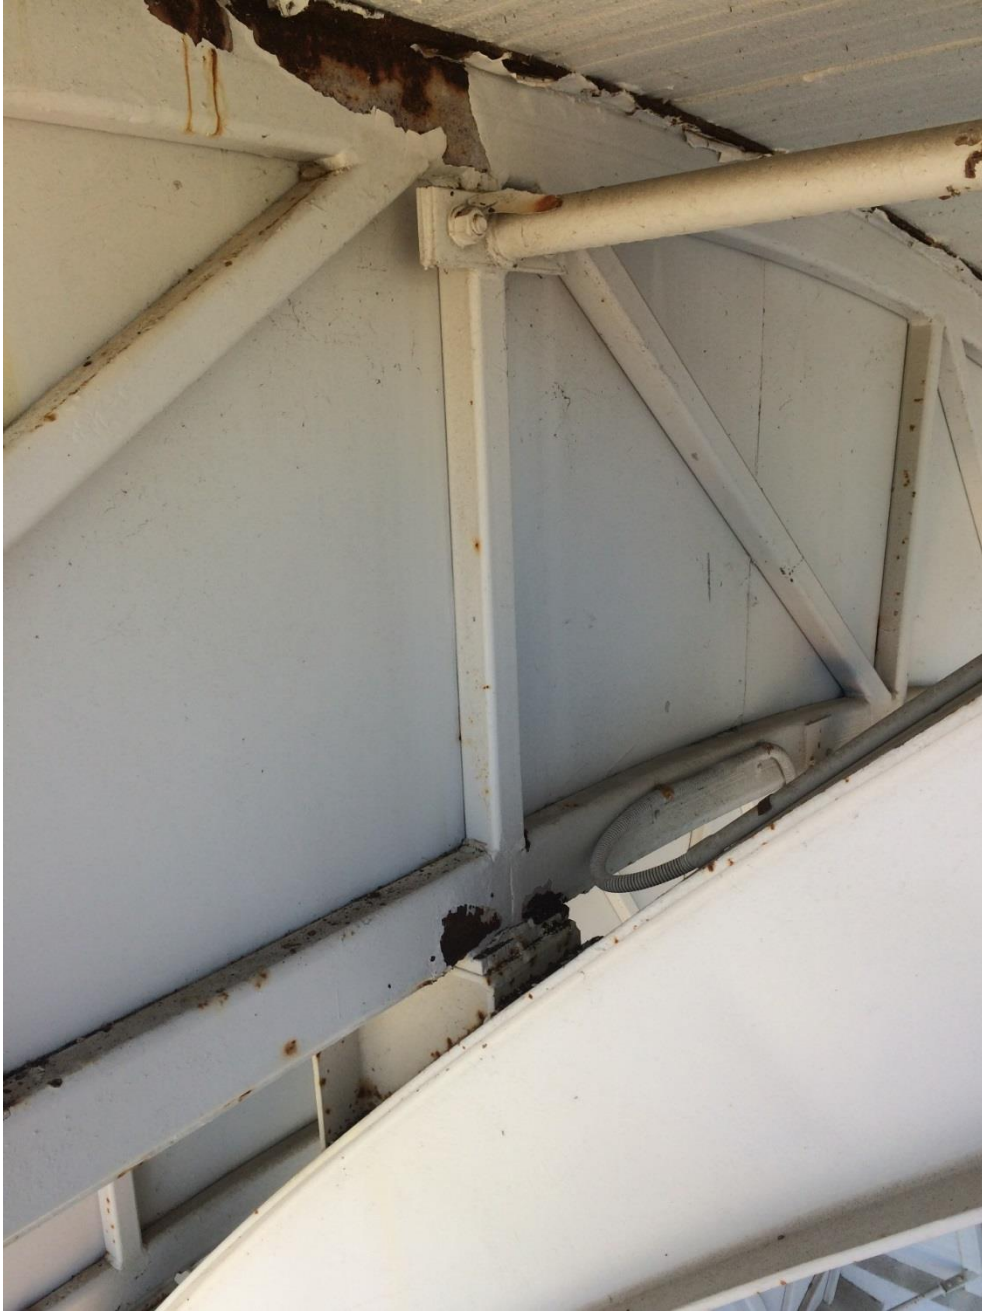
Photo 182 - Heavy corrosion to top plate and top chord of truss

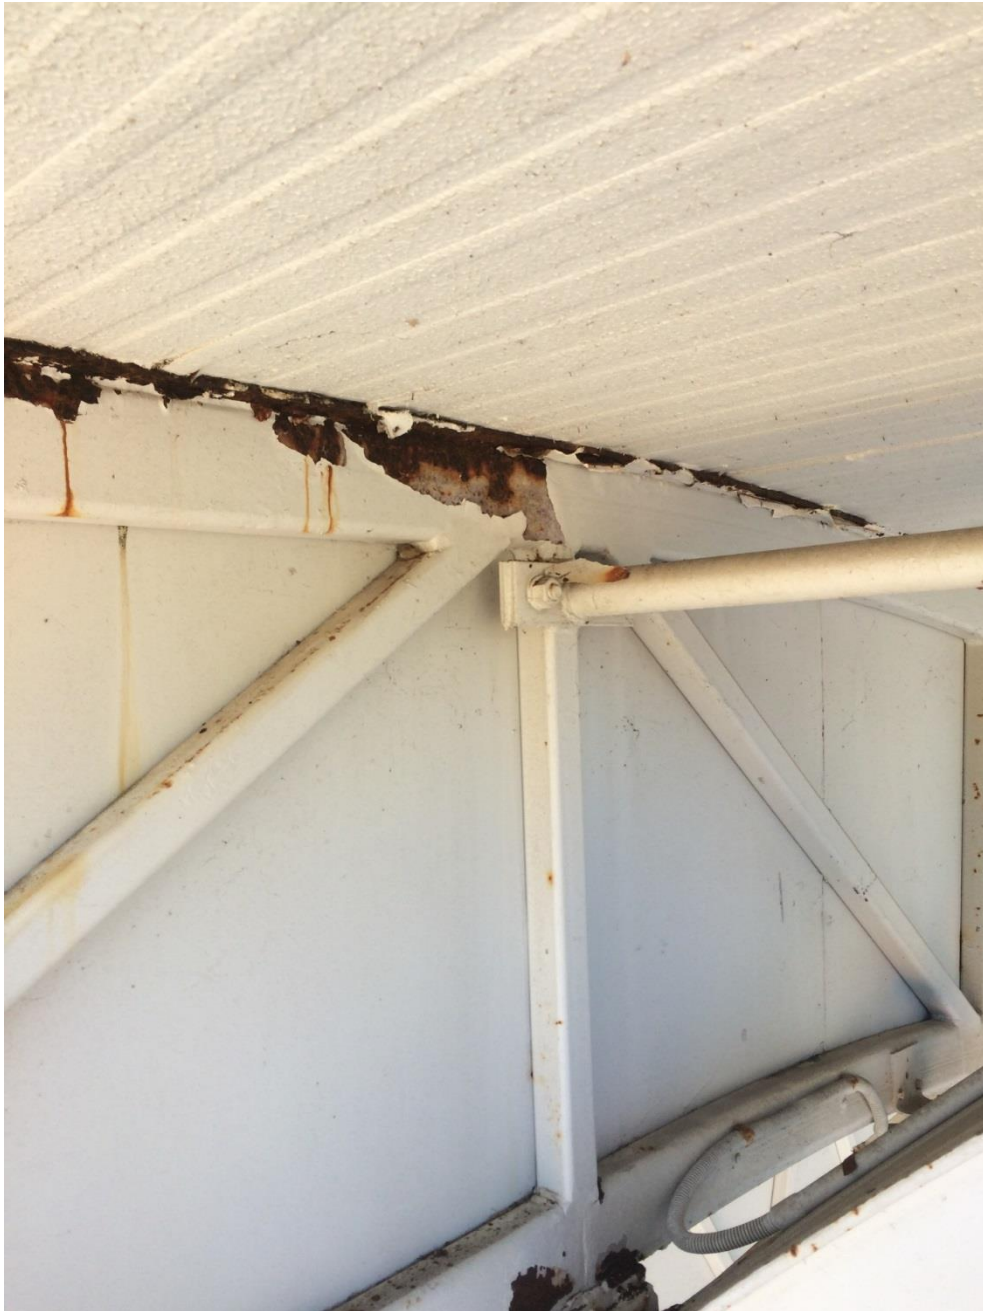
Photo 183 - Heavy corrosion to top plate and top chord of truss

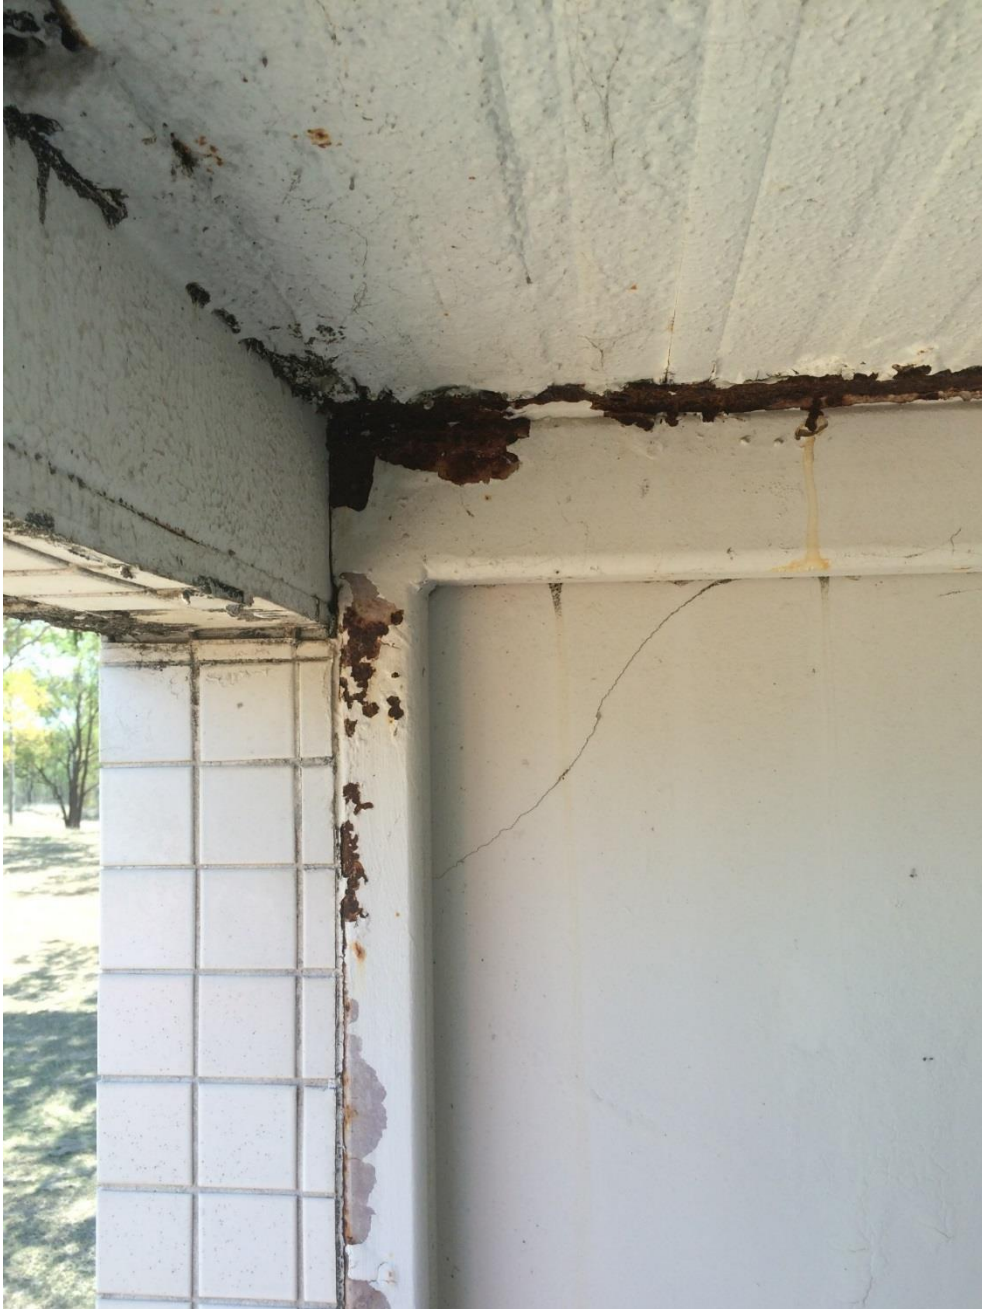
Photo 184 - Heavy corrosion to top plate, minor corrosion to end web of truss

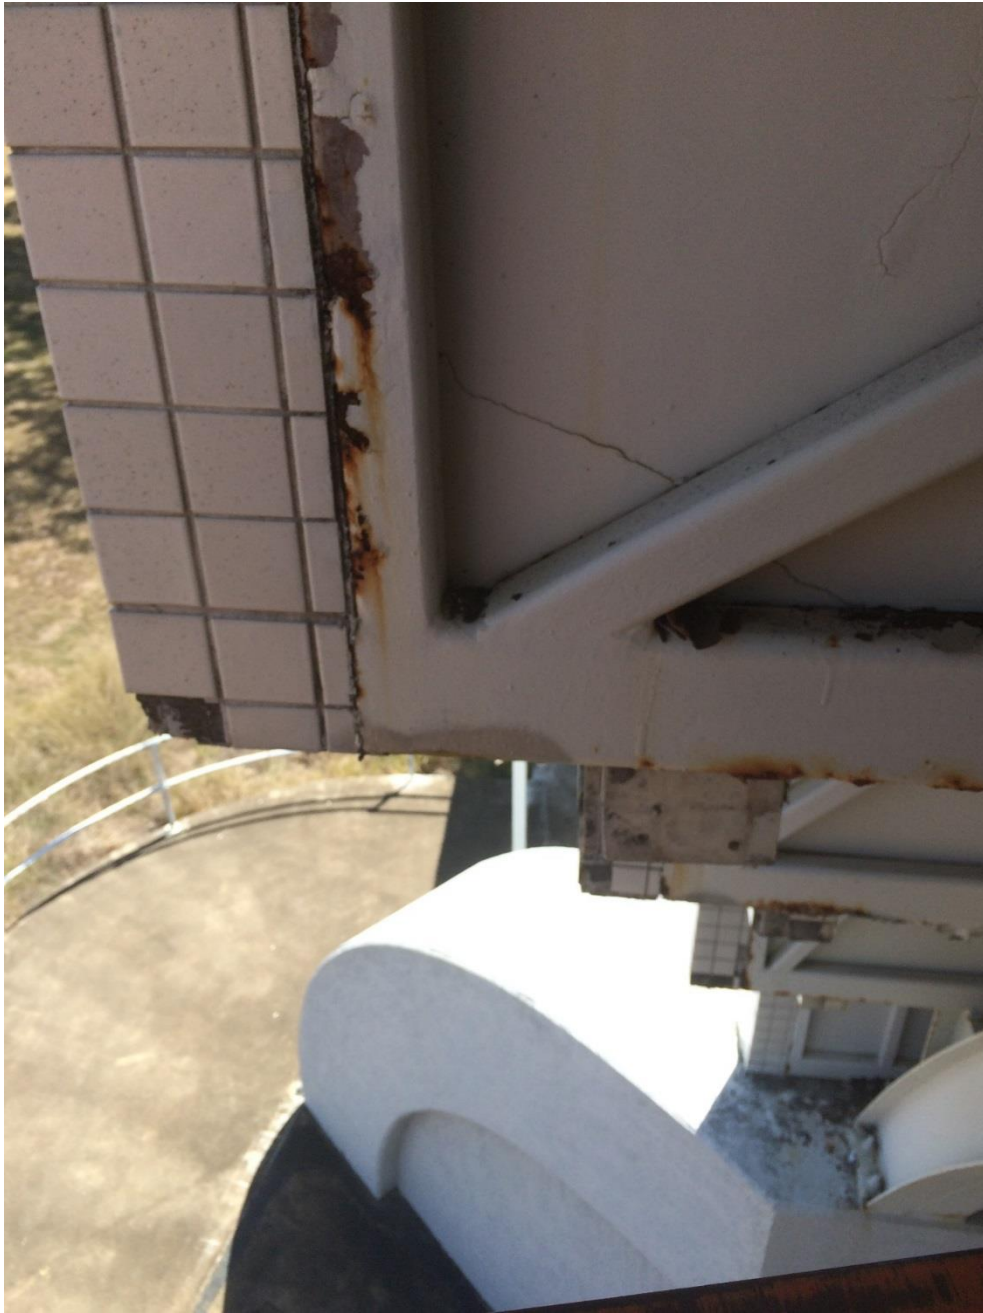
Photo 185 - Heavy corrosion to end web of truss

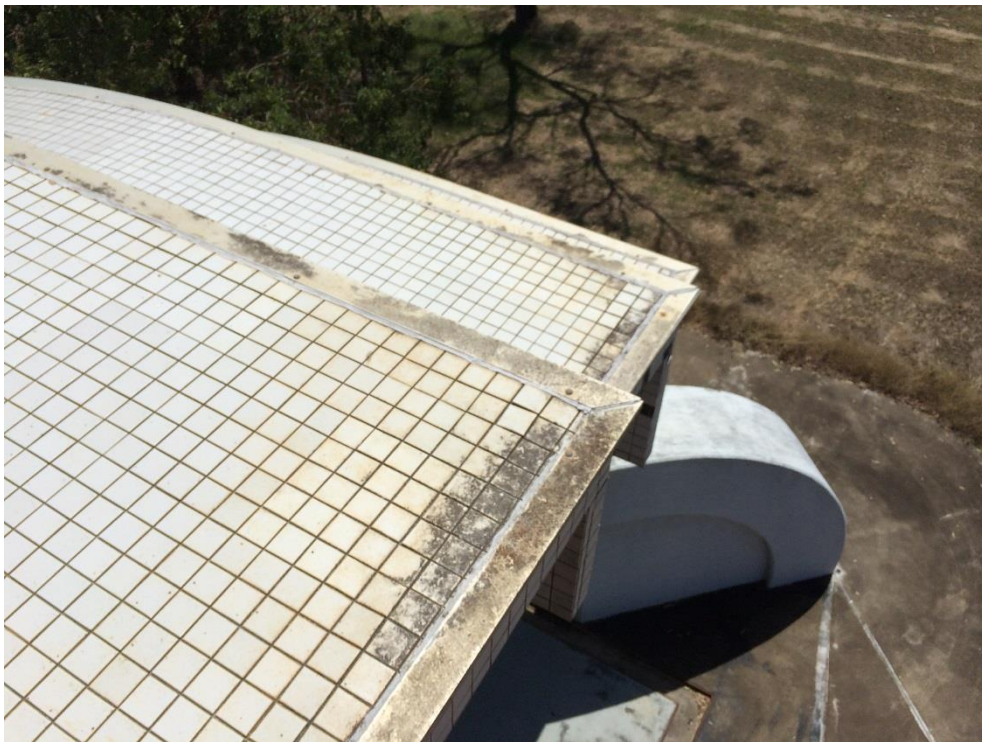
Photo 207 - Horizontal tiled surface with aluminium edge capping. Evidence of water ponding

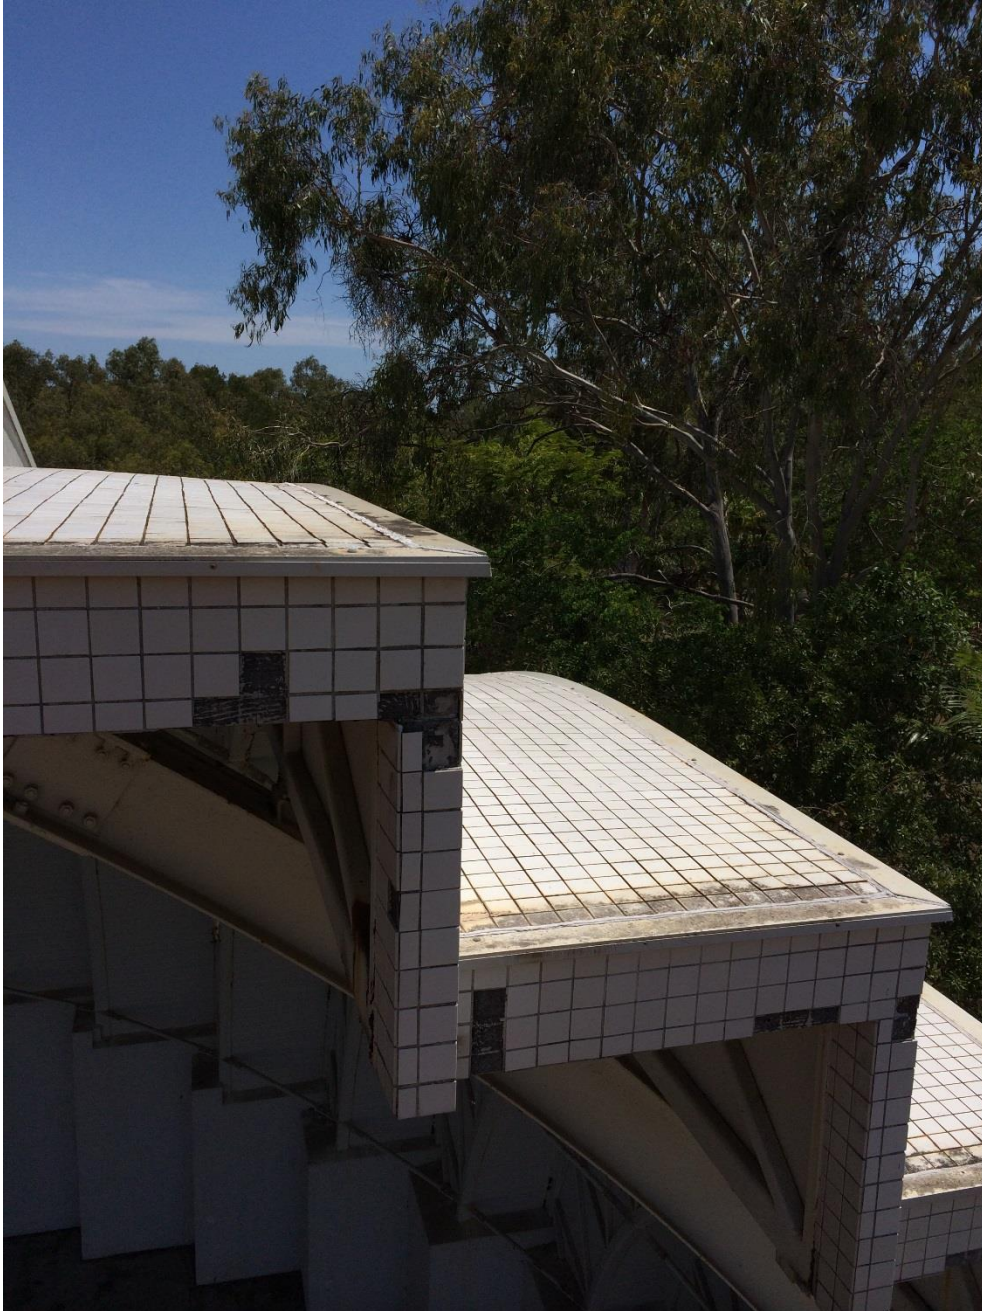
Photo 209 - Front fascia, tiles missing, aluminium edge capping slightly higher than horizontal tiles with evidence of water ponding

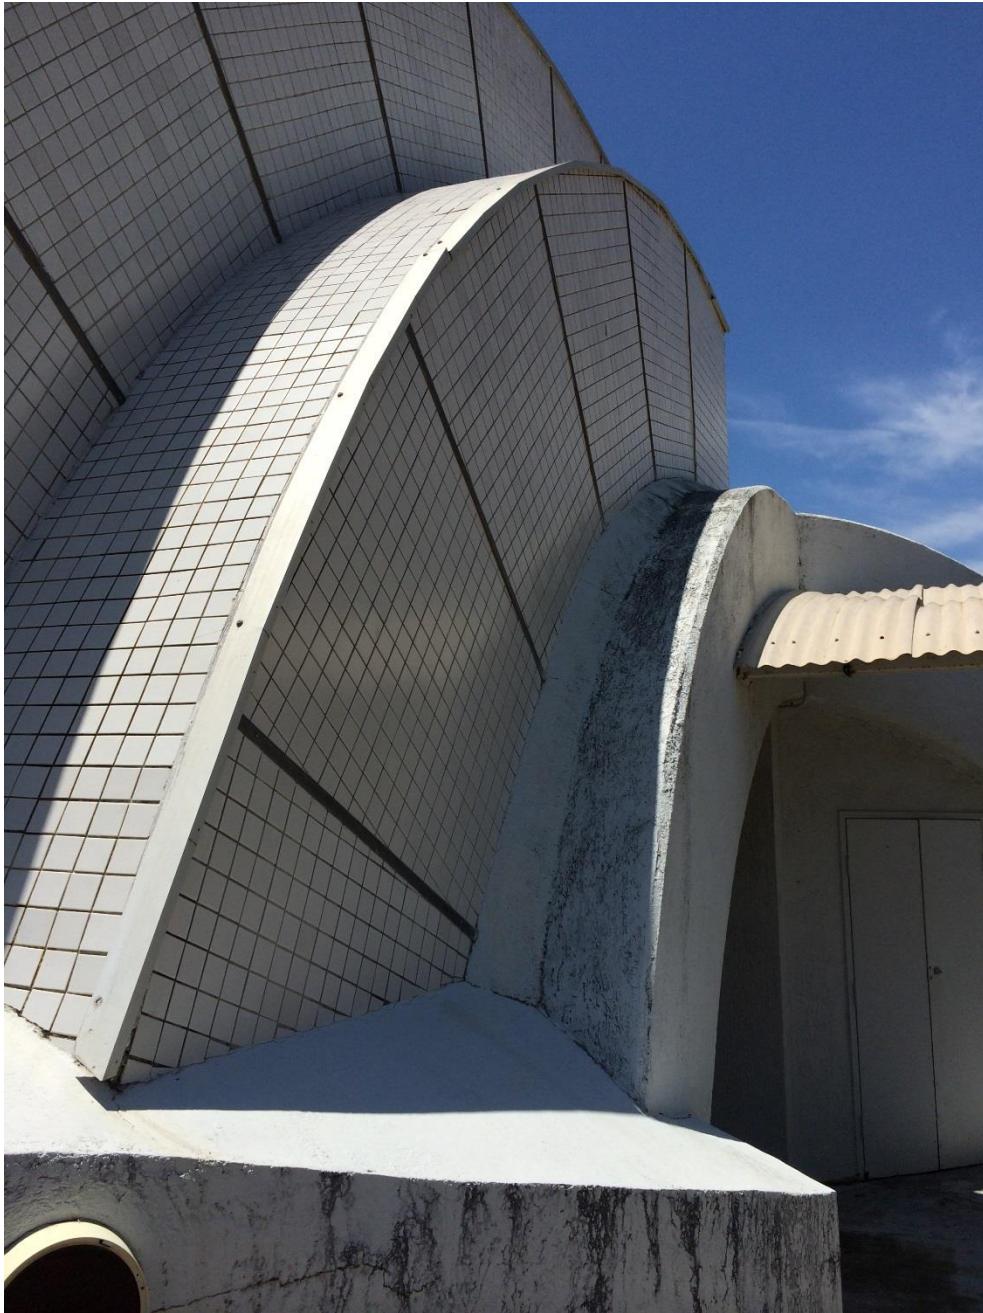
Photo 211 - Rear surface of sound shell and main arch support abutment

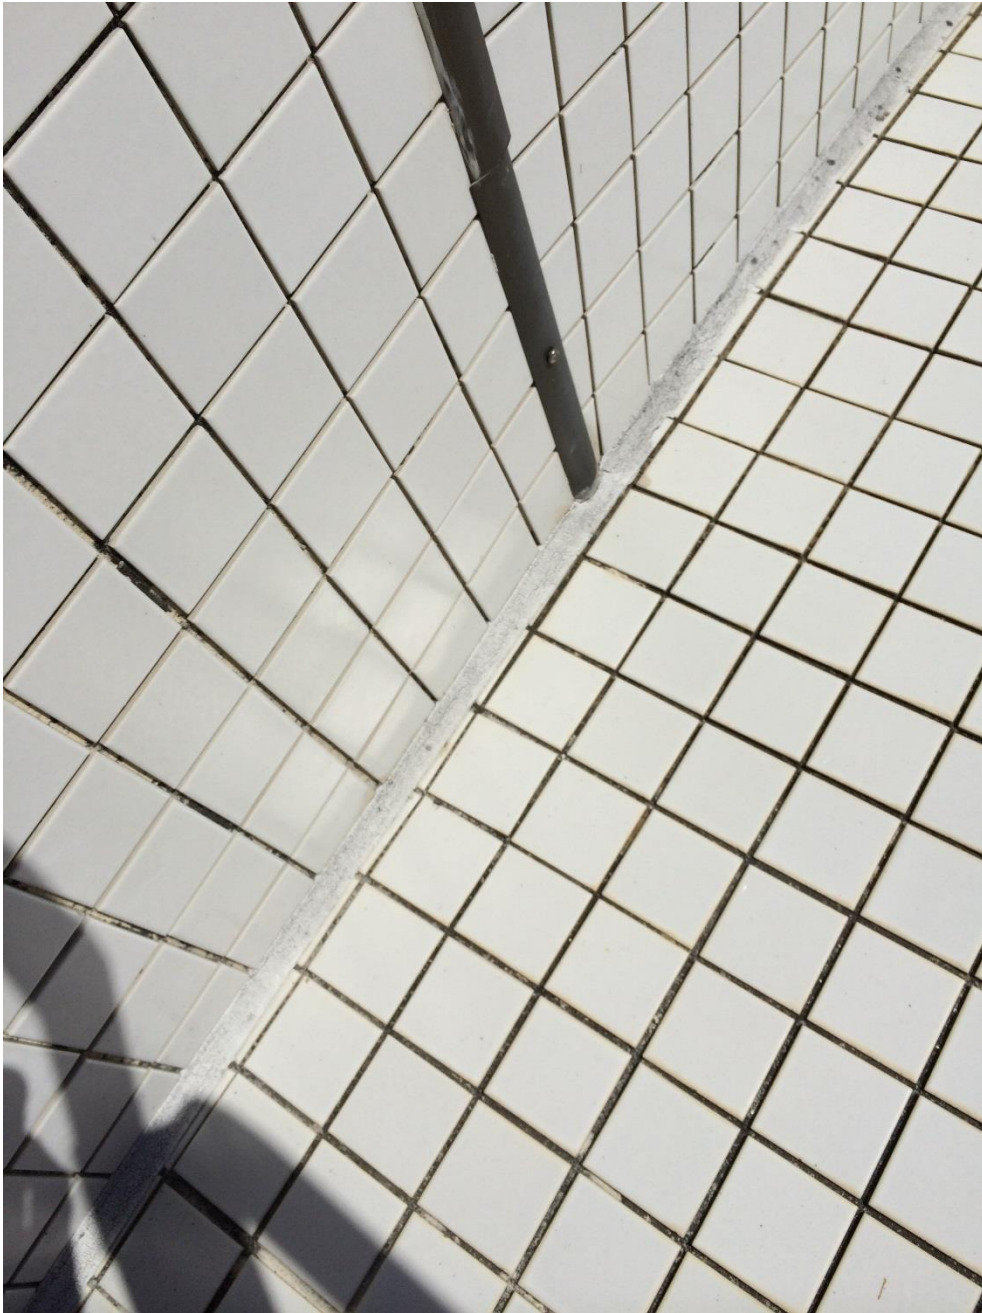
Photo 219 - Junction of vertical tiled surface and horizontal tiled surface, sealant at junction
