SLOPE STABILITY ASSESSMENT AND REPORT

Project: Slope Stability Assessment Lot 35 on SP285391, German Street Norman Gardens, QLD 4701

Job Reference: 2128E.P.531

Date: 18th May 2017

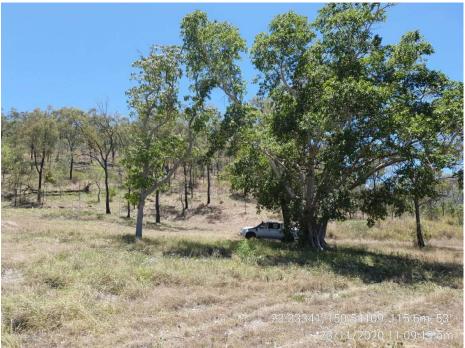
Figure 4. A narrow area of grasslands greater than 30cm in height located downslope from the dwelling.

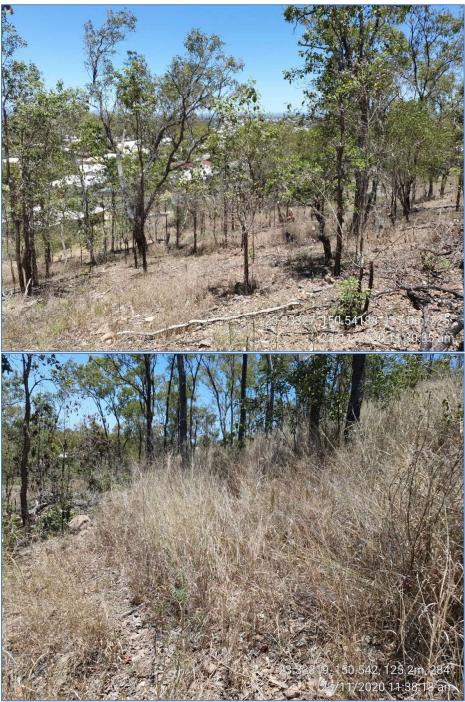
Figure 5. Grassy to shrubby woodland upslope from the proposed dwelling location. Surface fuels were variable between sparse grasses and scattered patches of dense grasses and shrubs (largely lantana).

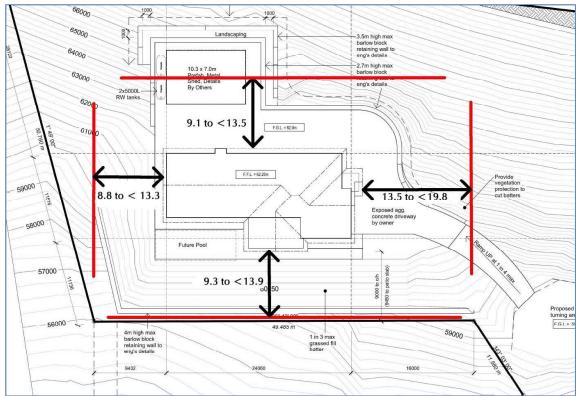
Aspect	APZ range (m) for BAL-19	Notes
N	9.1 to < 13.5	Retaining wall provides some shielding to radiant heat. Embers likely to circulate in enclosed areas
SE	13.5 to <19.8	Retaining wall provides some shielding to radiant heat. Embers likely to circulate in enclosed areas
SSW	9.3 to < 13.9	BAL 12.5 can be used where grasses between the dwelling and German Street are kept to < 30 cm tall.
W	8.8 to < 13.3

Figure 8. APZ distance ranges at each surface of the proposed dwelling to comply with AS3959: 2018 BAL-19.
