11 July 2018

Project No. 18144-001-Rev1

SLOPE STABILITY ASSESSMENT FOR PROPOSED RESIDENCE 43 ROSEWOOD DRIVE, NORMAN GARDENS

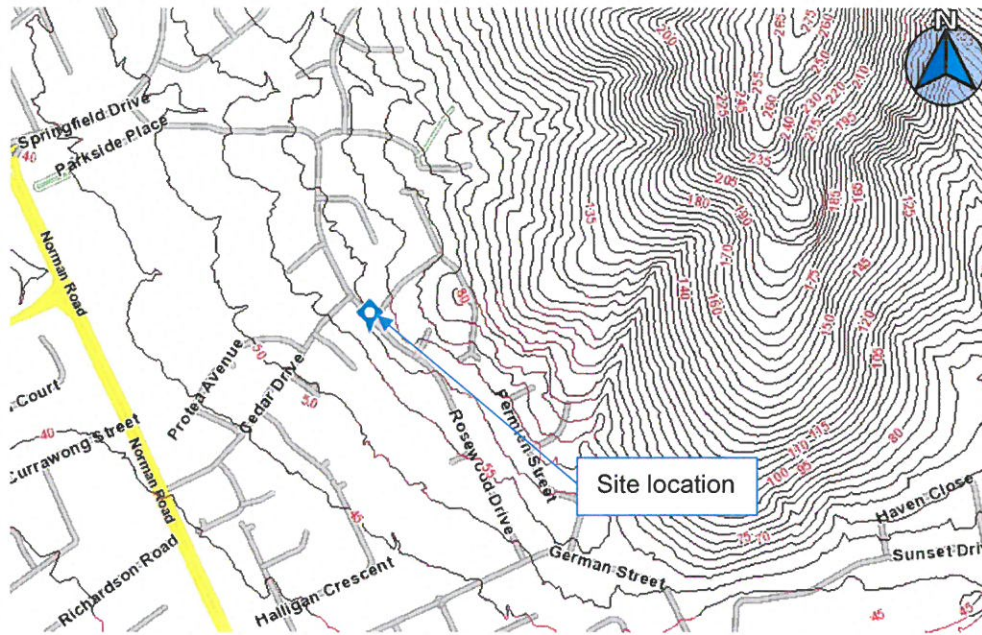
Text Figure 5: Image showing ground surface contours (courtesy RRC online mapping)

The shape of the ground surface is waning (decreasing) and planar. The contours generally indicate the steeper ground adjacent to Rosewood Drive is inclined at around 15° (27 %) to the south-west, and towards the bottom of the site is more gentle at around 8° (14 %). As shown in Text Figure 7 on the following page, there appears to be a fill embankment associated with the adjacent road construction along the front of the block. Although no boreholes were drilled in this area by CQ, we estimate that the fill ranges up to approximately 1 m high.

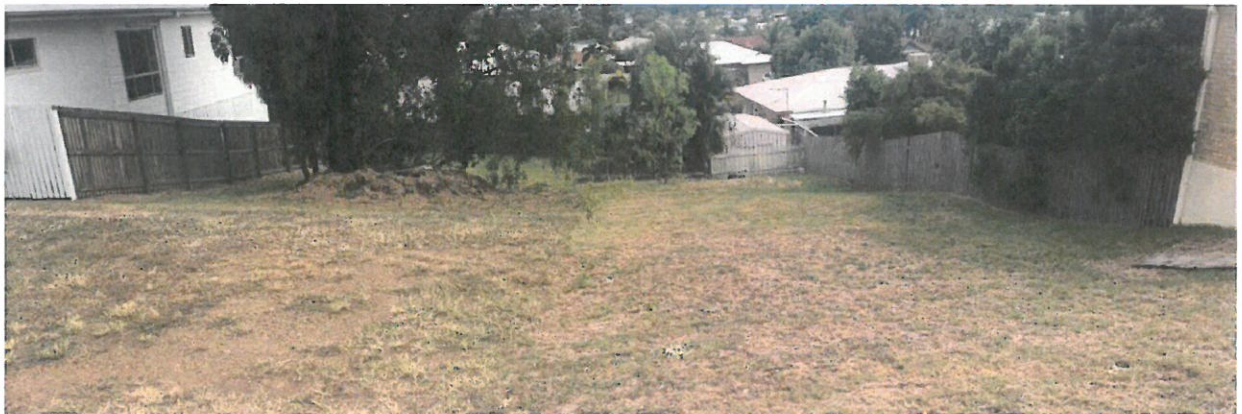
Text Figure 6: Site conditions at the time of investigation looking southwest from Rosewood Dr (photos by CQ)

The ground surface generally featured short grass, with one large mature tree towards the north-western corner of the site (Ref. Text Figures 6 and 7). Based upon photos provided by CQ, this does not appear to be unusually tilting or distorted in its growth.

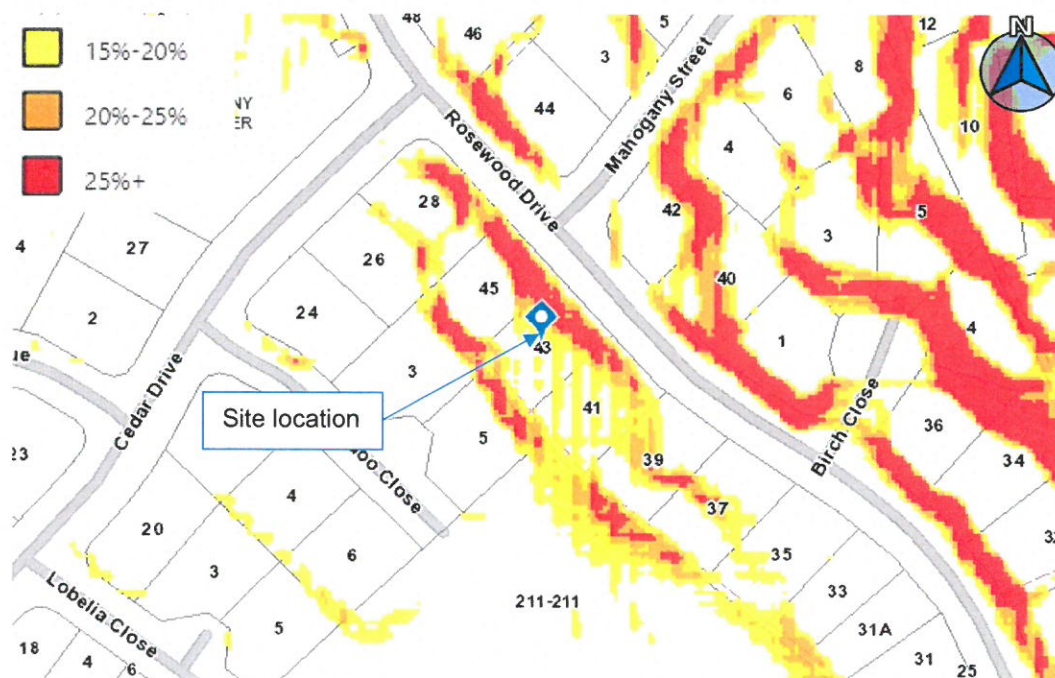
Text Figure 8: Extract from RRC Steep Land Overlay

RRC Planning Scheme Steep Land Overlay (Refer extract in Text Figure 8) mapping indicates that, towards the north-eastern and south-western boundaries of the site, land between 20 % and >25 % (11° and $>14^\circ$) (orange/red shading) exists, with some ground across the middle of the site indicated to be between 15 % and 20 % (8.5° and 11°).

It should be noted that the RRC mapping is an indication of land slope (land >15%) rather than potential landslide susceptibility. For slopes over 15%, RRC requires a site specific geotechnical report to address stability. Based on available information, the site does not exhibit any indicators of slope instability. No landslide back scarps, tension cracks, or areas of naturally 'hummocky' ground are apparent in photographs supplied by CQ, and slopes are moderate across the site (8° to 15°/14 % to 27 %).
