Slope Stability Assessment Report

YOUR REF: N/A
OUR PROJECT JOB NUMBER: GEO168574-B

SITE ADDRESS - Lot 36 on SP176990 (No.14) Connemara Drive, Kawana

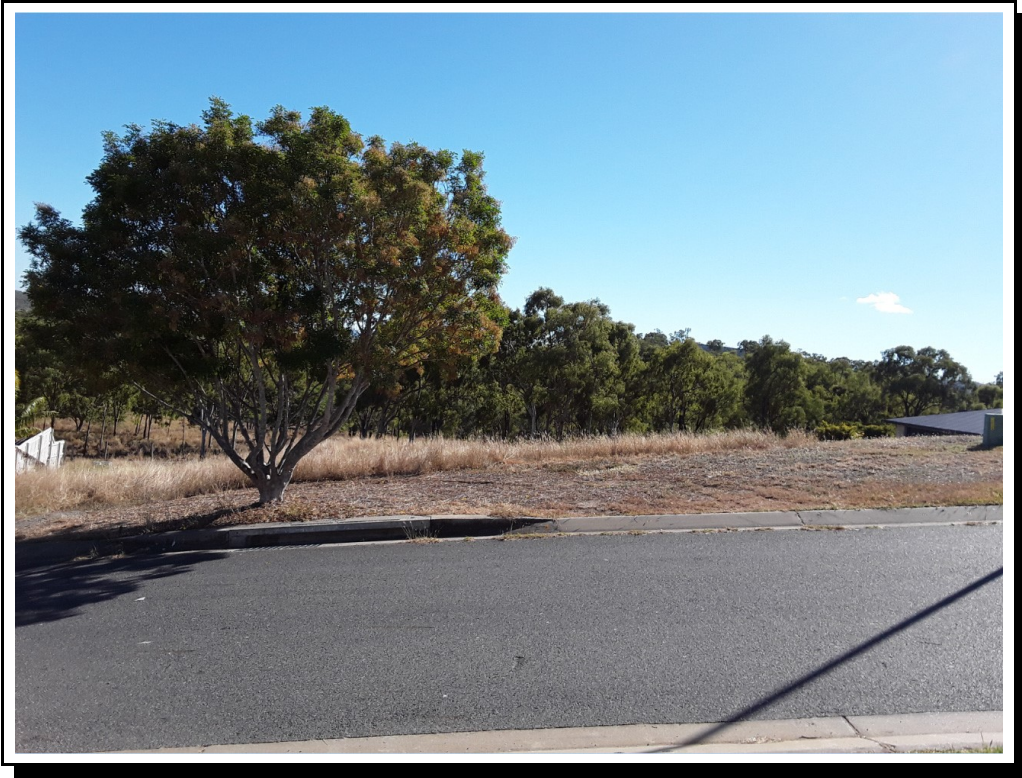
Figure 5. View North, North West towards site.

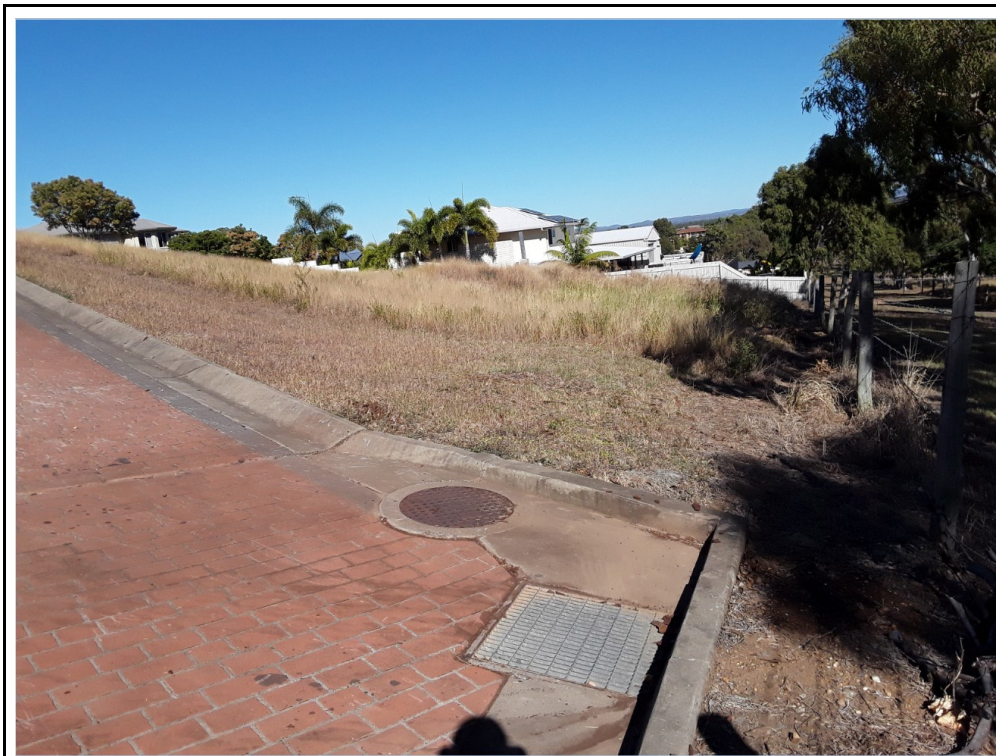
Figure 6. View West across rear of site.

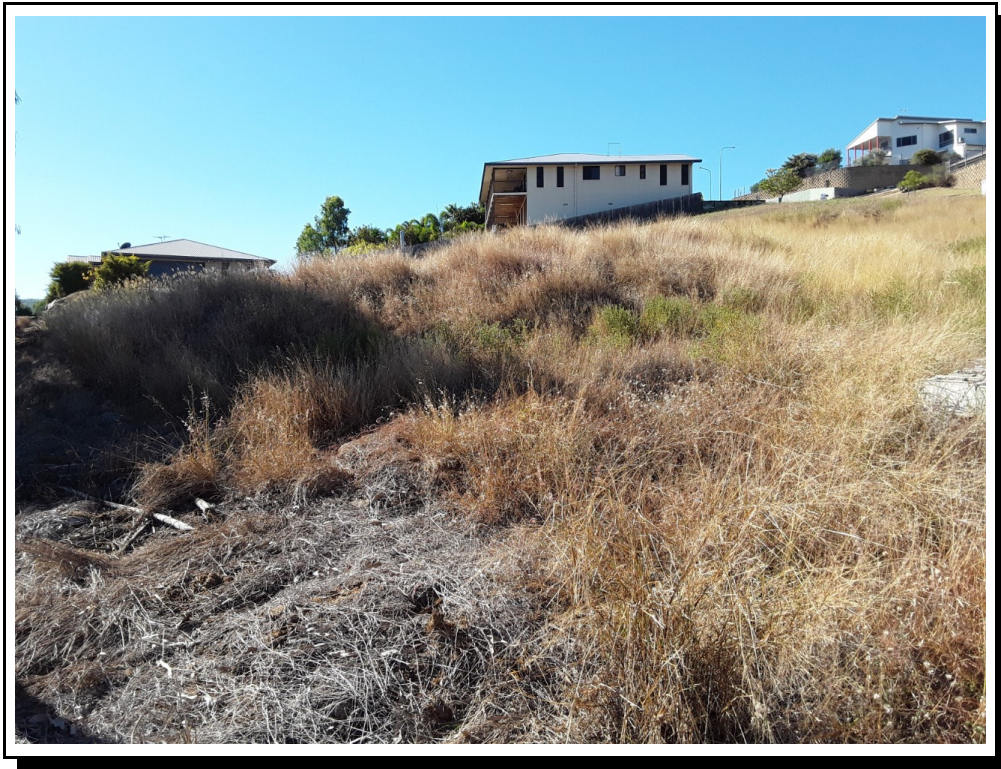
Figure 7. View East across site.

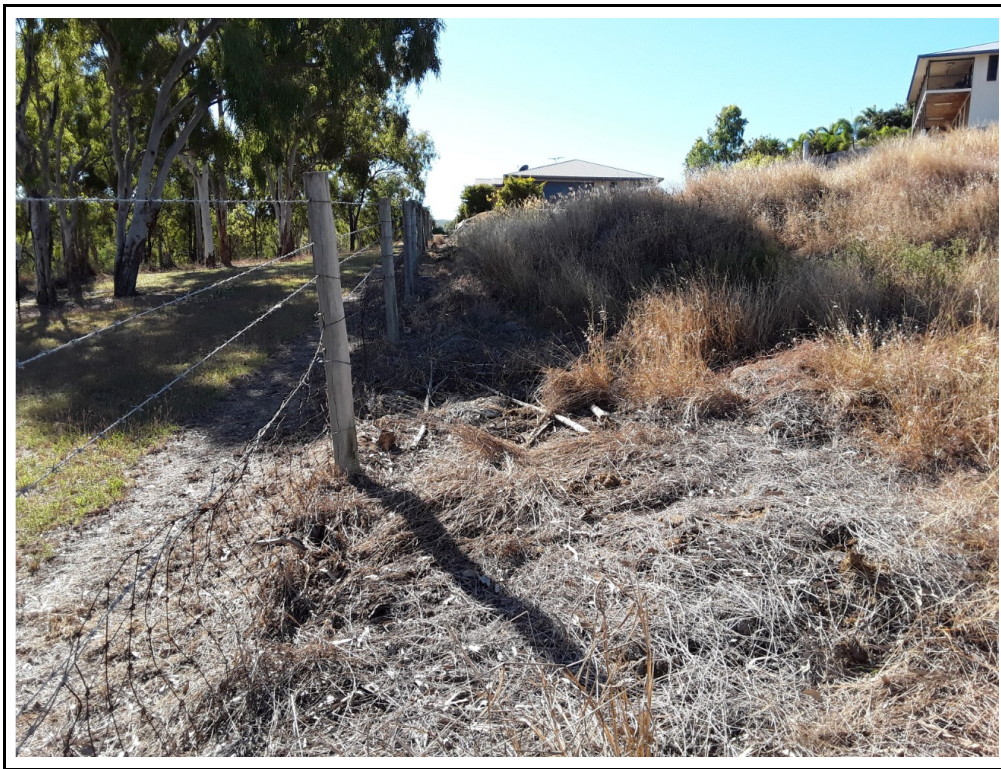
Figure 8. View North East along rear boundary.
