Project No. 18154-001-Rev0

SLOPE STABILITY ASSESSMENT FOR PROPOSED RESIDENCE 11 KILKENNY COURT, KAWANA

SOILS INVESTIGATION

11 Kilkenny Court, Kawana

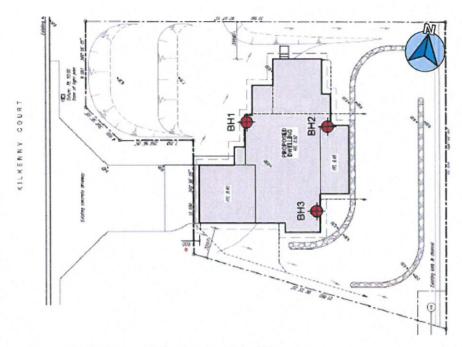
Text Figure 4: Borehole location plan (courtesy CQ)

The CQ investigation comprised three boreholes (designated BH1 to BH3) drilled to depths of 0.5 m to 2 m below ground level (BGL) spread across the proposed building footprint, along with dynamic cone penetrometer (DCP) testing at each borehole location. The locations of these are shown in Text Figure 4 on the following page, and the borehole reports are attached at the end of this report.

Subsurface conditions encountered in the CQ boreholes show that there is a deepening soil profile towards the downslope (eastern) part of the allotment.

Towards the top (west) of the slope (BH1) natural, medium dense to dense gravelly clayey sand is reported to a depth of 0.4 m BGL, overlying dense to very dense, clayey sandy gravel (inferred as possible extremely weathered (EW) material). It was possible to drill in to the dense to very dense gravel for 0.1 m before auger refusal at 0.5 m BGL, where inferred weathered rock was encountered.

Further down the slope, at the eastern edge of the proposed house footprint, (BH2 & BH3) fill comprising mostly medium dense, silty sandy gravel was logged to around 1 m BGL; underlain by natural, dense, clayey sandy gravel, to around 1.8 m BGL; then dense to very dense clayey sandy gravel to depths of around 2 m BGL (inferred as EW material), where auger refusal was encountered and weathered rock again inferred.

Footings for the residence and any retaining walls should penetrate through any fill placed on site, to found at least 300 mm into the very dense natural clayey sandy gravel (inferred EW material), or at drilling/excavation refusal in such materials. Footings, so founded, could be designed with an allowable bearing capacity of 400 kPa. Nominally this may mean footings at the top of the slope would be founded in the order of 1 m depth; with those furthest downslope being at least 2 m depth (below existing ground level).

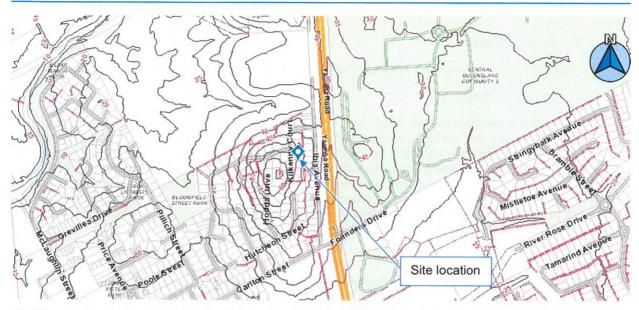
Text Figure 5: Image showing ground surface contours (courtesy RRC online mapping)

As shown by the ground surface contours in Text Figure 5 on the following page, the site is located towards the crest of a localised knoll, with ground rising gently to the west, but generally falling to the north, south, and east. The predominant slope local to the site is to the east, and ground surface contours (RCC) show that the site falls between about RL 57 m and RL 50 m AHD, from west to east. Lower lying ground at the base of the knoll, to the north-west and north-east, is situated around RL 25 m to 30 m AHD.

The shape of the original natural ground surface was linear and slightly convergent. The contours indicate a relatively consistent slope of around 13° (23 %) towards the east/south-east is present on site. Two retaining walls (Ref. Text Figure 2) were present on site at the time of the investigation, which have created a gently sloping terrace to the east of the site.

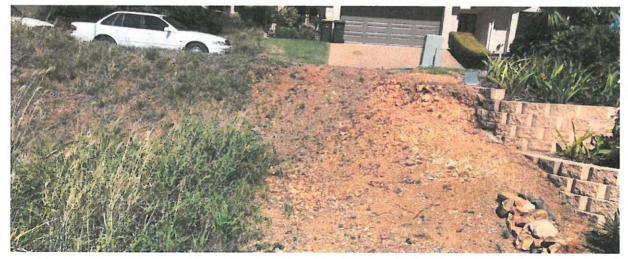
Text Figure 7: View of north-west corner of site, showing possible road fill embankment (photos by CQ)

As shown in Text Figure 7 on the following page, there appears to be a fill embankment associated with the road construction for Kilkenny Court along the front of the block. Although no boreholes were drilled in this area by CQ, we estimate that the fill ranges up to approximately 1 m high.

Based on the drawings provided to us, cutting and filling would be restricted to the garage/driveway area and would not exceed 1 m in height. Cut excavations or fill heights greater than 1 m should be retained by engineer designed retaining walls. Should fill earthworks greater than 1 m high be proposed Tectonic must be notified to enable an assessment of the impact on slope stability.

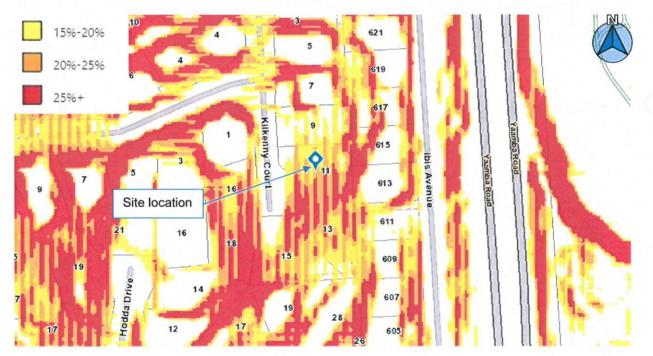
Text Figure 8: Extract from RRC Steep Land Overlay

RRC Planning Scheme Steep Land Overlay mapping (Ref. extract in Text Figure 8) indicates that the northern half of the site features land between 15 % and 20 % (8.5° and 11°) (yellow shading); while the southern half features land between 20 % and >25 % (11° and >14°) (orange/red shading).

It should be noted that the RRC mapping is an indication of land slope (land >15%) rather than potential landslide susceptibility. For slopes over 15%, RRC requires a site specific geotechnical report to address slope stability. Based on available information, the site does not exhibit any indicators of slope instability. No landslide back scarps, tension cracks, or areas of naturally 'hummocky' ground are apparent in photographs or notes supplied by CQ, and slopes are moderate across the site (13°/23 %). The natural subsurface profile comprises inferred residual soils overlying EW rock at shallow depth.
