PROPOSED CARAVAN SALES **AND REPAIR CENTRE**

FLOOD IMPACT INVESTIGATION

3 Glenmore Road, Park Avenue. QLD. 4701 MCU Application for Proposed Caravan Sales & Repairs Centre

PROPOSED CARAVAN SALES & REPAIR CENTRE MATERIAL CHANGE OF USE DOCUMENTATION 3 GLENMORE ROAD, PARK AVENUE, QLD. 4701 Lot 1 on CP 848924 AND Lot 43 on LN 1499

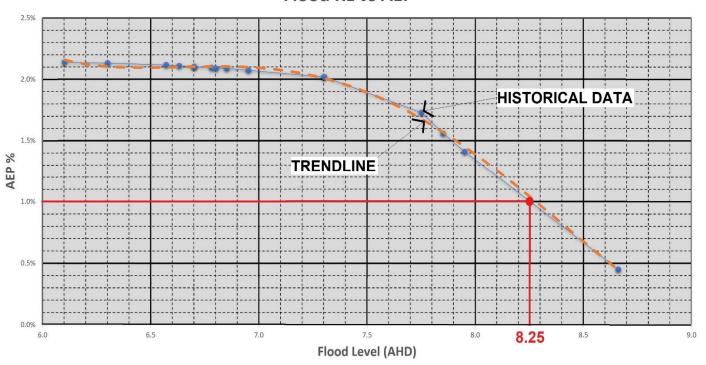
FIGURE 2 - Historical Flood Data

Plotting the data detailed in **TABLE 2** will show that the 1% AEP (Riverine) flood level in Rockhampton is at RL 8.25 (AHD) – see **FIGURE 2** below.

As evident from **TABLE 2** above – a flood level of RL 8.25 (AHD) has only been exceeded once in the past 104 years.

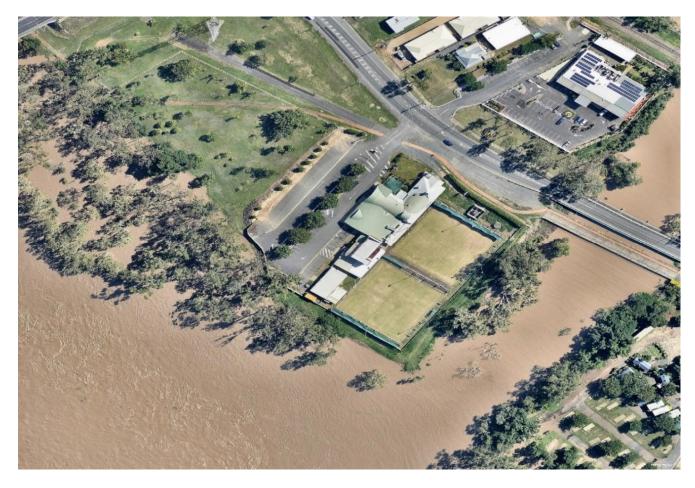
The above aerial image was taken on the 4 April 2017 – with a flood level of RL 7.30 (approx.)

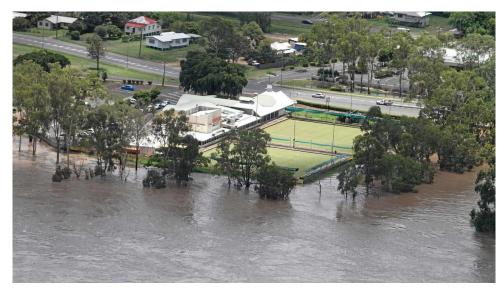
The above aerial image was taken in January 2011 – showing a flood level of approx. RL 7.75 (AHD)

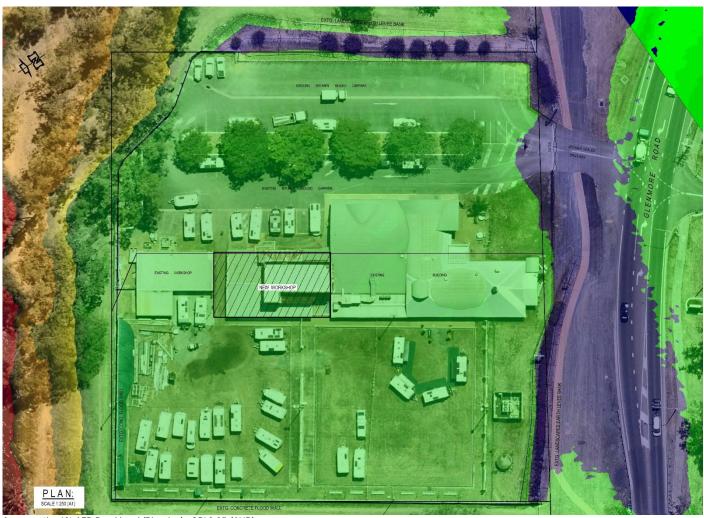
FIGURE 3 - Height Isopleths

Review of existing natural surface levels as shown in **FIGURE 3** below shows that the site is protected to the north and west from the 1% AEP flood inundation by higher ground and the existing levee banks. The site is also protected to the south and east by the existing concrete flood wall. The diagram also indicates that during the 1% AEP storm event, that sections of Glenmore Road is also flooded with flows of up 400mm deep across the crown of the road.

Assumes the 1% AEP flood level (Riverine) of RL8.25 (AHD)

Queens Park, the foreshores of Moores Creek and the Fitzroy River are discernibly inundated during the 1% AEP flood event. However, any 1% AEP flood impacts from the Moores Creek <u>localised</u> catchment will be negated by the presence of the existing concrete flood wall along the southern and eastern frontages of the site.

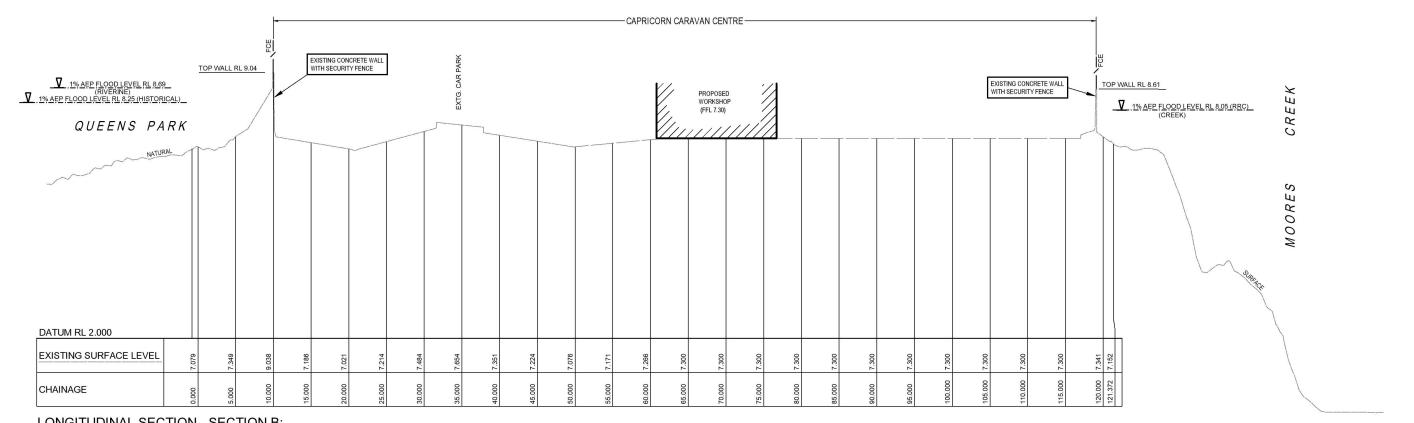
LONGITUDINAL SECTION - SECTION B:

A1 SCALE: H 1:250, V 1:50

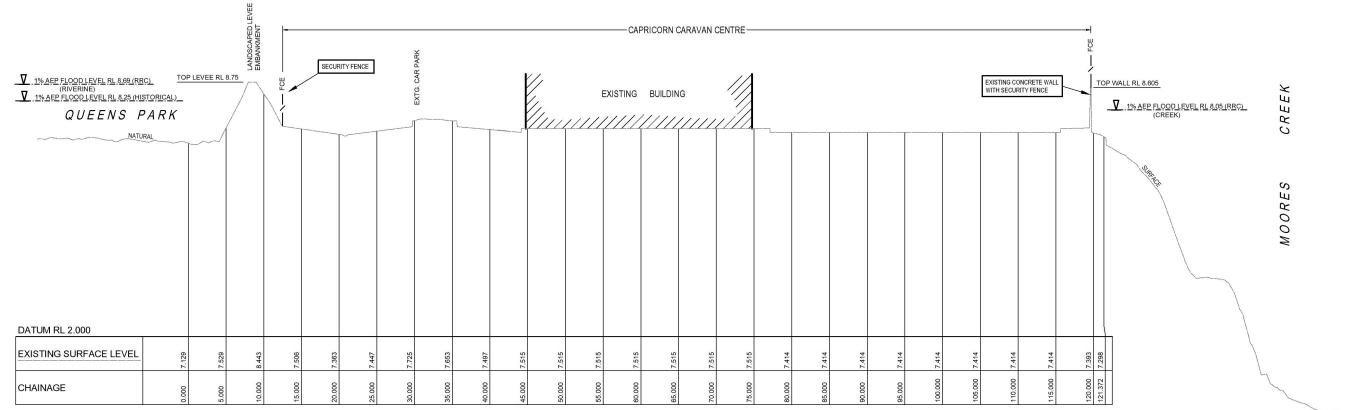
LONGITUDINAL SECTION - SECTION A:

A1 SCALE: H 1:250, V 1:50
