SLOPE STABILITY ASSESSMENT AND REPORT

Project: Slope Stability Assessment,
Lot 3 on RP837881,
318 Thirkettle Avenue
Frenchville, QLD 4701

Job Reference: 2128E.P.957B

Date: 4th March 2017

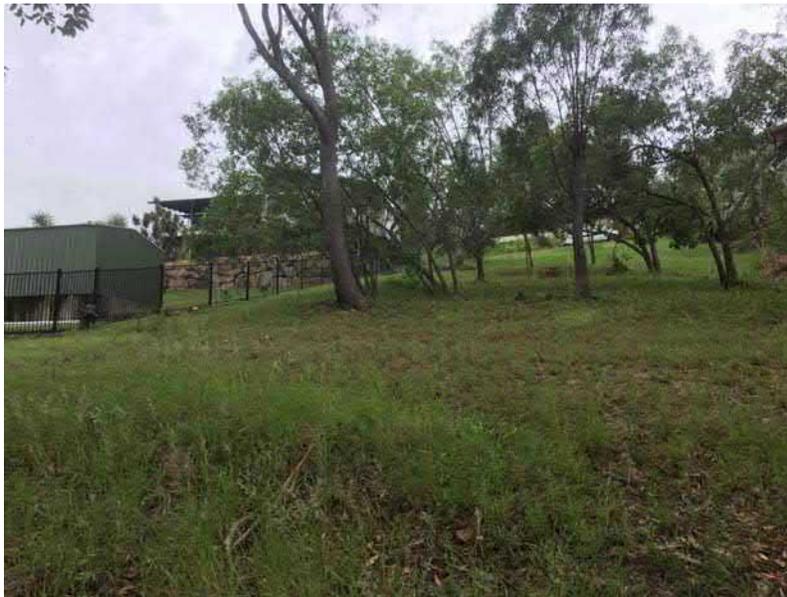
Plate 1: View of the site from the southern property boundary.

Refer to plates 1 and 2 for typical site conditions encountered during our investigation.

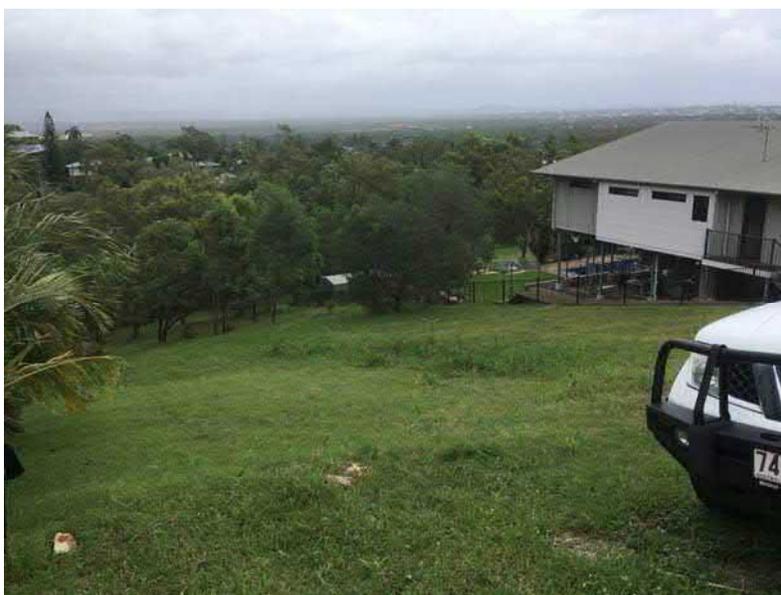
Plate 2: View of the site from north east corner of the property boundary.

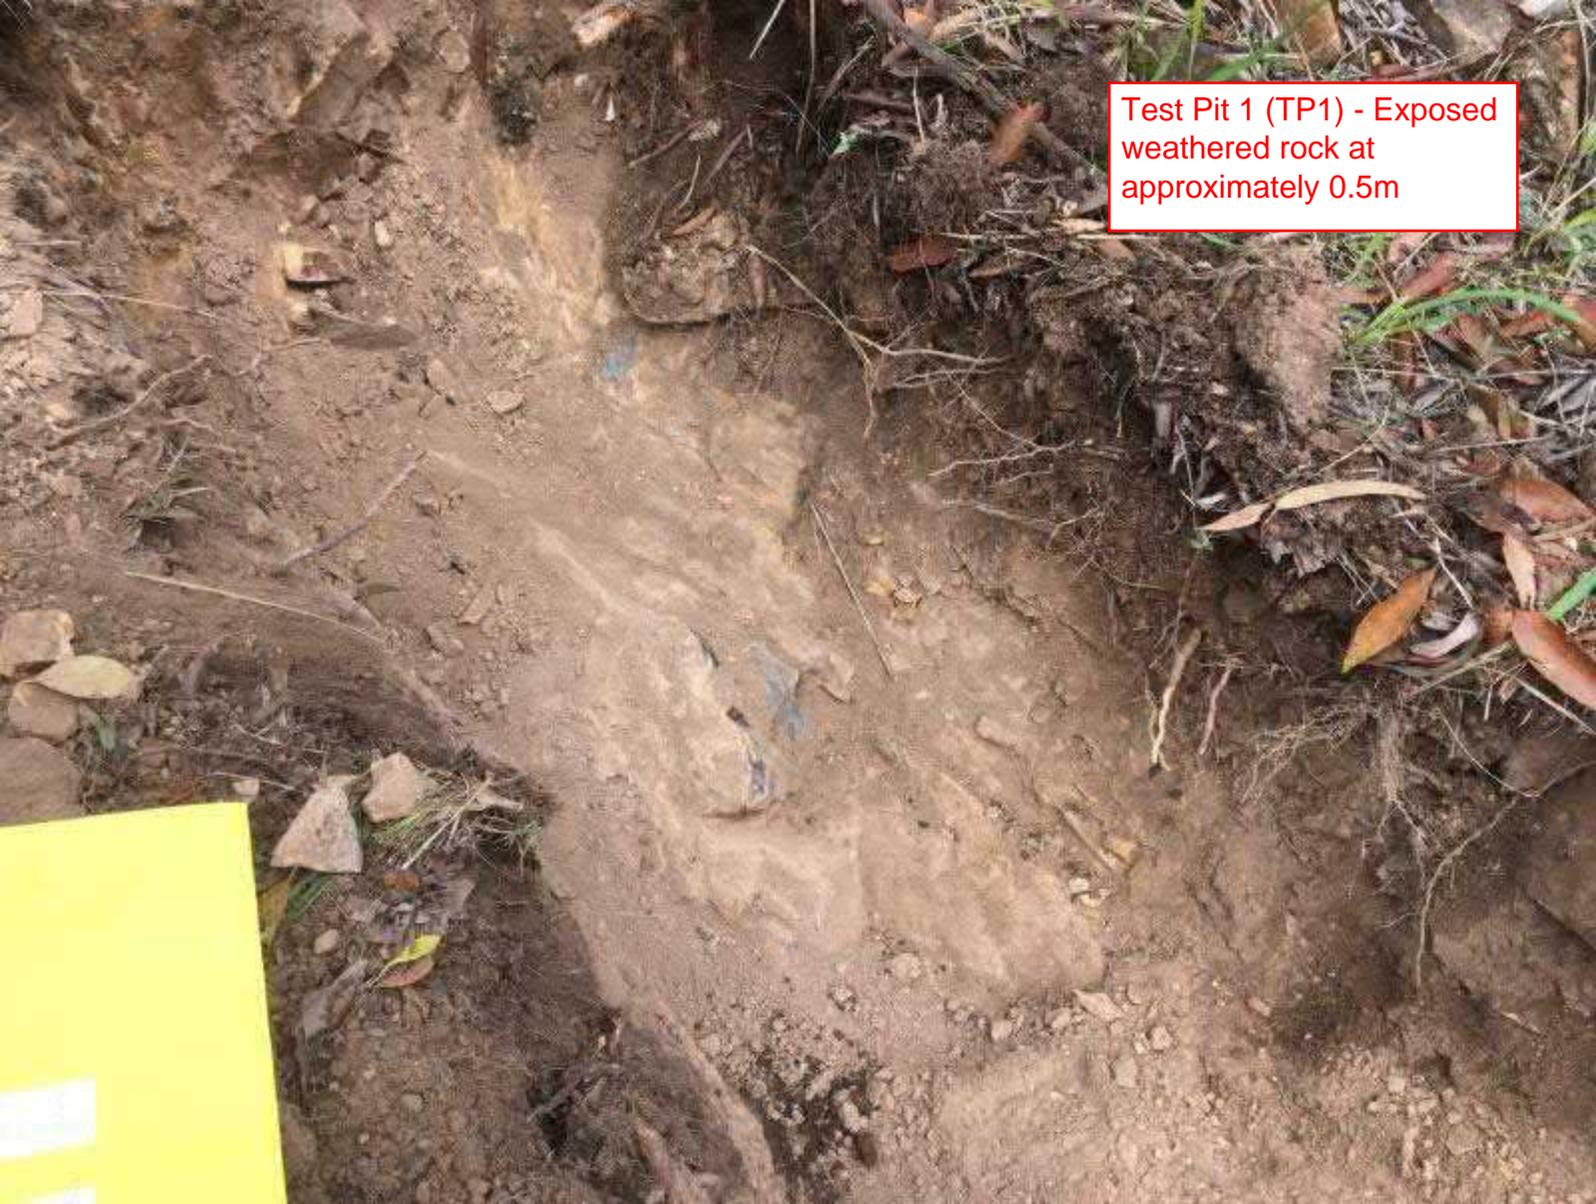
Test Pit 1 (TP1) - Exposed
weathered rock at
approximately 0.5m

A topsoil layer was observed to be common at both test pit locations with thickness ranging from 0.2-0.25m. Only colluvium and suspected fill material was encountered at TP2 location to approximately 0.5m depth.

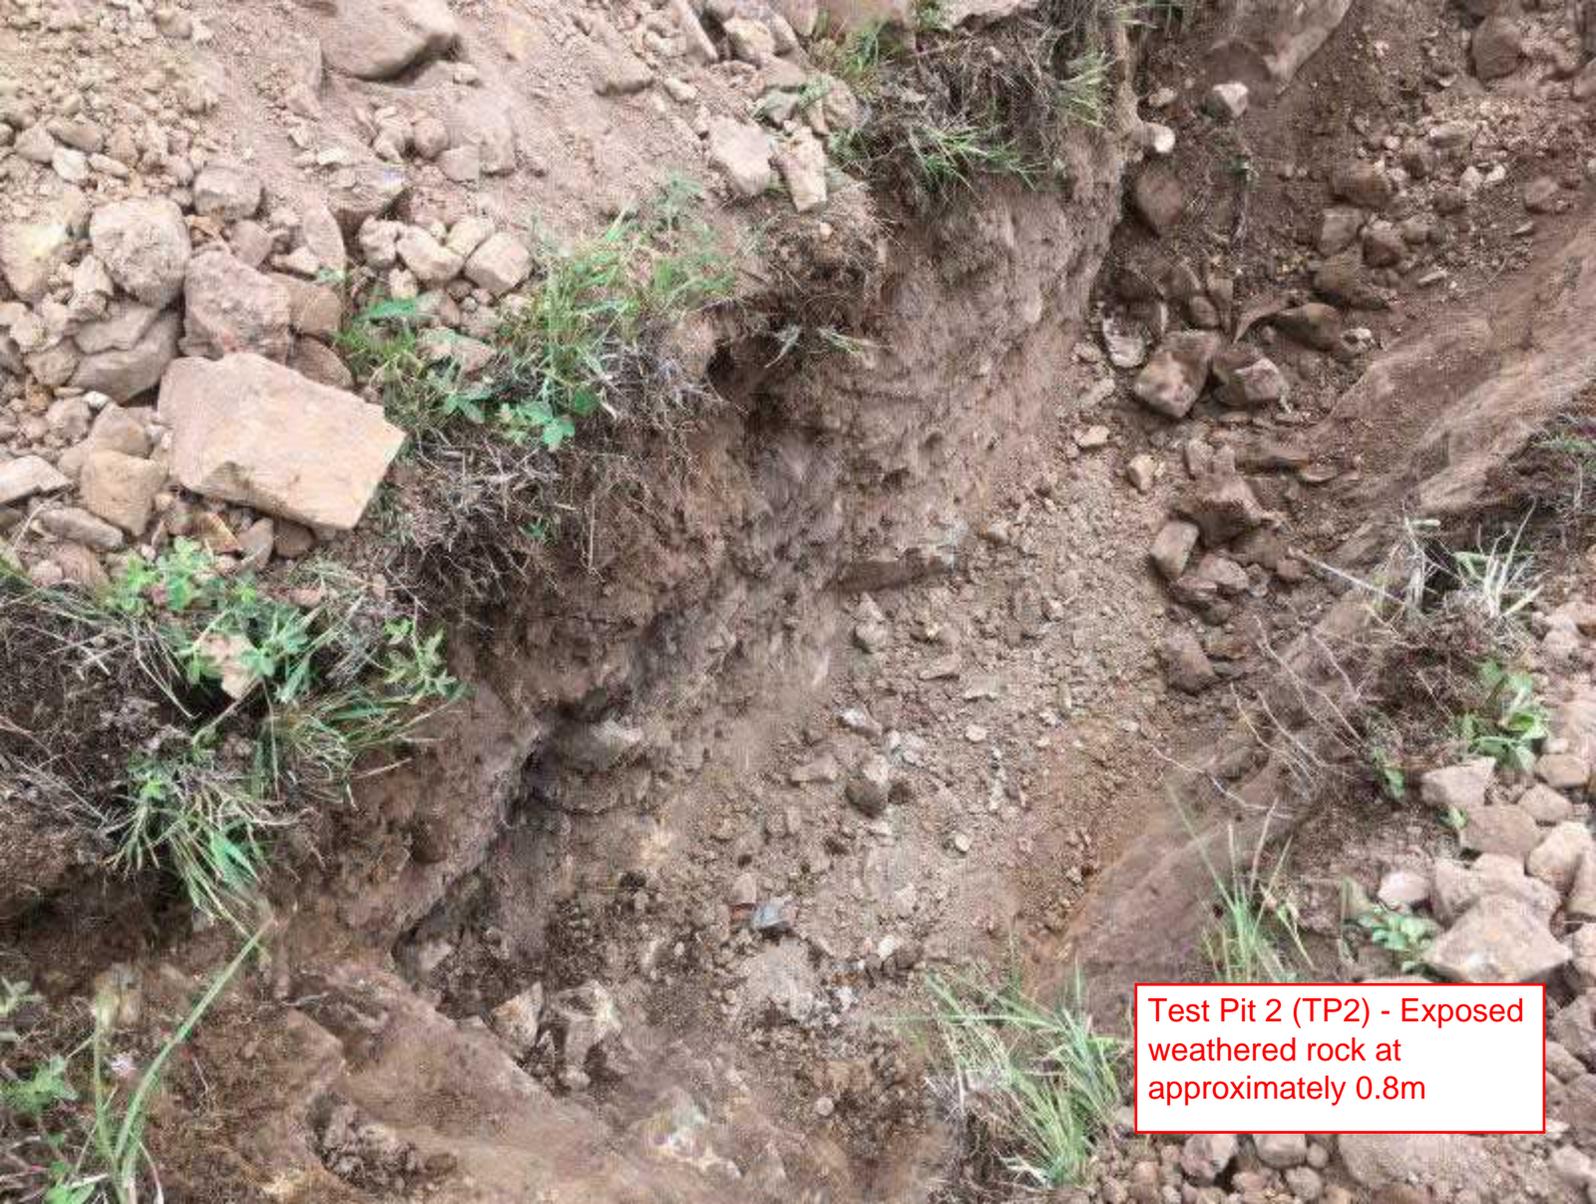
Test Pit 2 (TP2) - Exposed weathered rock at approximately 0.8m
