NORMAN PARK
RESIDENTIAL PRECINCT 2

PROPOSAL PLAN

PROJECT: Proposed Subdivision

SLOPE STABILITY ASSESSMENT AND REPORT

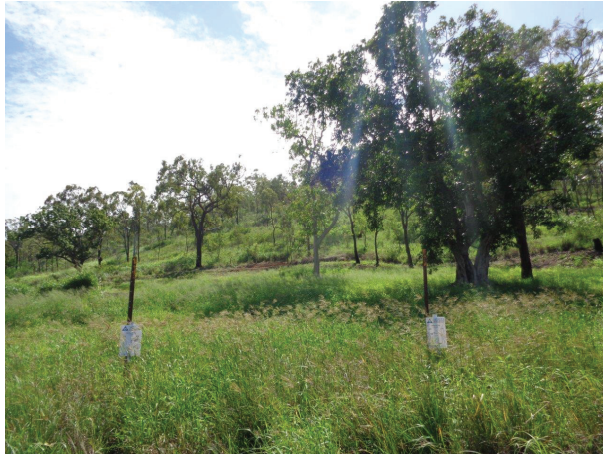
Plate 1: View of the site from German Street to the North

The sloping surface was generally planar in shape with a minor gully developing approximately half-way down the slope towards the southern boundary of the proposed allotment 2 block. Firebreaks have been constructed along the proposed common access as indicated on Vision Surveys Drawing No: 16025-PP-01 Rev C dated 03/02/2017, allowing access to the sites from a gated entrance. The existing slopes were measured onsite to range between 27-37%.

Refer to plates 1 and 2 for typical site conditions encountered during our investigation.

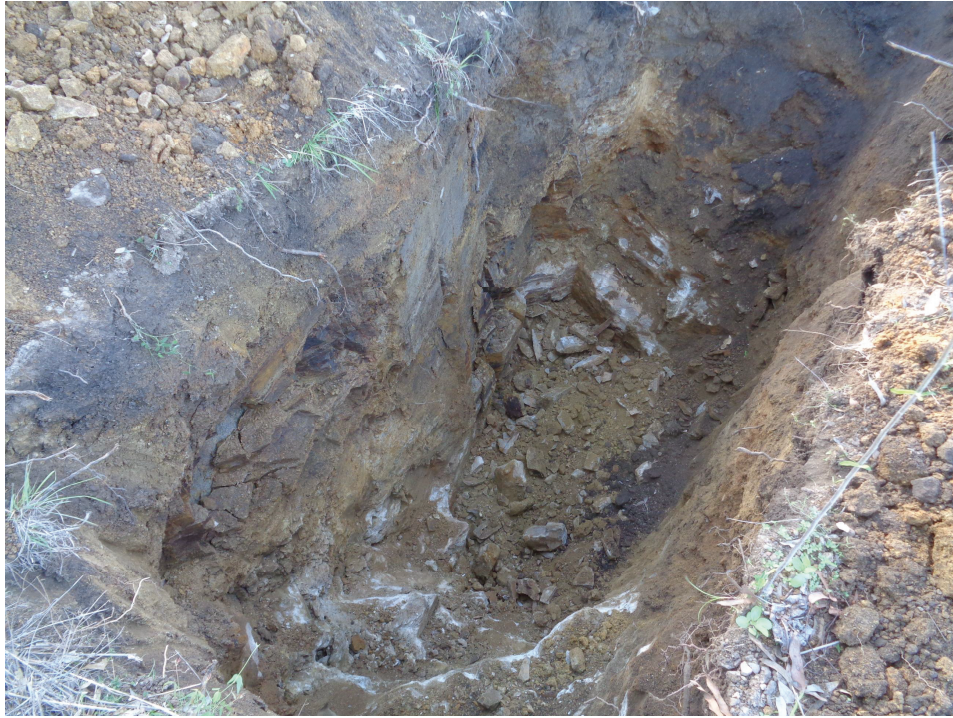
Test Pit TP1

CI/CH	SANDY CLAY (RESIDUAL) medium to high plasticity, brown, moist, very stiff to hard, fine to coarse sand, traces of fine to medium gravel, sub-angular.		1 1 1 21 22+

XW/DW	EXTREMELY TO DISTINCTLY WEATHERED ROCK extremely low to low strength, brown/dark brown, moderately fractured, fine to coarse grained, granular texture, excavates as sandy gravel, fine to coarse gravel with cobbles/boulders, MPS 300mm.		
Ripper			1.5

DW	DISTINCTLY WEATHERED ROCK medium to high strength, brown/dark brown, moderately fractured, fine to coarse grained, granular texture, excavates as cobbles/boulders, MPS 600mm.

2.5					
			3.0			Test Pit Terminated at 2.9m (Ripper Refusal)		
			3.5					
			4.0					
			4.5					
			5.0

Test pits TP1 and TP4 were undertaken on the lower end of the slope within proposed allotments 1 and 3 respectively, and intersected similar ground conditions. A mixture of clayey sands and gravelly clayey sands of colluvial origin were observed to overlay the weathered rock layers generally encountered at 0.8m below ground level. Soils of residual origin were only encountered at TP1 location made up of sandy clay composition with medium to high plasticity fines and hard in consistency.

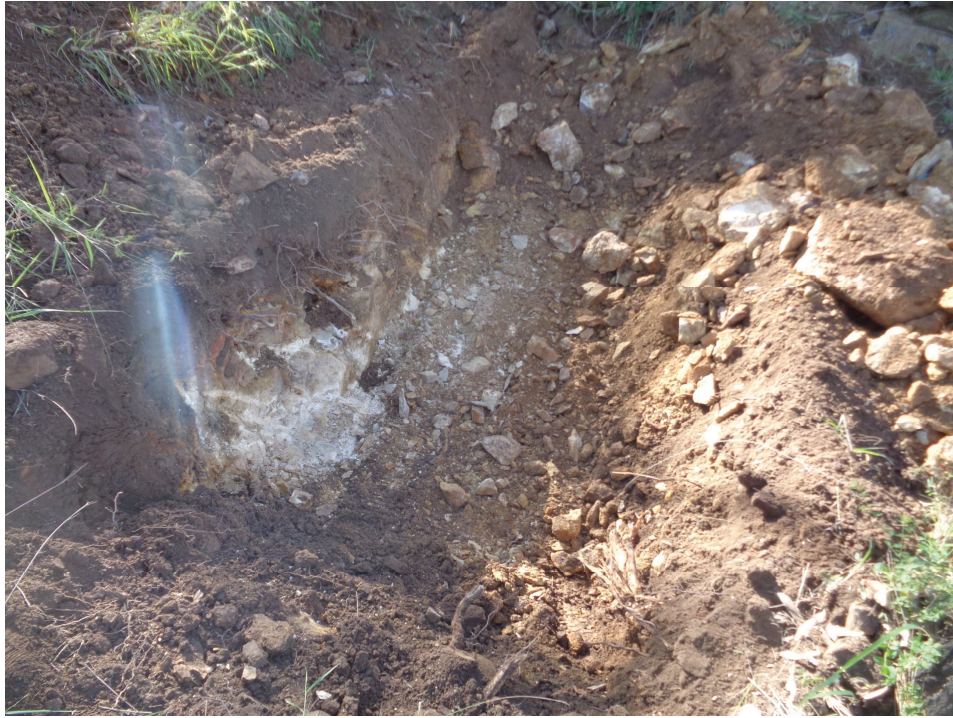
Test Pit TP2

<u>DISTINCTLY WEATHERED ROCK</u> high strength, brown/yellow, moderately to slightly fractured, fine to coarse grained, granular texture, excavates as sandy gravel with cobbles/boulders, MPS 600mm.		3 22+
			1.0			Test Pit Terminated at 0.8m (Ripper Refusal)		
			1.5					
			2.0					
			2.5					
			3.0					
			3.5					
			4.0					
			4.5					
			5.0

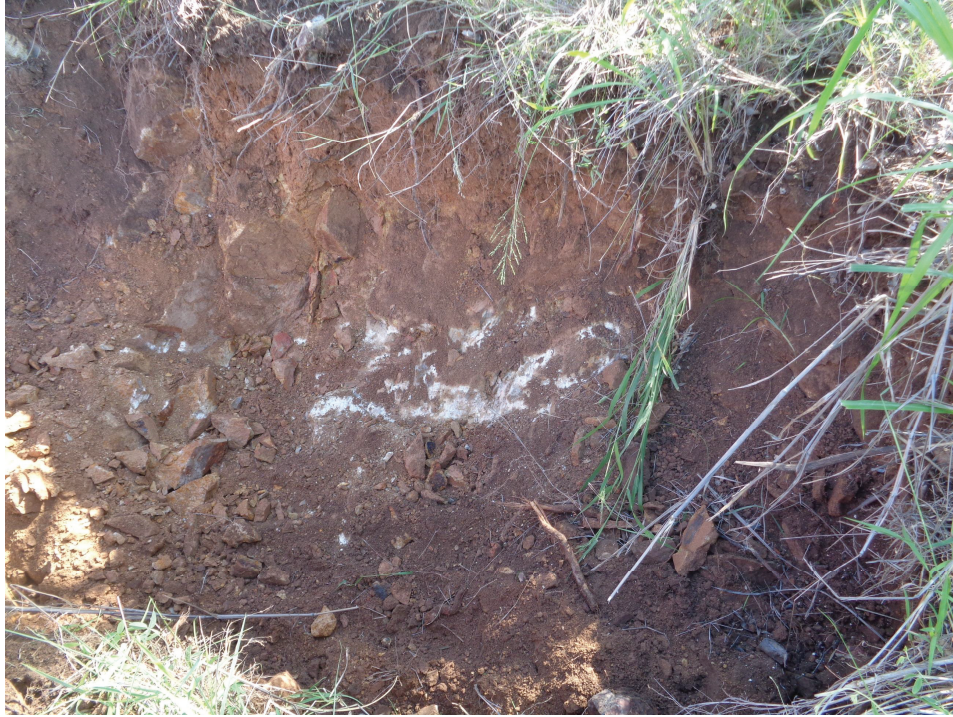
Test Pit TP3

1.5			Test Pit Terminated at 1.2m (Ripper Refusal)		
			2.0					
			2.5					
			3.0					
			3.5					
			4.0					
			4.5					
			5.0

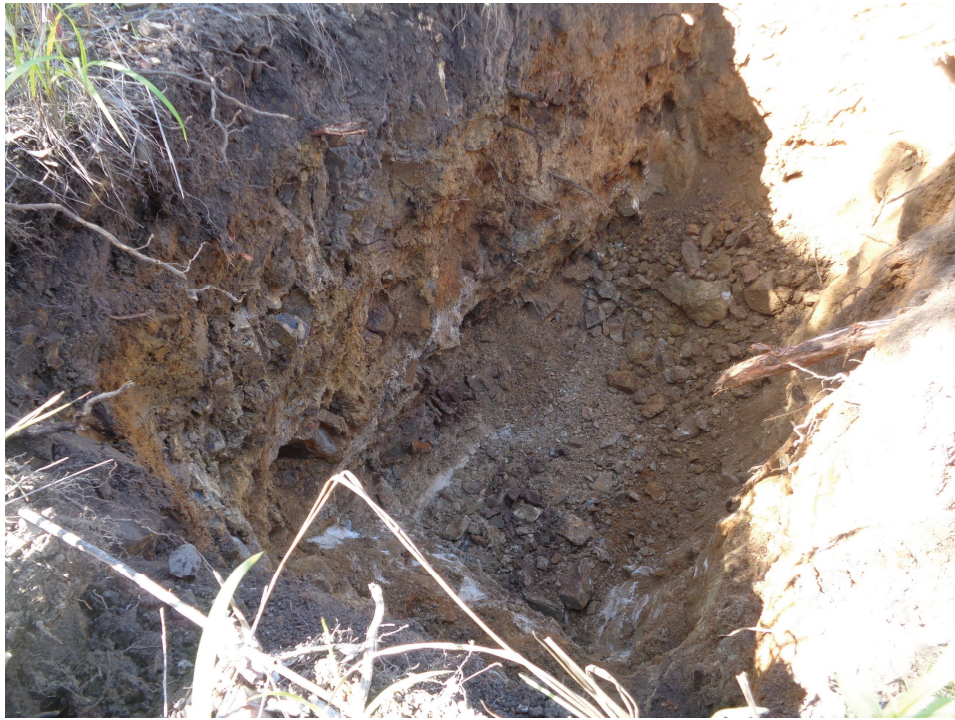
Test Pit TP4

5.0		DW	DISTINCTLY WEATHERED ROCK high strength, brown/dark brown, moderately to slightly fractured, fine to coarse grained, granular texture, excavates as cobbles/boulders, MPS 500mm.

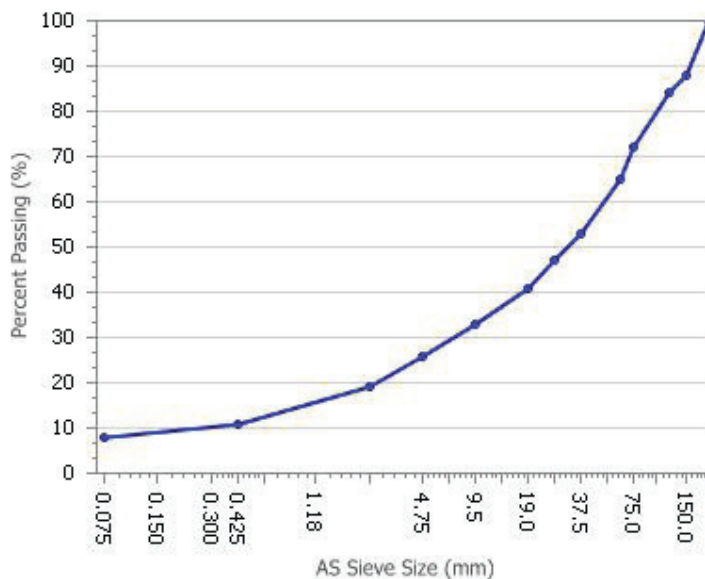
PARTICLE SIZE DISTRIBUTION GRAPH

AS Sieve (mm)	Specification Minimum	Percent Passing (%)	Specification Maximum
200.0		100	
150.0		88	
120.0		84	
75.0		72	
63.0		65	
37.5		53	
26.5		47	
19.0		41	
9.5		33	
4.75		26	
2.36		19	
0.425		11	
0.075		8

Test Result	Specification Minimum	Result	Specification Maximum	Test Result	Specification Minimum	Result	Specification Maximum
Liquid Limit (%)		37		0.075/0.425 Fines Ratio		0.70	
Plastic Limit (%)		19		PI x 0.425 Ratio (%)		196.2	
Plastic Index (%)		18		LS x 0.425 Ratio (%)		76.3	
Linear Shrinkage (%)		7.0		Linear Shrinkage Defects		-

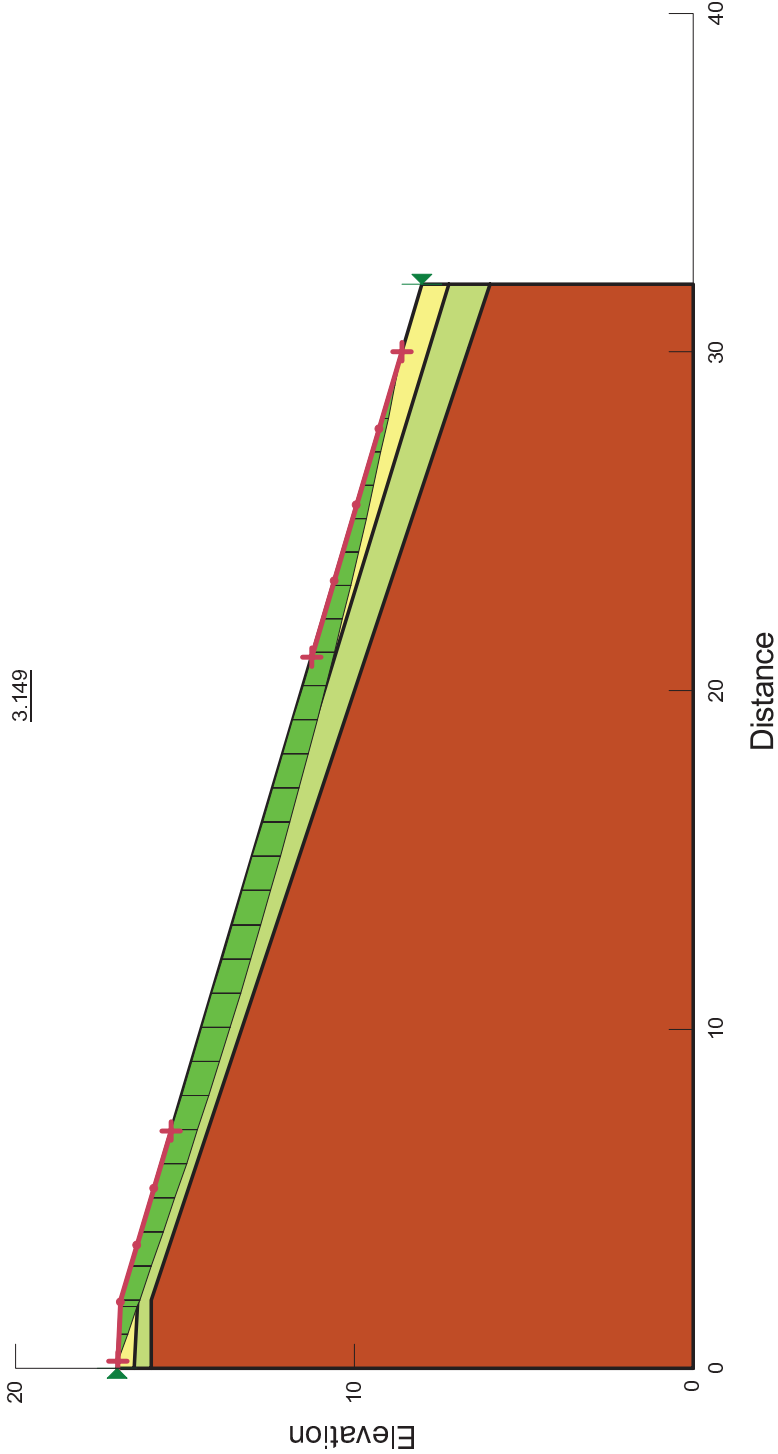
Slope Model Analysis

Lot 35 on SP285391 German Street
Name: gravelly clayey sand (Colluvium) Model: Mohr-Coulomb Unit Weight: 17 kN/m³ Cohesion: 3 kPa Phi: 28 °
Name: sandy clay (Residual) Model: Mohr-Coulomb Unit Weight: 16 kN/m³ Cohesion: 5 kPa Phi: 24 °
Name: XW rock Model: Mohr-Coulomb Unit Weight: 19 kN/m³ Cohesion: 15 kPa Phi: 35 °

From this analysis, some surficial creep may be expected to occur in the colluvium over the long term. Provided that the building is founded into the underlying weathered rock, the building should have a sufficient factor of safety against slip failure for the long-term. Furthermore, it is recommended that the building foundations be imbedded into the weathered rock profile to resist any lateral forces that may be applied from this surficial creep. There will still remain the potential for creep or slippage of the colluvium across the site.

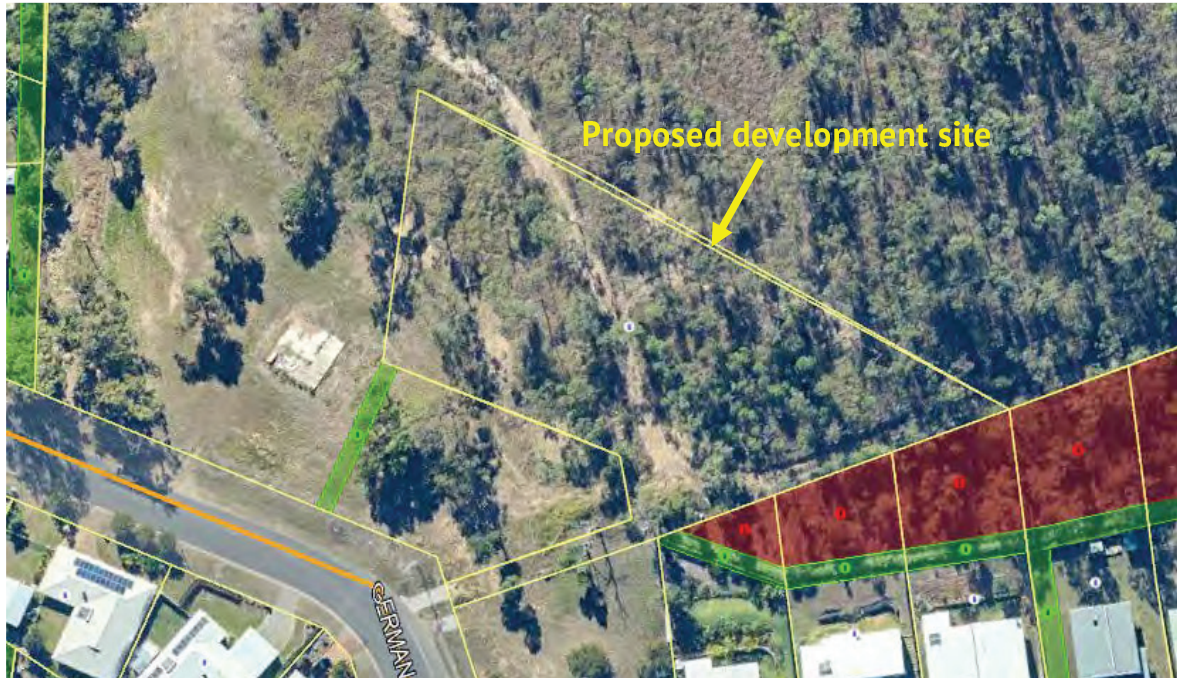
Figure 1: Aerial of proposed development site

Premise Mackay Pty Ltd (ABN: 80 145 564 852) t/as Premise (Premise) have been commissioned by Blue Dolphin Pty Ltd to undertake the preliminary stormwater management plan for the German Street development site. This stormwater management plan has been produced to summarise and highlight the effect of developing Lot 35 on SP285391 German Street in North East Rockhampton. The development will consist of subdividing Lot 35 into two (2) land parcels of 2,051m² and 2,600m² with a concrete driveway for access. The proposed development site is shown in Figure 1.

The existing catchment was assessed to identify its 'lawful points of discharge' and quantify the effects on neighbouring properties and downstream stormwater infrastructure (if any at all) when factoring for the proposed development. This will determine the impact of developing the site and provide insight into infrastructure required to cater for any changes.

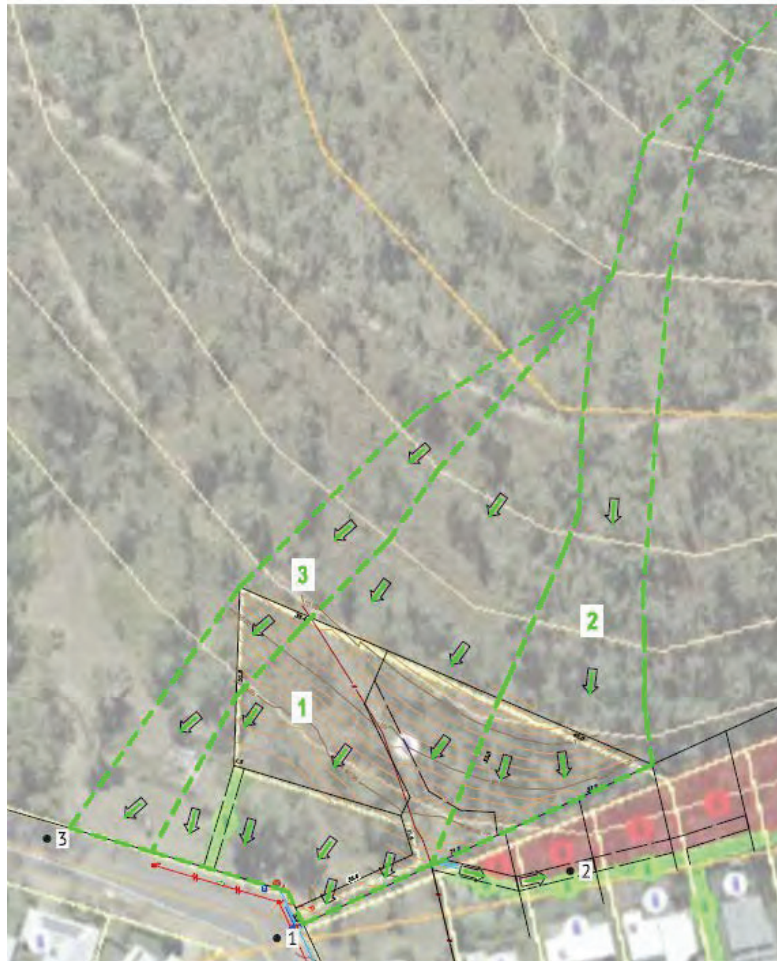
Figure 2: Pre-development catchment plan

The existing catchments are shown in Figure 2 below. The existing Q100 flows in these catchments are summarised in Table 1. The lawful points of discharge comprise of German Street in the western and southern direction and Easement L on the eastern boundary of the site.

The catchments that currently contribute to stormwater flows are distributed to German Street in the western and southern direction as well as Easement L part way down the subject site. The catchments include the proposed development site, uphill of the proposed development site, and the area between the proposed development site and German Street. Analysis of aerial photography determined appropriate fraction impervious values for the existing site and were taken as 0% for the whole site. The pre-development site and adjacent catchments can be seen in Appendix A – Catchment Plans.
