16 April 2018

Project No. 18098-001-Rev0

**SLOPE STABILITY ASSESSMENT FOR PROPOSED RESIDENCE
15 KILKENNY COURT (LOT 9 ON SP176990), KAWANA**

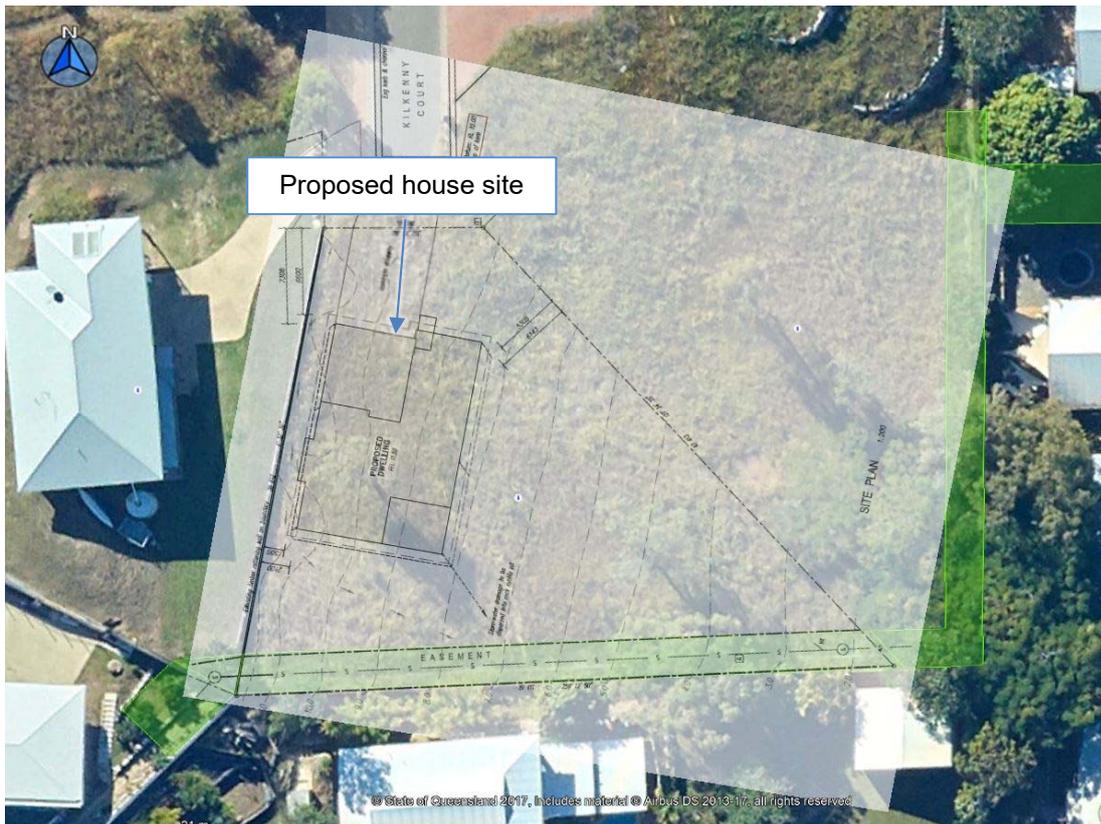
The property is described as Lot 9 on SP176990 and covers an area of 1125 m². The site slopes moderately to the east. Existing residences are located on surrounding properties. Text Figure 1 on the following page illustrates the site location and approximate building position. A more detailed description of the site is given in Section 2.

Text Figure 1: Aerial image of site and surrounds (Image source: Natural Resources, Mines and Energy, Queensland Government, Queensland Globe, licensed under Creative Commons, 2017); overlain house plan by Tectonic

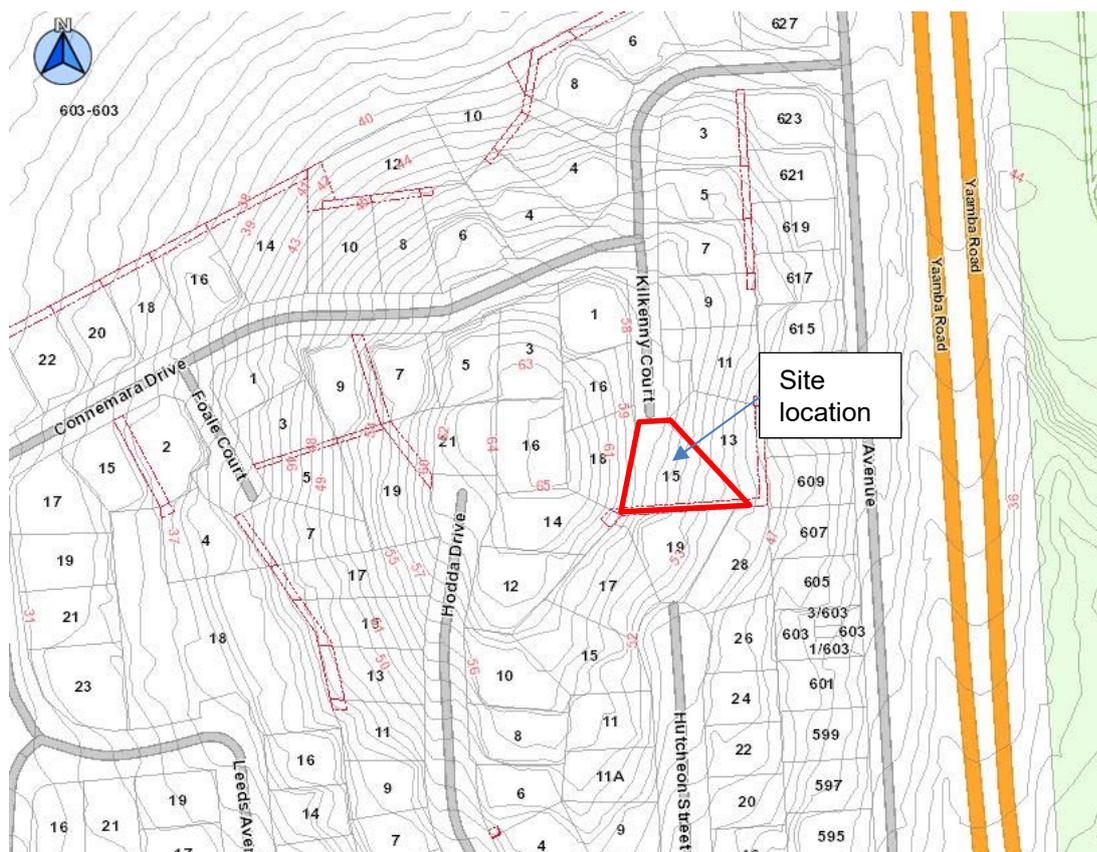
The site is located on the eastern side of hill which has a summit approximately 40 m to the west. Ground surface contours above and through the subject site are generally consistent, with elevations ranging between about RL 58 m and RL 50 m and falling to the east based on Rockhampton Regional Council (RRC) web mapping information (refer to Text Figure 4).

Text Figure 4: Extract of RRC web mapping ground surface contours

Contour information shown on the residential design drawing (drawing ref. 17-774 Sheet 3) and from the RRC web mapping site both indicate that the site slopes relatively consistently at between about 10° and 12°.

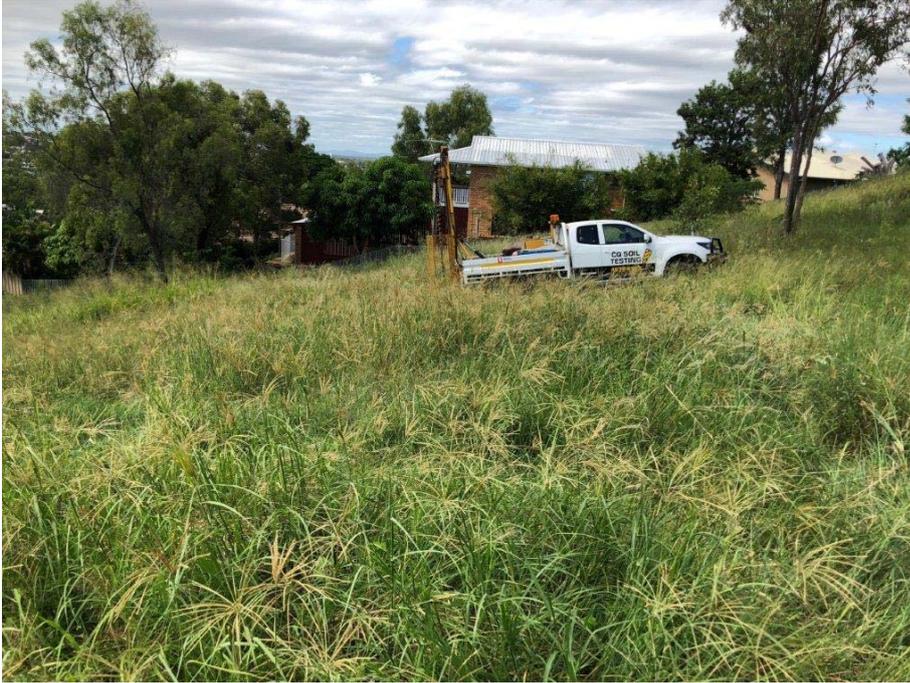
The topography on the site would be generally described as linear planar. Site conditions are shown in Text Figures 5 and 6 below.

Text Figure 5: Site conditions in proposed building envelope, looking south (photo provided by CQ)
