J Rayner and A Russell Information Request Response Rehabilitation Plan

**Prepared for Angela Russell
Project No. R15-182A, 21 December 2015**

*Proposed Residence
17 Greenwood Close, Frenchville
Project No.: R15-182A
21 December 2015*

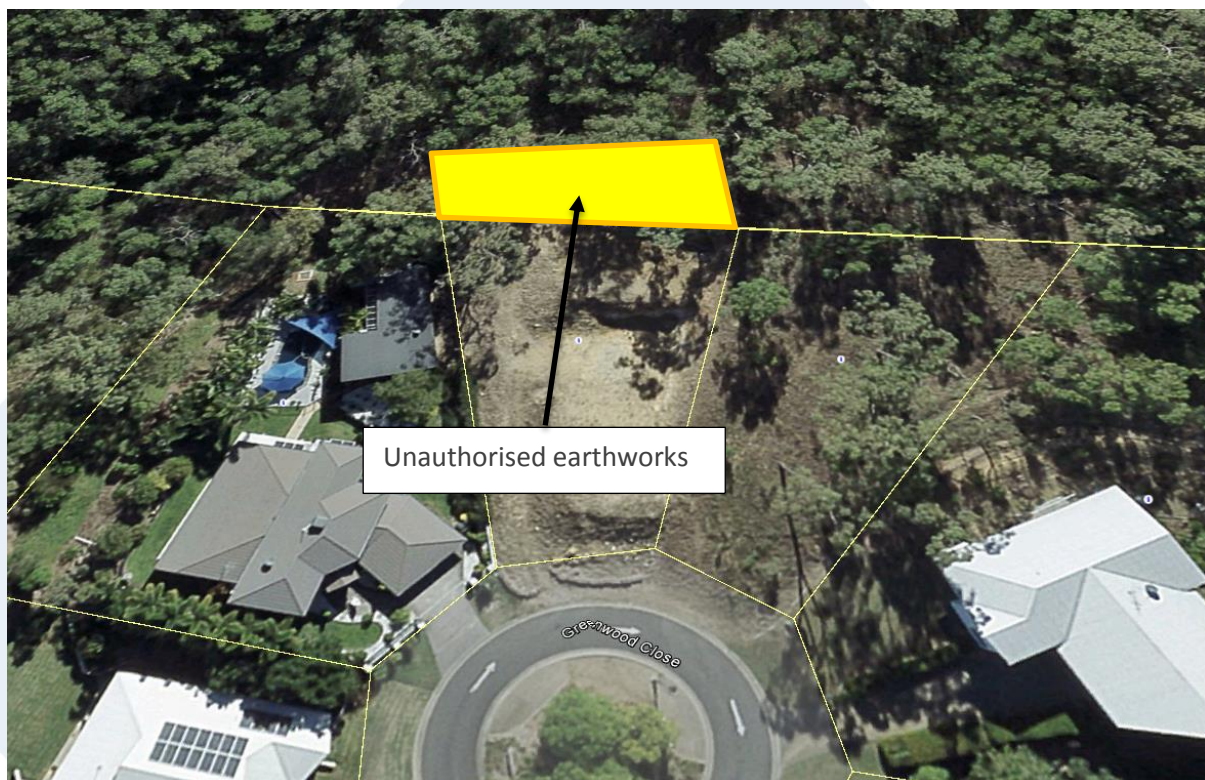
Figure 1. Location of unauthorised earthworks on Lot 1 RP618495, adjacent to Lot 1 SP245873.

The location of the unauthorised earthworks is on the adjoining Rockhampton Regional Council land (Lot 1 RP618495) to Lot 1 SP245873 (owned by J Rayner and A Russell). The location of the unauthorised earthworks are represented in Figure 1.

RRC states that the site of the unauthorised earthworks has been mapped as having matters of high and general local environmental significance. Following investigation and assessment of the subject site, STEER Environmental Consulting (STEER EC) is in agreement that the site is covered by an area mapped as having matters of high and local environmental significance. The location of the site in relation to biodiversity areas overlay map OM-3A is shown in Figures 1 and 2.

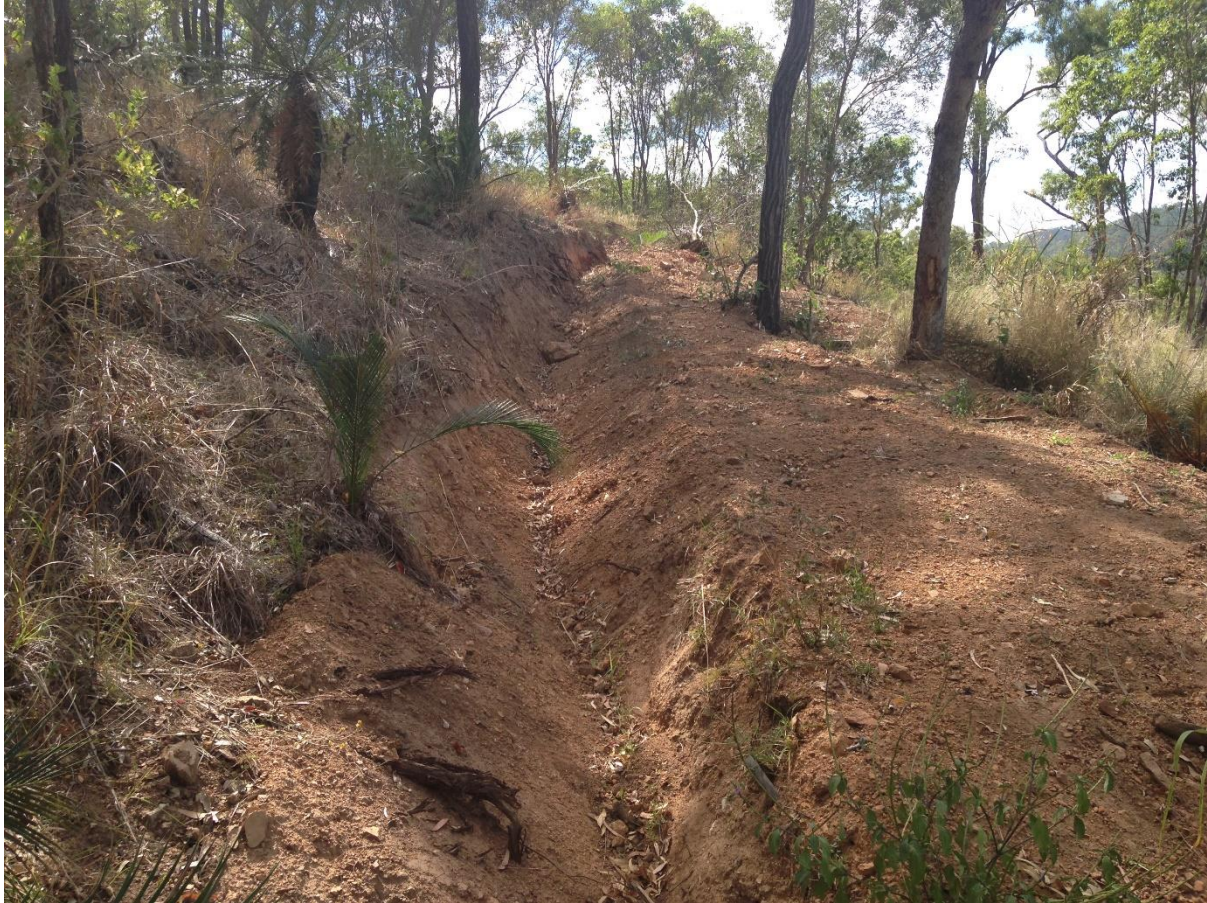
Figure 3. Unauthorised earthworks on Lot 1 RP4444. Open drain structure. Note Macrozamia miquelii left undamaged at left of drain, and Lantana camara at bottom right of image.

- Construction of an unstabilised drain of approximately 20m length.
- Removal of at least one mature naturally occurring native tree (appears that a maximum of 2 trees may have been removed).
- Removal of approximately 1-2 *Macrozamia miquelii* shrubs.
- Likely removal of 2-3 *Acacia* species.

Rehabilitation Activity	Detail
Stabilisation of unauthorised drain.	The unauthorised drain should be either stabilised through “rock armouring” or similar treatment, or removed. This process must be conducted to appropriate engineering standards and the satisfaction of RRC. Care should be taken during this process to not cause further damage to remaining vegetation.
Installation of sediment control measures.	Sediment management/mitigation structures such as rubble traps and geotextile sediment barriers should be installed to capture liberated sediment from the rehabilitation area.
Pest/weed removal	Prior to introduction of the new rehabilitation vegetation, pest/weed removal and/or treatment should be undertaken. This should primarily focus on removal of <i>Lantana camara</i> .
Planting of tubestock seedlings.	3 x <i>Eucalyptus crebra</i> and 3 x <i>Acacia</i> species (seeded from nearby naturally occurring <i>Acacia</i>) and 3 x <i>Macrozamia miquelii</i> (if reasonably available) should be replanted in the rehabilitation area in random placements, reasonably spaced from each other..

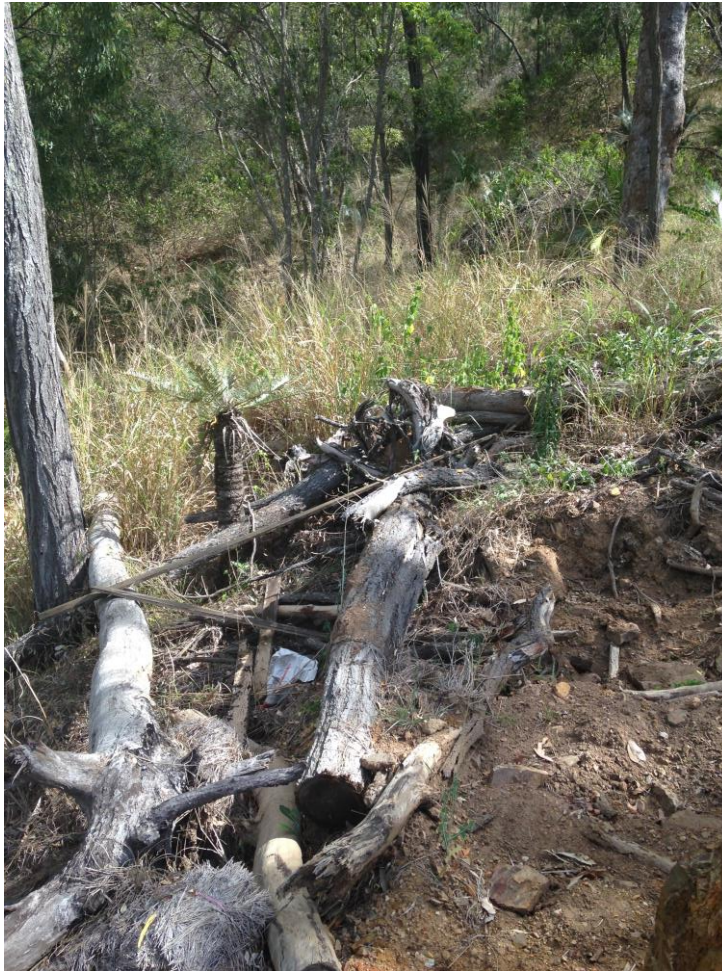
Figure 4. Fallen timber pile in/adjoining rehabilitation area.

Application of mulch.	Clean, weed free mulch sourced from native vegetation should be applied around each of the replanted plants. Exposed areas of earth in the rehabilitation should be treated with mulch.
Spreading of fallen timber.	The rehabilitation area contains a small pile of dead timber that may be from the removal of vegetation from the area (see Figure 4). This timber should be carefully spread randomly across the rehabilitation area. Care needs to be taken not to damage newly introduced plants or existing remaining vegetation during this process.
Ongoing management	Irrigation and pest/weed management should be undertaken on an ongoing basis until rehabilitation success criteria have been met.
Handover of rehabilitation area	Handover of rehabilitation area to RRC after 12 months, or upon achievement of success criteria.

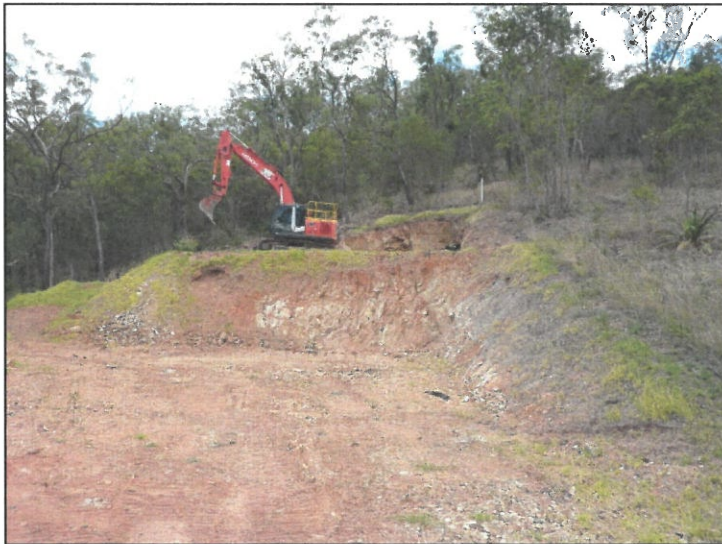
Photograph 1: View from lower platform toward the rear of the allotment

Ground surface levels generally fall in a south-westerly direction with the former 'natural' slope (pre-earthworks) estimated to be in the order of 15 to 17 degrees with an overall difference in elevation across the site of approximately 15m. Four general views of the site at the time of investigation are given in Photographs 1 to 4.

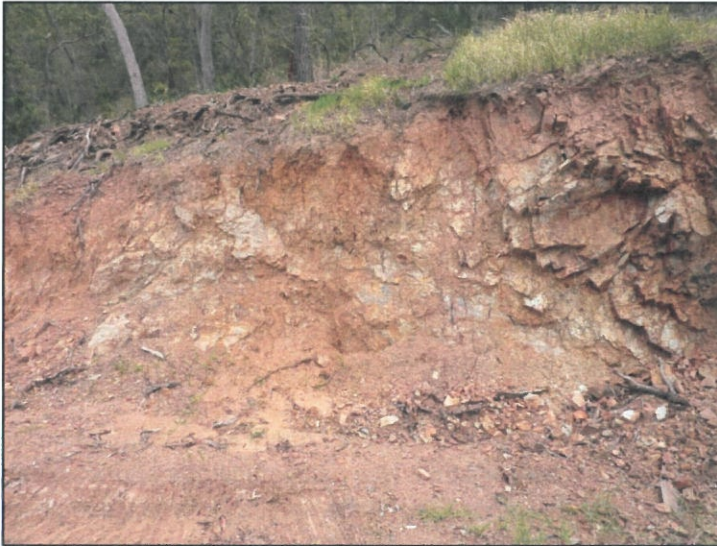
Photograph 2: View of cut face behind the upper platform

The site is described as Lot 1 on SP245873, and is located at the end of Greenwood Close, with an existing residential development on the adjoining lot to the west and vacant land to the east. An existing boulder retaining wall approximately 1.0m to 1.5m high was observed in the adjacent allotment along the western boundary. At the time of the investigation, the site had recently (understood to be within the last six to nine months) undergone significant earthworks including excavation and filling to create two reasonably level platforms in the area of proposed development. Subsurface conditions exposed in the approximately 3m to 4m high cut faces comprise extremely to distinctly weathered siltstone.

The joints observed in the exposed cut were relatively closely spaced (20mm to 300mm) and were rough and irregular. The dip angle in the distinctly weathered siltstone was estimated to be approximately 70° to 80° in a south to south west direction, across the rock face. The slope batters generally comprise sparse grass cover, with the building platforms mostly clear of vegetation. At the time of the fieldwork, there was some evidence of movement/creep observed through tension cracking near the crest of the uncontrolled fill at the front of the allotment.

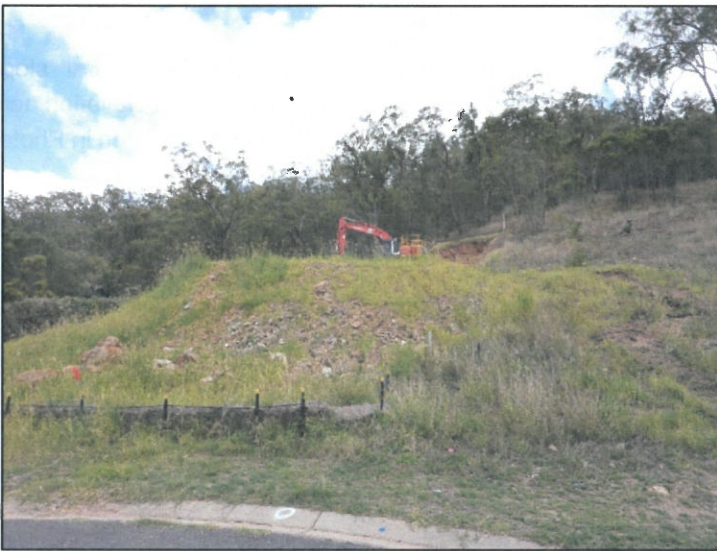
Photograph 3: View of the fill batter from Greenwood Close

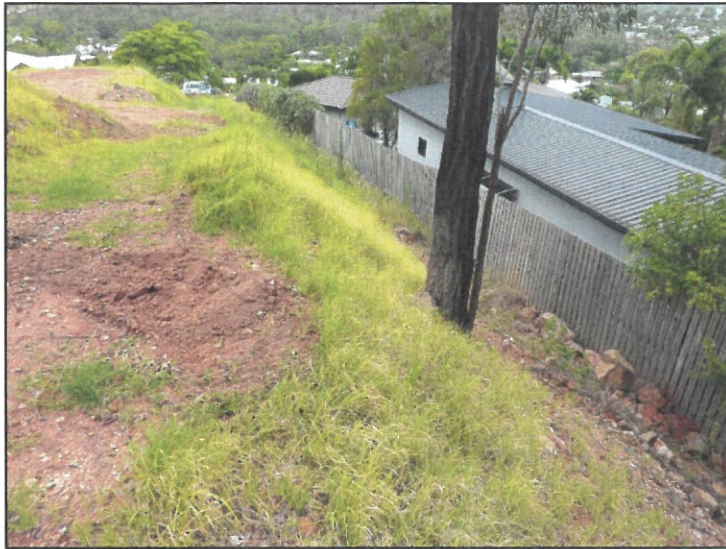
Photograph 4: View along western boundary toward Greenwood Close

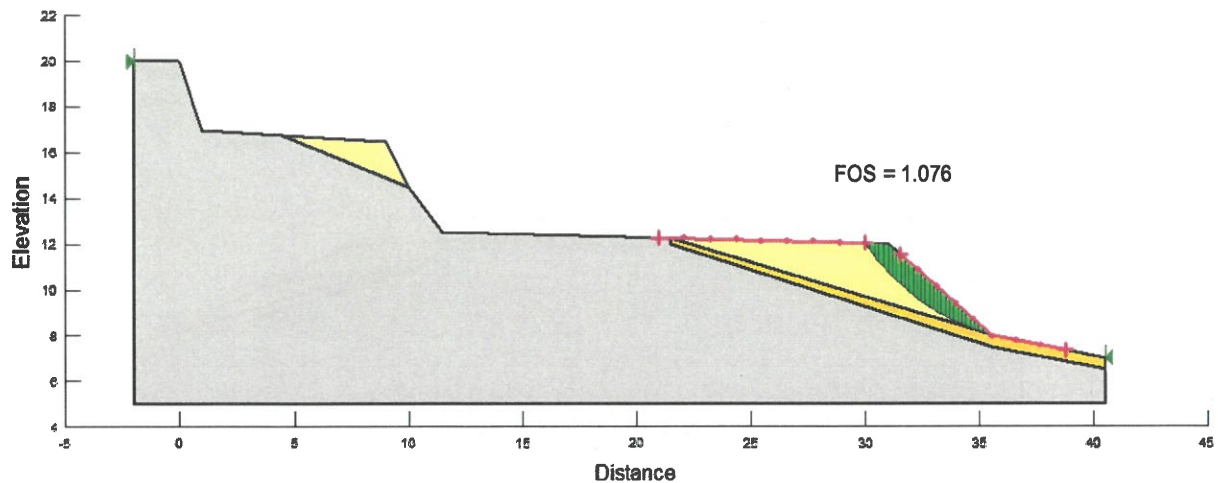
Figure 2: 'Long term' analysis for existing 'lower platform' fill profile

The results of the analysis discussed above indicate that, in its current state, the long term stability of the fill embankment is not acceptable and must either be removed and replaced as described in Section 5.3 or design and construct and engineered retaining wall to mitigate any further movement in the fill material.

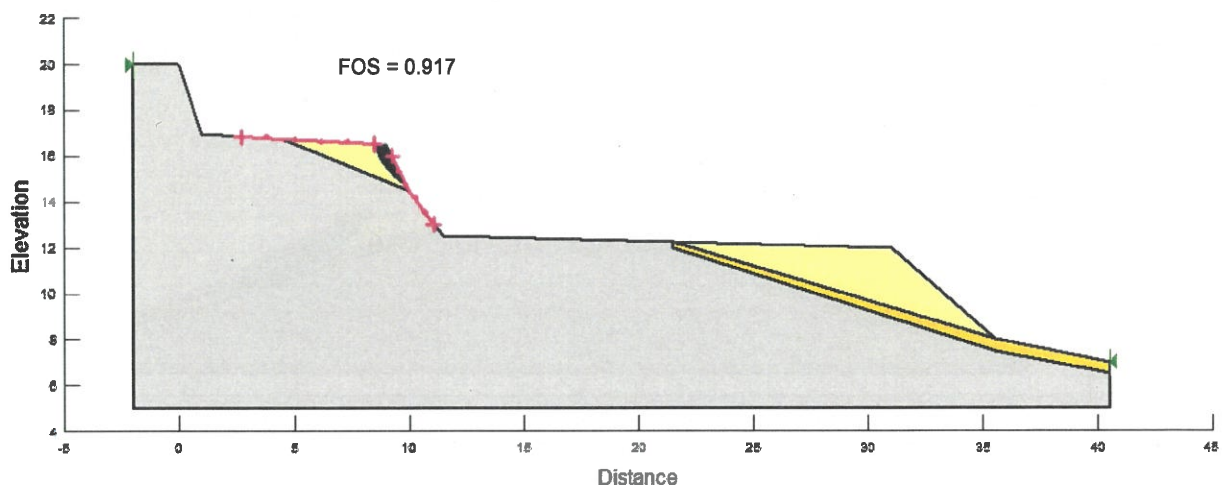
Figure 3: 'Long term' analysis for existing 'upper platform' fill profile
