INFRASTRUCTURE COMMITTEE MEETING

AGENDA

25 JUNE 2019

8.2 ROCKHAMPTON REGION FLOOD STUDIES

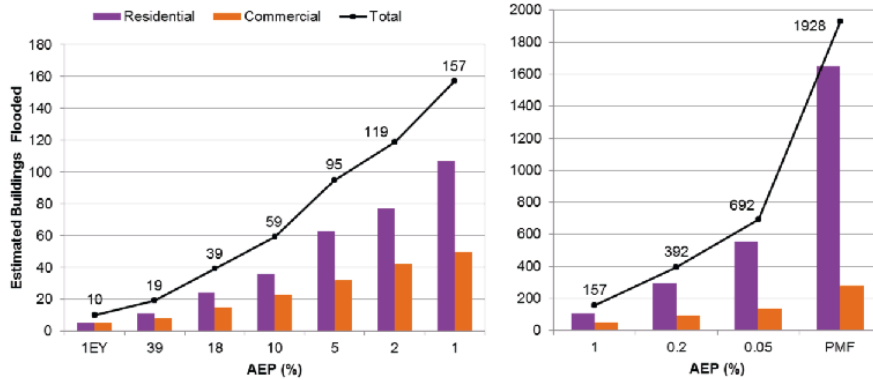
Figure E2 Estimated Buildings with Above Floor Flooding (Number of Buildings)

Table E2 provides a summary of the number of residential and commercial buildings anticipated to be inundated for various flood events within the Moores Creek catchment. These results are also shown graphically in Figure E2. Existing buildings which experience flood levels above ground level are noted and buildings inundated above floor level are shown in brackets beside.

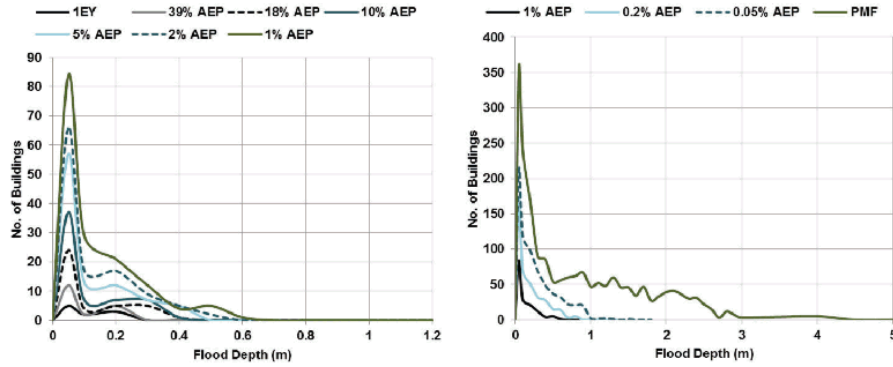
Figure E4 Estimated Flood Depths Above Floor Level by % AEP (Number of Buildings)

As shown in Figure E4, median flood depths are generally less than 0.1 metre for each flood event. This indicates that reductions in flood depths of 0.1 metre could significantly reduce overall damage. The figure also shows that a significant number of buildings experience flood depths of 0.3 metre or less during frequent events such as the 1EY flood event, generally corresponding to higher flood damages.

It is noted that where surveyed floor levels were not available, slab on ground buildings were assumed to have a floor level 0.1m above the existing ground level. This is consistent with other studies undertaken in the Rockhampton area, however may result in a higher estimate of inundated buildings and consequential flood damages due to the increased incidence of above floor flooding.

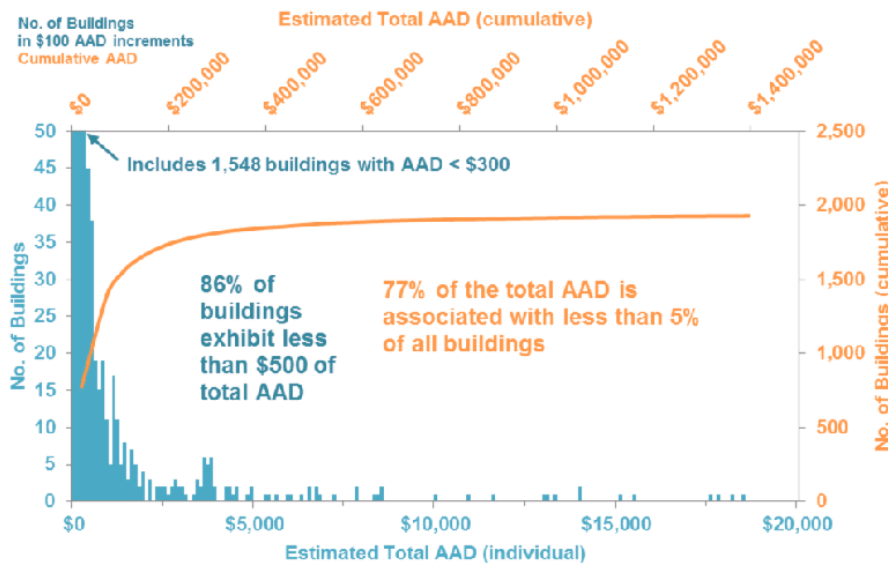
Figure E6 Individual Building vs. Cumulative Total Average Annual Damages

Figure E6 provides a breakdown of the AAD and building impact assessment. The area in blue corresponds to individual building AAD (residential and non-residential combined) in brackets of \$100 per annum. The orange line corresponds to the cumulative AAD for residential and non-residential buildings combined. Note that this does not include infrastructure damages.

As shown, 88% of all buildings exhibit less than \$500 damage per annum and produce only 11% of the total damage.

77% of damages are associated with less than 5% of all buildings. This demonstrates that a minority of buildings produce the majority of damages.

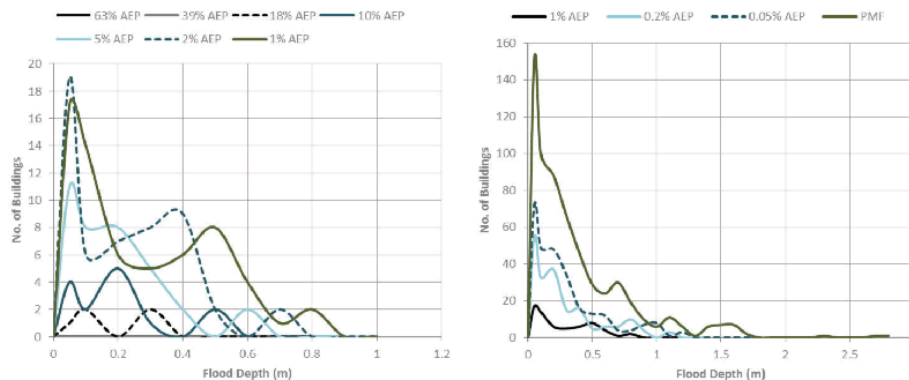
It is noted that where surveyed floor levels were not available, slab on ground buildings were assumed to have a floor level 0.1m above the existing ground level. This is consistent with other studies undertaken in the Rockhampton area, however may result in a higher estimate of inundated buildings and consequential flood damages due to the increased incidence of above floor flooding.

Figure E3 Estimated Flood Depths Above Floor Level by % AEP (Number of Buildings). Note: curves for the 63% AEP and 39% AEP events are not shown as there is not predicted to be above floor flooding in these events.

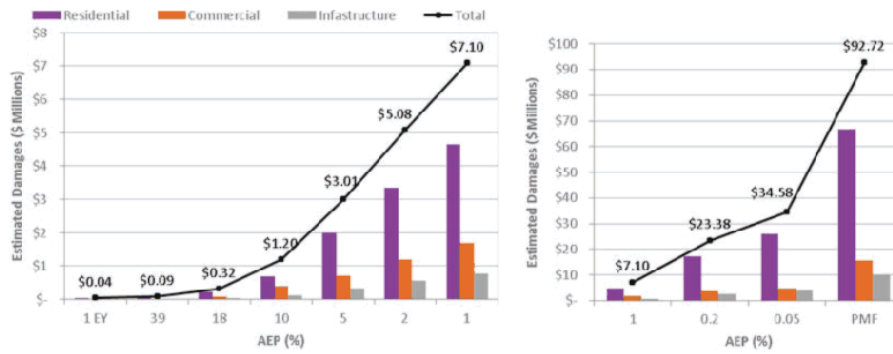
Figure E4 Estimated Flood Damages – O2 Environmental Damage Curves (\$ Million)

Figure E4 summarises the estimated total flood damages for various flood events according to their AEP. As shown, total damages range from \$42,000 (1EY flood event) to \$92.7M (PMF event) using the O2 Environmental Damage Curves. Figure E2 shows that zero buildings are expected to be inundated above floor in the 1EY event, whilst 613 buildings are anticipated to be inundated above floor in the PMF event.

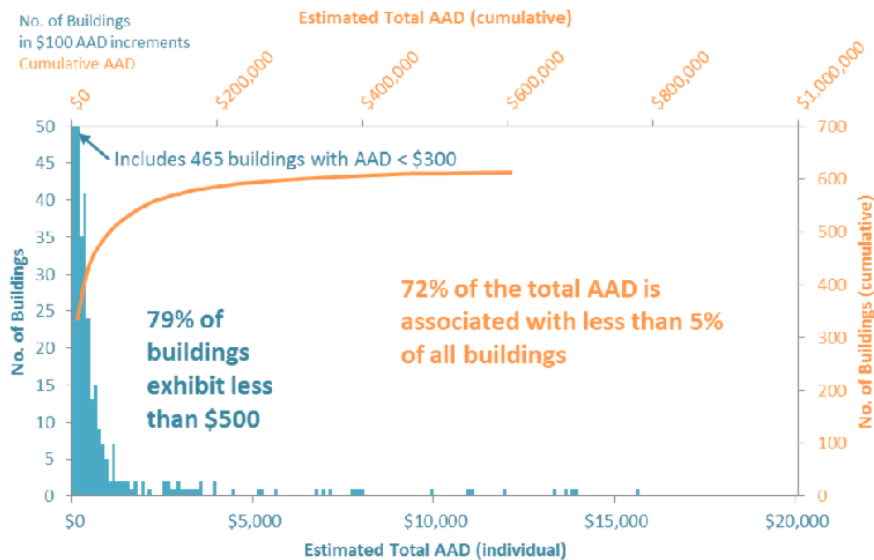
Figure E5 Individual Building vs. Cumulative Total Average Annual Damages

72% of damages are associated with less than 5% of all buildings. This demonstrates that a minority of buildings produce the majority of damages.

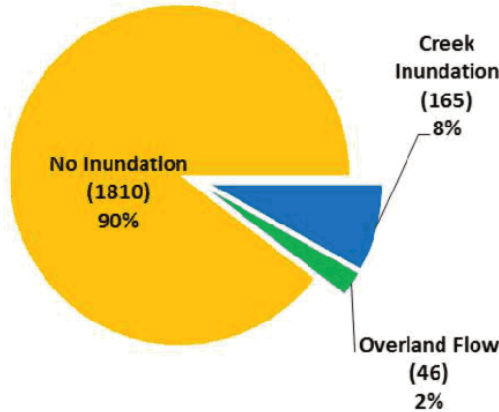
Figure E3 Inundation within Creek and Overland Flow Areas (Number of Buildings)

Figure E3 provides a breakdown of the number of buildings inundated in 'creek' and 'overland flow' areas. The graph confirms that the majority of buildings within the catchment (90%) are not inundated up to and including the PMF event. Of the 10% of buildings predicted to experience inundation, approximately 23% are impacted by overland flow and 77% are impacted by creek inundation.

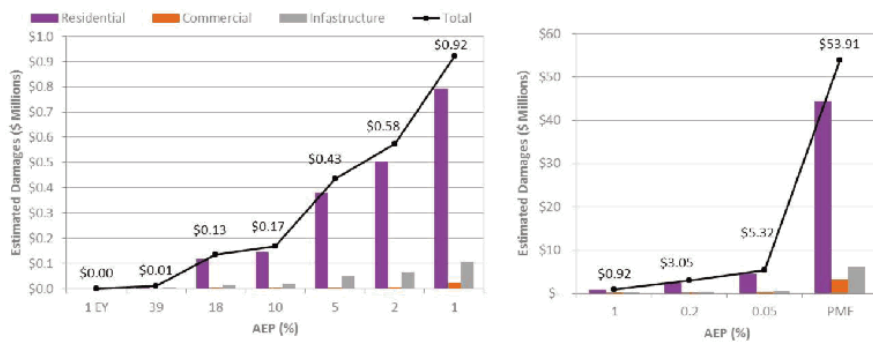
Figure E5 Estimated Flood Damages – 02 Environmental Damage Curves (\$ Million)

Figure E5 summarises the estimated total flood damages for various flood events according to their AEP. As shown, total damages range from no damage (1EY flood event) to \$54M (PMF event). Figure E4 confirms that no buildings are expected to be inundated above floor in the 1EY event, whilst 211 buildings are anticipated to be inundated above floor in the PMF event.

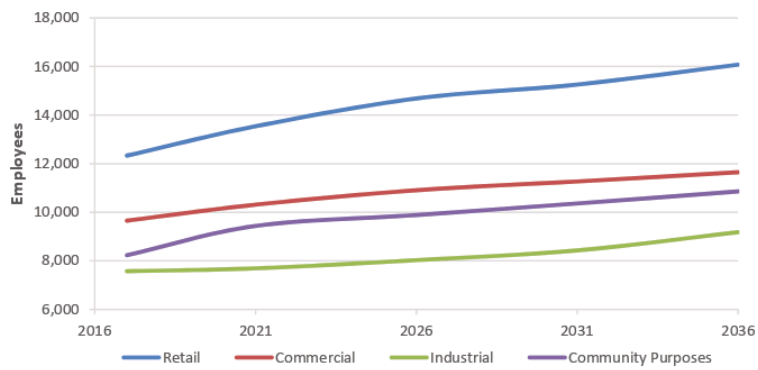
Figure E.4 - Employment Projections by Employment Category

As shown in Figure E.4, it is projected that retail and commercial development will drive employment growth, with steady growth in community purposes based employment.

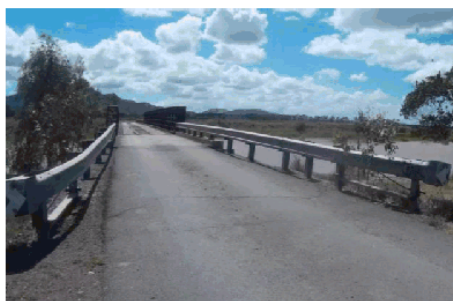
Photo 4: AP1. Note transverse crack

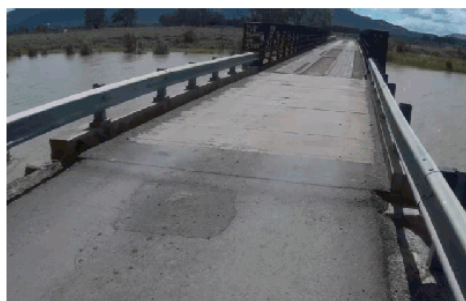
Photo 5: AP1. Note repair and crack at rear of abutment

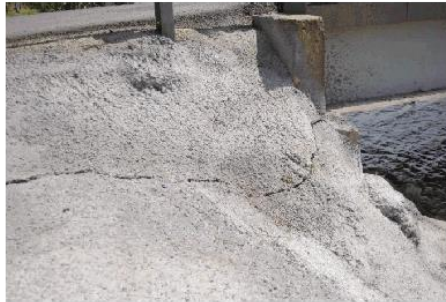
Photo 6: PRO to RHS A1. Note crack

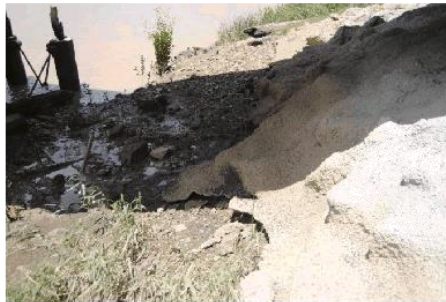
Photo 8: A1 toe of PRO showing minor scour under

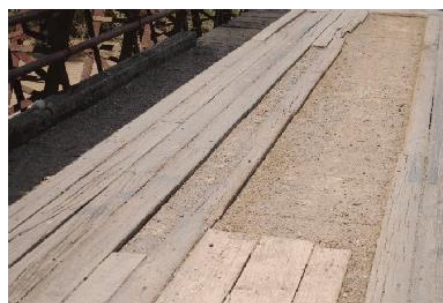
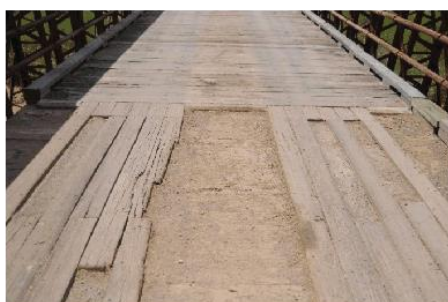
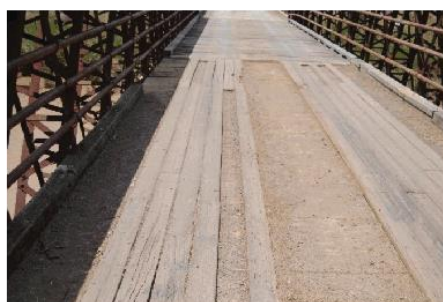
Due to the missing boards in the deck, the timber deck for S2 is rated as CS4. RRC has been notified of the missing boards and that is expected to be fixed in the short term, at which stage the condition rating would return to CS2.

Photo 11: Longitudinal decking boards missing

Photo 12: Longitudinal decking boards missing

Photo 13: Longitudinal decking boards missing, note kerb board missing LHS

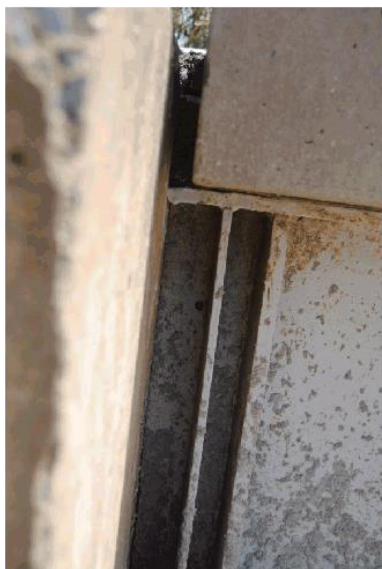
The major concern with the abutments leaning forward is that the bridge is totally locked up. The main span rocker bearings on Pier 1 are leaning over and locked into position, leaving no capacity for movement in them. Coupling this with the abutment leaning over and pushing the approach spans against the main spans potentially increases lateral loads on the piers which have severe corrosion and therefore likely reduced capacity to take horizontal loads. This will be discussed further at a later stage in this report.

Photo 14: Girder at A1 hard up against ballast wall

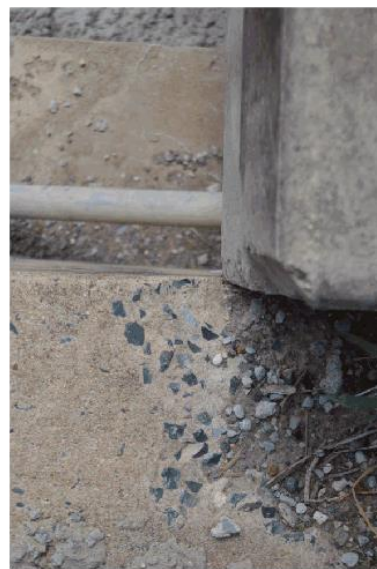
Photo 15: Spalling concrete at top of ballast wall from impact of deck slab

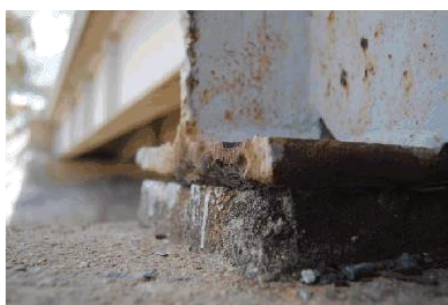
Photo 16: Headstock Girder at Pier 1 looking towards A1 showing tilt of girder

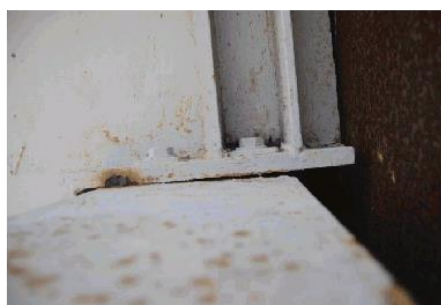
Photo 17: View of top of headstock girder showing tilt and separation between deck beam and headstock girder

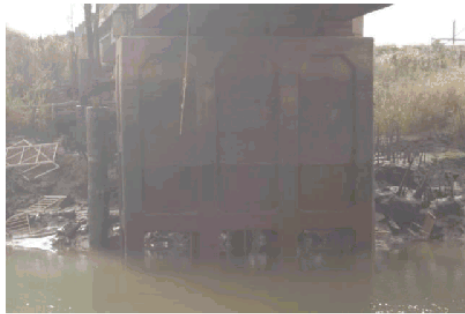
significantly, effectively resulting in the majority of the pier being in the tidal/splash zone. This would mean that the entire pier could be exposed to chlorides when the tide level is up, and subsequently exposed to the open air, allowing oxygen to access the reinforcement through the cracks and spalls. These are the essential ingredients for corrosion and therefore it is safe to conclude that corrosion is extensive and ongoing in the pier reinforcement.

Photo 18: Pier 2 face 1 (previous 2013 inspection). Note water level
