J Rayner and A Russell Information Request Response Rehabilitation Plan

J Rayner and A Russell C/- Dileigh Consulting Engineers –
Rehabilitation Plan - Information Request Response –
Development Application D/124-2016 for operational works
for stormwater, drainage works, earth works and access
works – situated at 17 Greenwood Close, Frenchville QLD
4701 – Described as lot 1 on SP245873, Parish of Archer.

Project: Development Application D/124-2016 for operational works for stormwater, drainage works, earth works and access works – situated at 17 Greenwood Close, Frenchville QLD 4701 – Described as lot 1 on SP245873, Parish of Archer.

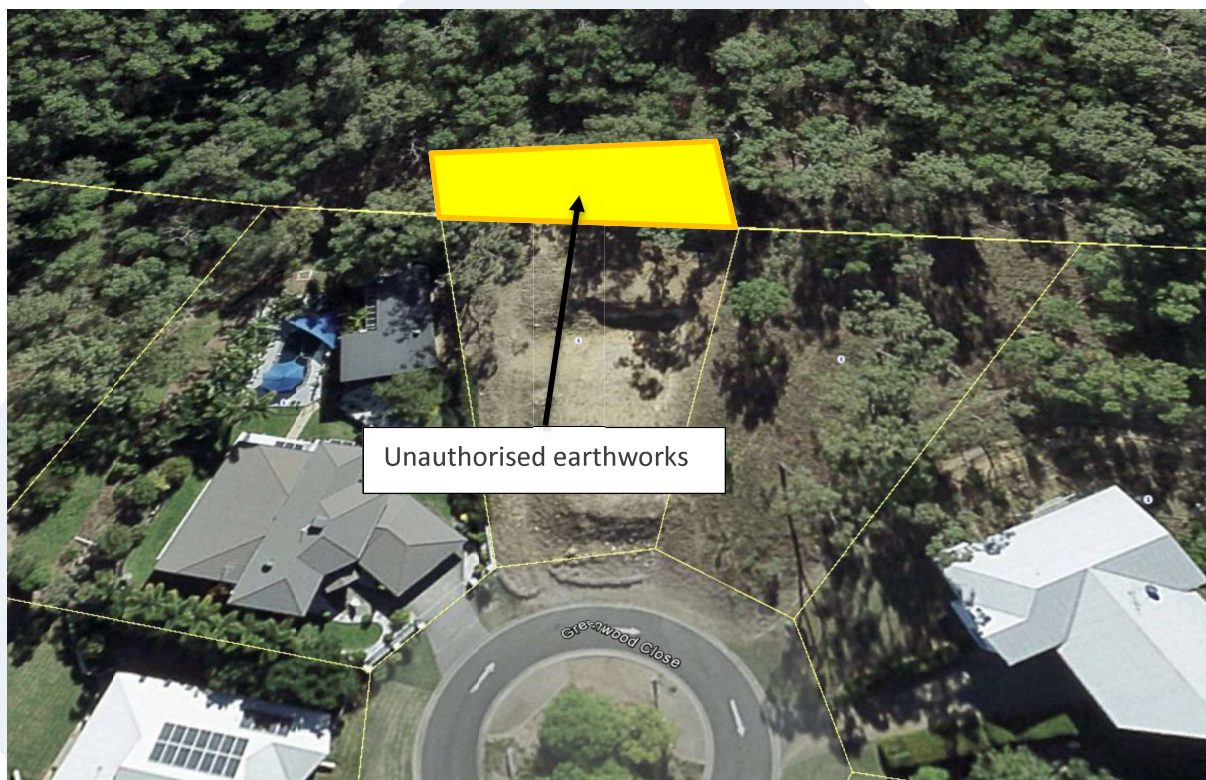
Figure 1. Location of unauthorised earthworks on Lot 1 RP618495, adjacent to Lot 1 SP245873.

The location of the unauthorised earthworks is on the adjoining Rockhampton Regional Council land (Lot 1 RP618495) to Lot 1 SP245873 (owned by J Rayner and A Russell). The location of the unauthorised earthworks are represented in Figure 1.

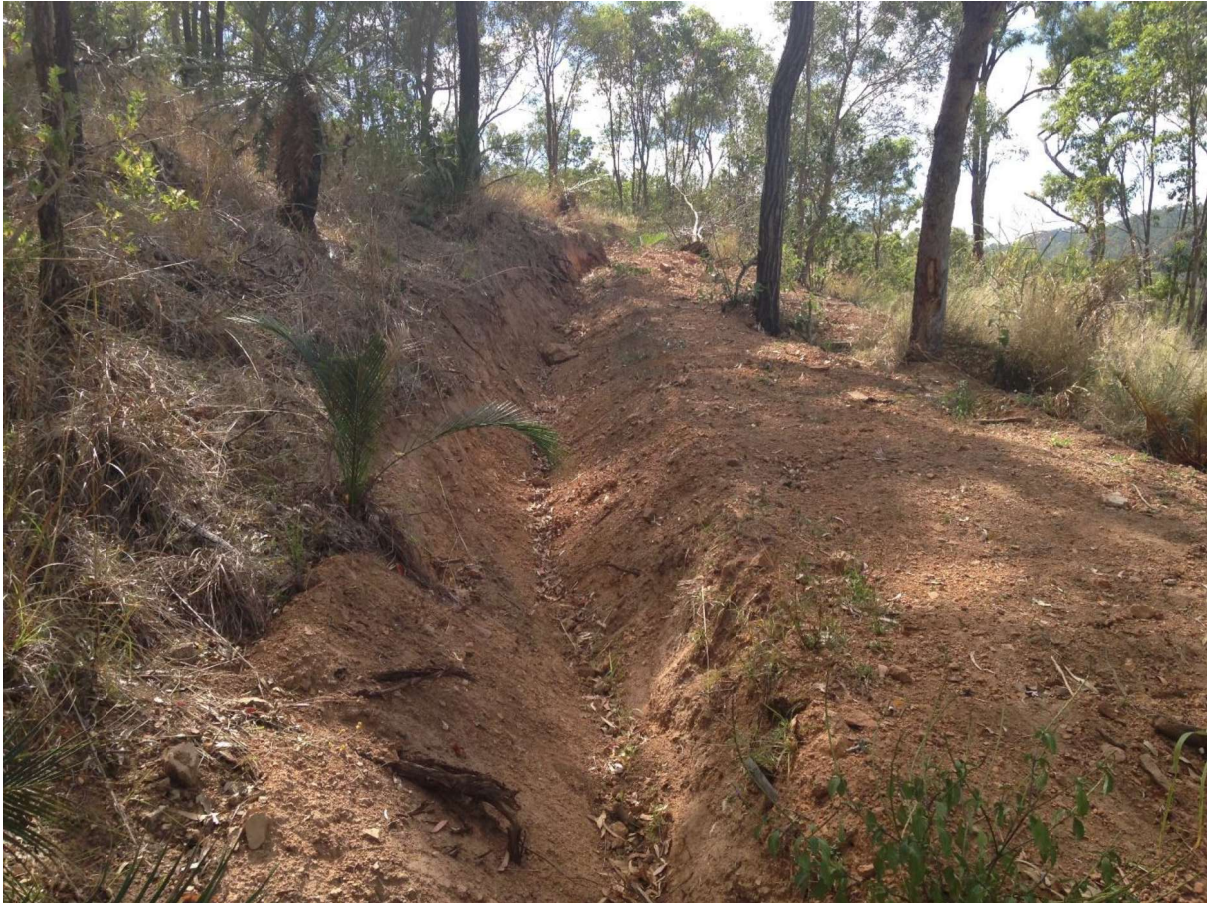
Figure 3. Unauthorised earthworks on Lot 1 RP4444. Open drain structure. Note Macrozamia miquelii left undamaged at left of drain, and Lantana camara at bottom right of image.

- Construction of an unstabilised drain of approximately 20m length.
- Removal of at least one mature naturally occurring native tree (appears that a maximum of 2 trees may have been removed).
- Removal of approximately 1-2 *Macrozamia miquelii* shrubs.
- Likely removal of 2-3 *Acacia* species.

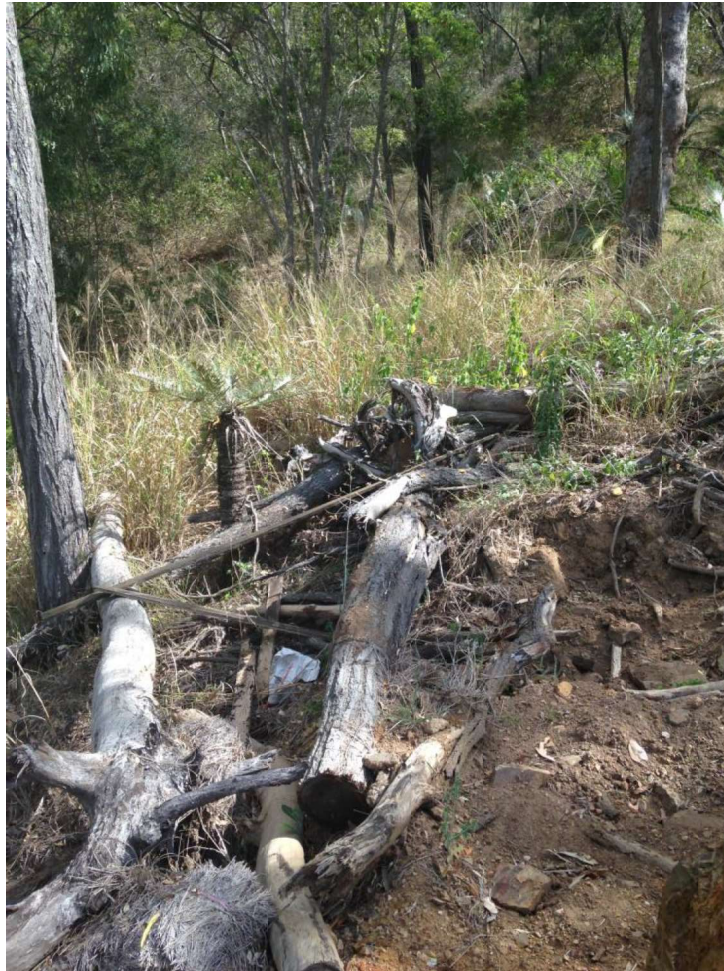
Figure 4. Fallen timber pile in/adjoining rehabilitation area.

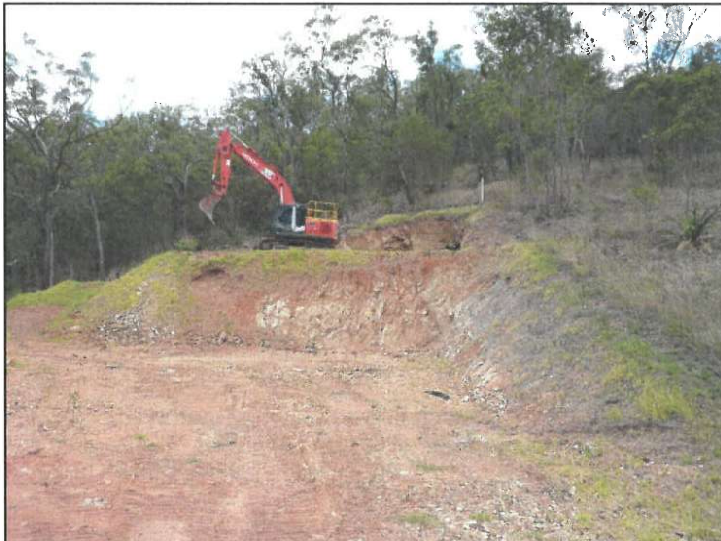
Photograph 1: View from lower platform toward the rear of the allotment

Ground surface levels generally fall in a south-westerly direction with the former 'natural' slope (pre-earthworks) estimated to be in the order of 15 to 17 degrees with an overall difference in elevation across the site of approximately 15m. Four general views of the site at the time of investigation are given in Photographs 1 to 4.

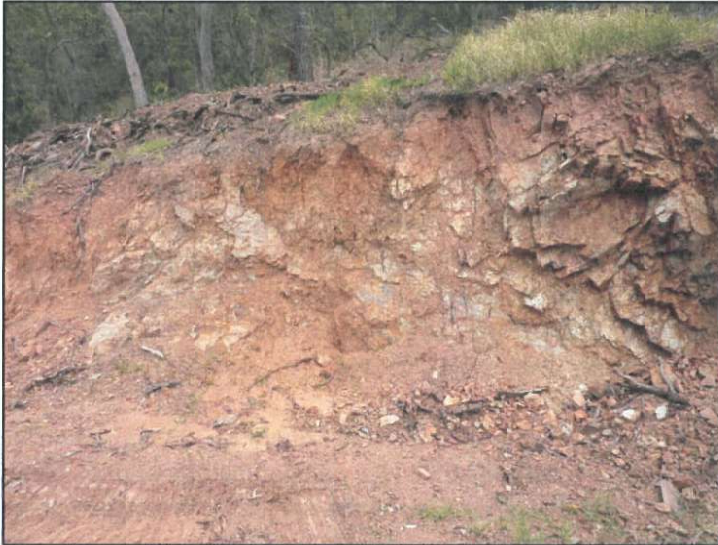
Photograph 2: View of cut face behind the upper platform

The joints observed in the exposed cut were relatively closely spaced (20mm to 300mm) and were rough and irregular. The dip angle in the distinctly weathered siltstone was estimated to be approximately 70° to 80° in a south to south west direction, across the rock face. The slope batters generally comprise sparse grass cover, with the building platforms mostly clear of vegetation. At the time of the fieldwork, there was some evidence of movement/creep observed through tension cracking near the crest of the uncontrolled fill at the front of the allotment.

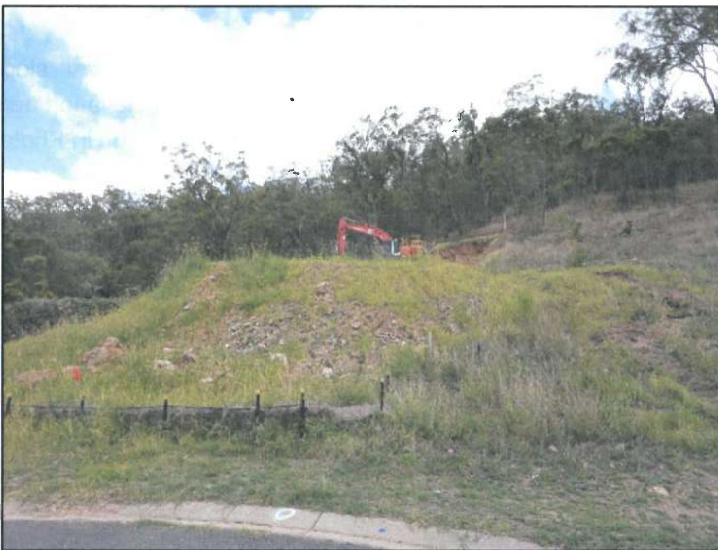
Photograph 3: View of the fill batter from Greenwood Close

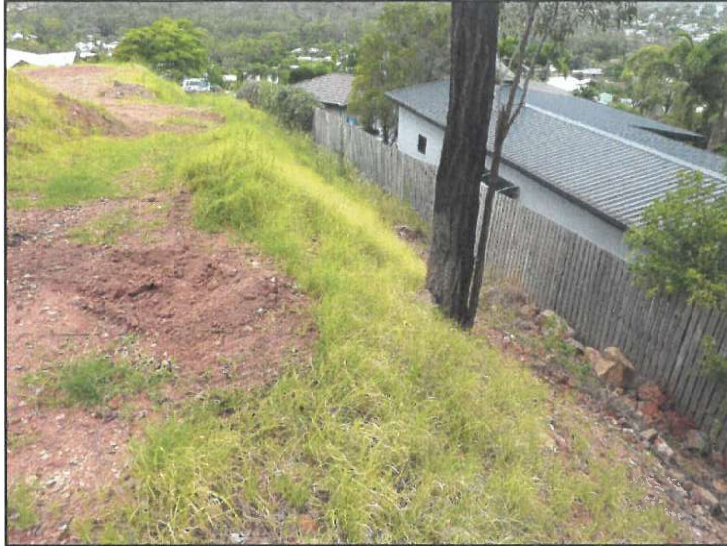
Photograph 4: View along western boundary toward Greenwood Close

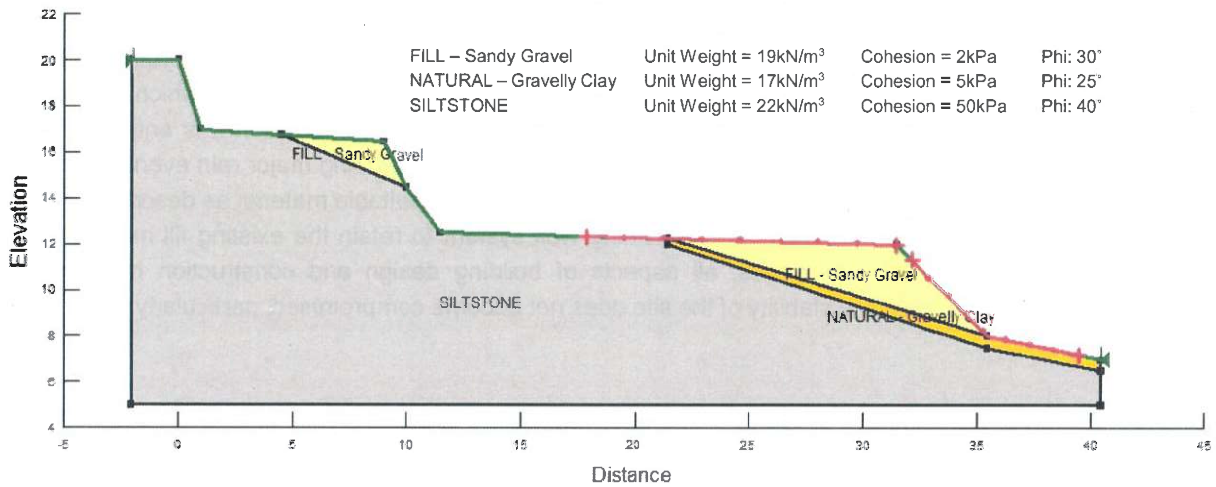
Figure 1: 'Long term' soil strength parameters and stratigraphy

For the analysis an automated search of potential circular failure surfaces was carried out to assess the failure surface with the lowest calculated FOS. The soil strength parameters and stratigraphy is presented in Figure 1, with results of the analysis is presented in Figure 2 and Figure 3 showing the failure surface with the lowest calculated FOS.

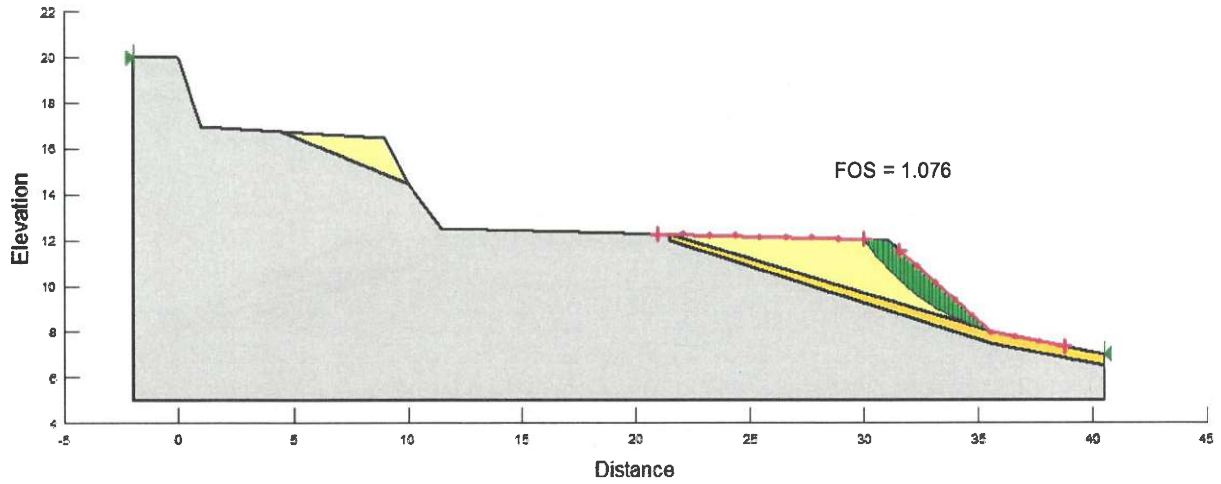
Figure 2: 'Long term' analysis for existing 'lower platform' fill profile

The results of the analysis discussed above indicate that, in its current state, the long term stability of the fill embankment is not acceptable and must either be removed and replaced as described in Section 5.3 or design and construct and engineered retaining wall to mitigate any further movement in the fill material.

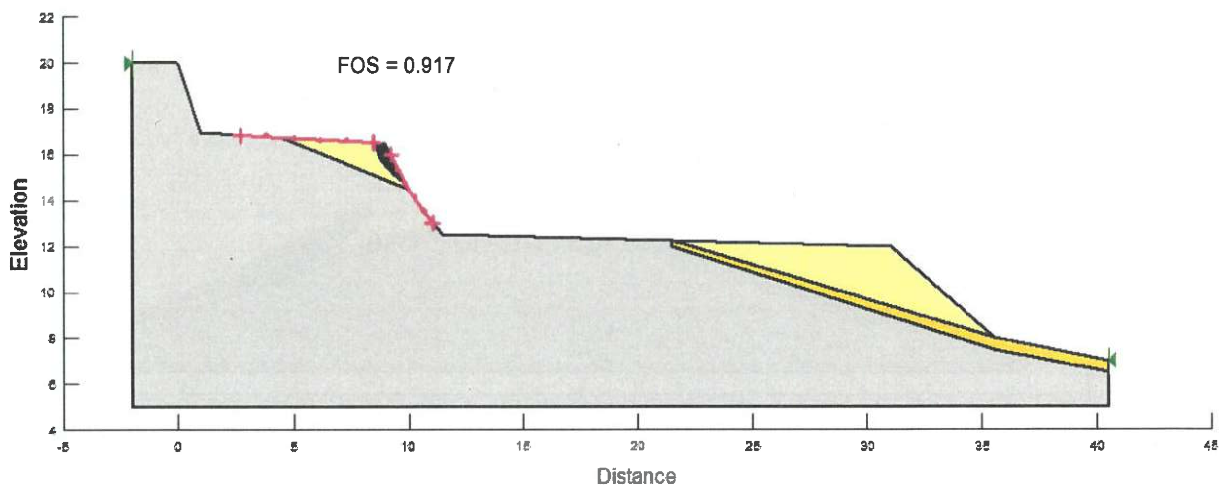
Figure 3: 'Long term' analysis for existing 'upper platform' fill profile

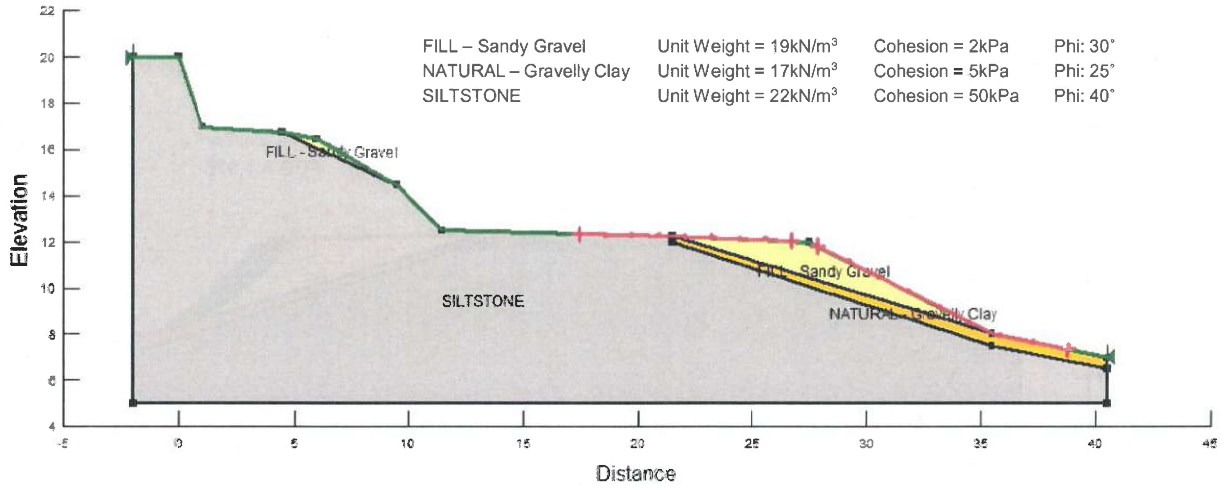
Figure 4: 'Long term' soil strength parameters and stratigraphy for 1V:2H controlled fill batter

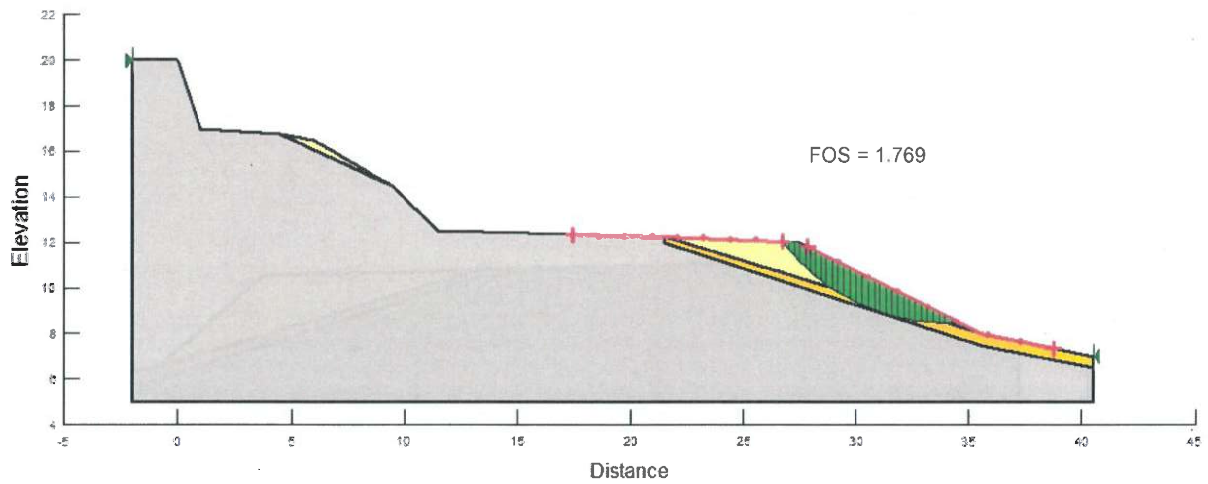
Figure 5: 'Long term' analysis for existing 'lower platform' for 1V:2H controlled fill batter profile

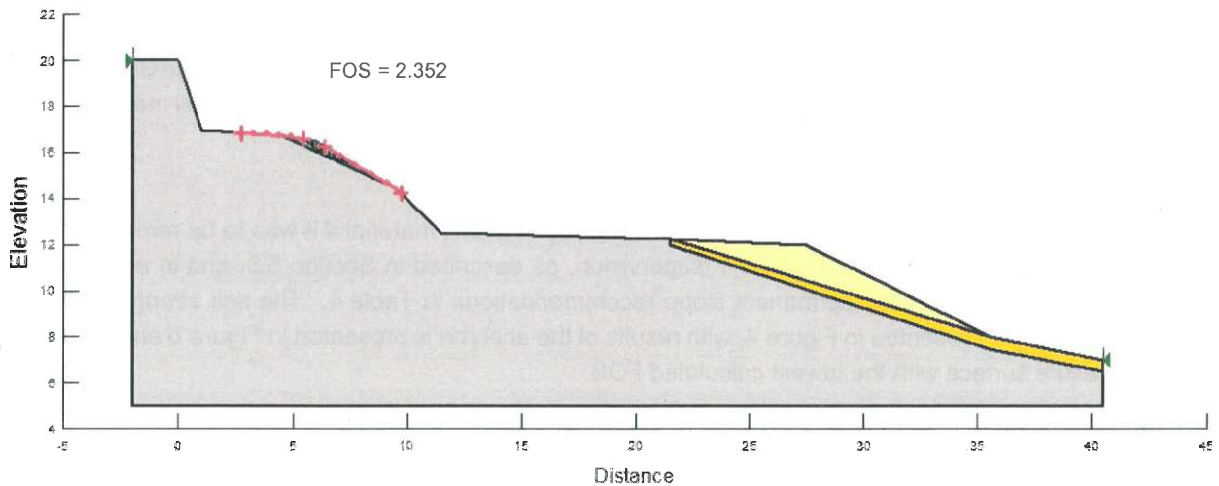
Figure 6: 'Long term' analysis for existing 'upper platform' for 1V:2H controlled fill batter profile

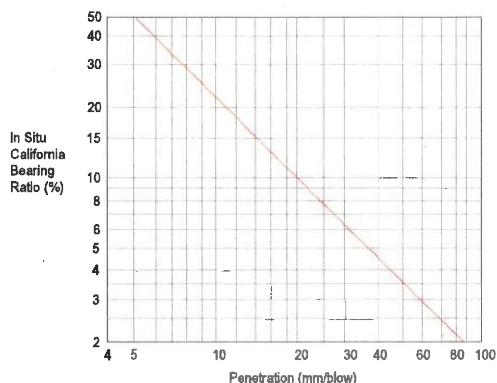
Figure 7: Correlation of DCP Results and Insitu CBR

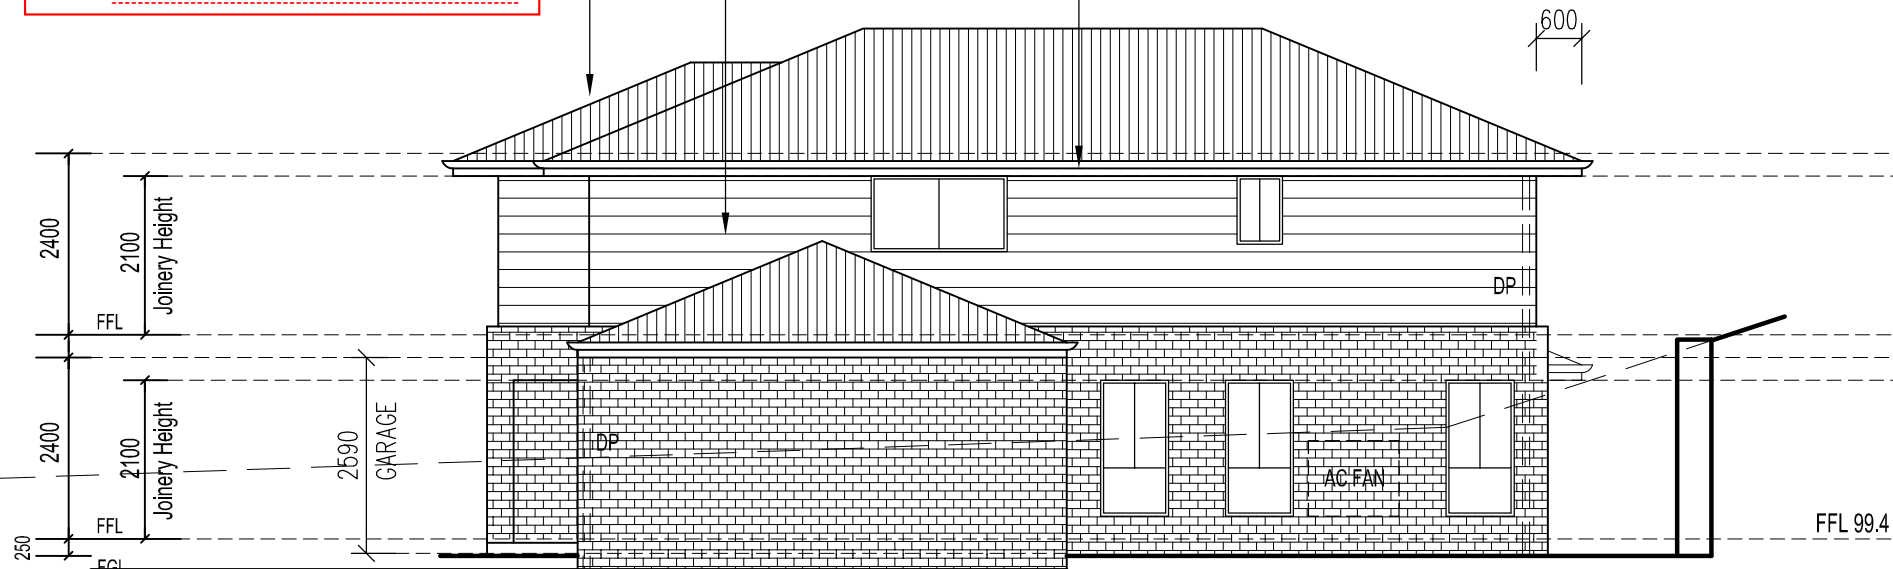
EAST ELEVATION

BRICK VENEER WITH FACE BRICK FINISH

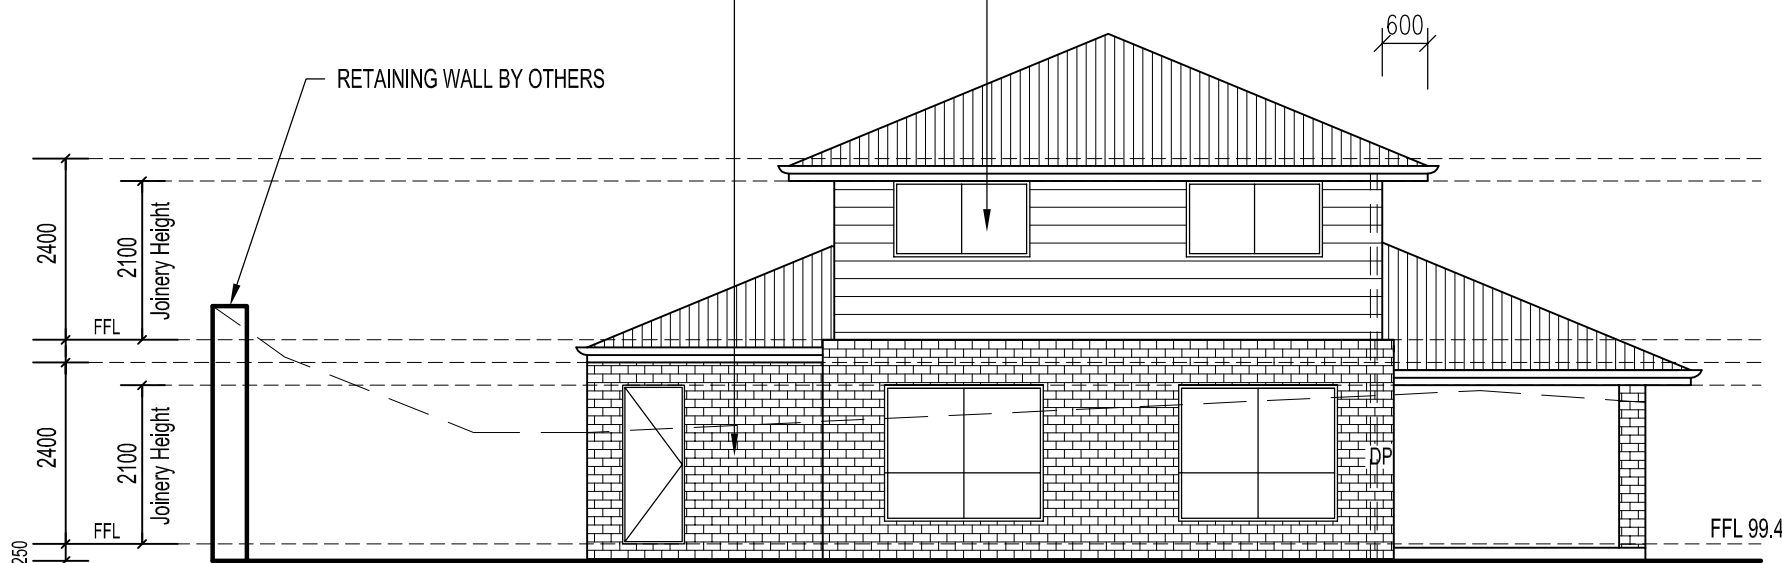
NORTH ELEVATION

RETAINING WALL BY OTHERS

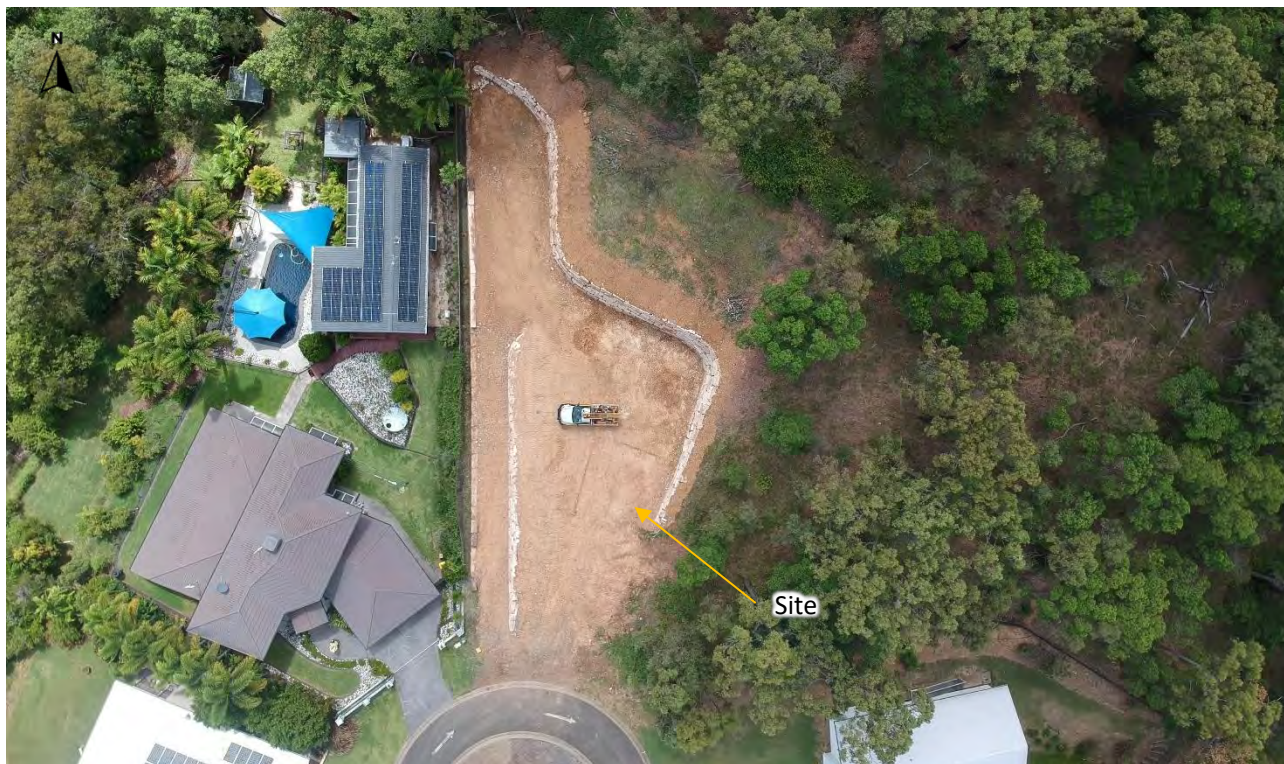
Figure 2: Recent drone image of the site and surrounds (Source: CQ)

The site is formally described as Lot 1 on SP245873 and covers an area of 1,050 m², with frontage to Greenwood Close on the southern boundary. A recent drone aerial image of the site and immediate surrounds is provided in Figure 2 below.

The site was surrounded by existing residential dwellings to the south, east and west, with a national park comprising dense vegetation to the north.

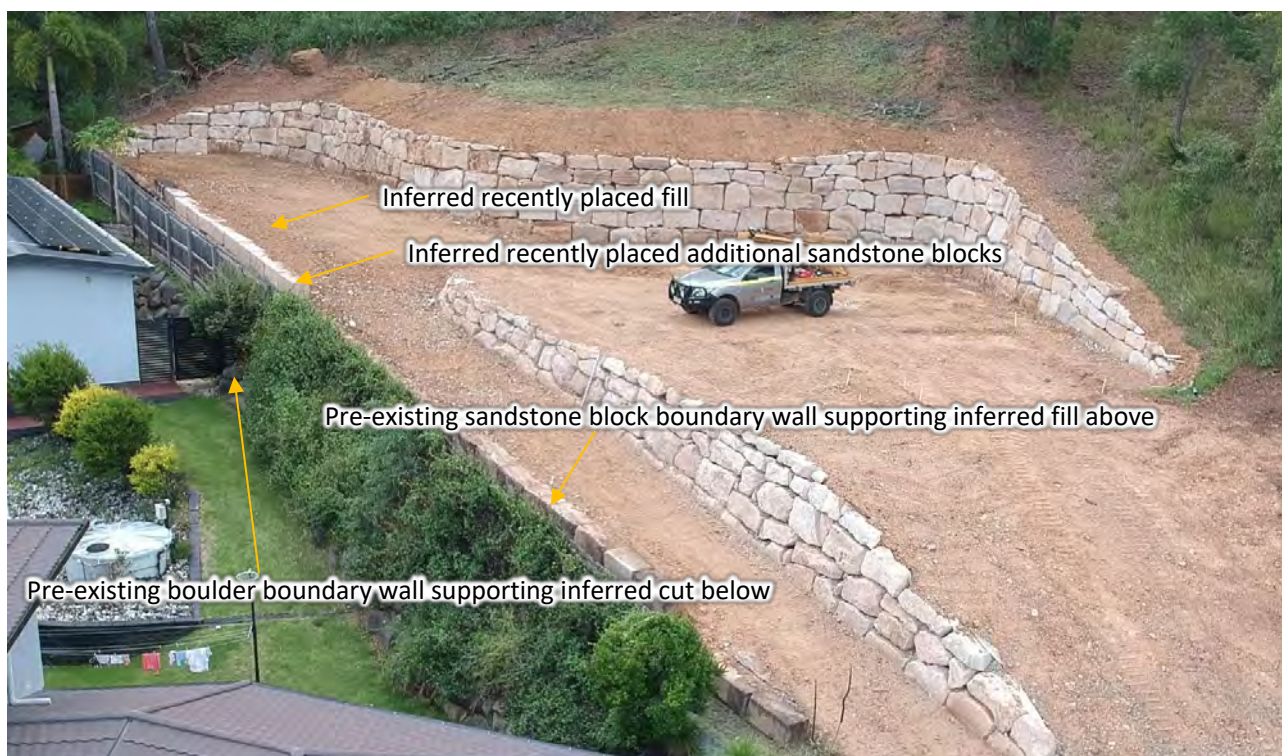
Figure 3: Image of site showing inferred recently placed sandstone blocks and fill in northwestern part

New, recently constructed retaining walls support cut and fill earthworks for the building pad, with older boulder and sandstone retaining walls supporting previous earthworks along the western boundary, which drops down to the building pad on the neighbouring property. Although not shown on the provided retaining wall design drawings, one layer of sandstone blocks appear to have been added to the top of the sandstone block boundary retaining wall to support additional filling in the northwestern part.

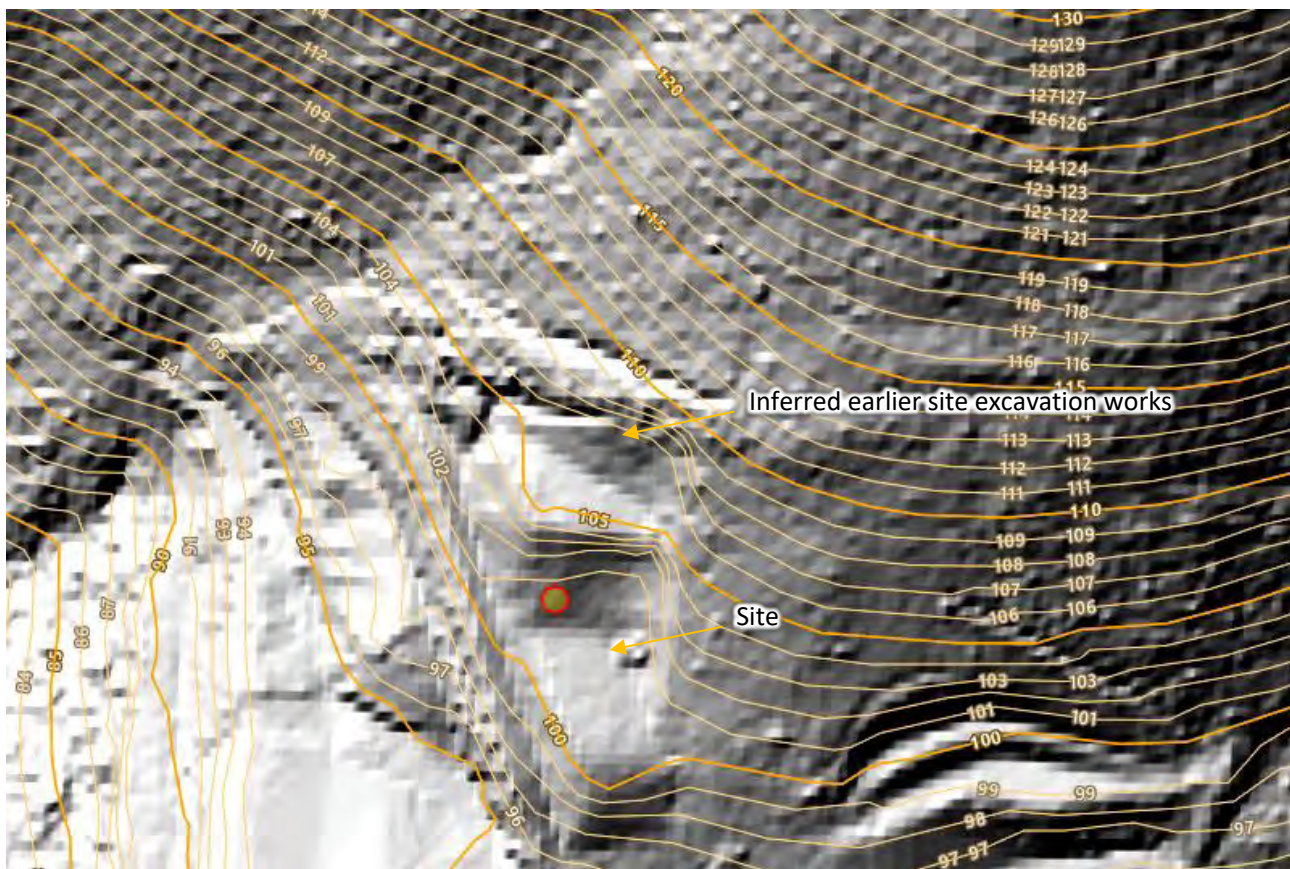
Figure 4: Hillside shading and ground surface contours (Source: QLD GeoResGlobe)

Review of the attached contour plan, along with hillside shading data sourced from GeoResGlobe, indicates that the site is located on the southwest facing flanking slope of a hillslope that crests about 260 m to the northeast an RL of 205 m AHD. Locally, the site slopes downward from the northern extent which sits at an RL of 106 m AHD to the southwest at an RL of 97 m AHD. The calculated natural slope across the site, prior to earthworks, was estimated to range between about 12° to 20°.

Review of earlier aerial imagery indicates that several phases of earthworks have previously been carried out on the site, initially as part of what appears to have been subdivisional works with later phases to construct the western boundary wall as well as other phases of works to build a driveway to a more elevated cut and fill pad in the northeastern part. The upper 'scarp' type feature shown in Figure 4 below in the more elevated part of the site is inferred to be associated with earlier earthworks excavations as opposed to a landslide feature.

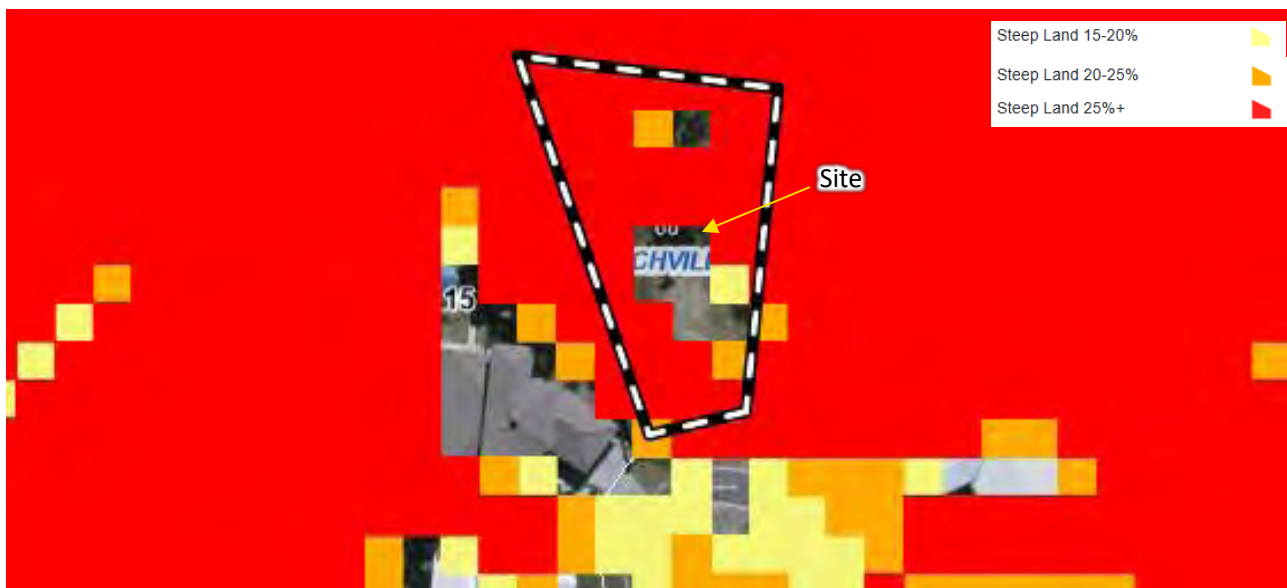
Figure 5: Council Landslide Hazard Overlay Map

Rockhampton Regional Council has developed a Planning Scheme mapping tool to identify sites requiring a landslide hazard assessment before obtaining building approval. The Planning Scheme mapping identifies the site is mostly mapped as “steep land”, hence the need for a slope stability assessment under current regulatory guidelines (Figure 5).

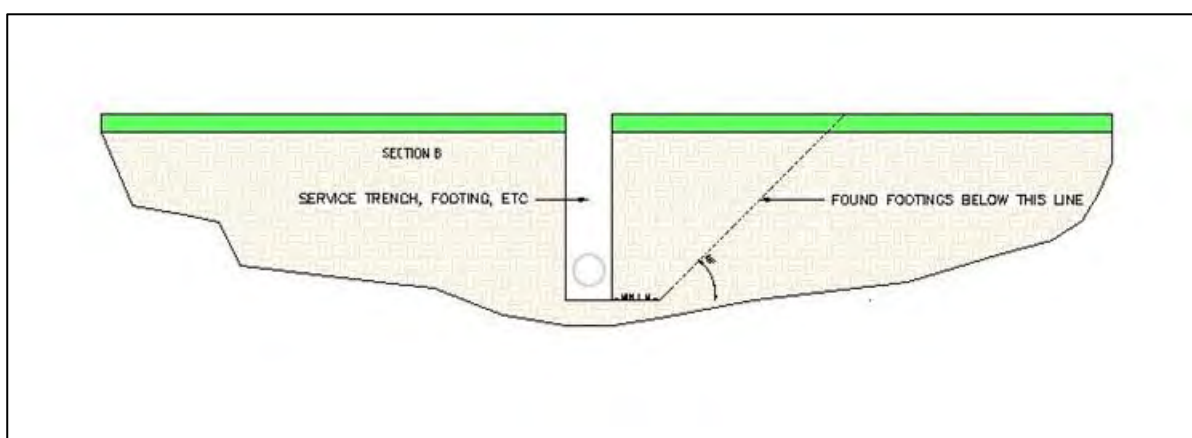
Figure 6: Recommended influence zone

When footings are located near an underground service or other structural elements (such as other footings or retaining walls), they should be founded at least 0.3 metres below an imaginary line extending at a 45-degree angle from the base of the service or obstruction. Where footings are positioned near other structures, such as retaining walls or existing foundations, the potential influence on and from those structures should also be assessed. Figure 6 provides a visual reference.
