**Development Permit No.: D/17-2025**

**Proposed Lots 1 & 2  
Cancelling Lot 10 on Plan LN51**

## **Soil Assessment Report**

### **“103 Morgan Street, Kabra QLD 4702”**

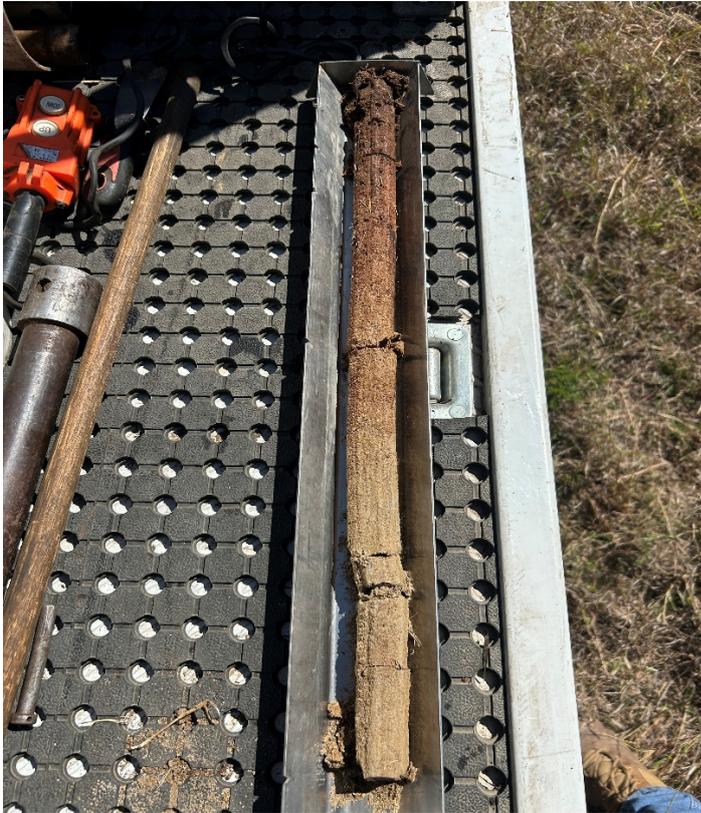
The predominate soil type is of texture-contrast soil, with a red, brown, loam to clay texture over a gravelly, yellow-grey subsoil. Refer *Appendix A, Image 1*.

*Image 1. Example of Soil core taken*

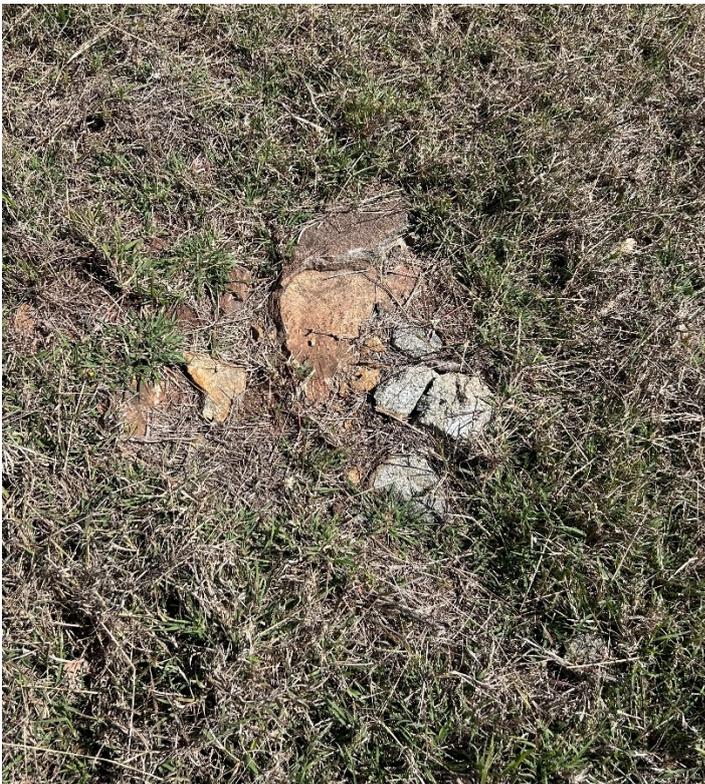
The entire area has been cleared of all free surface rock except for the steepest portion of the area in the northern-most corner of the block. There is still considerable evidence of granitic rock (up to 50cm diameter) buried within the upper part of the soil profile. These stones were regularly encountered when conducted the soil testing to a depth of 60cm. Refer *Appendix A, Image 2*.

*Image 2. Example of Buried Granitic Rock found on-site.*

- Any ripping / renovating operations to remediate historical soil compaction and apply deeper placed fertilizers or soil tillage to remove unproductive pasture and seedbank could be moderately impacted by the buried granitic rock present throughout the soil profile. The choice of cultivation implements and the conditions for successful completion would require careful management.

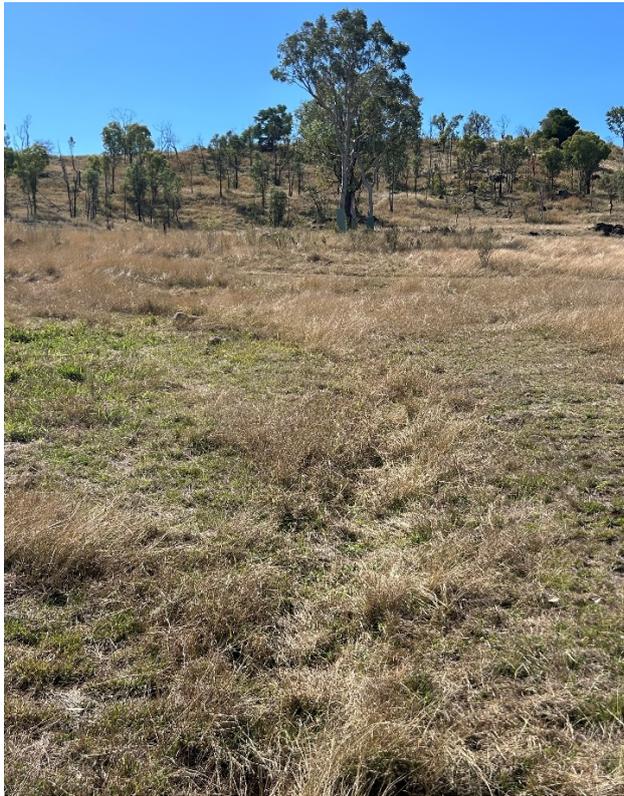
The block is quite steeply sloped with areas being >10% slope. The field drains runoff from the northern & eastern boundaries towards the most north-western corner of the surveyed area. Areas of historic soil erosion are present. Refer *Appendix A, Image 3*.

*Image 3. Example of Historic soil Erosion*

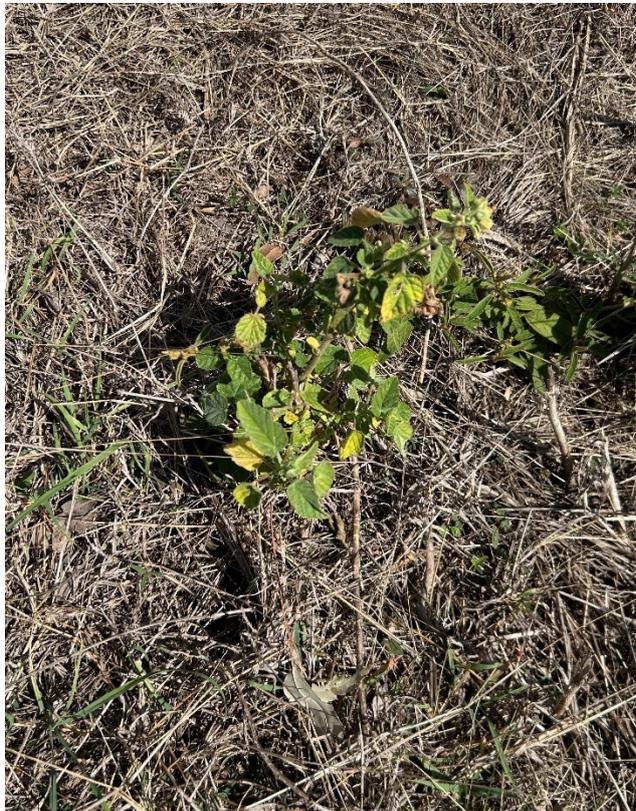
The entire area has at one time been established with native or improved grass pasture species, but this has almost entirely been overtaken in recent years with Indian Couch grass (An invasive grass species, that spreads through seed & runners and provides ground cover but offers poor drought tolerance and reduces overall forage productivity and biodiversity). Some very scattered tropical legume species are also present. Refer *Appendix A, Image 4*.

*Image 3. Example of infestation of Indian Couch Grass & scattered pasture legume.*

- Re-establishment of more productive tropical pasture species with a minimum of 30% of the established pasture mix to be legumes.
  - Grasses -Reclaimer Rhodes grass & Premier Digitaria grass
  - Legumes - Caatinga Stylo & Desmanthus sp.
- The application of a Potassium based fertilizer into the subsoil in conjunction with pasture ripping/renovation to support the long-term nutrition requirements of the pasture.
- The application of Nitrogen, Sulphur & Boron based fertilizers as required to maximise fodder production

- Prior to planting the recommended pasture species, the removal of the current stand of Indian Couch grass and rundown of the associated soil seedbank would require aggressive tillage and soil disturbance over a minimum of a 3 month

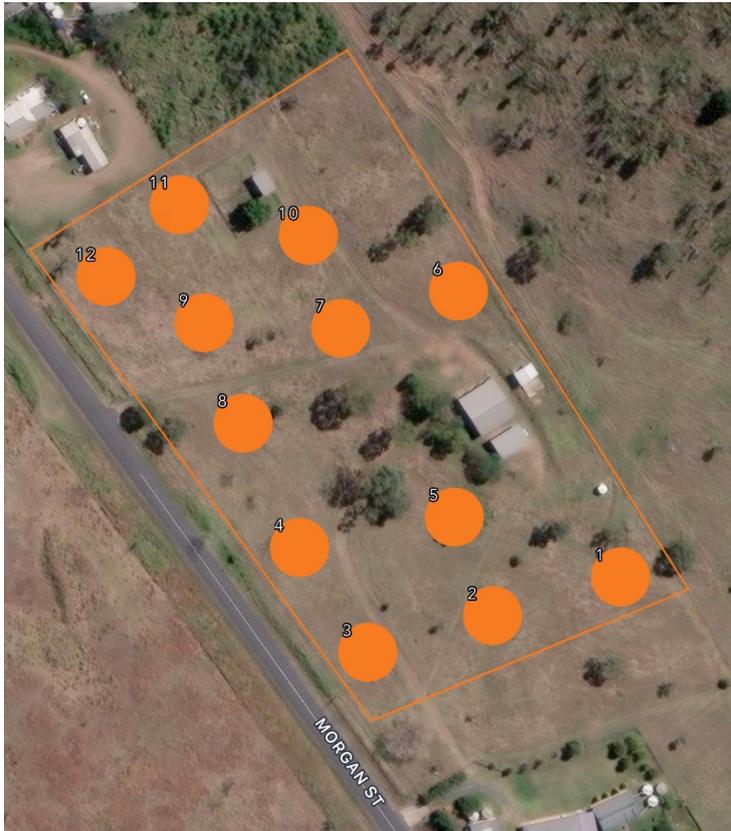
Soil testing was conducted randomly across the site at depth ranges of 0-10cm, 10-30cm & 30-60cm with samples from each depth bulked together to obtain a representative average for the area. For the location of the soil sampling sites, Refer to *Appendix A, Image 5*.

Image 5. Map of soil sampling sites.
