**PROJECT:**  
PROPOSED DWELLING  
LOT 164 TOONDA ROAD  
MARMOR

**REPORT ON**  
**SITE CLASSIFICATION**  
**&**  
**SITE SPECIFIC LANDSLIDE**  
**SUSCEPTIBILITY RISK ASSESSMENT AND SLOPE STABILITY**  
**ANALYSIS**

**Lot 164 (DS251)  
Toonda Road, Marmor QLD 4702**

**CQ16057**

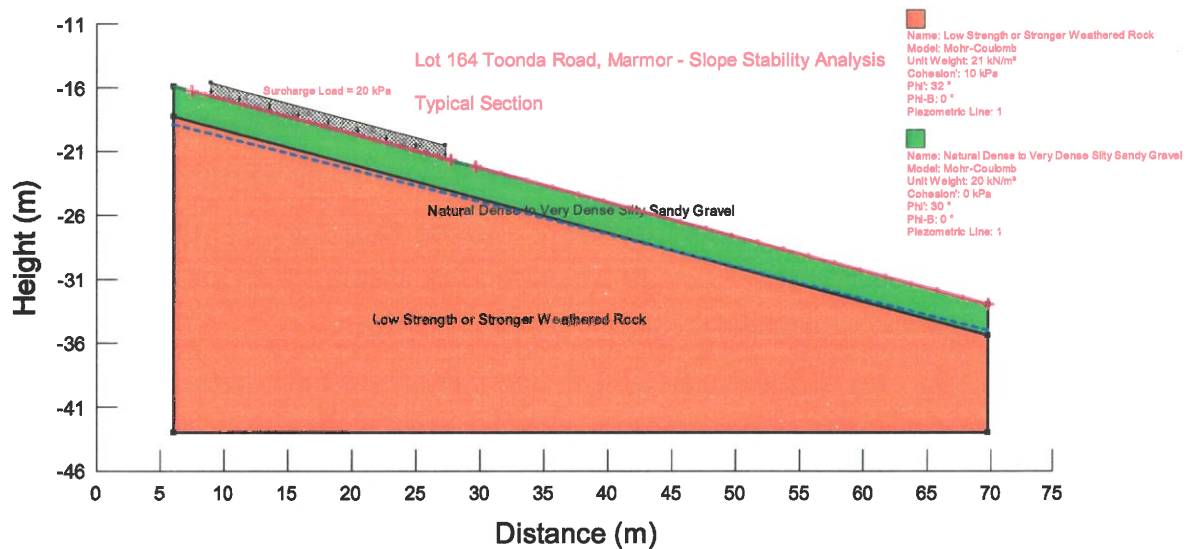
**Figure 1:** Typical Section Adopted in this Analysis

Typical section was used for slope stability analysis using commercially available *Slope/W* software. The assumed soil, rock and its parameters adopted in the stability analysis are presented in Table 2 below.

<b>Material</b>	<b>Drained Cohesion, <math>C'</math> (kPa)</b>	<b>Drained Friction Angle, <math>\Phi'</math> (°)</b>	<b>Unit Weight, <math>\gamma</math> (kN/m<sup>3</sup>)</b>
Natural Dense to Very Dense Silty Sandy Gravel	0	30	20
Low Strength or Stronger Weathered Rock	10	32	21

The slope profiles were modelled using the parameters given in Table 2 in line with the Morgenstern and Price method. Surcharge load of 20 kPa was adopted for residential load. Appropriate groundwater level has been incorporated into the modelling.

Model adopted in this stability analysis is presented below;

<b>Analysis Area</b>	<b>Analysis Condition</b>	<b>Long Term Factor of Safety (FOS) Achieved</b>	<b>Required Long Term FOS by "Geotechnical Stability Assessment Guidelines"</b>
Typical Section	Existing/Proposed Slope Geometry with Surcharge Load and Appropriate Groundwater	2.02 (>1.50) (Drawing 1)	1.50

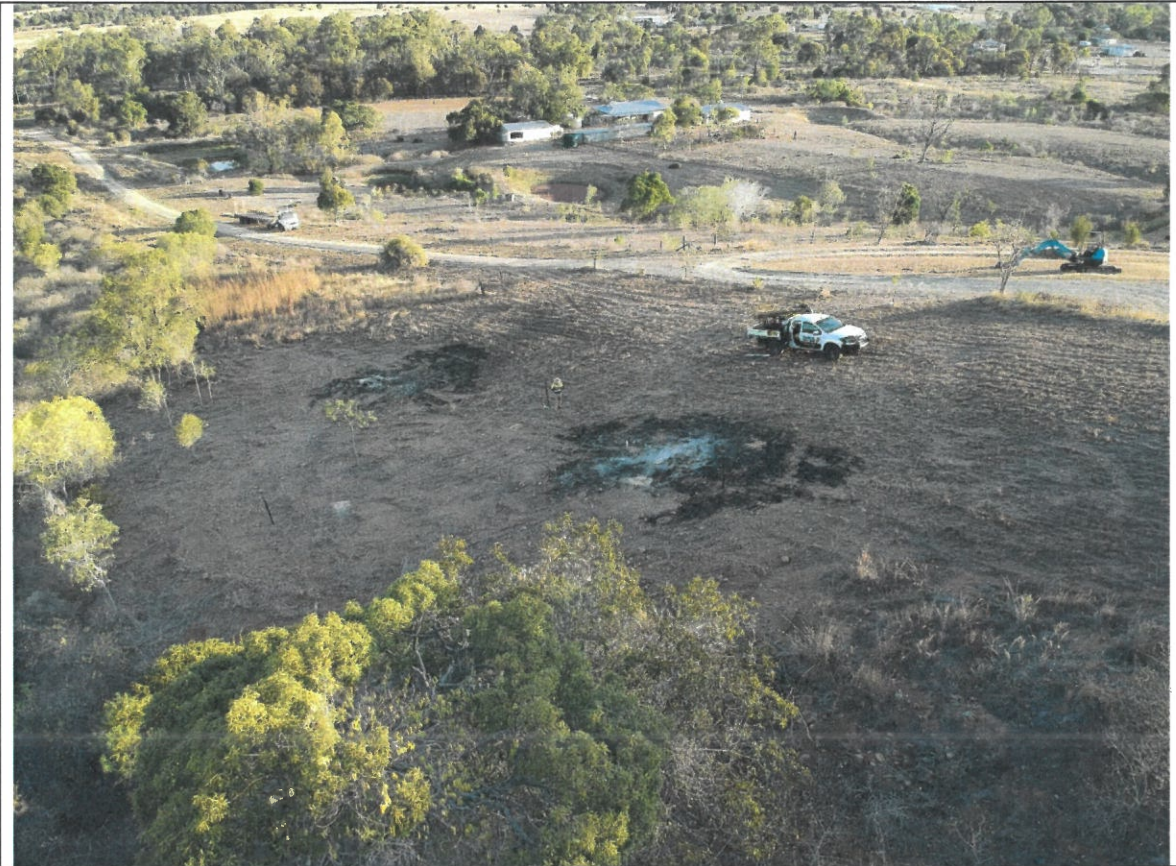
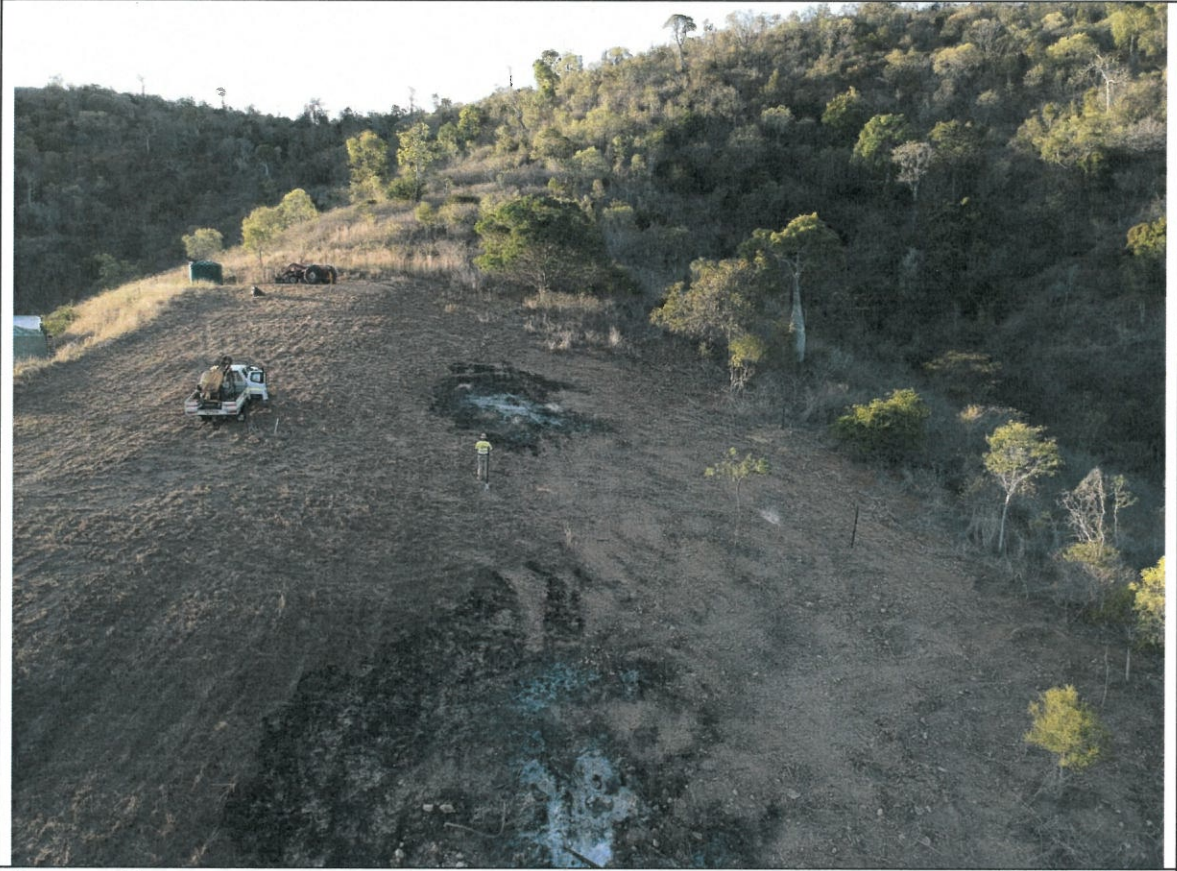
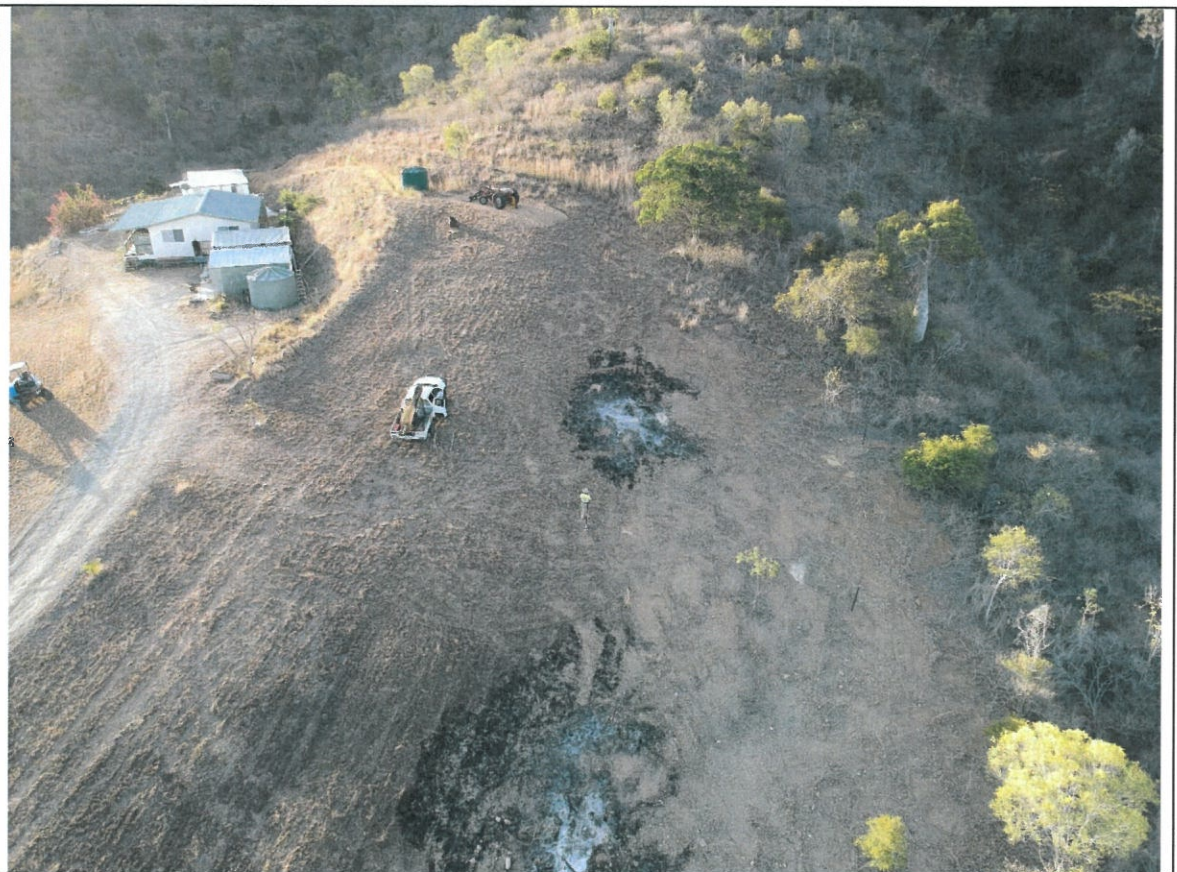
**Figure 1** Proposed construction site

**Figure 2** Proposed construction site

**Figure 3** Proposed construction site

**Figure 4** Proposed construction site

The dwelling site is sparsely grassed and there no evidence of any large trees having been removed from within the proposed dwelling footprint (see photographs attached). The construction site falls towards the southeast and is considered to be well drained. Surface water will drain toward the southeast. Surface water from the adjoining allotments may traverse the site. A site sketch is attached to this report.
