COMMUNITIES COMMITTEE MEETING

AGENDA

18 NOVEMBER 2025

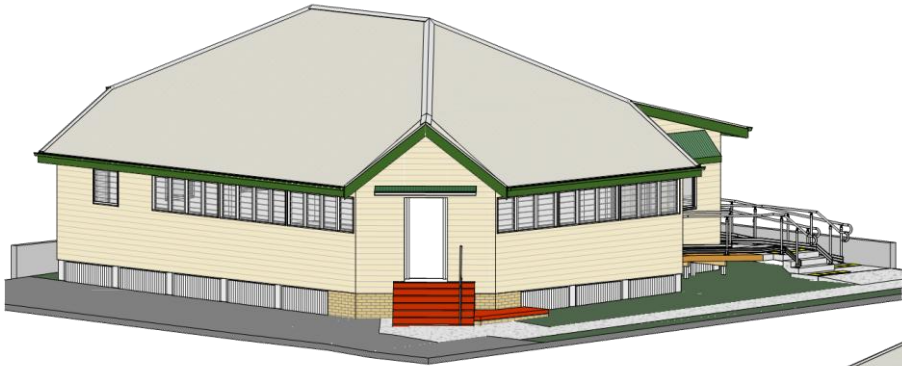
CENTRAL / MORGAN STREET VIEW

project: MOUNT MORGAN COMMONWEALTH BANK BUILDING UPGRADE		
client: ROCKHAMPTON REGIONAL COUNCIL		
<div>  Shop 5/10 Denham St Rockhampton QLD, 4700 p 0749 222880</div> <div>building design - documentation</div> <div>  QBCC MEM. NO # 1123040   BDAQ MEM. NO # 0000761</div>		
title: EXTERNAL ELEVATIONS		
scale: 1 : 100	project no: 2502-21	rev: 1
drawn: EM	drawing no A-05

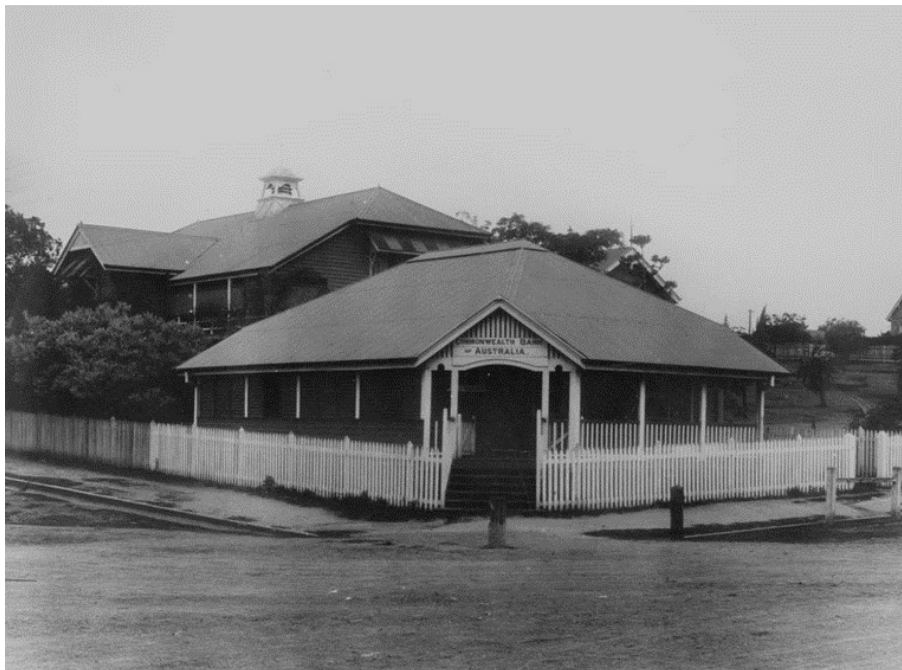
Figure 8: Commonwealth Bank, 1922 (SLQ Negative 17788).

An office extension and brick strong room appear to have been added around the interwar period. The original verandahs of the bank were enclosed with weatherboard and louvres around 1950-1960, probably coinciding with the construction of the rear skillion for toilets and wash area at the rear of the building.

The roof has been replaced also, presumed to have been undertaken in the last decade of the twentieth century. The original ridge ventilation detail appears to have been lost at this time (see Figure 8). Between 2001 and 2016 an additional entry door and ramp was installed. The building is not currently used for any permanent activity (QHR 600746).

To the northeast corner of the building a small section of white timber picket fence remains (Figure 47). Early imagery (see Figure 8) indicates that a white picket fence was present at the property thus it is possible this fence is a remanent of early fabric.

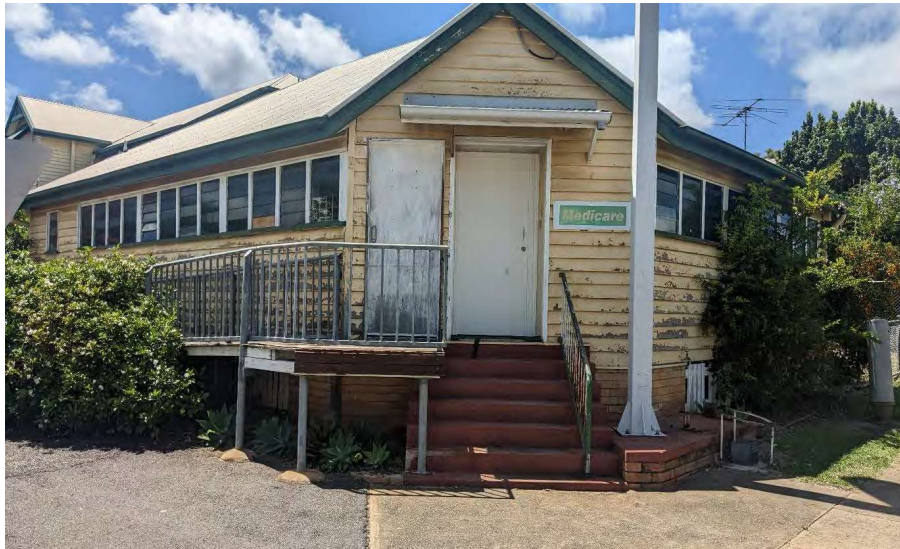
Figure 17: Former Commonwealth Bank Building (AHS 2023).

The former Commonwealth Bank building is situated on the corner of Morgan and Central Streets, Mount Morgan, in the north east corner of the Central State School site. The building is a single storey, timber framed structure clad in weatherboards and set on low stumps (Figure 17).

The building has a rectangular plan, truncated at the northeast to allow for a principal corner entrance, with concrete steps and a small, cantilevered awning existing (see Figure 17). The western and southern elevations of the building show evidence of two skillion extensions accommodating offices, a brick strong room and ablutions areas. Banks of glass louvred windows line the original building footprint of the western elevation under the eave while the skillion extension and southern elevations possess four light sash windows, shaded by an awning on the western elevation.

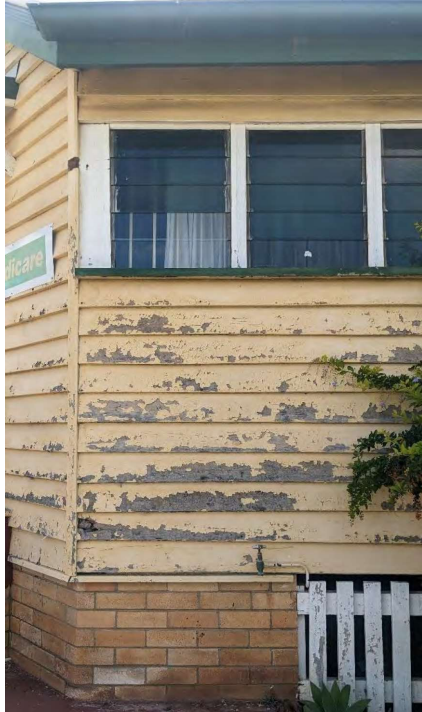
The paint to this elevation is in poor condition along with dilapidation present to the weatherboards, likely from subterranean termite (white ant) attack (Figure 20). Gutters along this elevation also show signs of rust damage in multiple places (Figures 21 and 22).

Figure 20: Damage to paint and weatherboards of western elevation (AHS 2023).

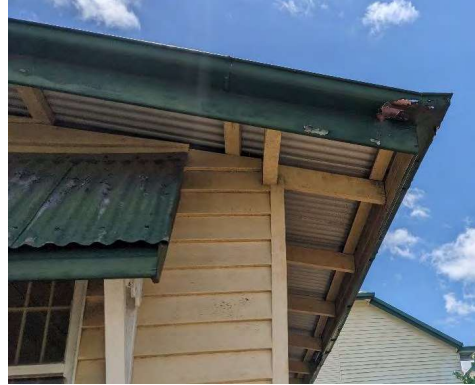
Figure 21: Rust damage to gutter of the western elevation (AHS 2023).

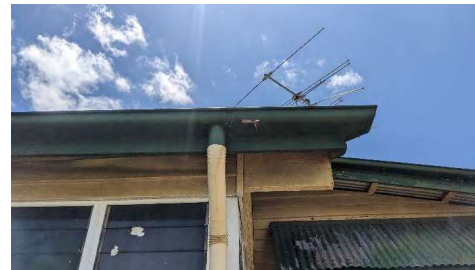
Figure 22: Rust damage to gutter of the western elevation (AHS 2023).

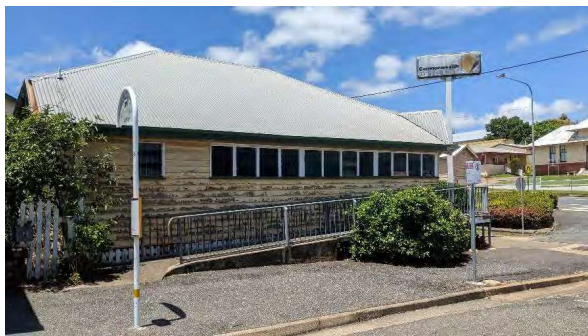
Figure 23: Northern elevation (AHS 2023).

Similar to the western elevation the northern elevation of the building is characterised by sections of glassed louvered windows and poor condition of paint and weatherboards (Figures 23 and 24).

An access ramp also exists to this elevation which continues from concrete to timber with stainless steel handrails and is currently overhung with vegetation (Figure 23 and 25). The timber of the access ramp and landing bears evidence of both damage and replacement of boards (Figure 26).

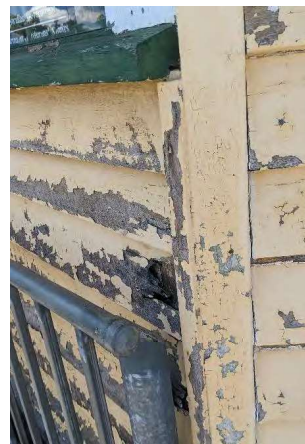
Figure 24: Damage to paint and weatherboards of northern elevation (AHS 2023).

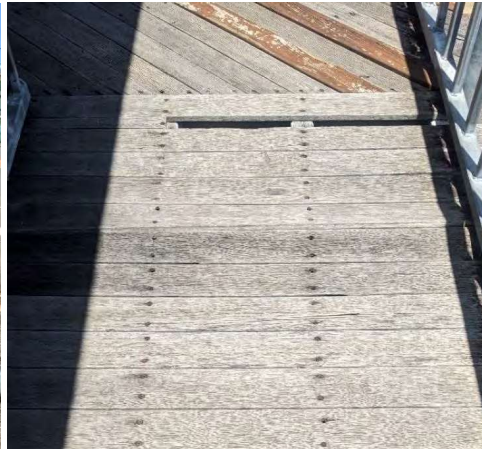
Figure 26: Damage to access ramp (AHS 2023).

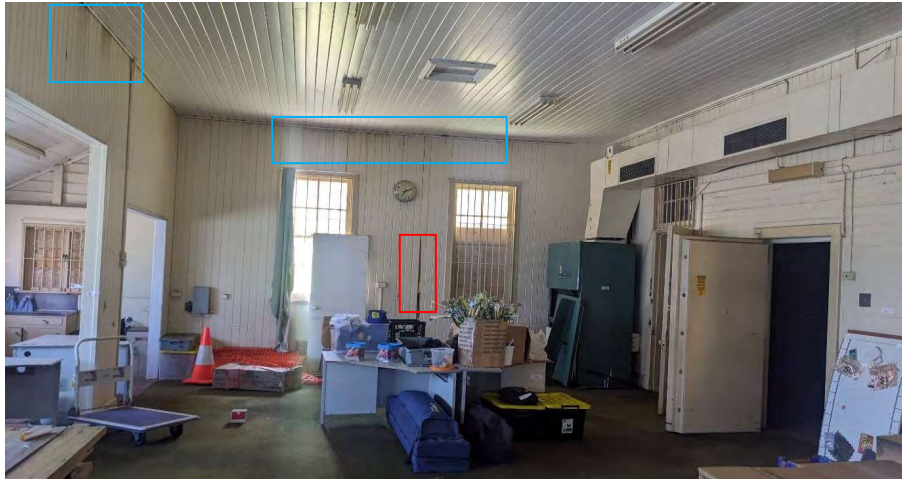
The floor of the main office area is carpeted (likely 1908s) with timber skirts present. Due to the enclosure of the northern and western verandahs original walls of the main office area are only present to the east and south which are lined with tongue and groove vertical joint (VJ) timber boards. The walls of the main office are dramatically impacted by insect (white ant) activity which is visible on almost every plane and aspect. Further, evidence of water ingress, suggesting roof leaks, is present in multiple locations (Figure 28).

Figure 28: Main Office Area showing eastern and southern walls and the presence of damage from water ingress [Blue] and insect activity [Red] (AHS 2023).

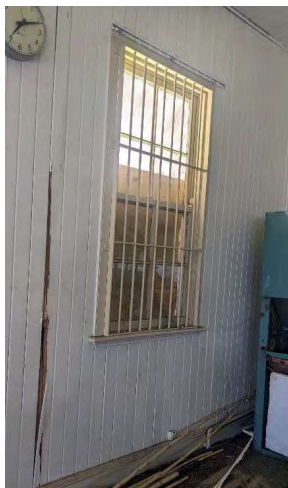
Two four light sash windows with bars internally are present along the eastern wall which are likely to be early or original fabric. However, it is suggested that the glass, which is damaged in places, is likely not original (Figure 29). Four doors along the southern wall provide access to the skillion extensions (Figure 30). Tongue and groove VJ timber boards with evidence of white ant activity are present.

Figure 29: Damage to glass of sash window along eastern wall (AHS 2023).

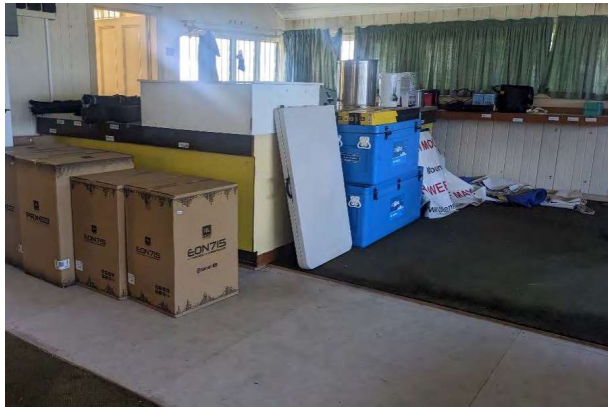
Figure 31: Countertops and slips counter relating to banking activity (AHS 2023).

To the west of the main office area evidence remains of countertops and benches from when the building was used as bank. Slips counter also remains aligning the western wall on the inside edge of the verandah proper.

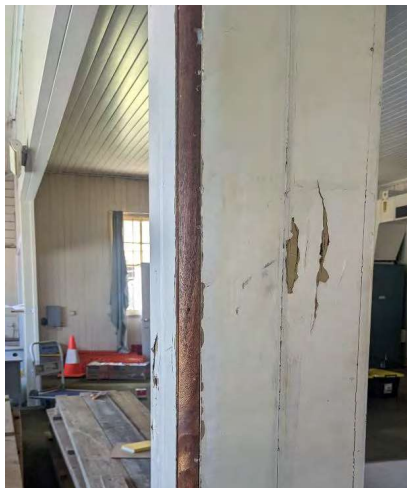
Figure 32: Corner post (foreground) and kitchenette wall (background) (AHS 2023).

Internally the former interna; walls of the northern verandah have been largely demolished when the verandahs were enclosed, c. 1970's. Remaining sections of the VJ T&G walls survive highlight former doorways and associated details at height (Figure 32).

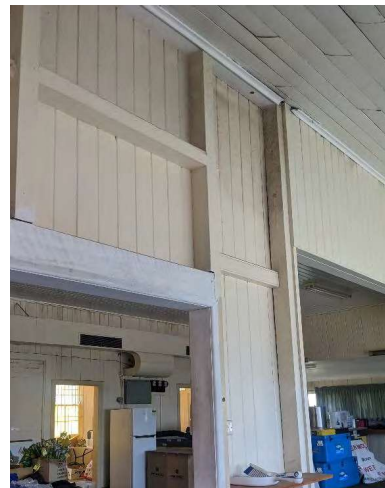
Figure 33: Infilled section of early door (AHS 2023).

The presence of a portion of an early infilled door suggests a kitchenette may have been located in this area from early times (Figure 33), however, it is uncertain if it is an original feature.

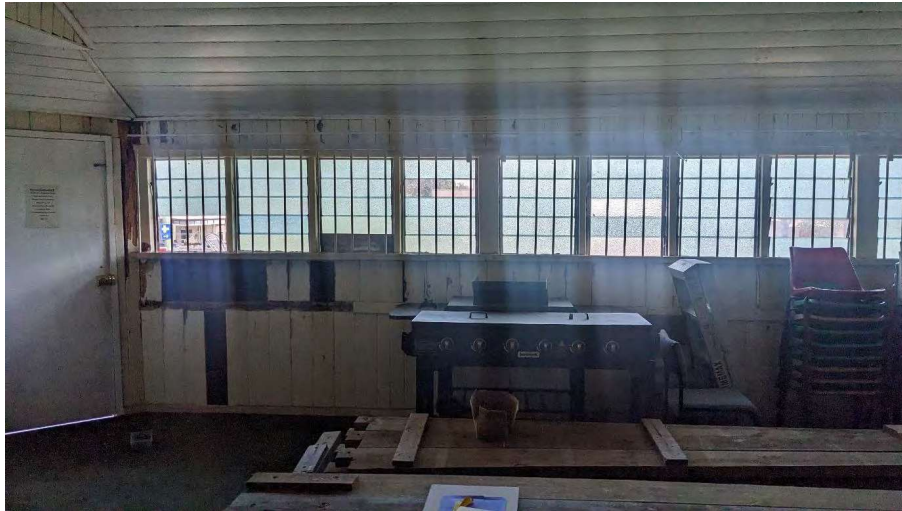
VJs are present along the northern wall of the building to a height of approximately 1.2 metres at which point they meet the sections of louvred windows with internal bars. A small portion of VJs also exists above the windows along the wall. Evidence of substantial white ant activity is present on these boards, particularly to the west of this wall (Figure 34). The pitched ceiling of the verandah is clad with 100mm VJs which likely date to the verandah enclosure.

Figure 34: Northern wall showing white ant activity (AHS 2023).

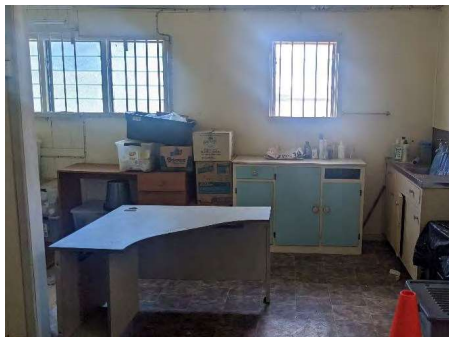
Figure 35: Kitchenette showing the transition from VJ to FC (AHS 2023).

The kitchenette is located to the east of the northern enclosed verandah which unlike the northern wall is sheeted with fibre cement (FC) cladding and possesses linoleum flooring (Figure 35). A two-casement window with damaged artic glass is present on the eastern wall of the kitchen and a single louvred window present on the northern wall (Figure 36).

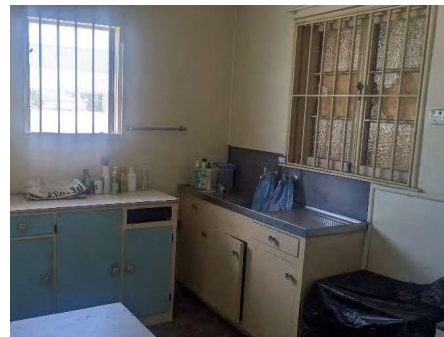
Figure 36: Kitchenette (AHS 2023).

The fit-out of the kitchenette is likely from the 1950's and consists of cupboards along the northern and eastern walls and a sink.

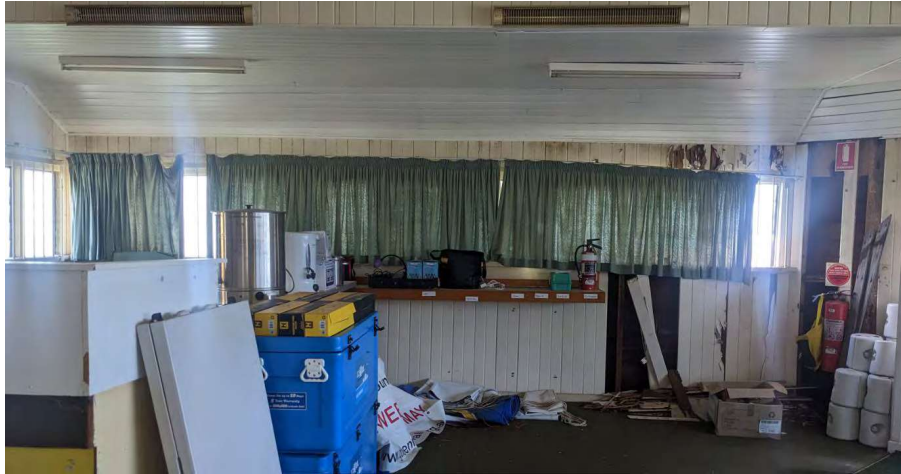
The western enclosed verandah possesses fabric similar to the of the northern verandah. Again, substantial insect activity is present to the VJ timber walls (Figure 37).

Figure 37: Western wall (AHS 2023).

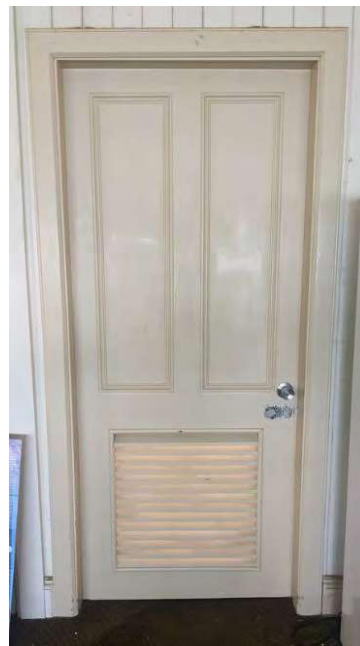
Figure 38: Four panel access door from main office area (AHS 2023).

The skillion office to the south-west of the building is likely a bank managers office and can be accessed from the main office area and from behind the bank counter through four panel doors. The four-panel door leading from the main office however has had the lower panels cut through and replaced with louvres (Figure 38).

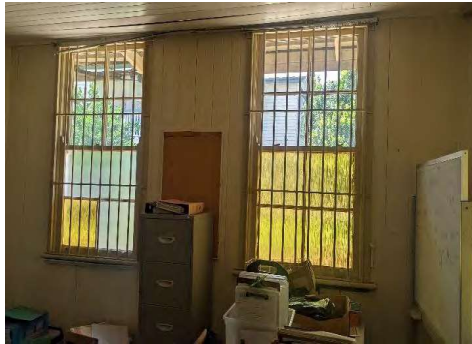
Figure 39: Southern wall of skillion office (AHS 2023).

Inside the skillion office two sets of four panel sash windows are present to both the southern and western walls with internal bars. The glass of these windows appears to have been replaced with yellow/orange tempered glass to the lower panels likely dating to the 1980's (Figure 39).

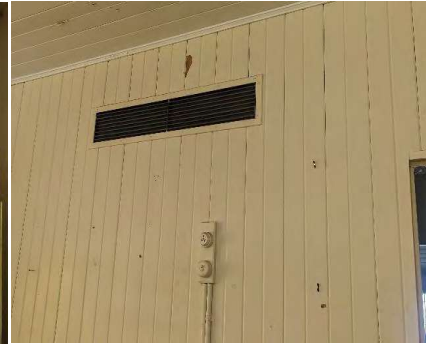
Figure 40: Northern wall showing air conditioning vent (AHS 2023).

Similar to the main office area the skillion office possesses 1980's carpet, timber skirts, tongue and groove vertical joint and VJ ceilings. This room also possesses evidence of white ant damage on both the walls and ceiling. A small cut through for air conditioning vents has been made to the northern wall of the office (Figure 40).

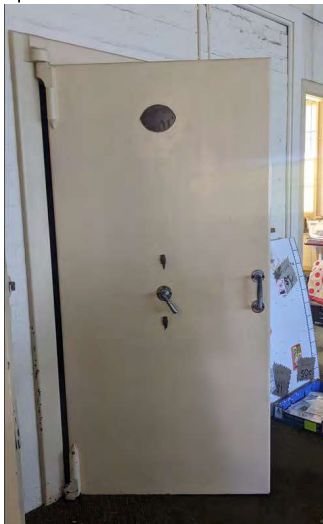
To the side of the strong room door is a capped metal tube which can be unscrewed from the inside of the strong room which is likely to allow coins/notes to be dropped into the vault during bank operation.

Figure 41: Door to strong room (AHS 2023).

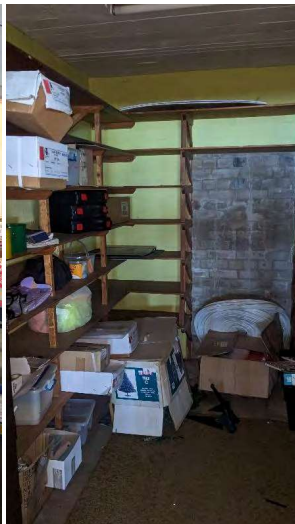
Figure 42: Strong room internally (ASH 2023).

Inside the vault is largely intact possessing early timber pine shelving related to the early banking era (Figure 42) and a steel cupboard with brass handles likely used to store change or paperwork dating to c.1950's at the latest (Figure 43).

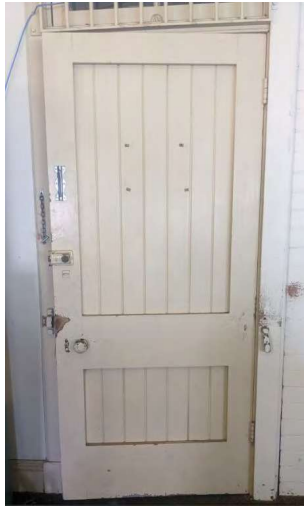
Figure 45: VJ door leading to ablutions (AHS 2023).

To the eastern rear of the main office area is a skillion extension housing ablutions accessed through a VJ door. The material of this door suggests it was originally built as an external door with a low waist with the hardware and locks of the door suggest it is original (Figure 44).

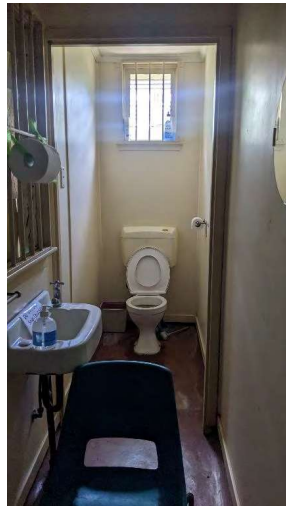
Figure 44: Female toilets (AHS 2023).

This door leads down concrete steps into what would originally have been open but now lies under a skillion roof providing cover to one male and one female toilet (Figure 45) and a second VJ door leading outside (Figure 46). The fabric of the toilets indicates their construction c. 1950's and louvered windows are present within the cubicles.

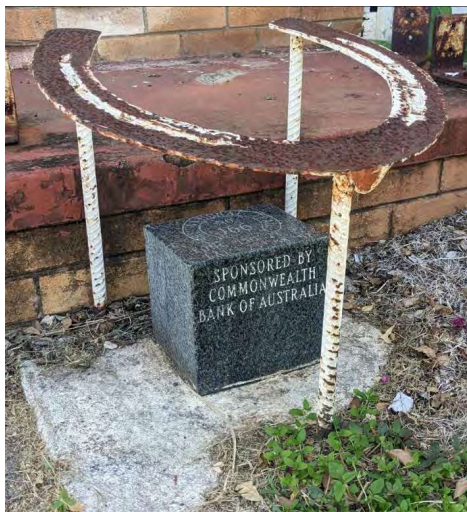
Figure 48: National Trail Memorial (AHS 2023).

A few small hedges and plantings, overgrown in places, exist around the building. A chain wire fence is located along various boundaries, including the rear from Central Street. There is a signpost (c.1990s) and memorial noting “The National Trail No. 166” with associated horseshoe motif located adjacent to the entrance (Figure 48). Finally, a Commonwealth Bank sign remains to the northwest corner of the building, however the sign shows evidence of previously being painted over (Figure 49).
