Music Bowl Structural Assessment

24 November 2014

R14265

Prepared for Rockhampton Regional Council

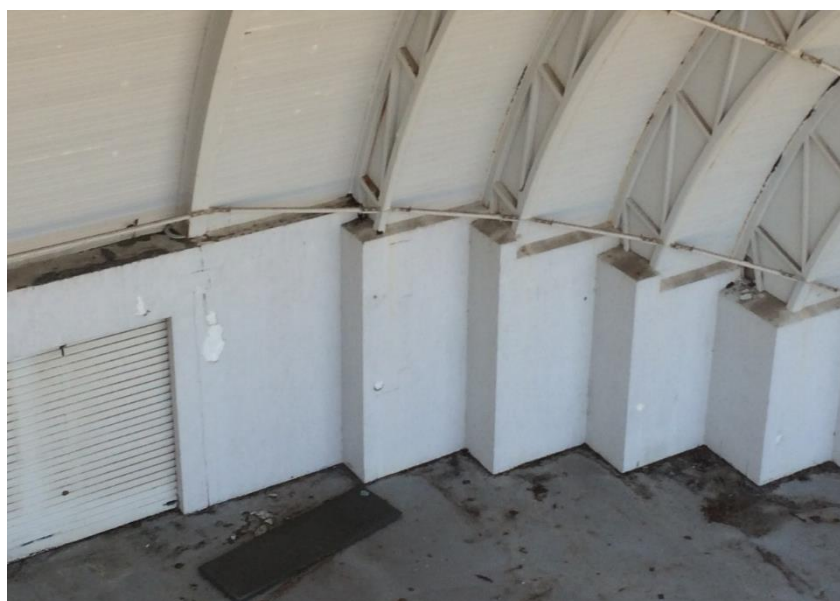
Figure 4 - Roof trusses enclosed in masonry wall

It is noted that the bottom section of trusses and beams could not be observed because they are concealed behind blockwork. This is demonstrated by Figure 3 and Figure 4 below, showing the design detail and a photograph. As a result the condition of these structural steel elements could not be assessed.

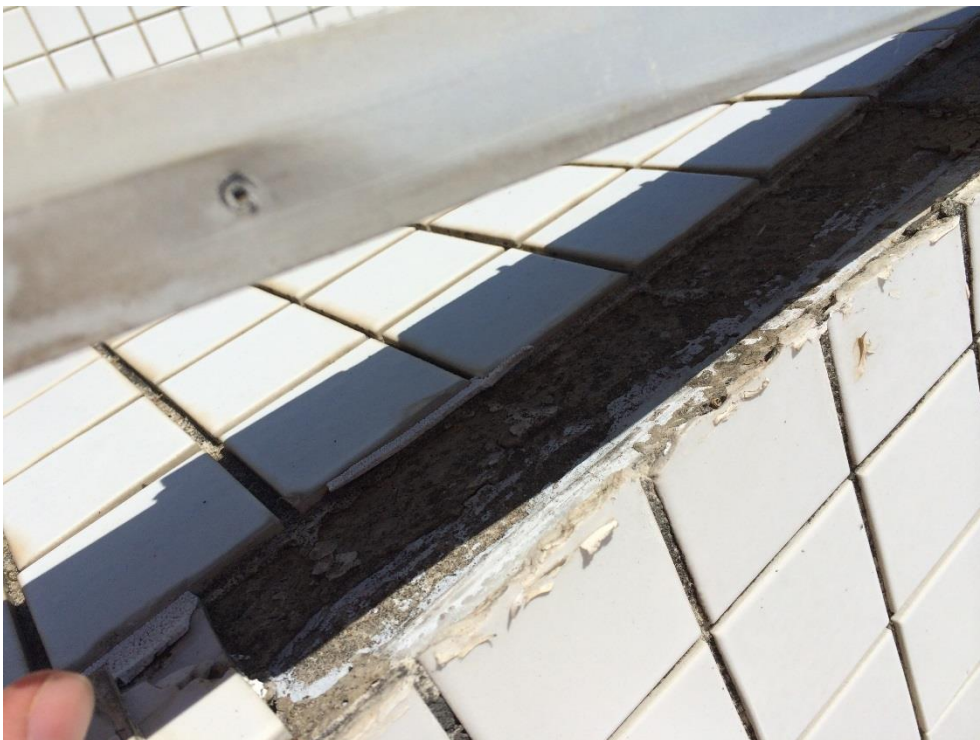
Figure 8 - Loose aluminium capping

Detailed view of aluminium edge capping coming loose on curved section of roof.

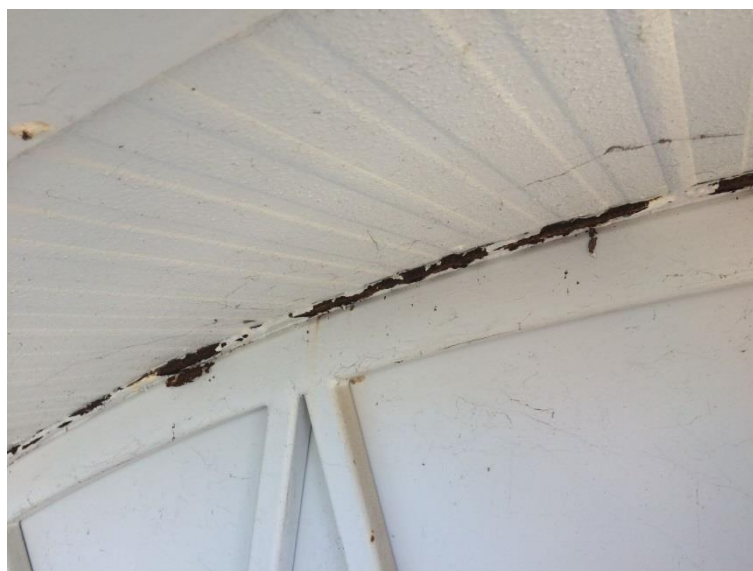
Figure 10 - Corrosion of top plate

The top plate was used to fix metal formwork in place during construction, and provides support to the concrete slab.

The top plates are generally heavily corroded, with between 20% and 50% section loss in some areas.

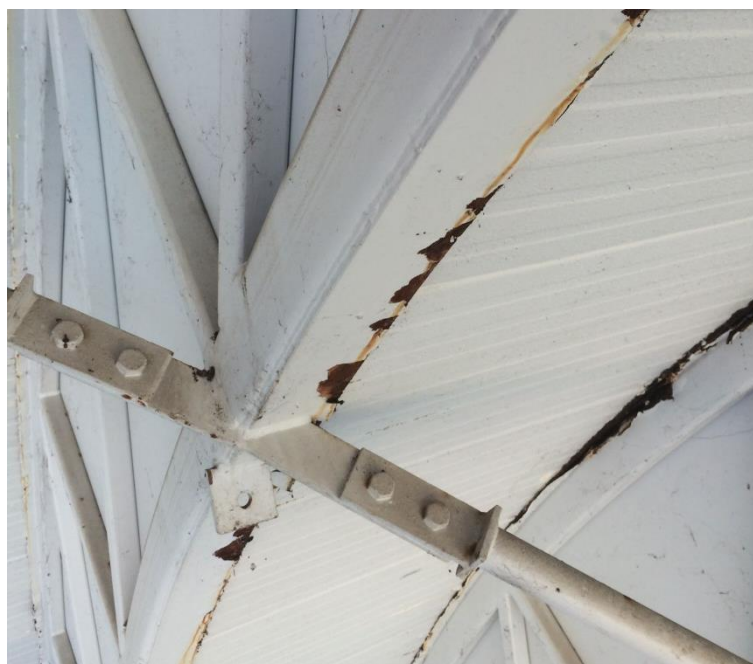
Figure 11 - Corrosion of bottom plate

The metal formwork is supported by the bottom plate and is screwed in place.

The bottom plates generally have a minor degree of corrosion with up to 10% section loss.

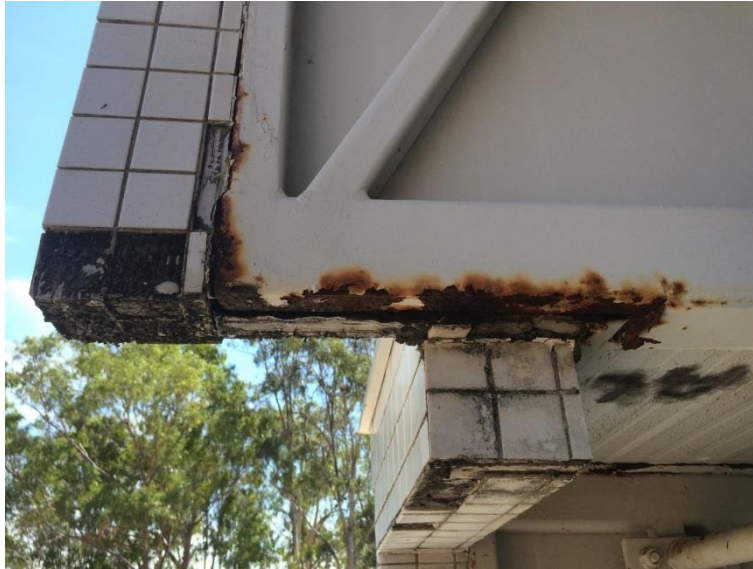
Figure 12 - Corrosion of bottom chord at the exterior face of the sound shell

The bottom chords at the front face of the sound shell have generally corroded to approximately 10% on the bottom face of the members.

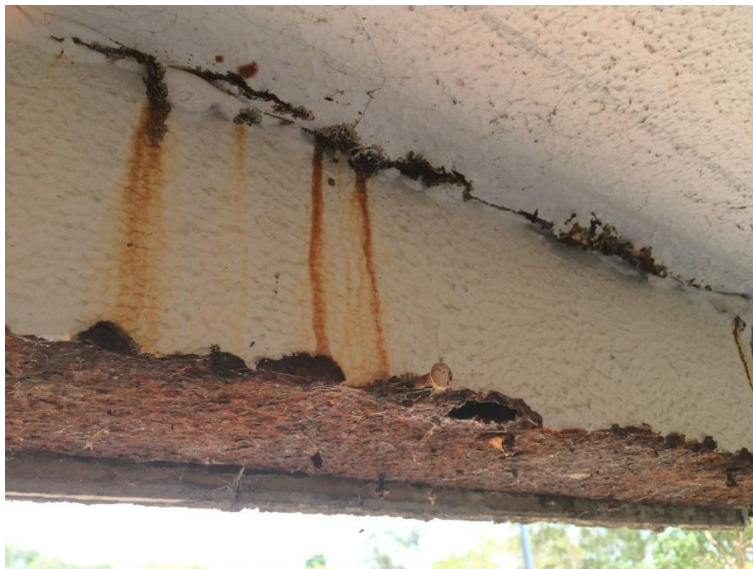
Figure 13 - Corrosion of the steel fascia section at top front of the sound shell

The fascia at the top front of the sound shell is made of thin cold formed steel section, and is heavily corroded. Corrosion has caused holes in the section.

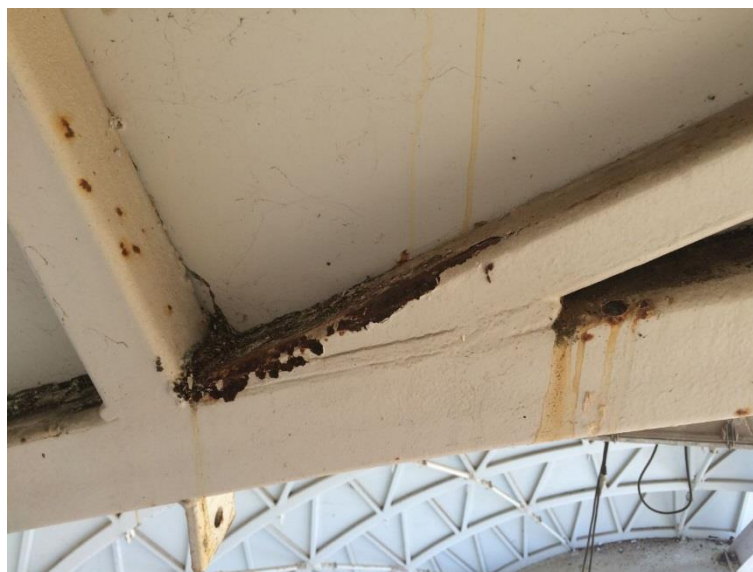
Figure 14 - Corrosion to the truss web members at the bottom chord

There is a minor degree of corrosion to the bottom of web members across some areas of the trusses, generally on the lower end where water can potentially pond.

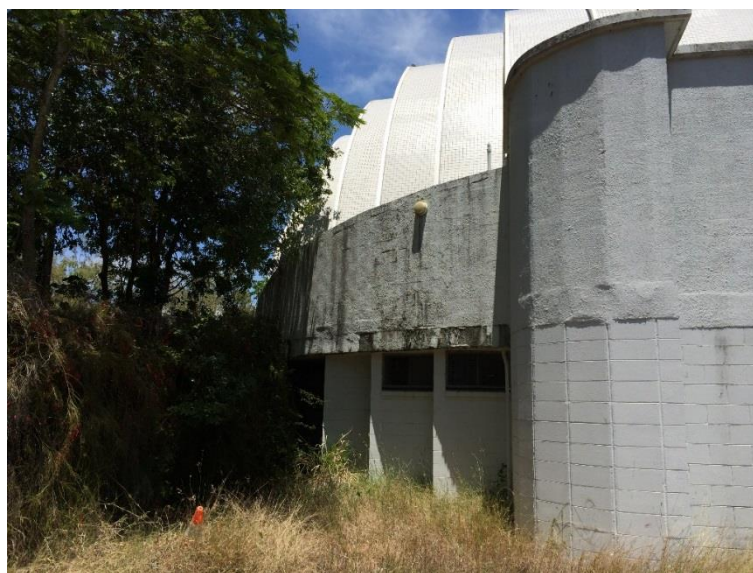
Figure 15 - Rear view of substructure

External view of substructure, some staining, minor shrinkage cracking, structure generally in sound condition.

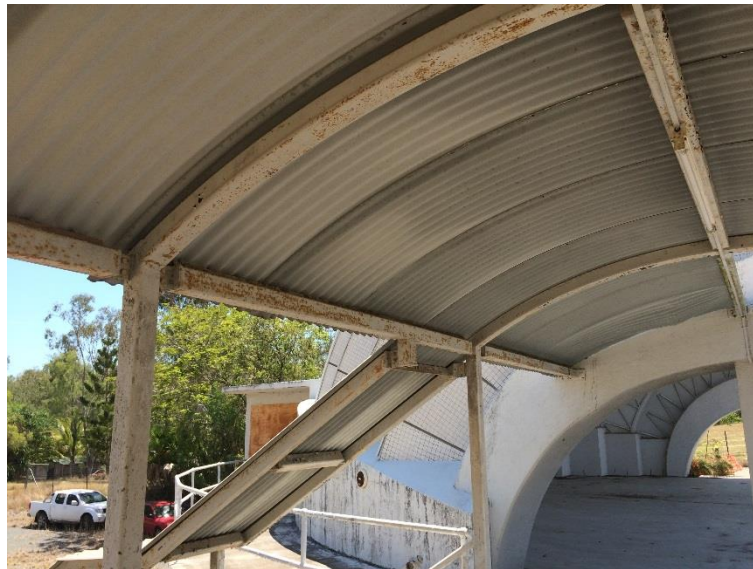
Figure 18 - Minor corrosion across covered walkway structure

There is a minor degree of corrosion across the entire covered walkway structure.

It is recommended that the covered walkway structural steel is cleaned to remove corrosion, and painted with a suitable corrosion protective paint. Consideration should be made for the replacement of roof sheeting in some locations.

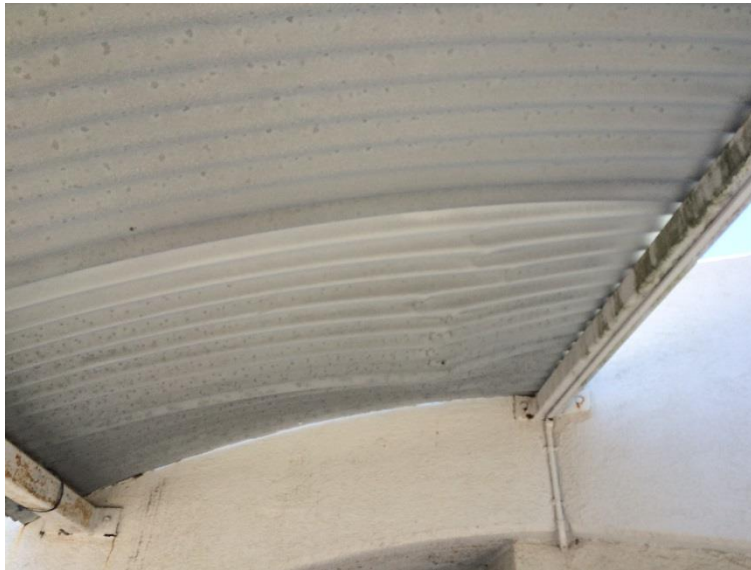
Figure 19 - Dent in roof sheeting

The roof sheeting over the covered area is dented.

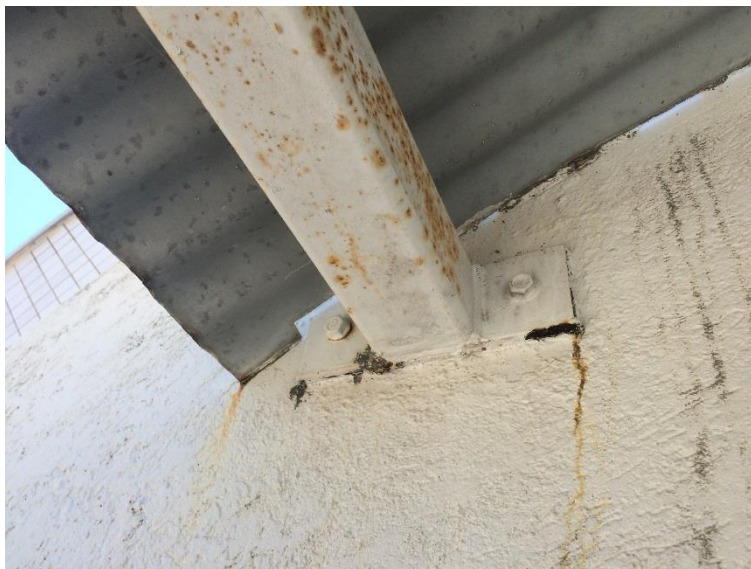
Figure 20 - Minor corrosion to connections

There is some minor corrosion to each of the wall connections of the covered area.

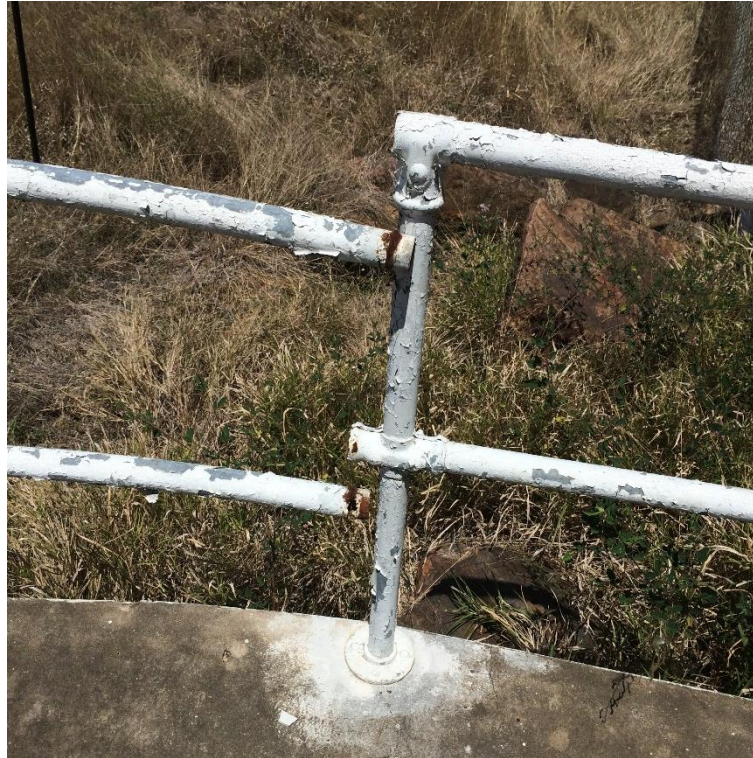
Figure 21 - Handrails disconnected from stanchions and coating deteriorated

The handrails have disconnected from the stanchions in some locations. Paint coating is generally deteriorated.

With the handrails in their current condition, and for the relative cost of repair, it is recommended that these are replaced.

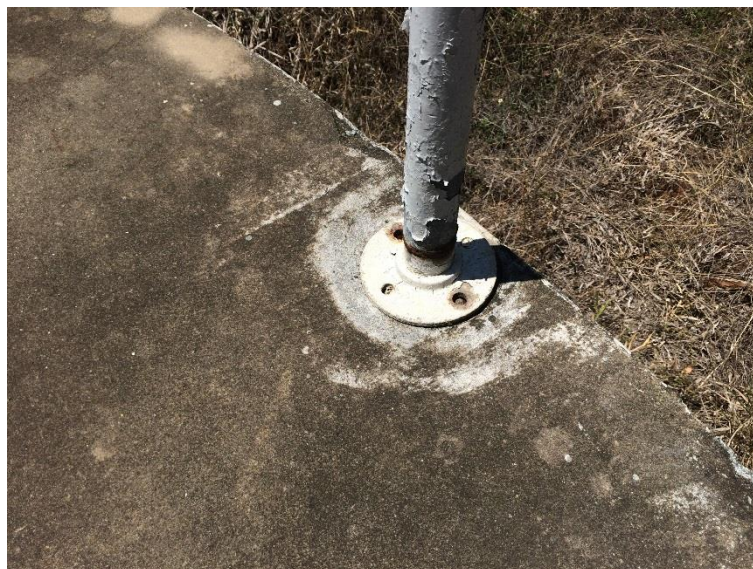
Figure 22 - Bolts missing from stanchions

Bolts missing from the base connection of stanchions in many cases.

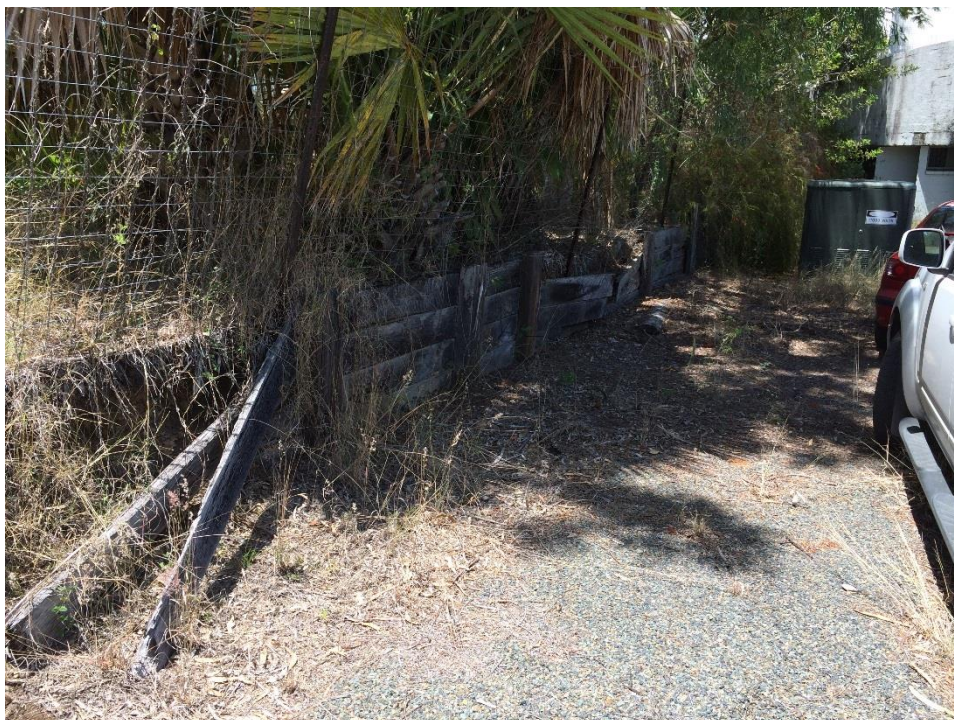
Figure 24- Timber retaining wall

Collapsed and rotting timber retaining wall. Heavy vegetation on high side of retaining wall

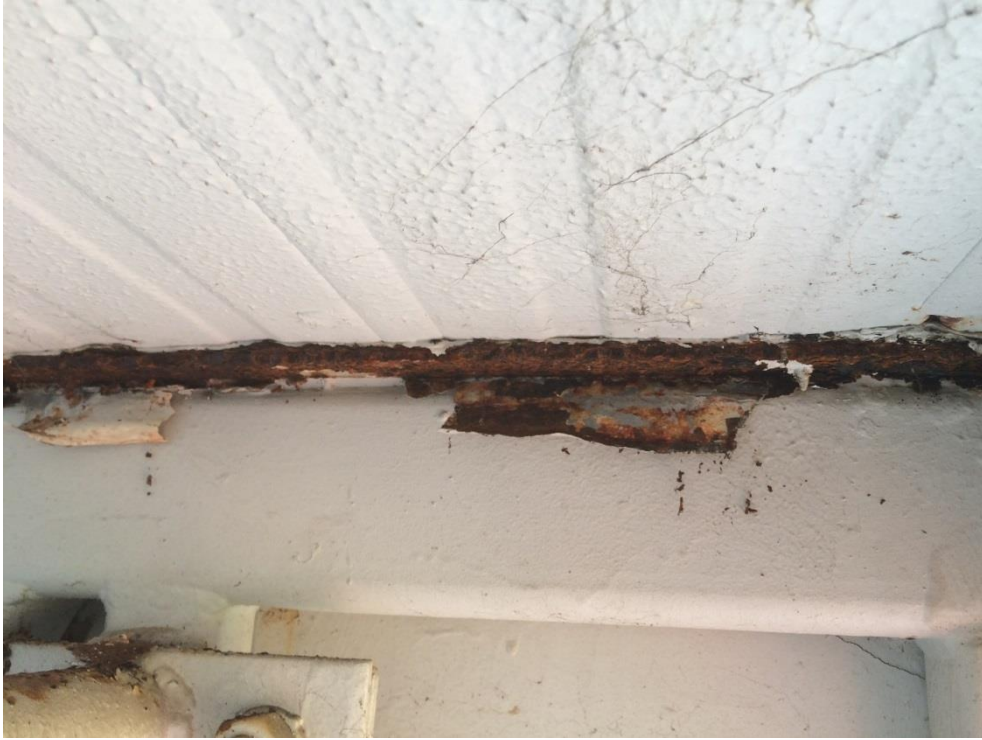
Photo 003 - Corrosion to top plate

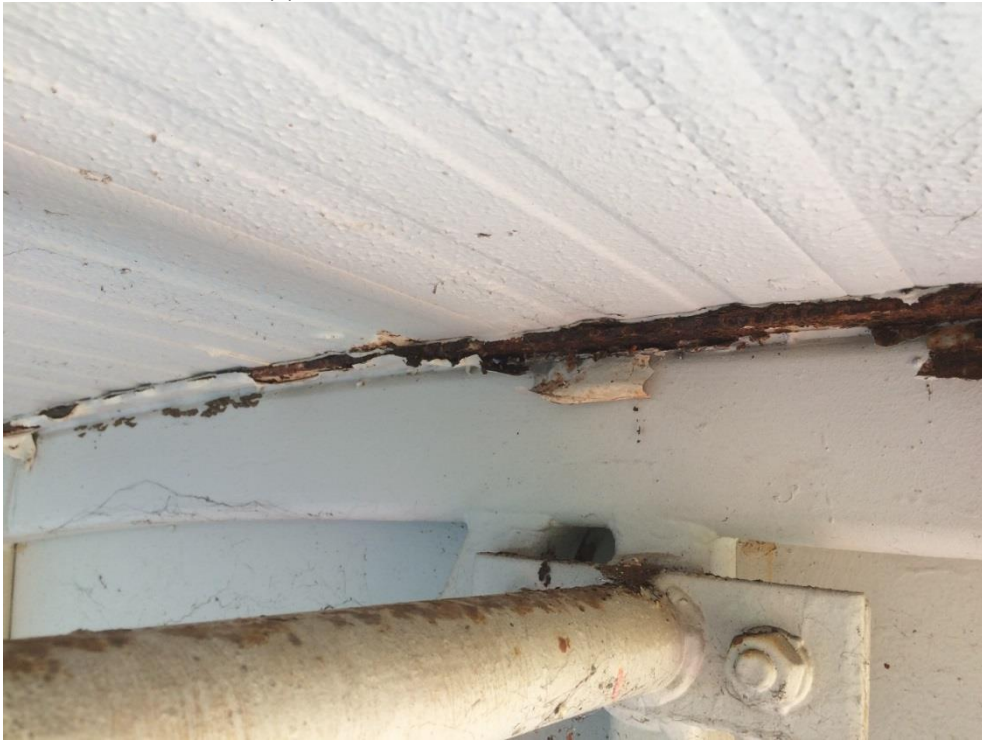
Photo 004 - Corrosion to top plate

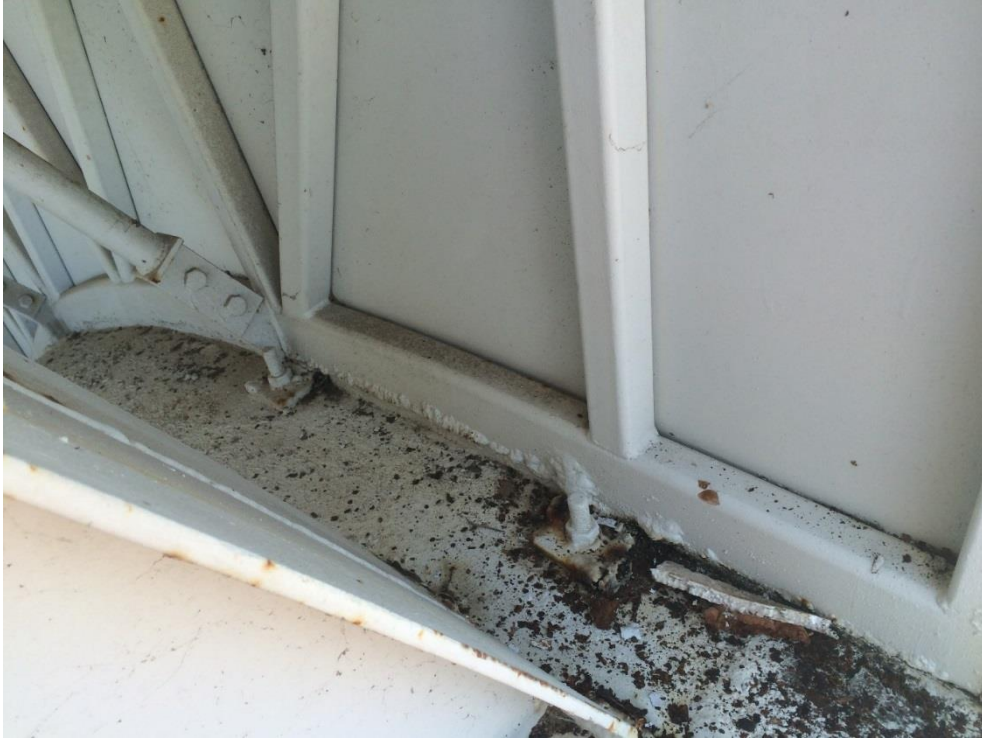
Photo 005 - Corrosion to truss tab plate

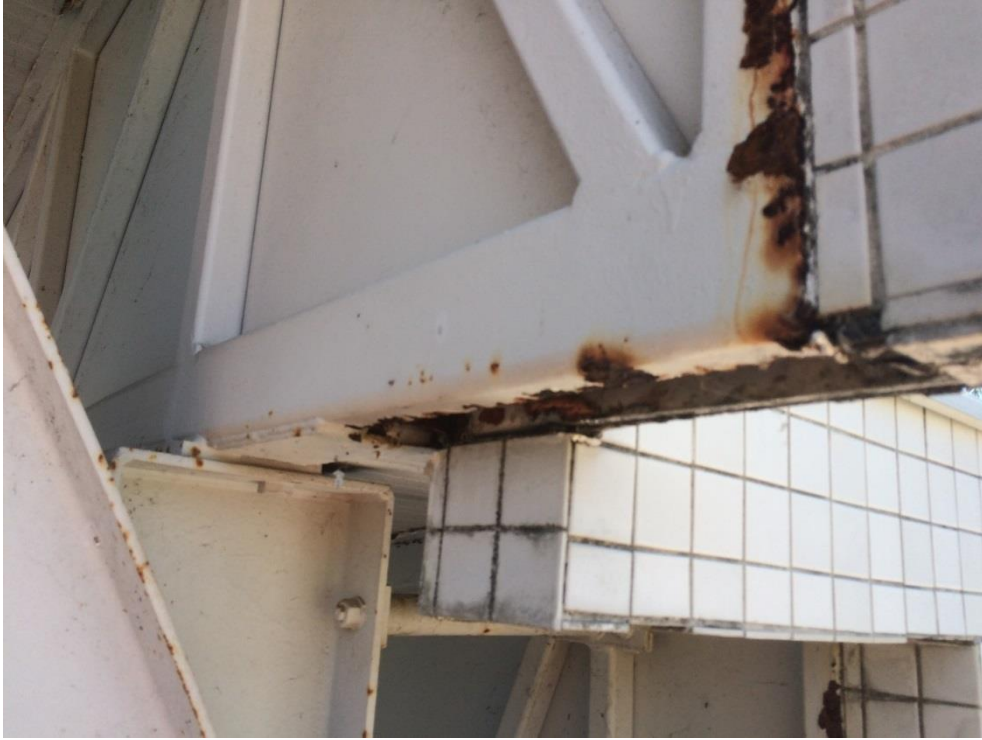
Photo 008 - Corrosion to truss bottom chord and web at end

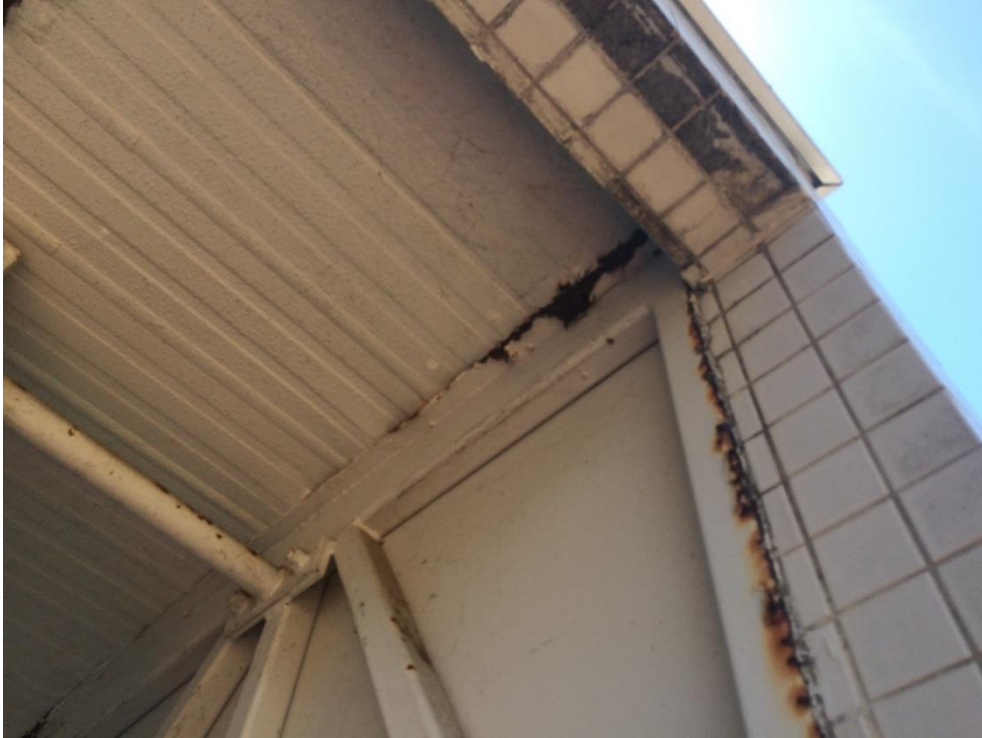
Photo 010 - Corrosion to truss bottom chord and web at end

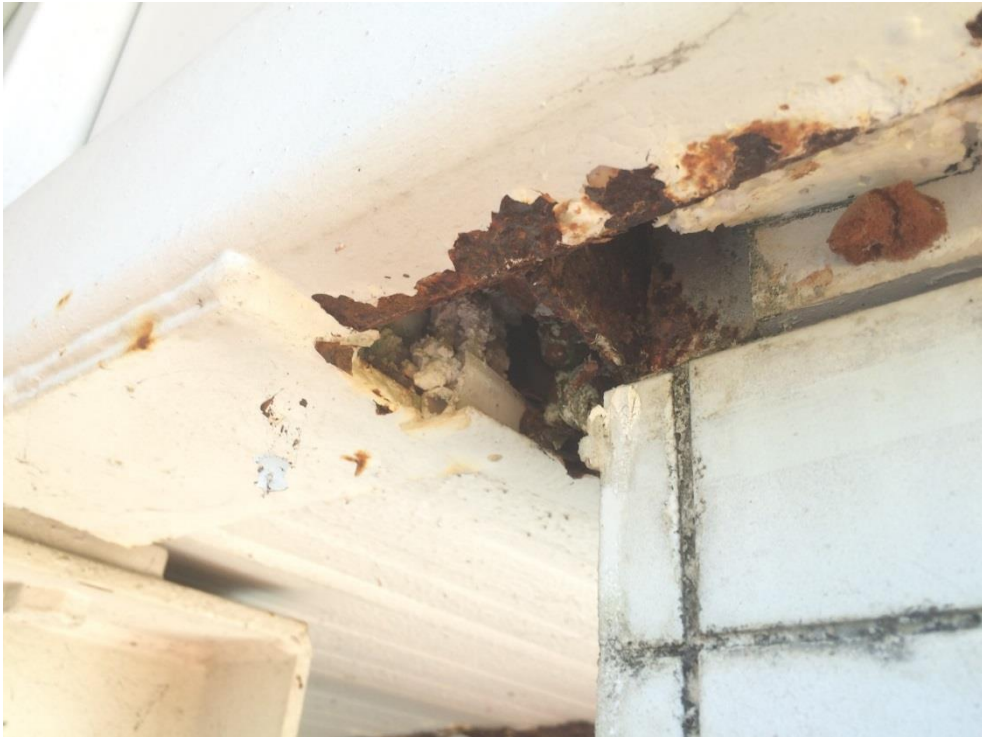
Photo 011 - Corrosion to truss bottom chord and web at end

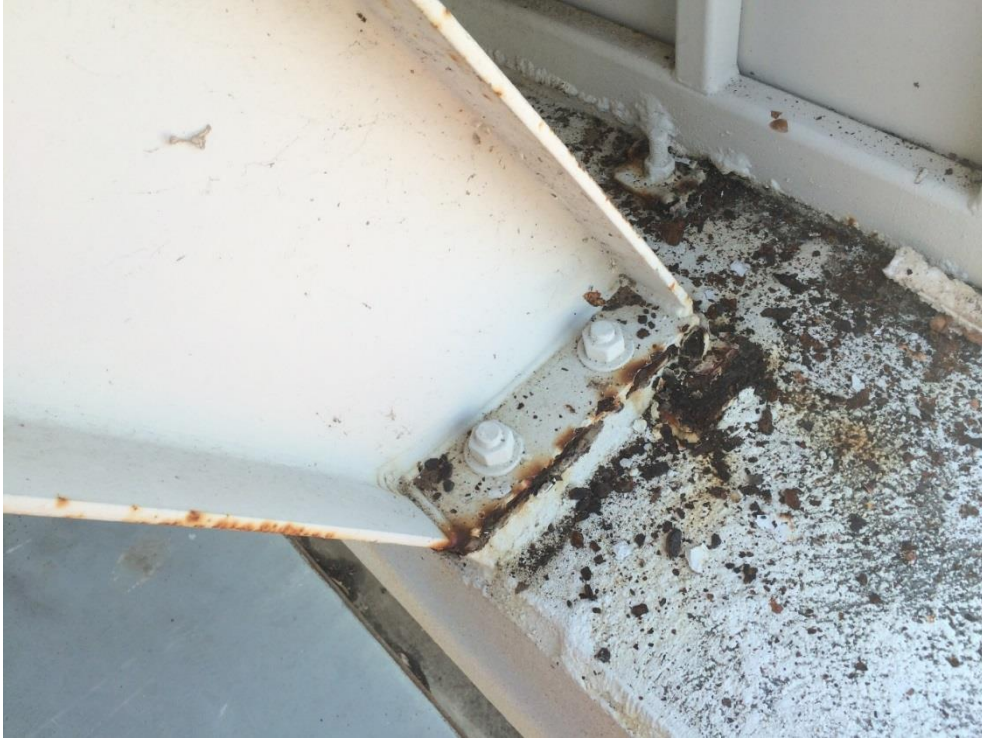
Photo 012 - Minor corrosion to main arch baseplate

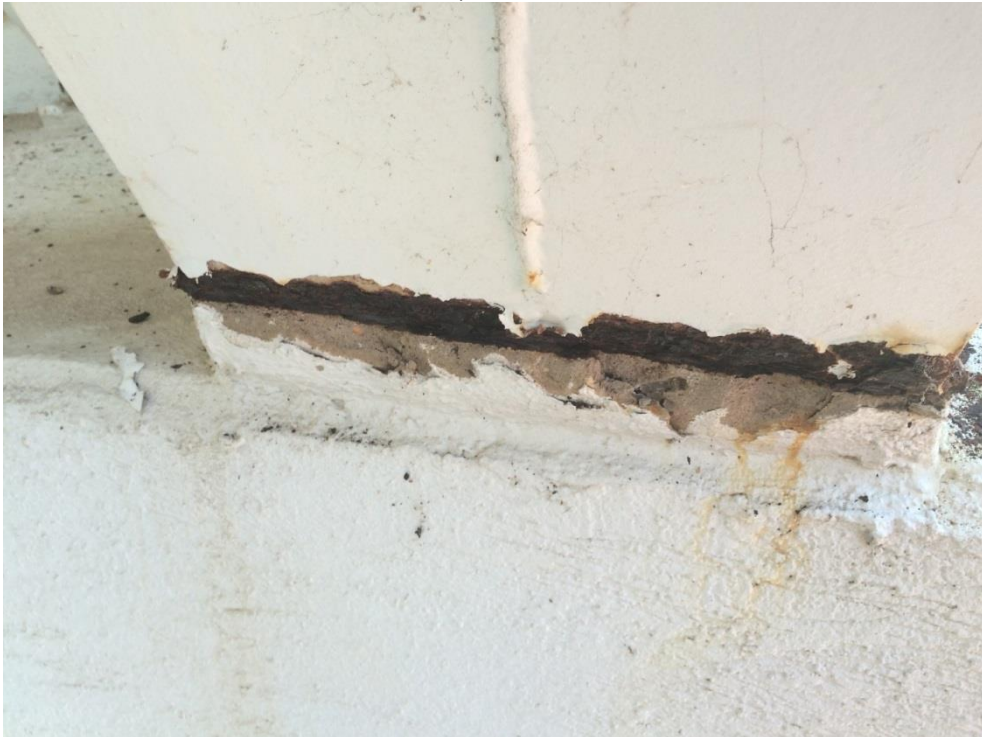
Photo 013 - Minor corrosion to main arch bottom flange at baseplate

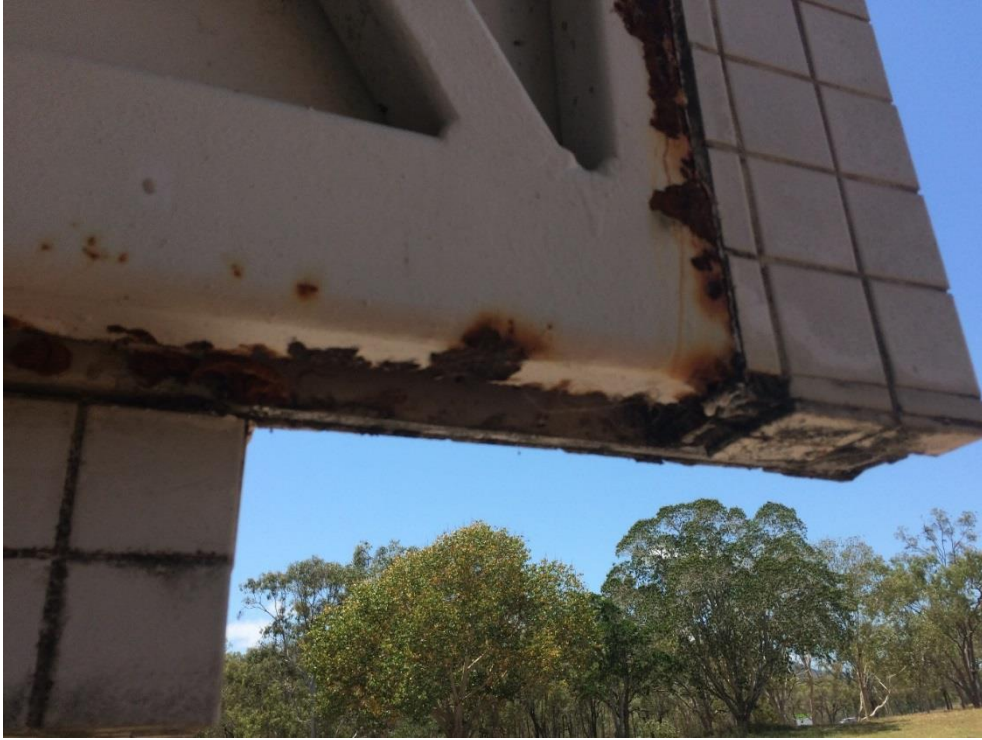
Photo 018 - Heavy corrosion to bottom chord

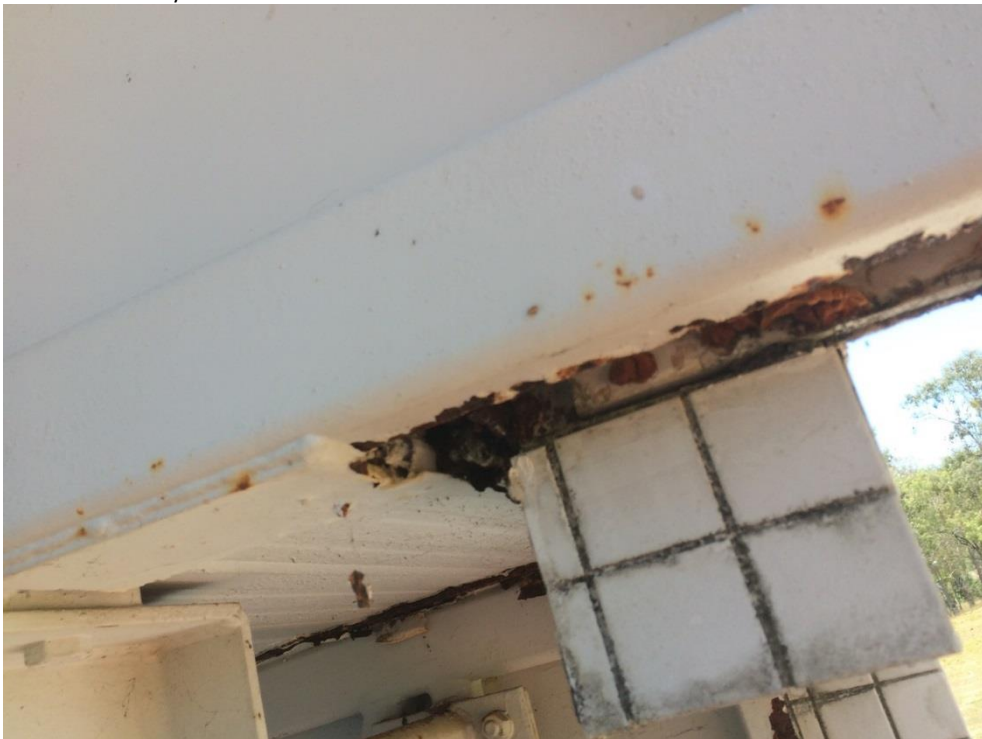
Photo 019 - Heavy corrosion to bottom chord

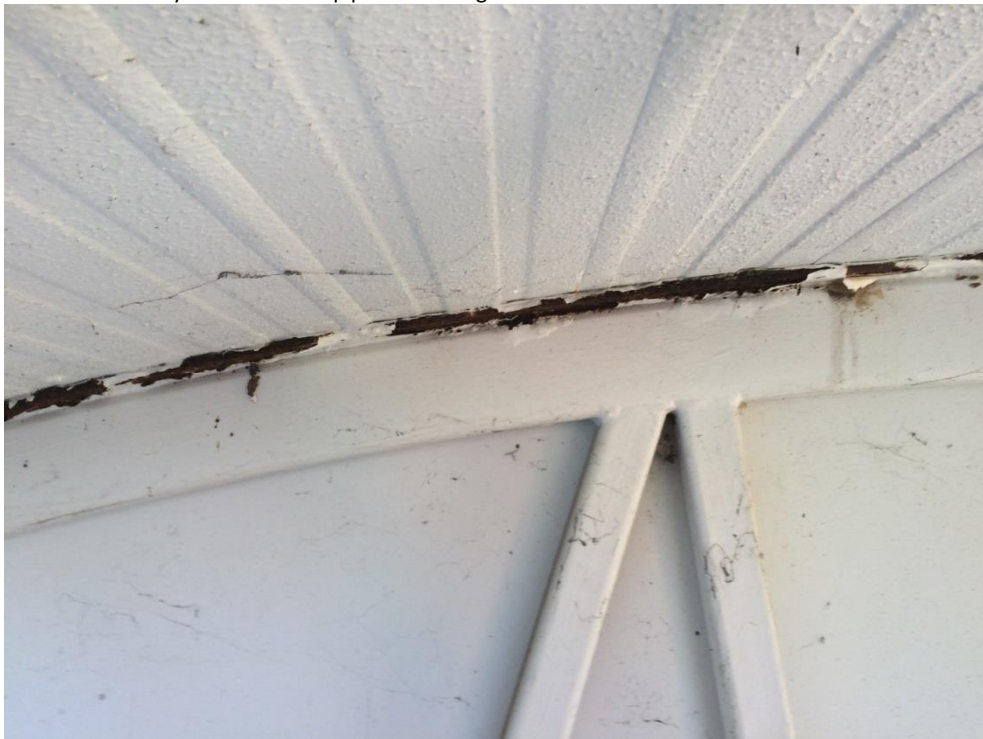
Photo 022 - Heavy corrosion to top plate all along

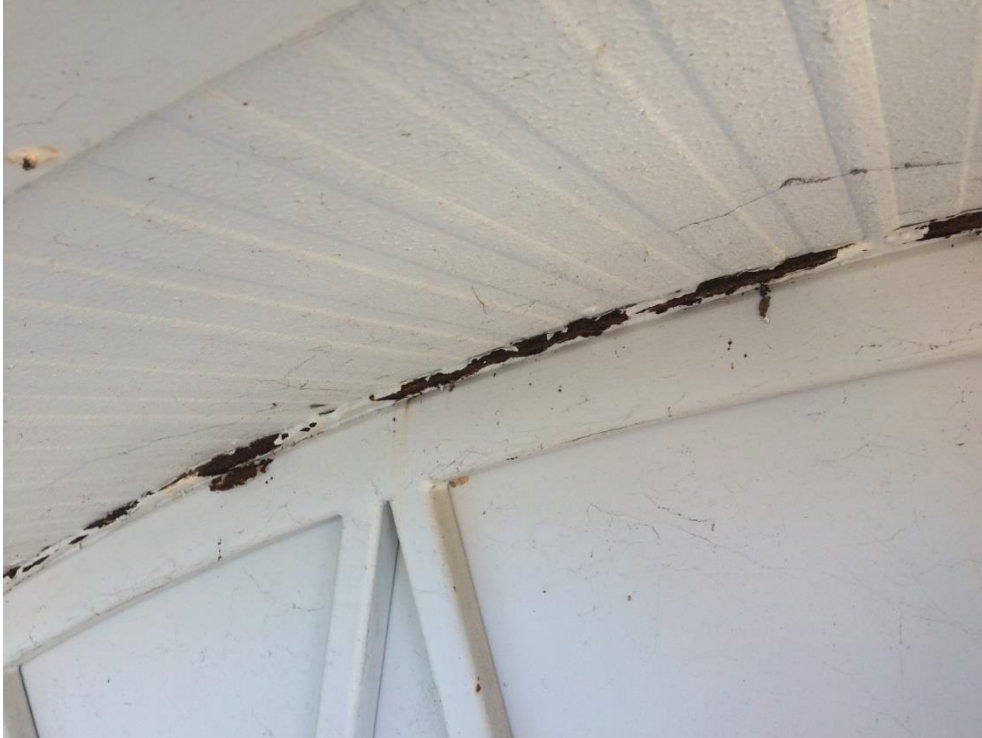
Photo 023 - Heavy corrosion to top plate all along

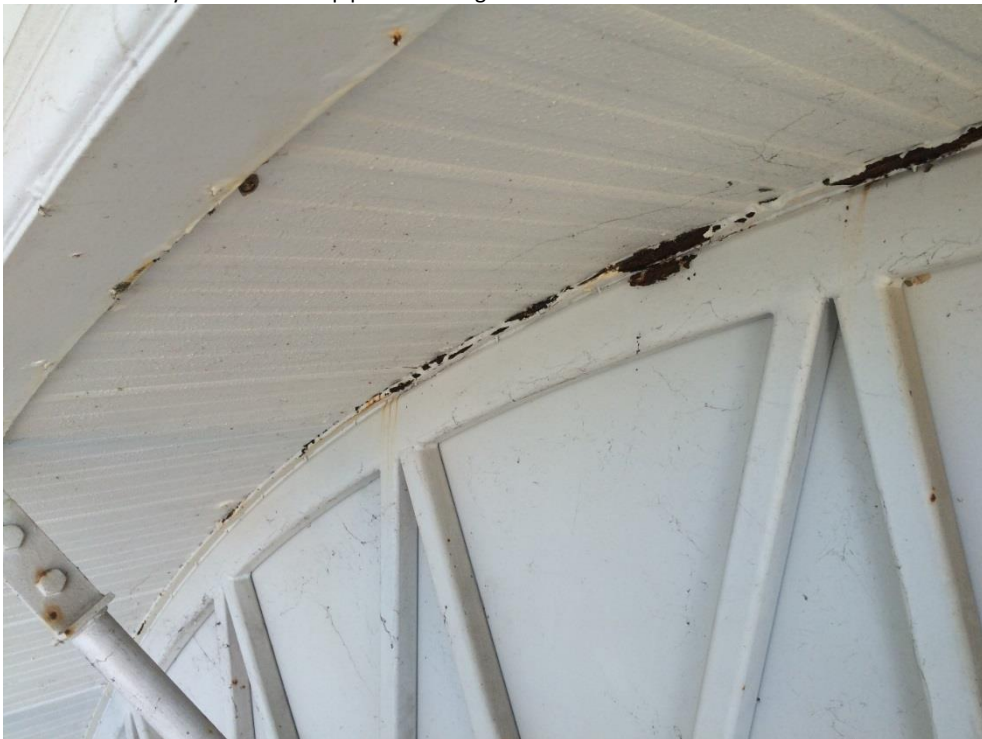
Photo 024 - Heavy corrosion to top plate all along

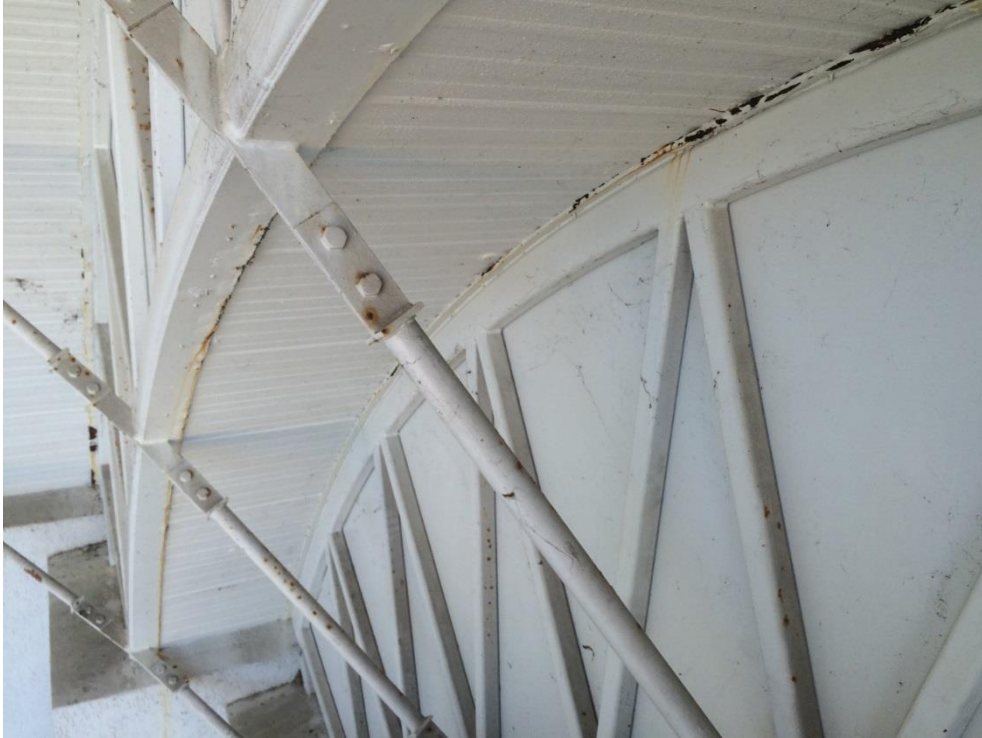
Photo 025 - Struts generally in good condition

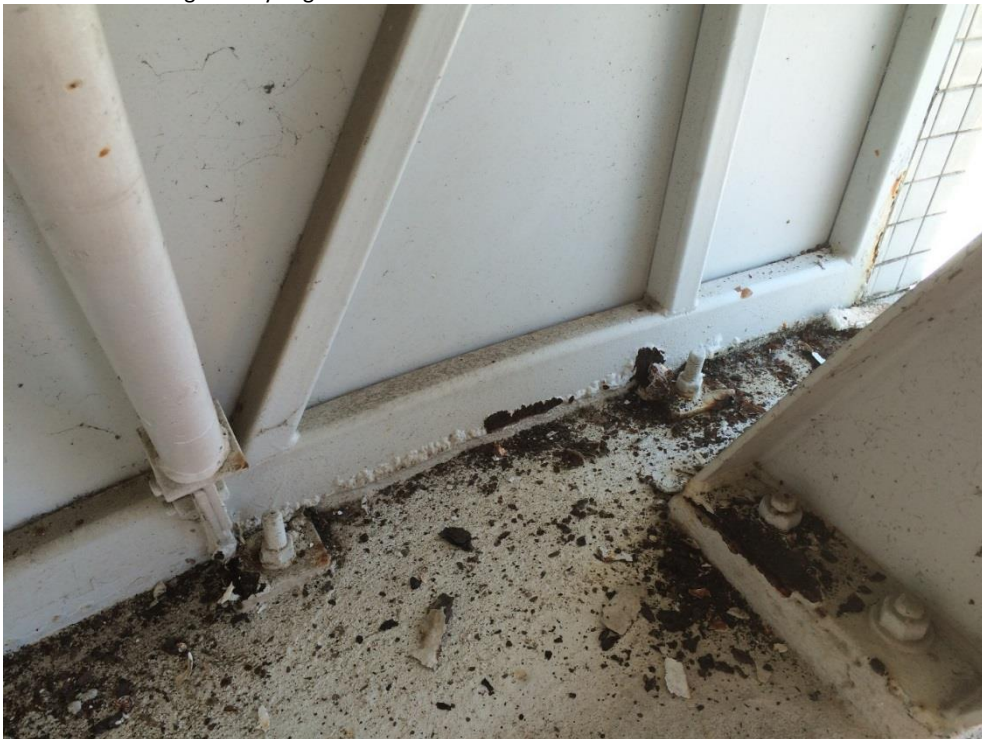
Photo 026 - Heavy corrosion to side of bottom chord

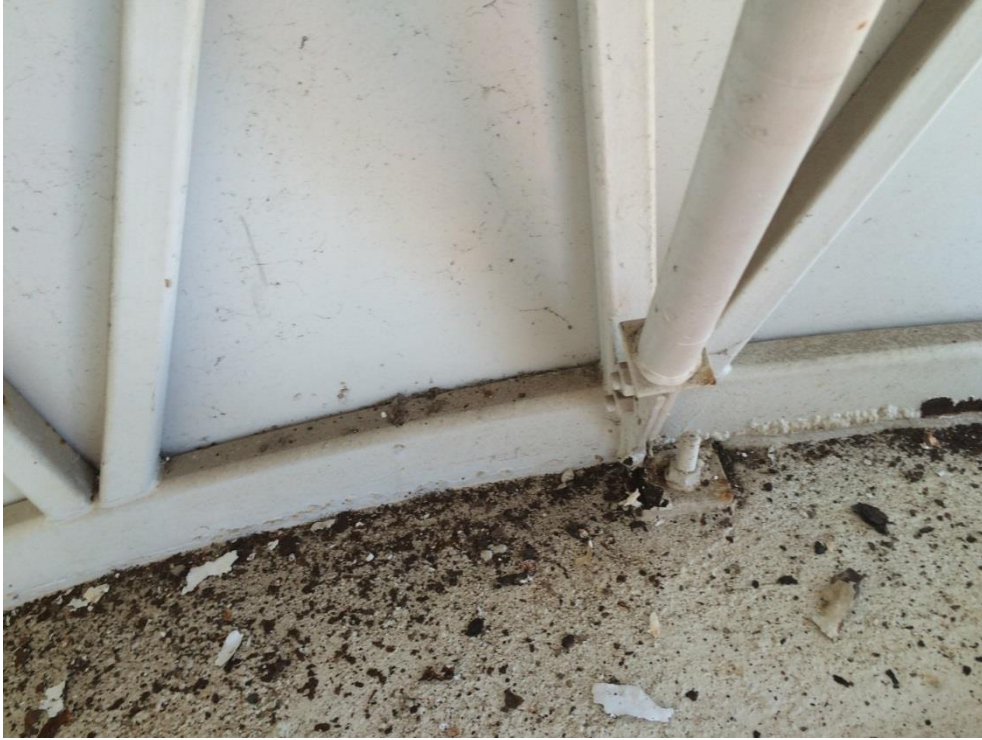
Photo 027 - Heavy corrosion to side of bottom chord

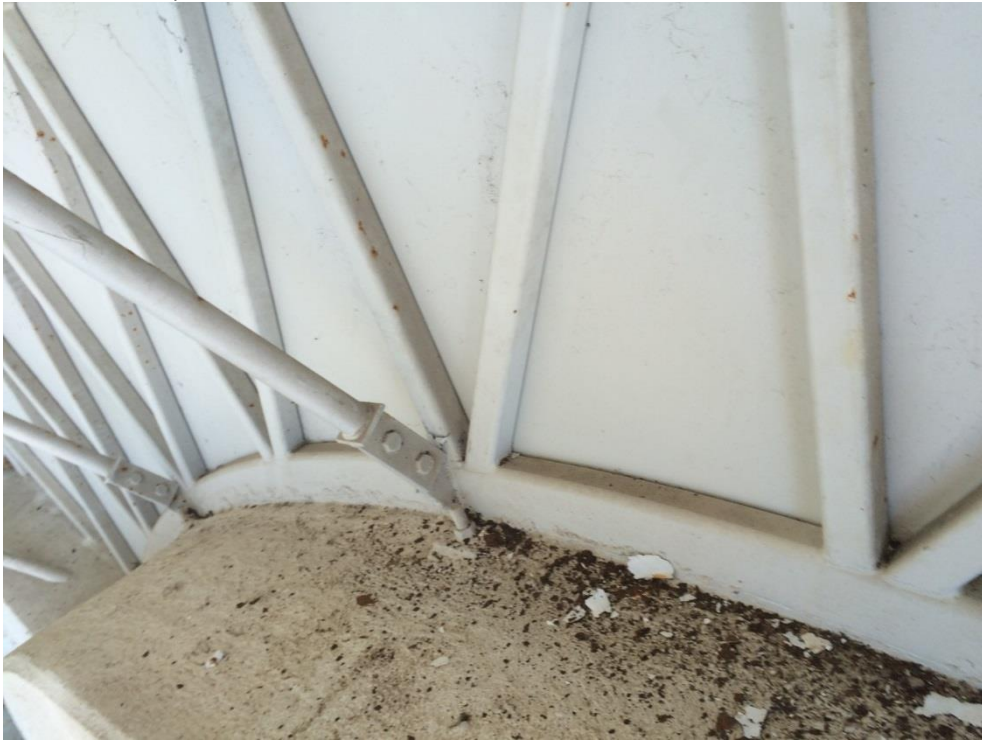
Photo 028 - Heavy corrosion to side of bottom chord

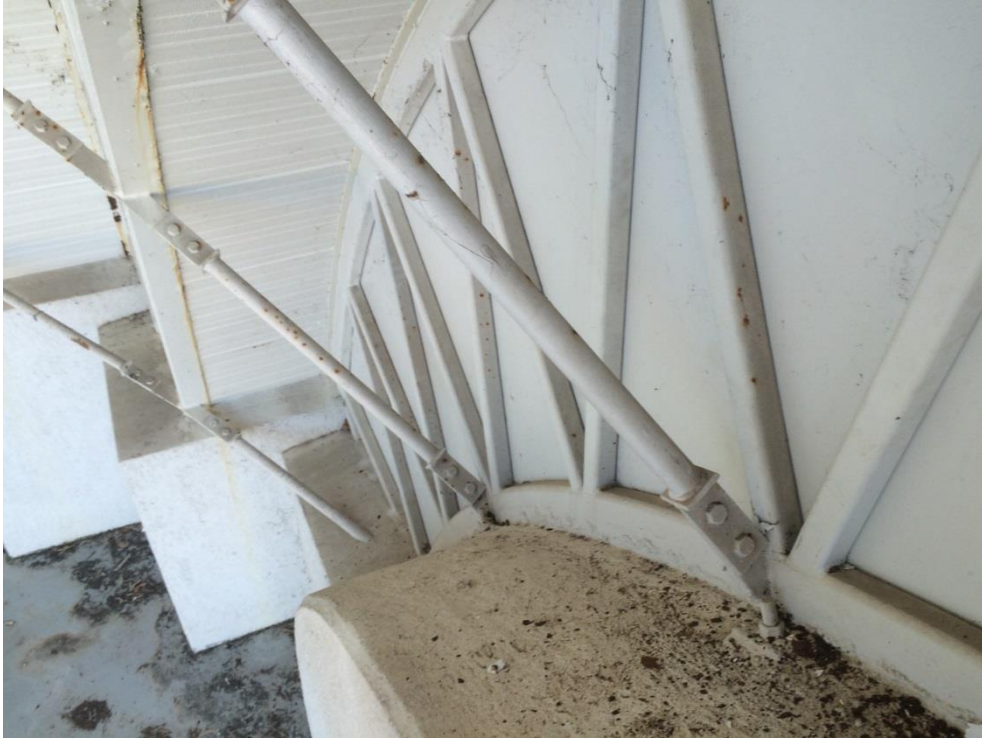
Photo 029 - Heavy corrosion to side of bottom chord

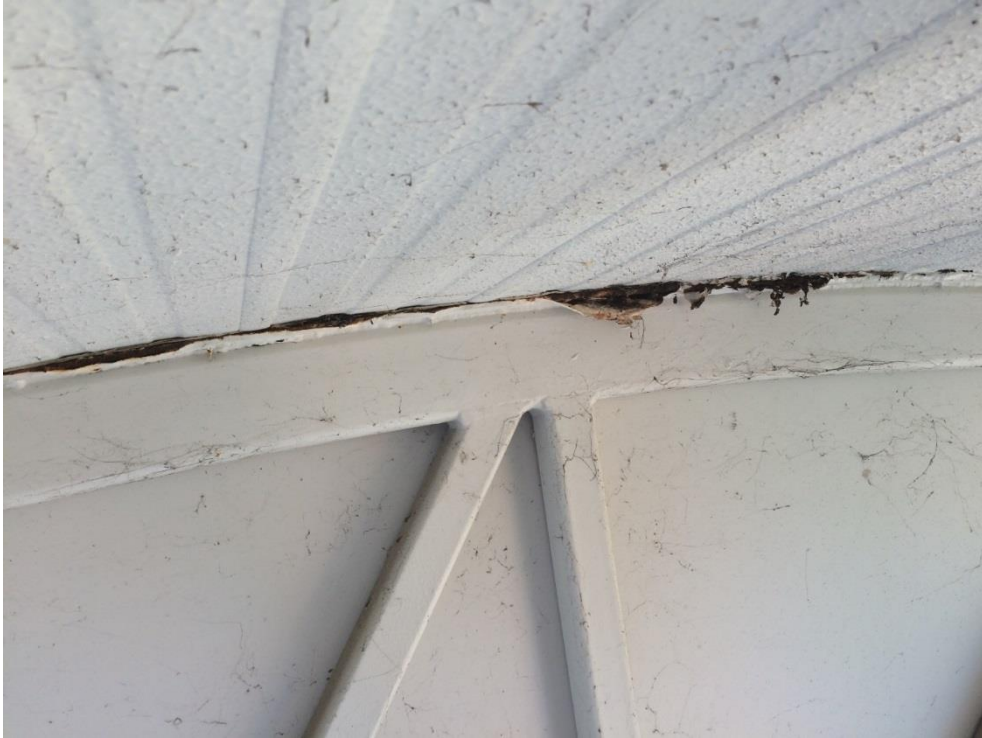
Photo 031 - Heavy corrosion to top plate

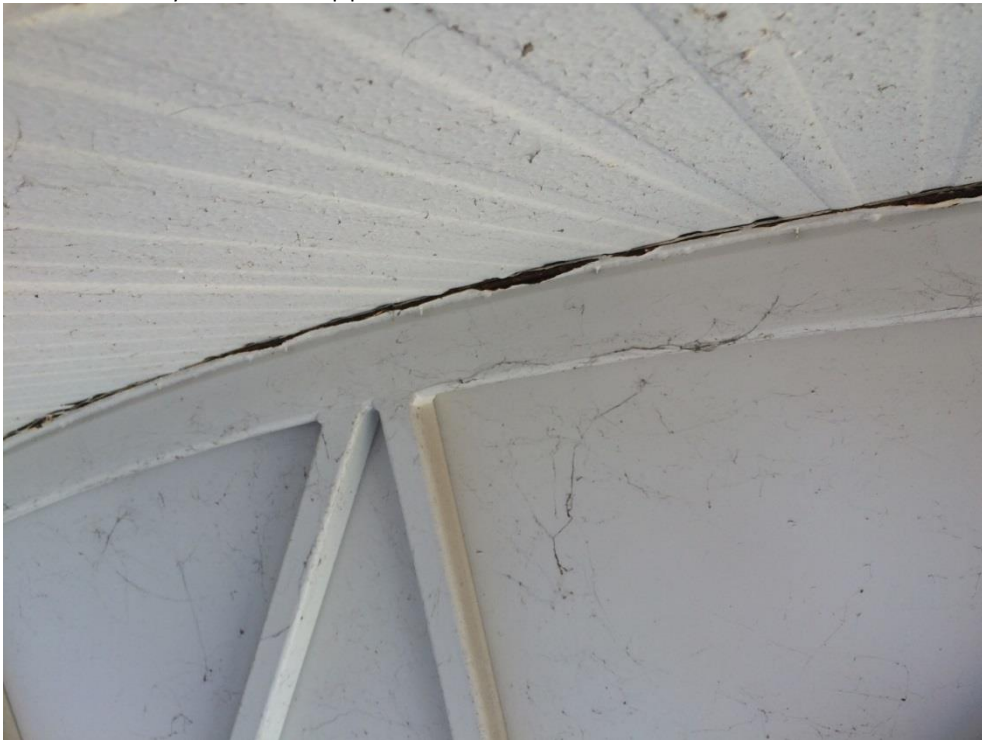
Photo 032 - Heavy corrosion to top plate

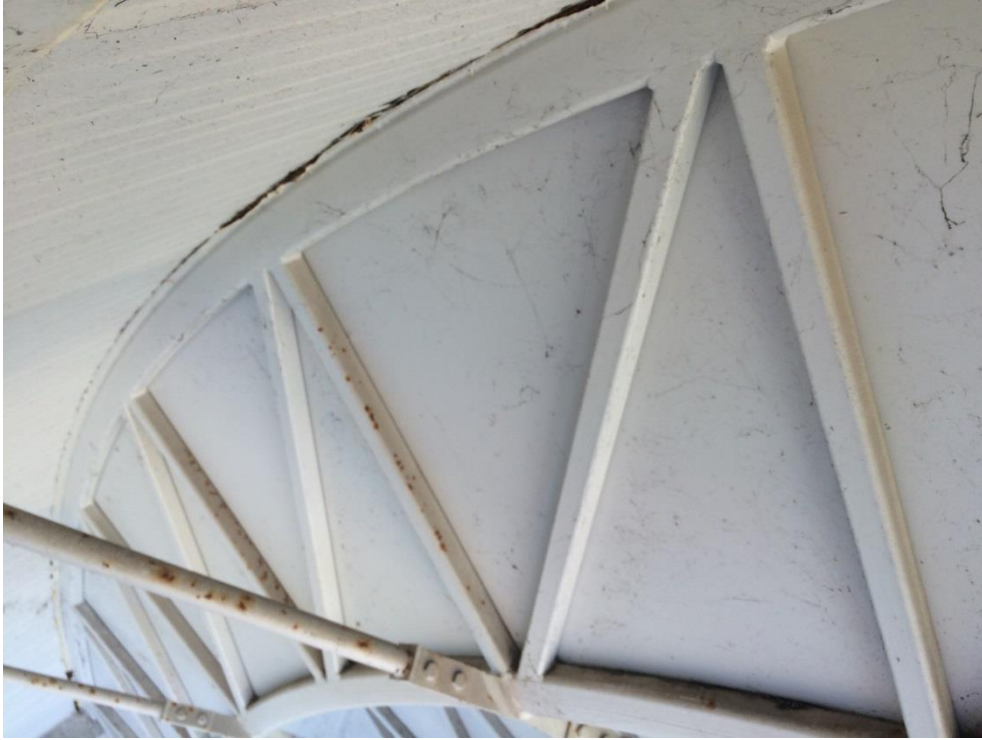
Photo 033 - Minor corrosion to struts
