Music Bowl Structural Assessment

24 November 2014

R14265

Prepared for Rockhampton Regional Council

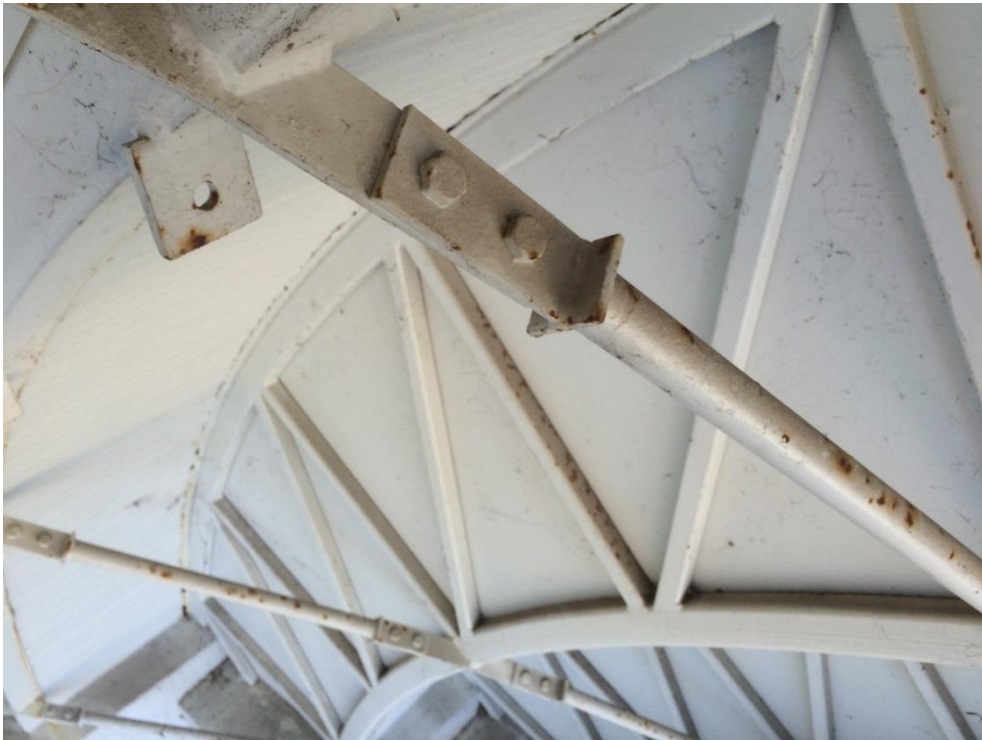
Photo 034 - Minor corrosion to struts

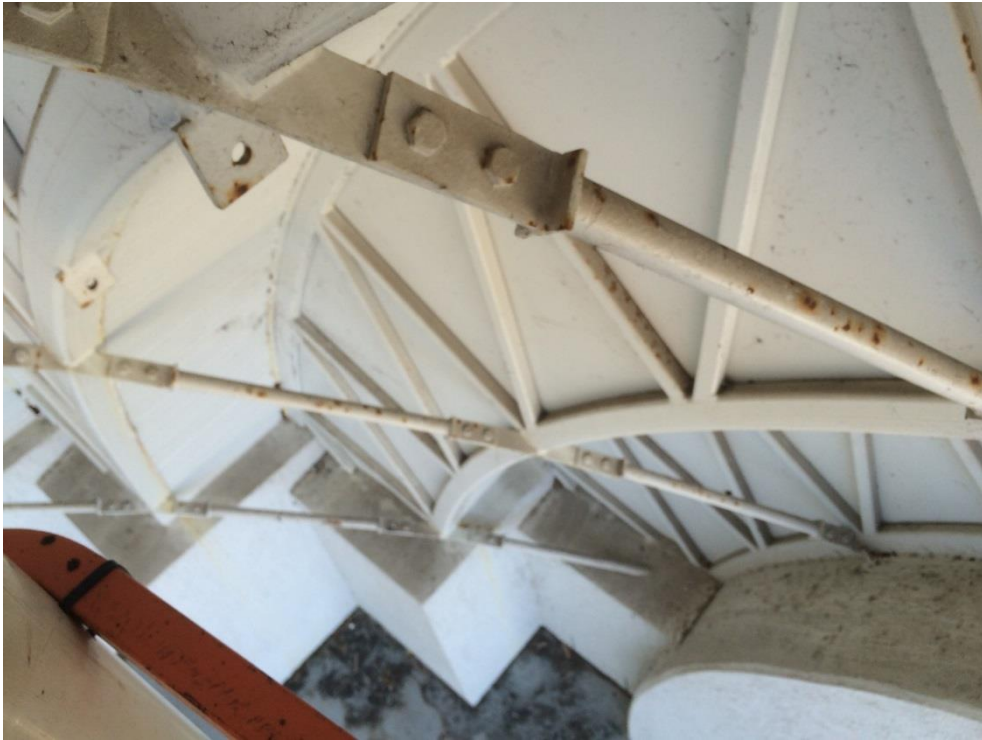
Photo 035 - Minor corrosion to struts

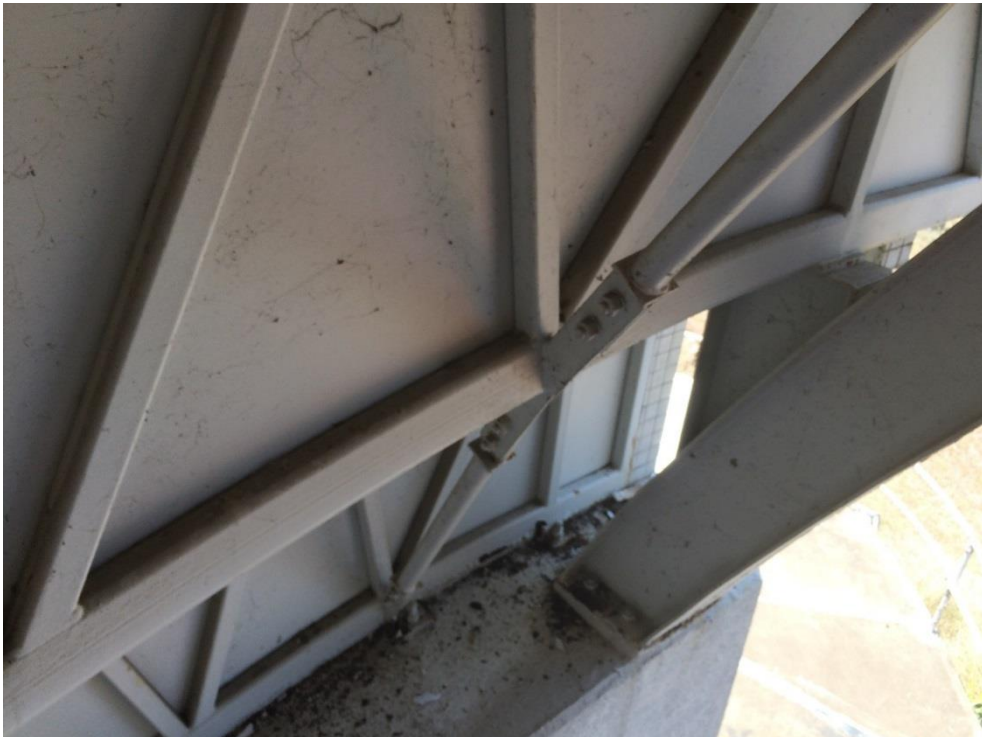
Photo 036 - Minor corrosion to struts

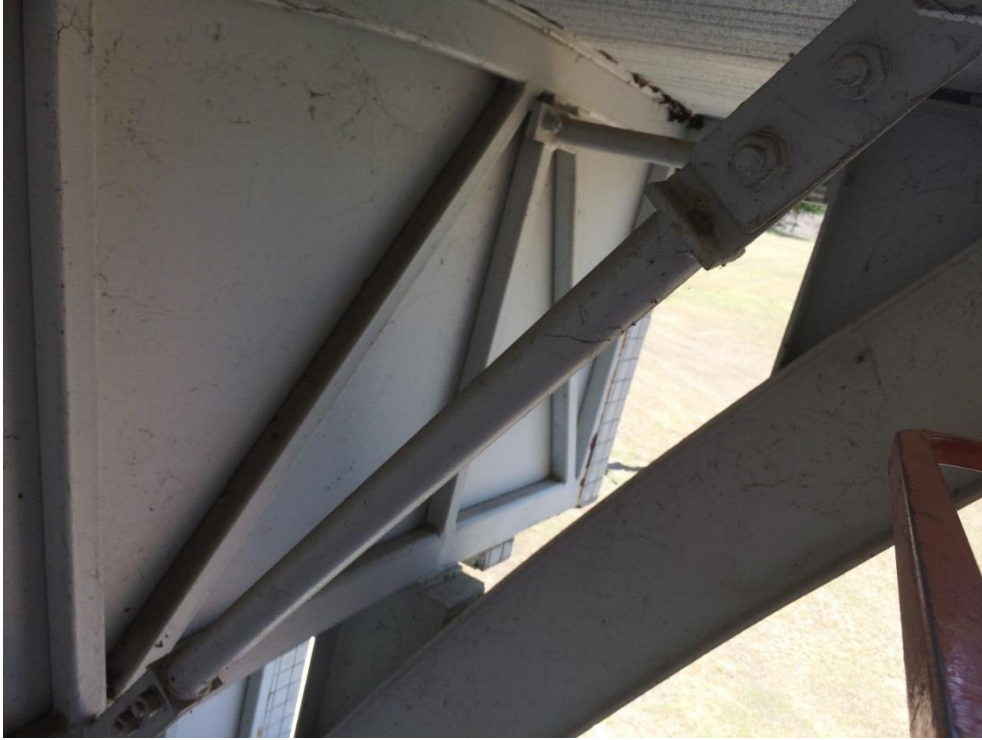
Photo 037 - Minor corrosion to struts

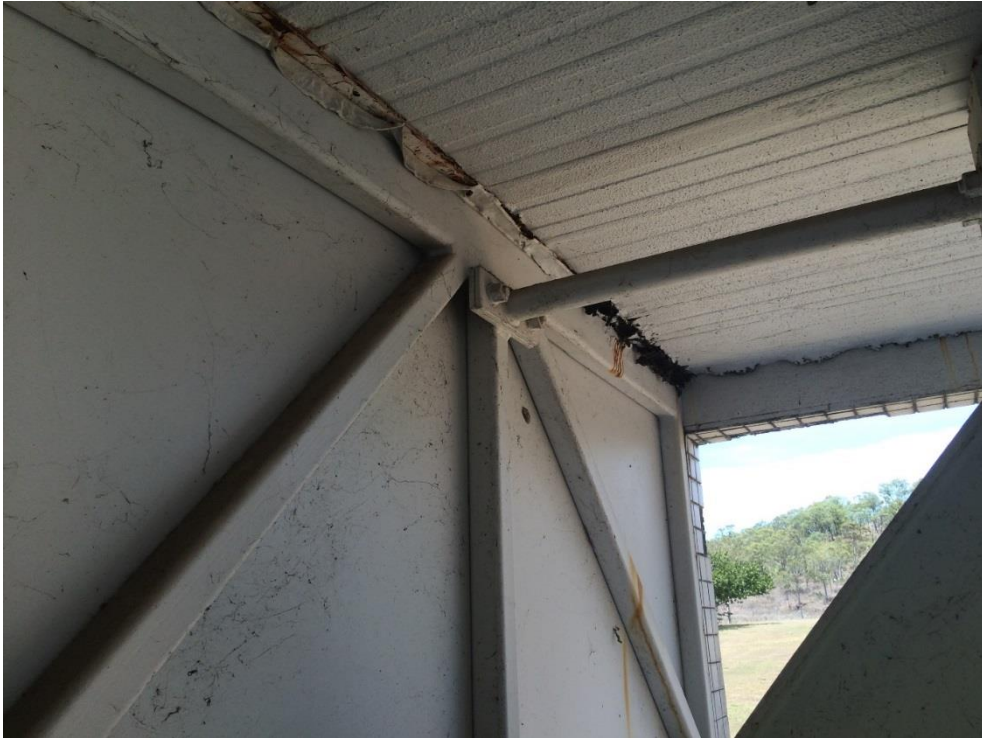
Photo 038 - Heavy corrosion to top plate

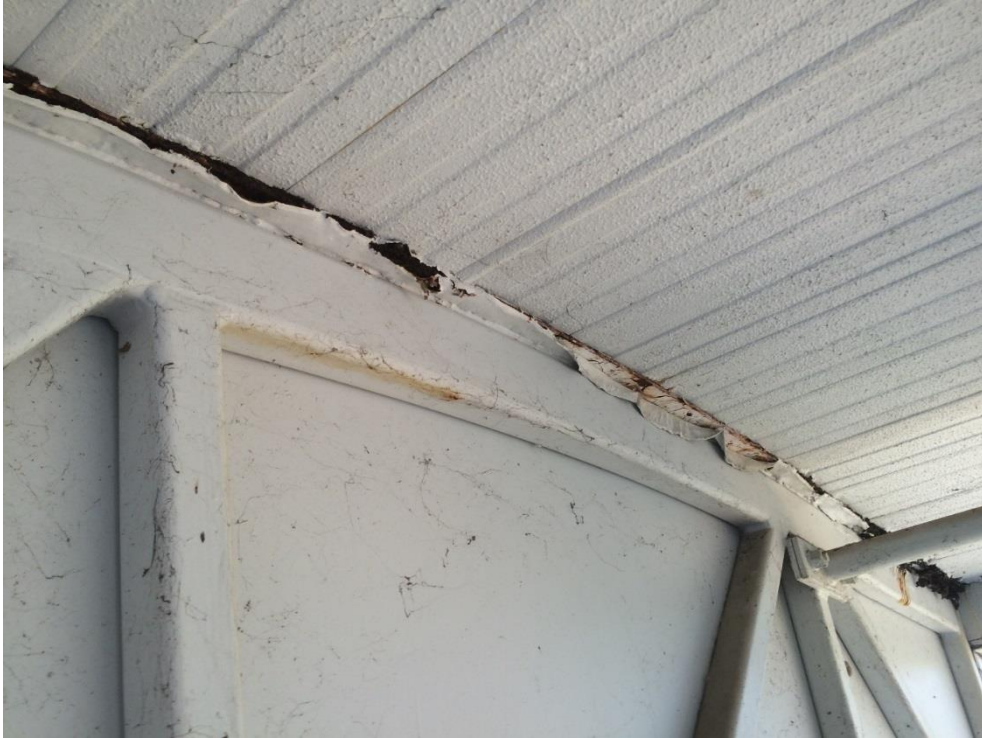
Photo 039 - Heavy corrosion to top plate

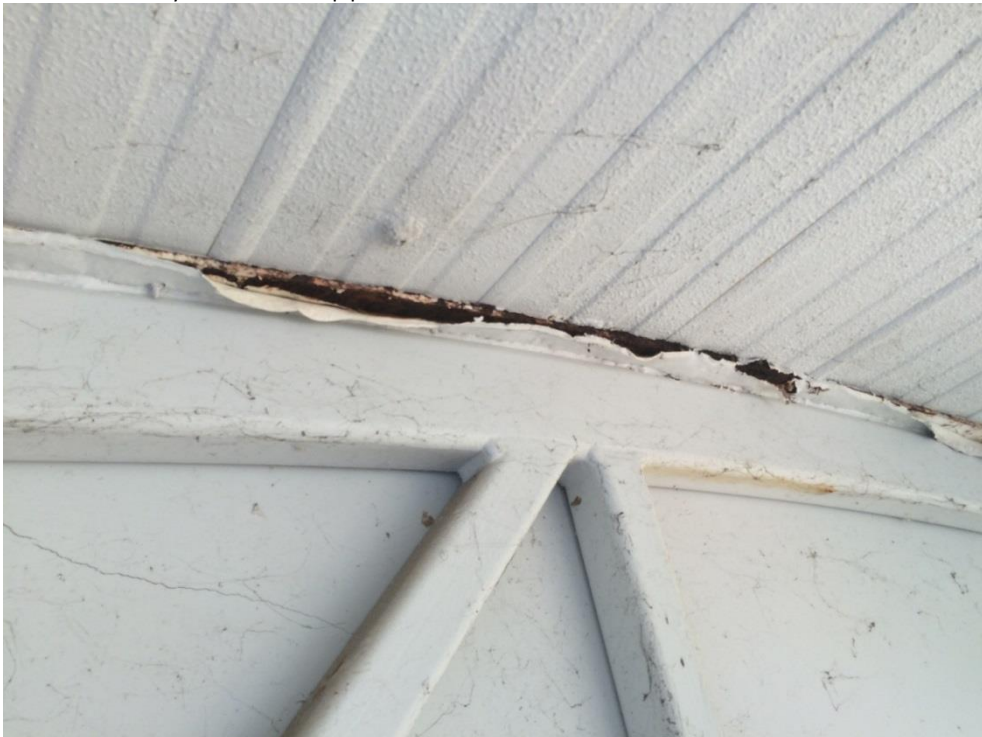
Photo 040 - Heavy corrosion to top plate

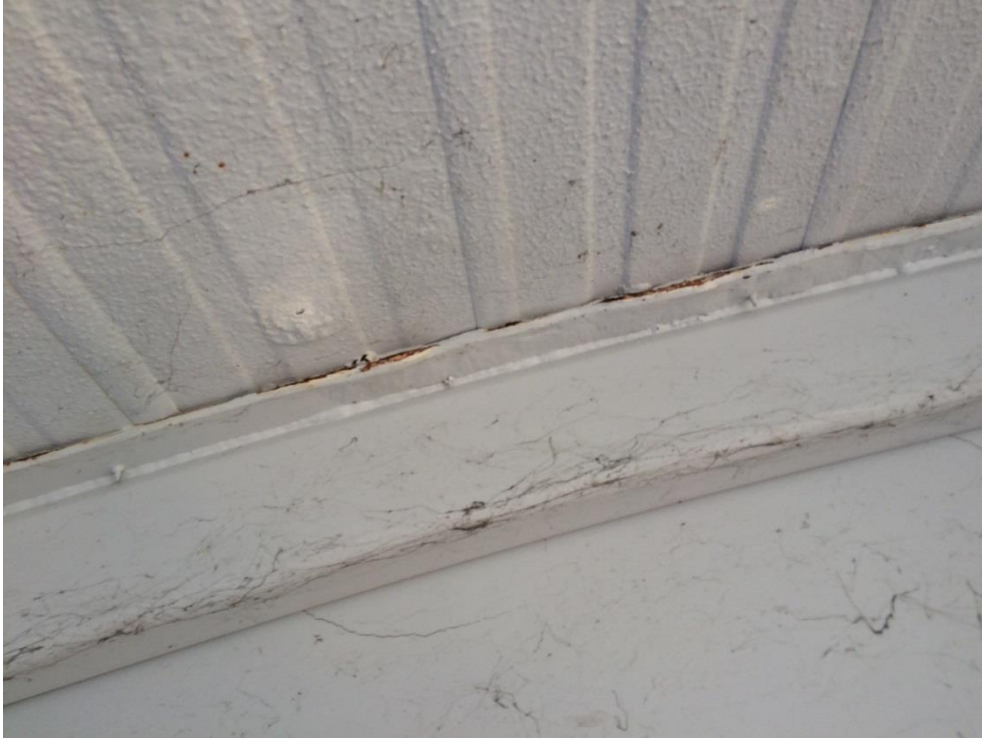
Photo 041 - Heavy corrosion to top plate

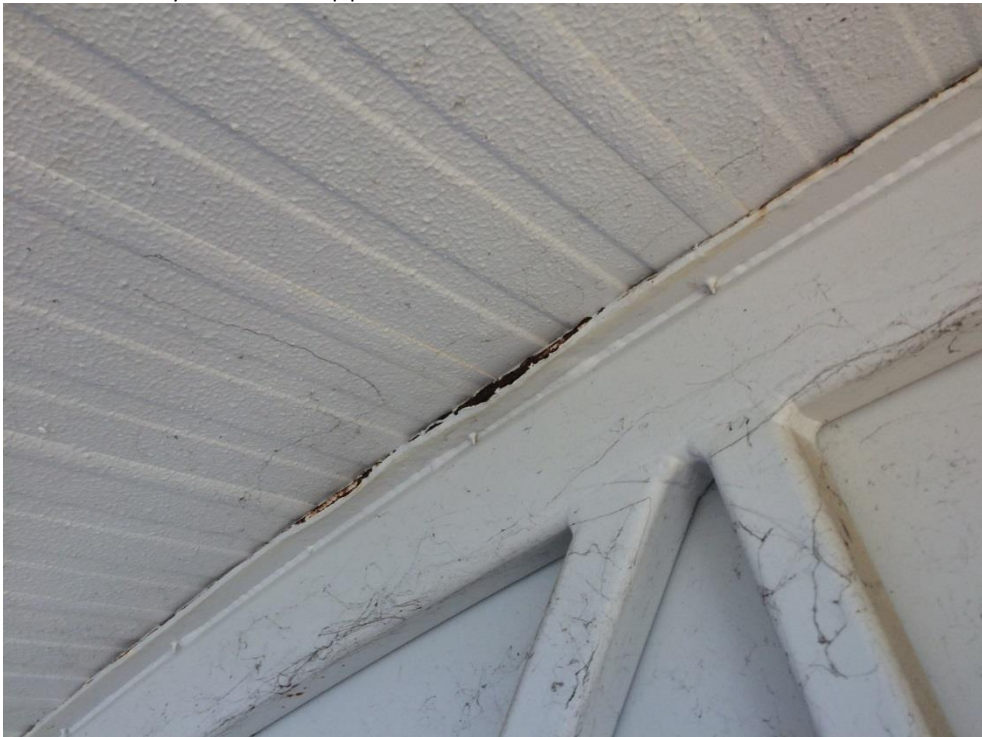
Photo 042 - Heavy corrosion to top plate

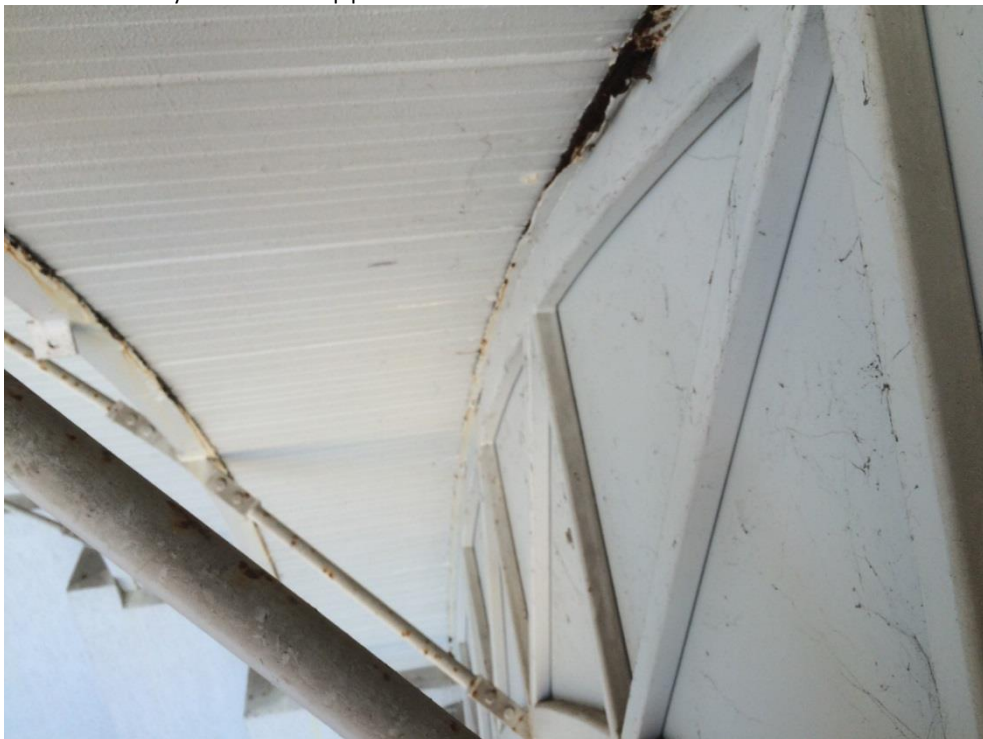
Photo 044 - Heavy corrosion to top plate

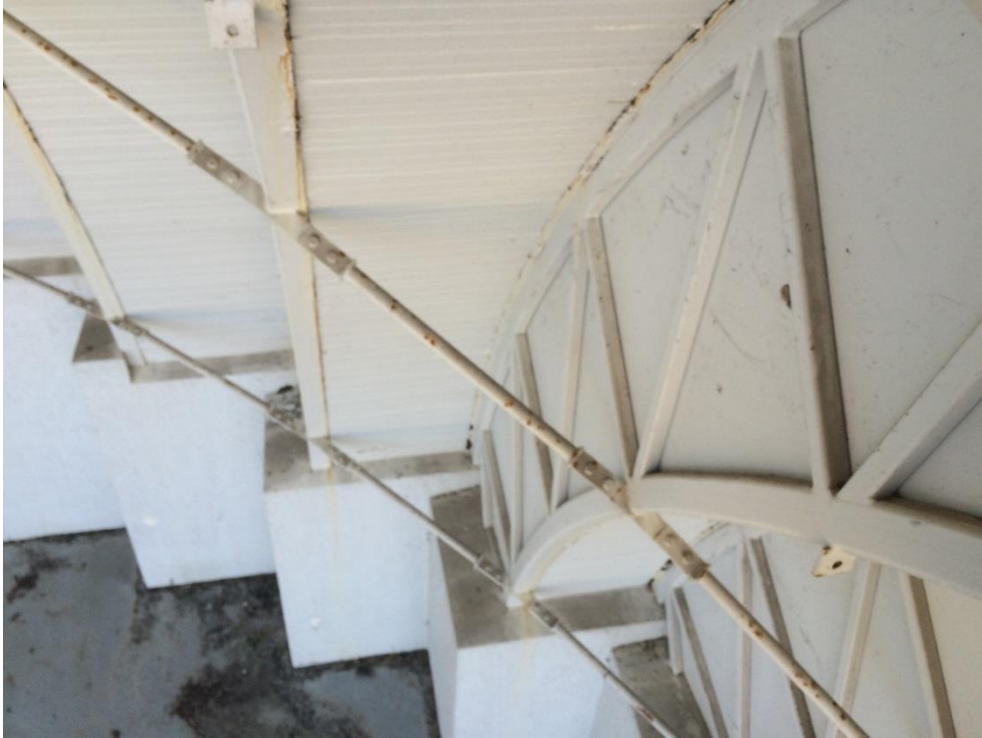
Photo 045 - Minor corrosion to struts

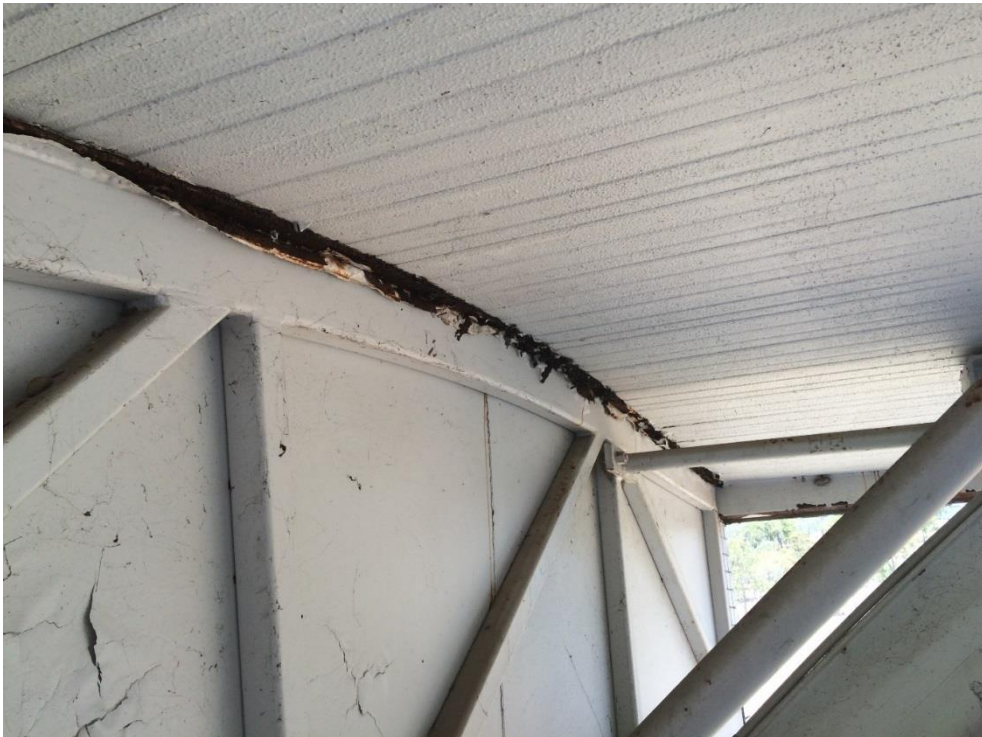
Photo 046 - Heavy corrosion to top plate

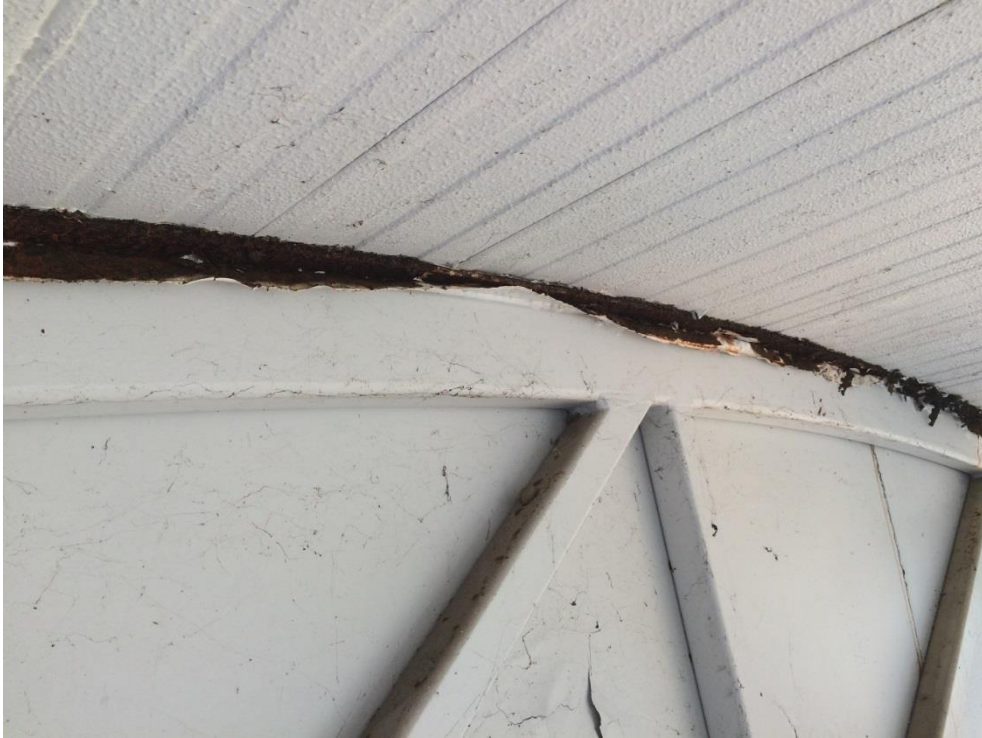
Photo 047 - Heavy corrosion to top plate

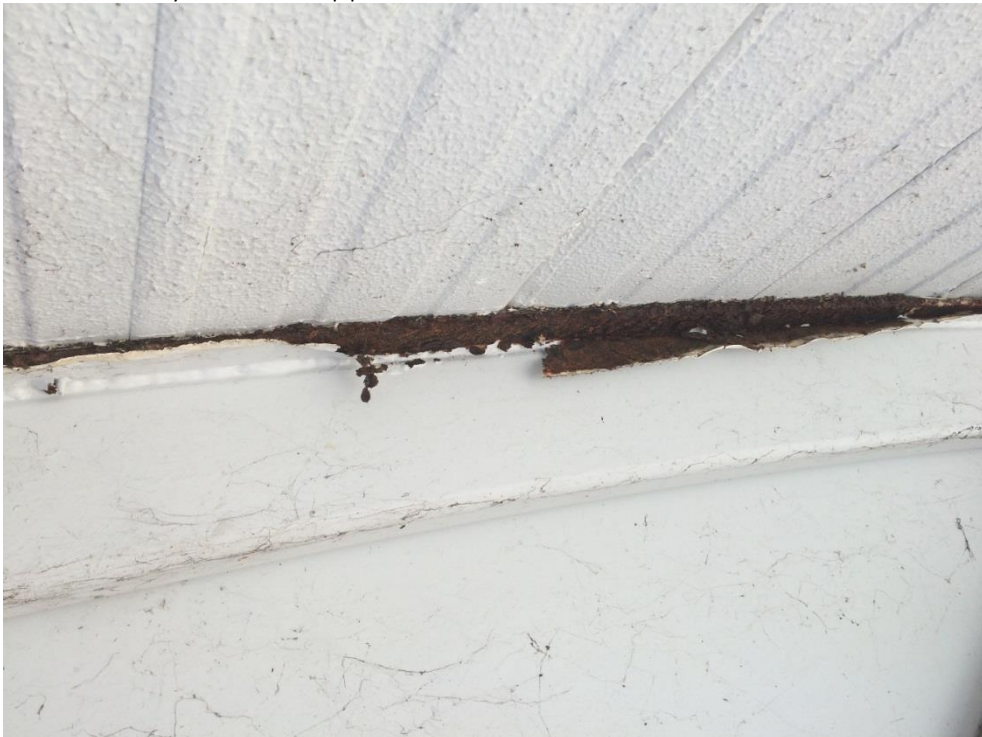
Photo 048 - Heavy corrosion to top plate

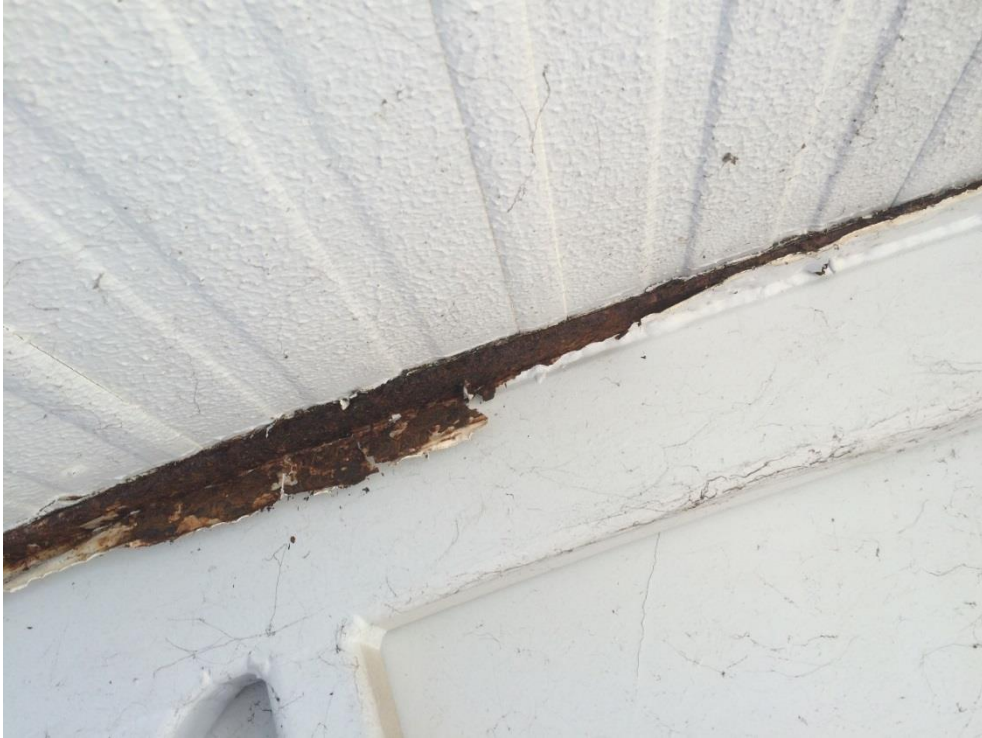
Photo 049 - Heavy corrosion to top plate

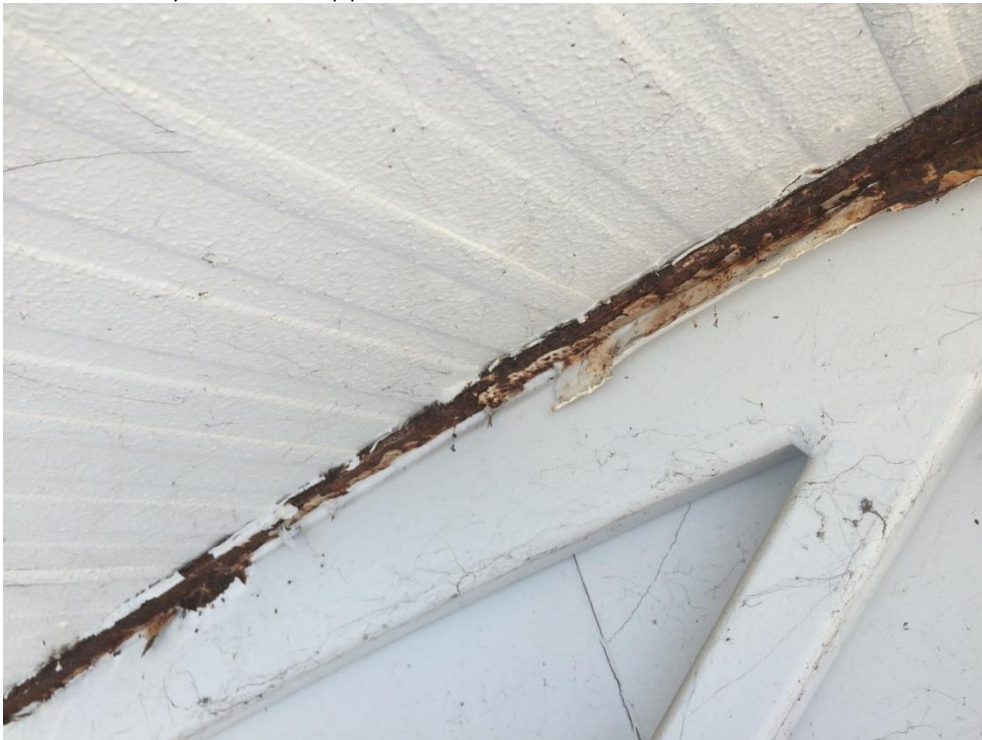
Photo 050 - Heavy corrosion to top plate

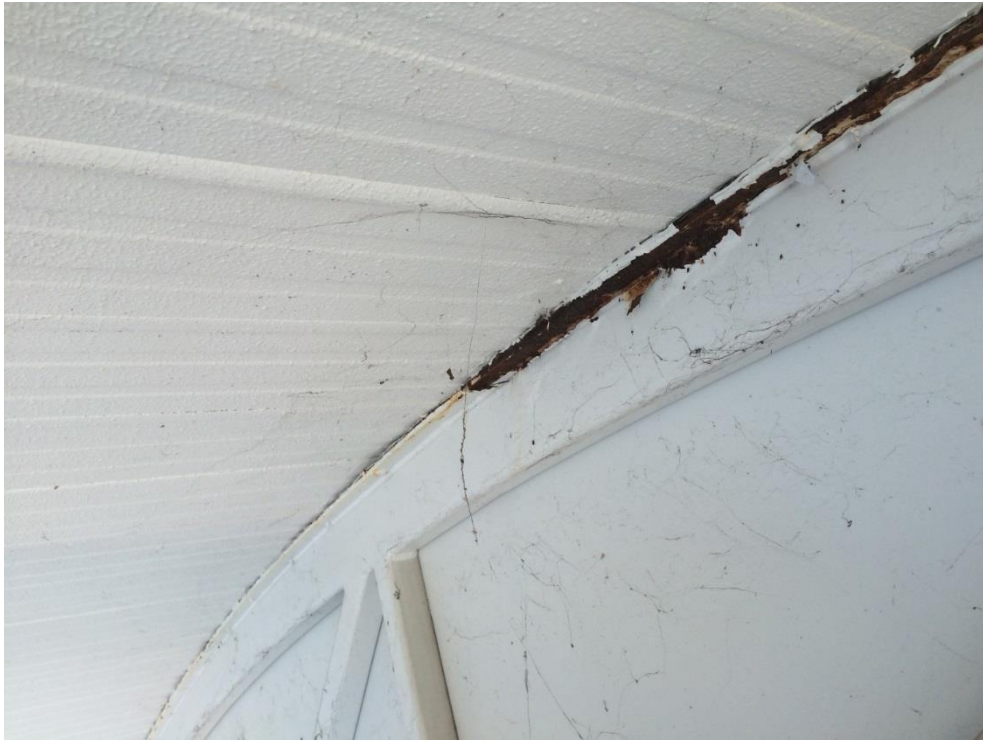
Photo 051 - Heavy corrosion to top plate

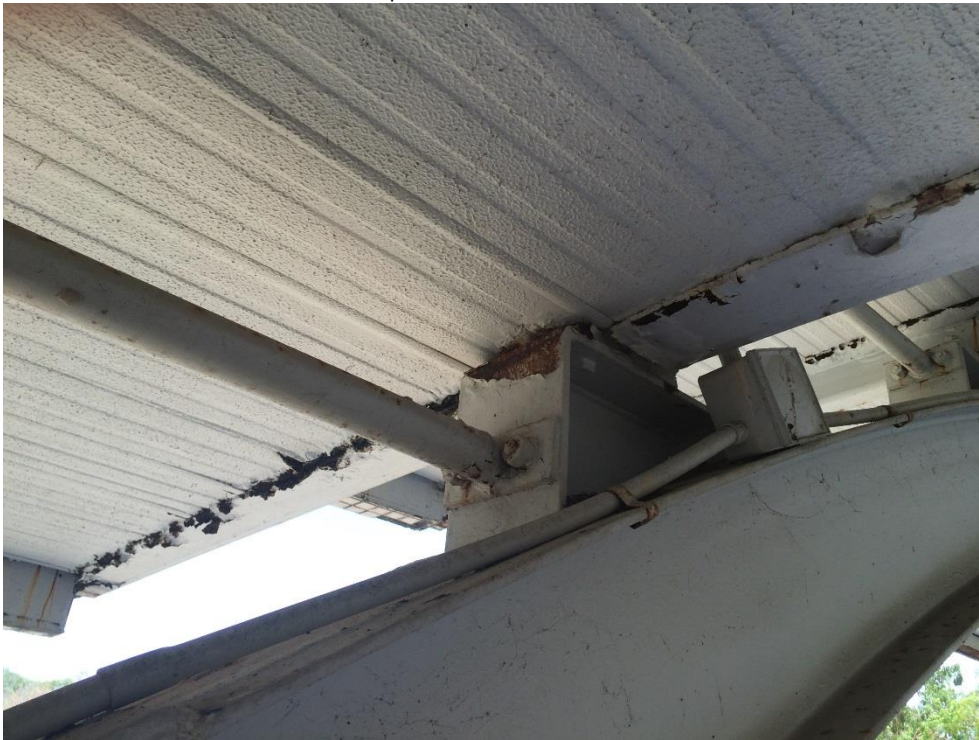
Photo 066 - Heavy corrosion to bottom plate

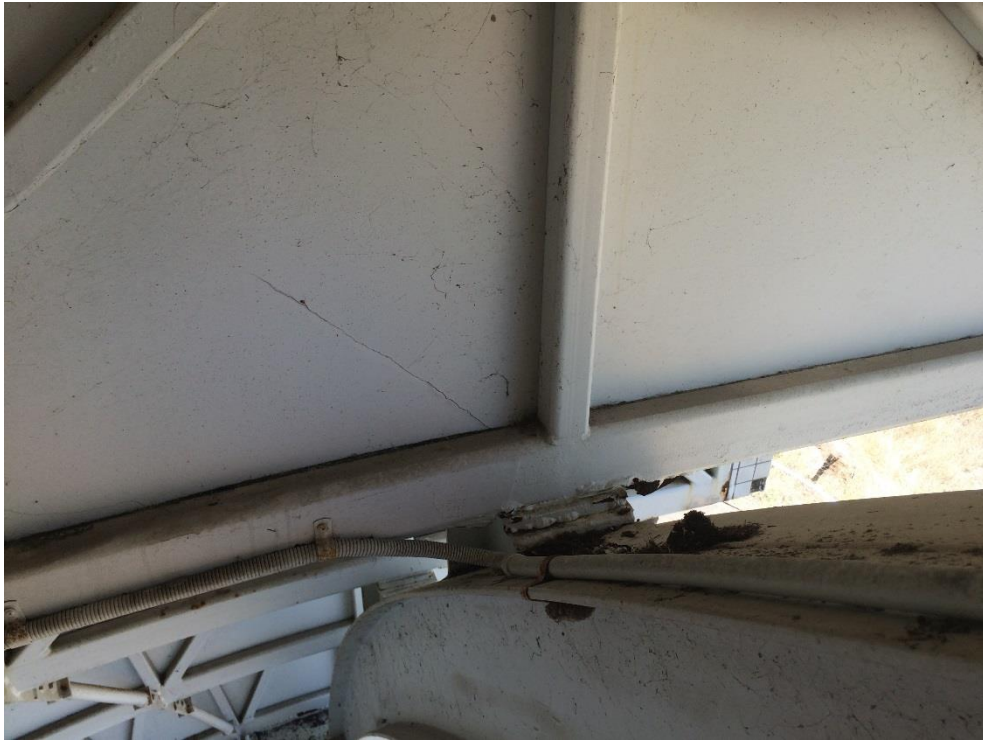
Photo 067 - Heavy corrosion to bottom plate

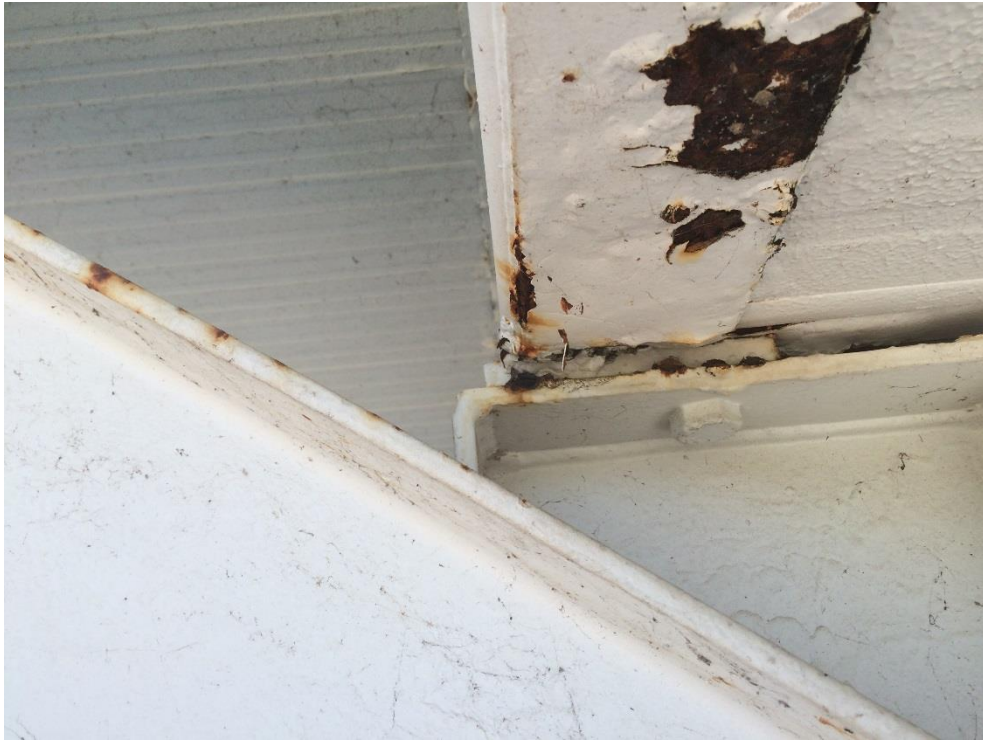
Photo 068 - Heavy corrosion to bottom plate

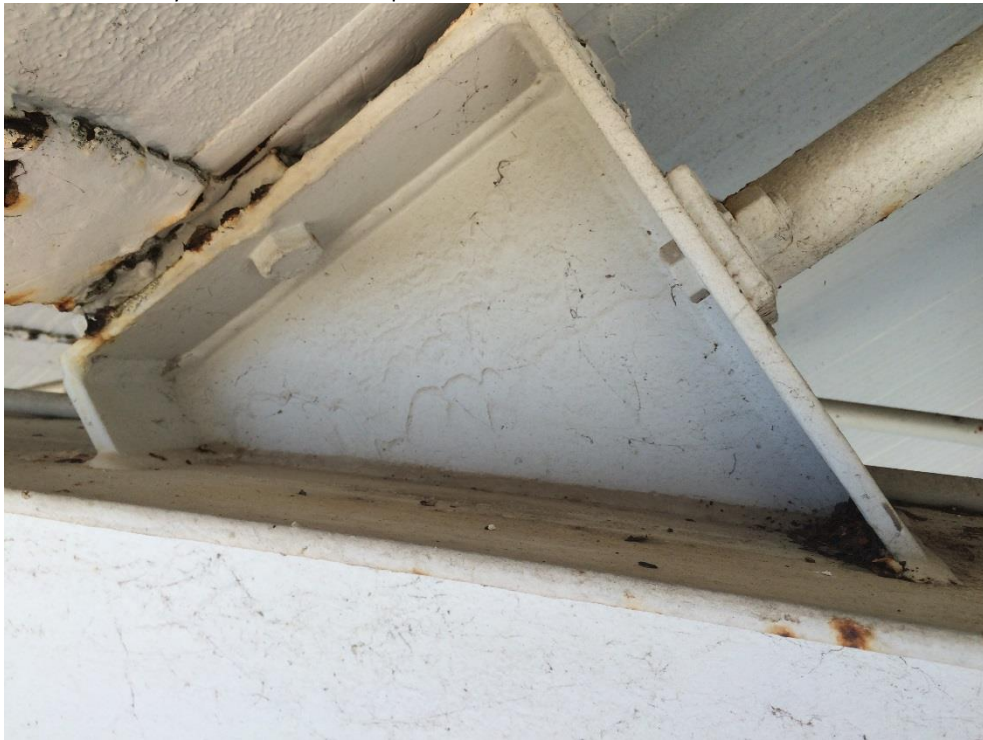
Photo 069 - Minor corrosion to stub

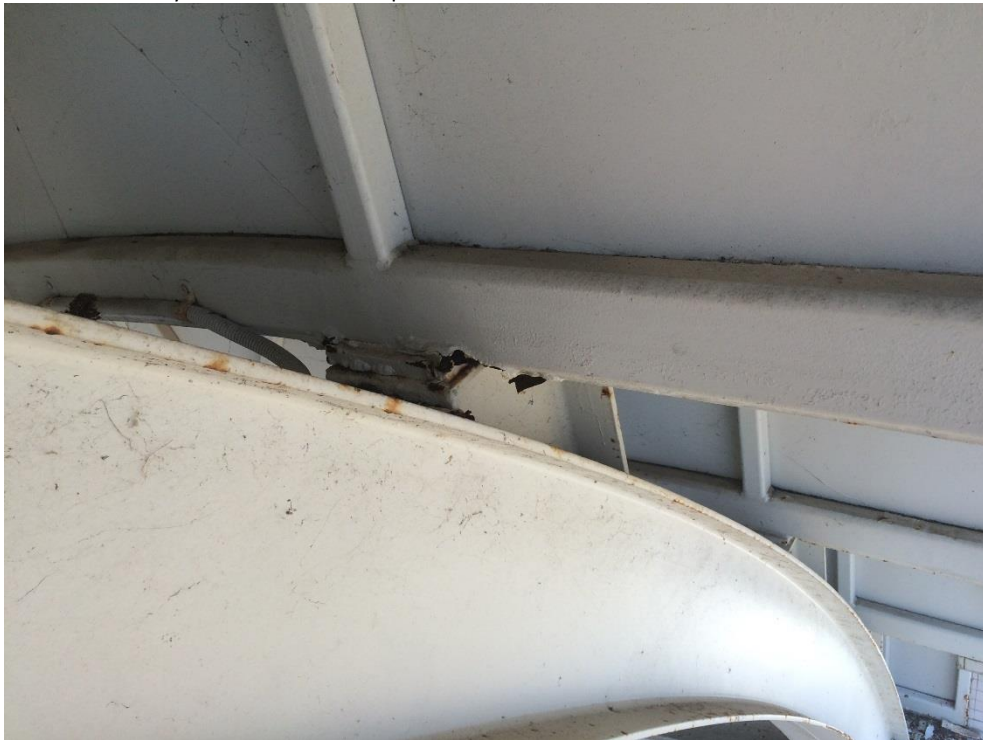
Photo 071 - Minor corrosion to stub

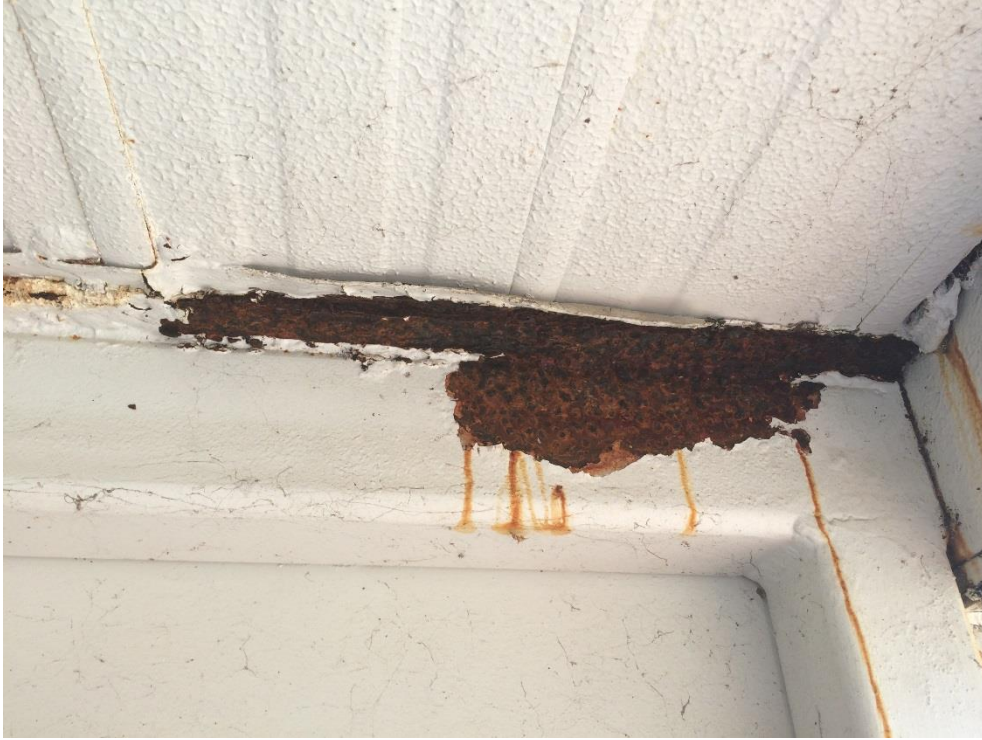
Photo 076 - Heavy corrosion to top plate and top chord

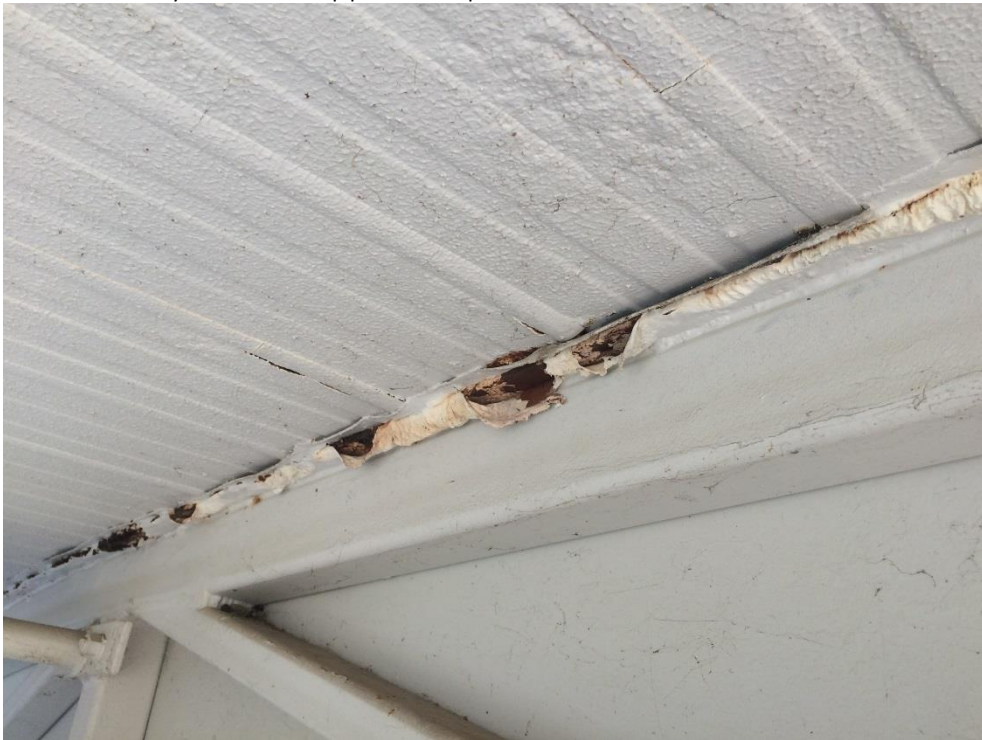
Photo 077 - Heavy corrosion to top plate all along

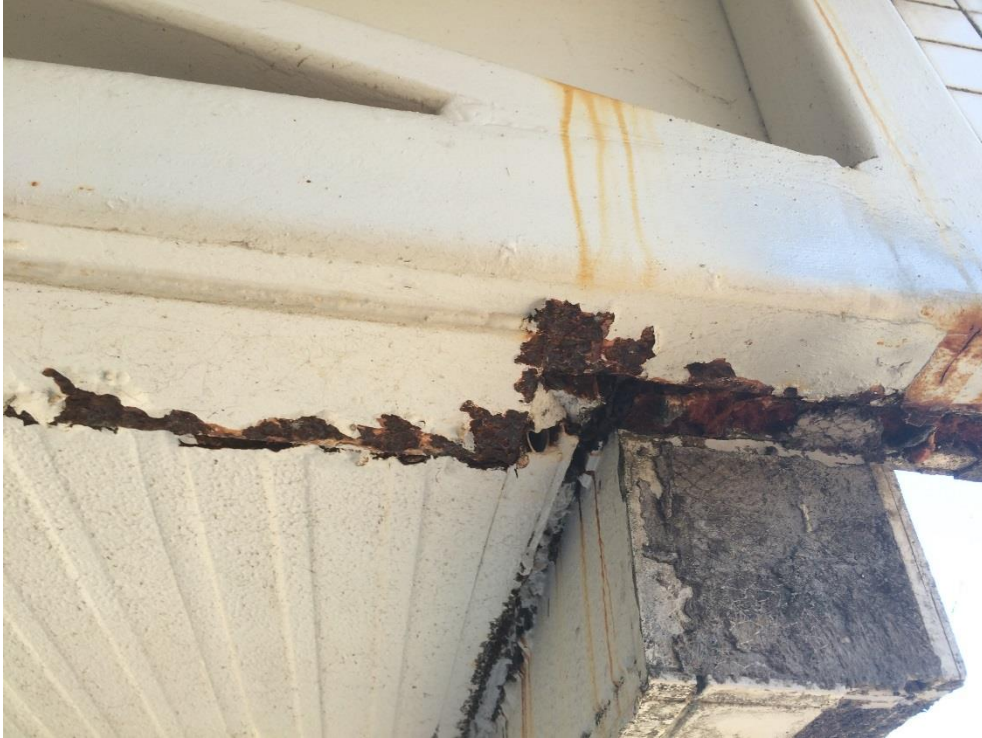
Photo 078 - Heavy corrosion to truss bottom chord at the exterior face of the soundshell

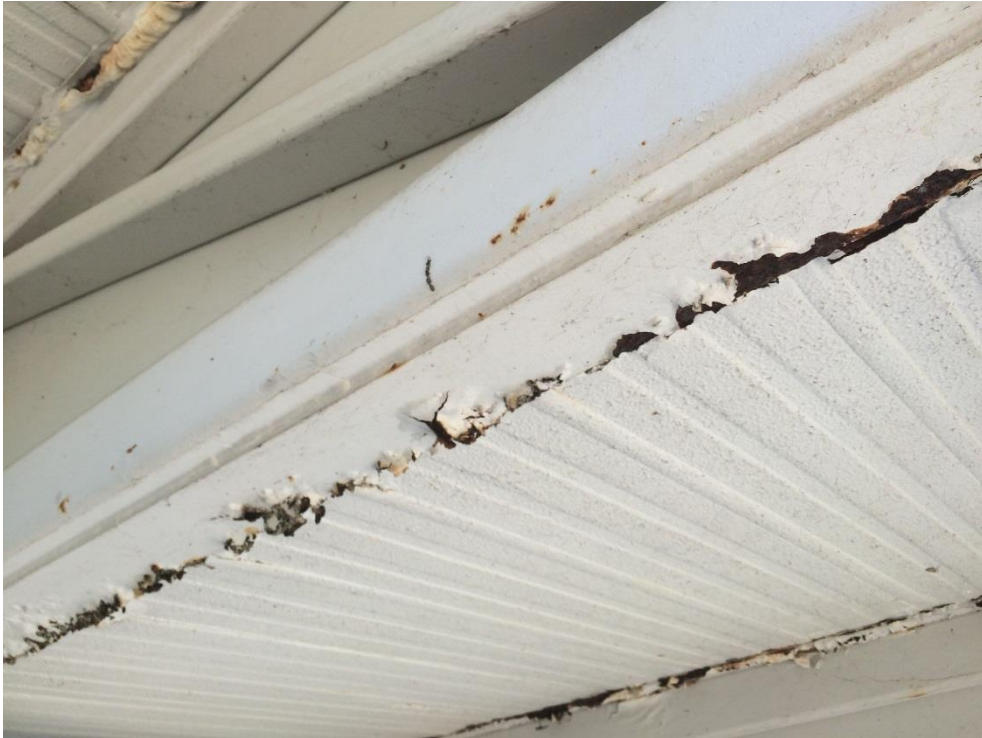
Photo 079 - Minor corrosion to bottom plate

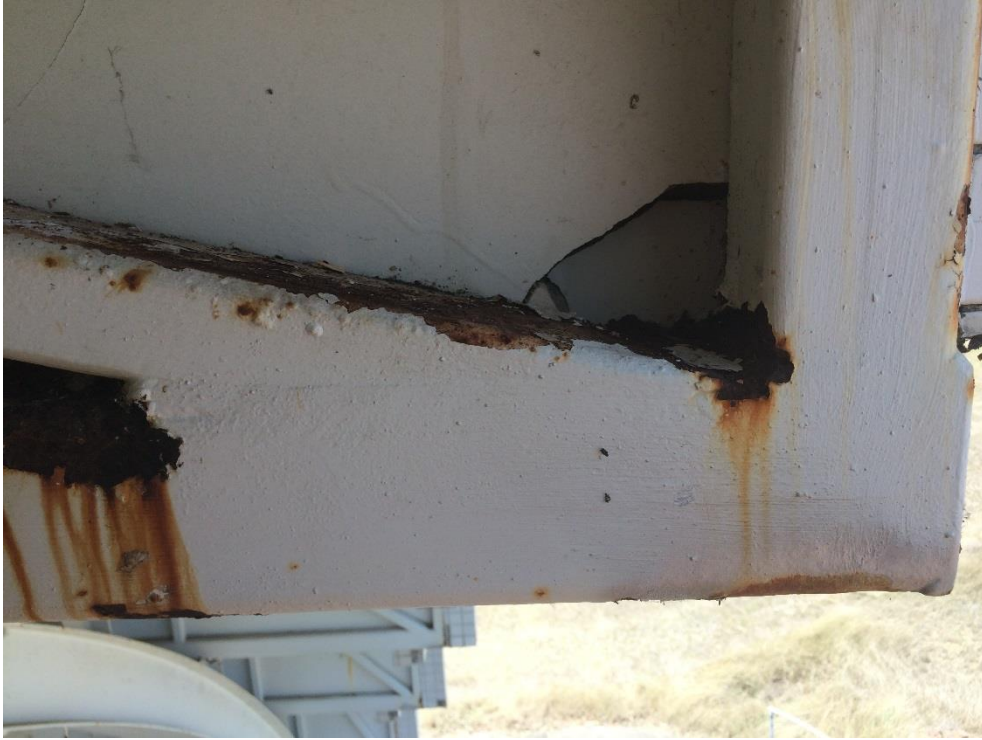
Photo 083 - Heavy corrosion to truss bottom chord and web at the exterior face of the soundshell

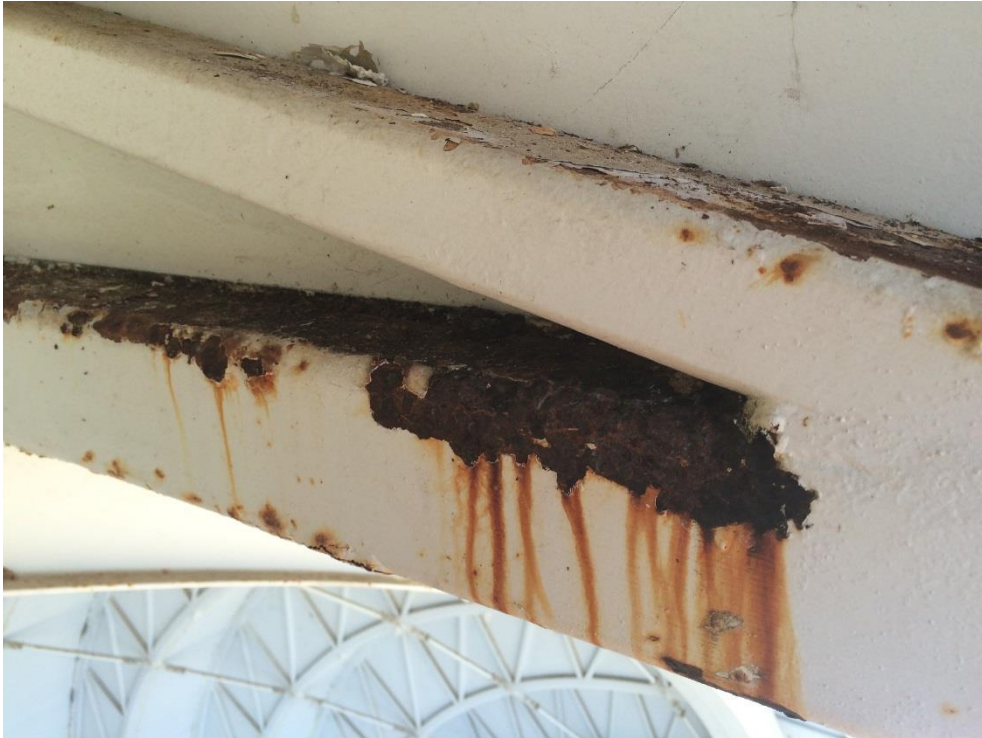
Photo 084 - Heavy corrosion to truss bottom chord at the exterior face of the soundshell

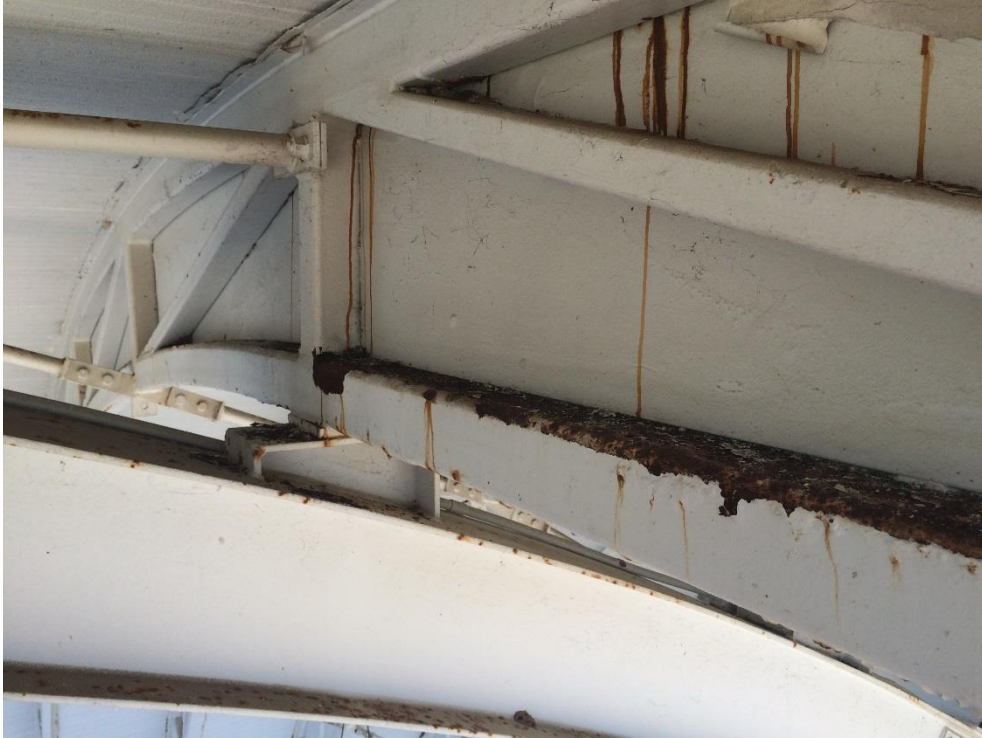
Photo 085 - Heavy corrosion to truss bottom chord

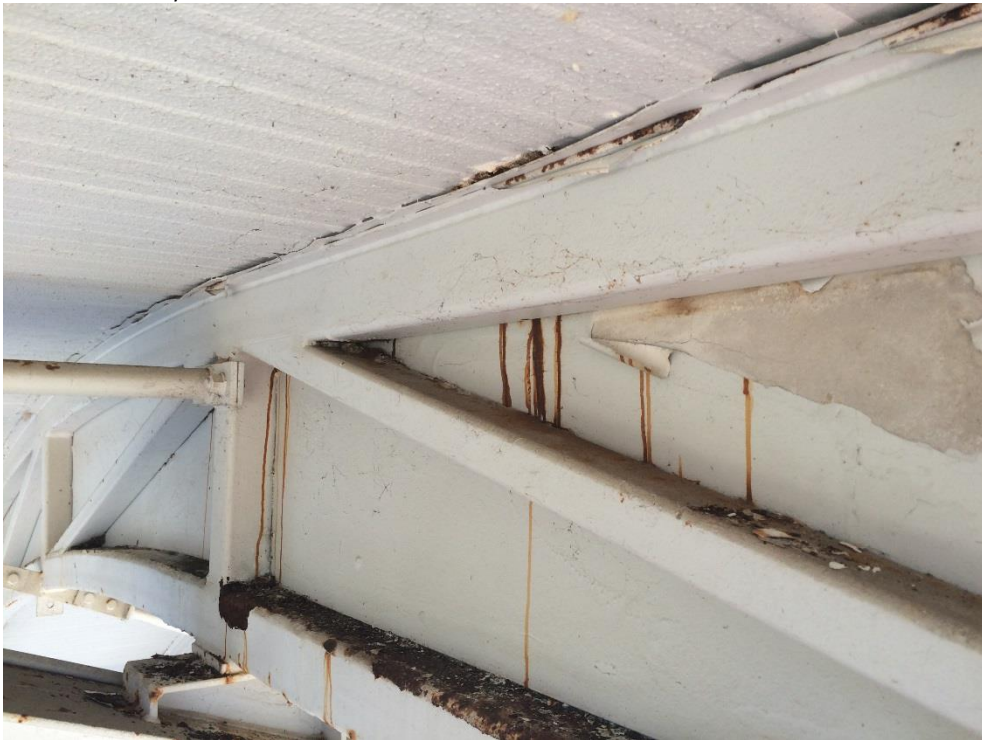
Photo 086 - Heavy corrosion to truss bottom chord

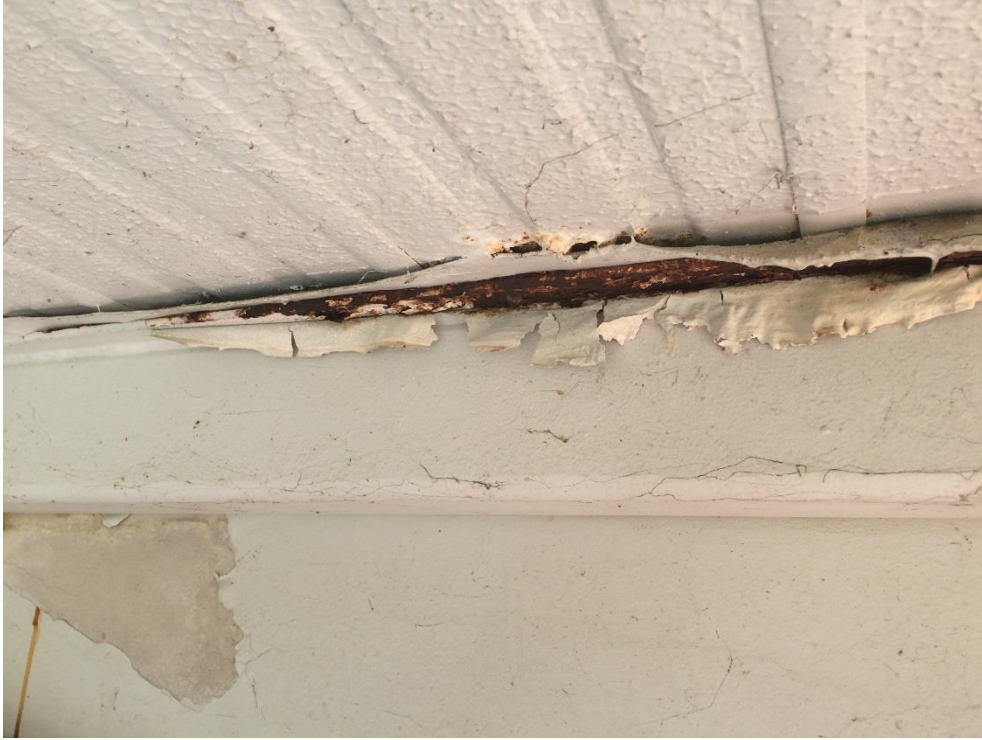
Photo 087 - Heavy corrosion to top plate
