Music Bowl Structural Assessment

24 November 2014

R14265

Prepared for Rockhampton Regional Council

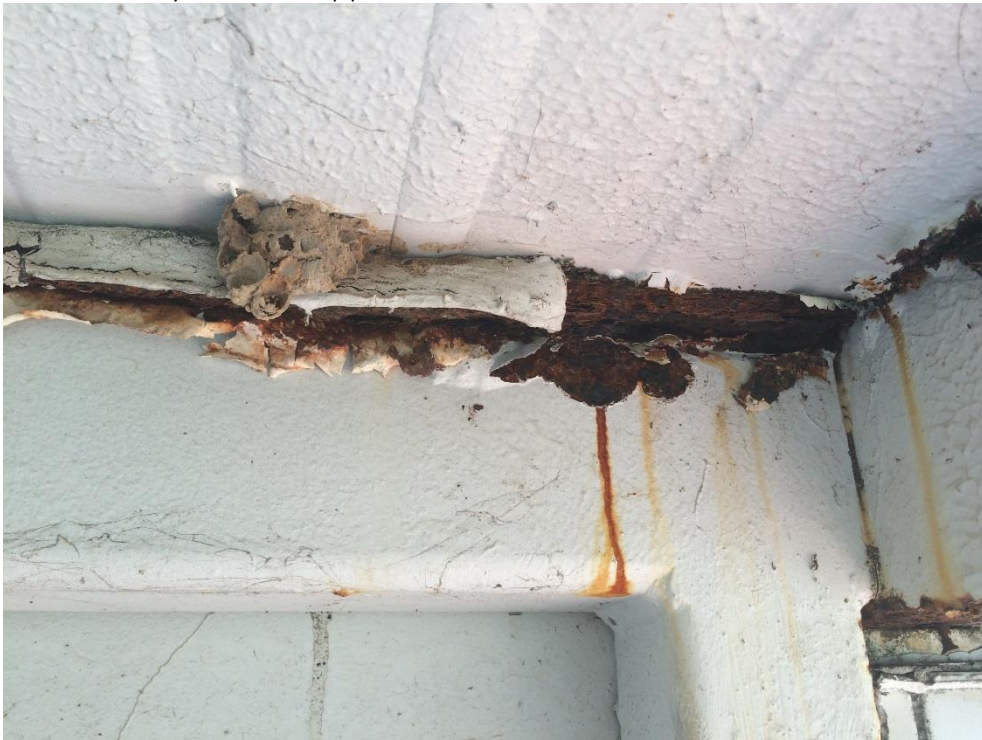
Photo 088 - Heavy corrosion to top plate

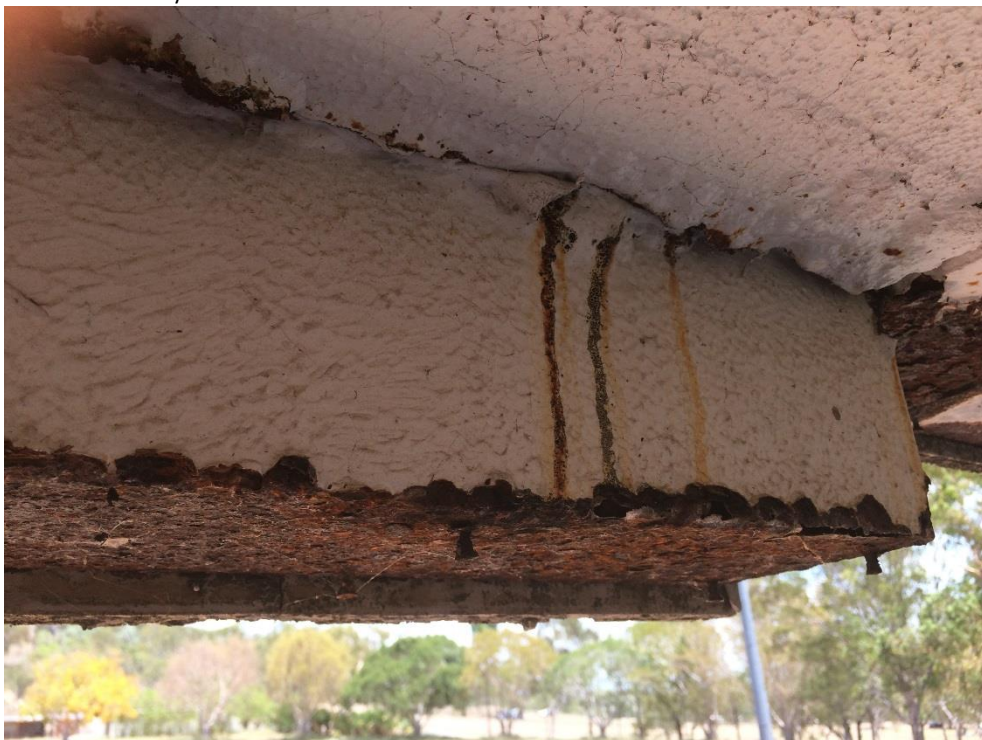
Photo 096 - Heavy corrosion to fascia

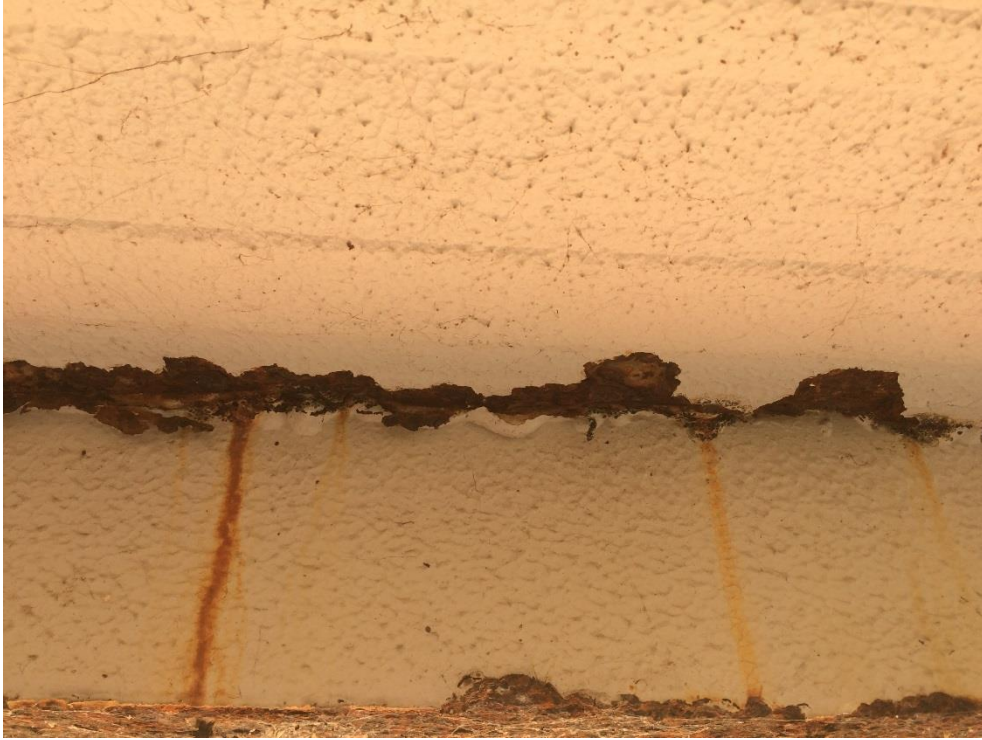
Photo 097 - Minor corrosion to metal formwork

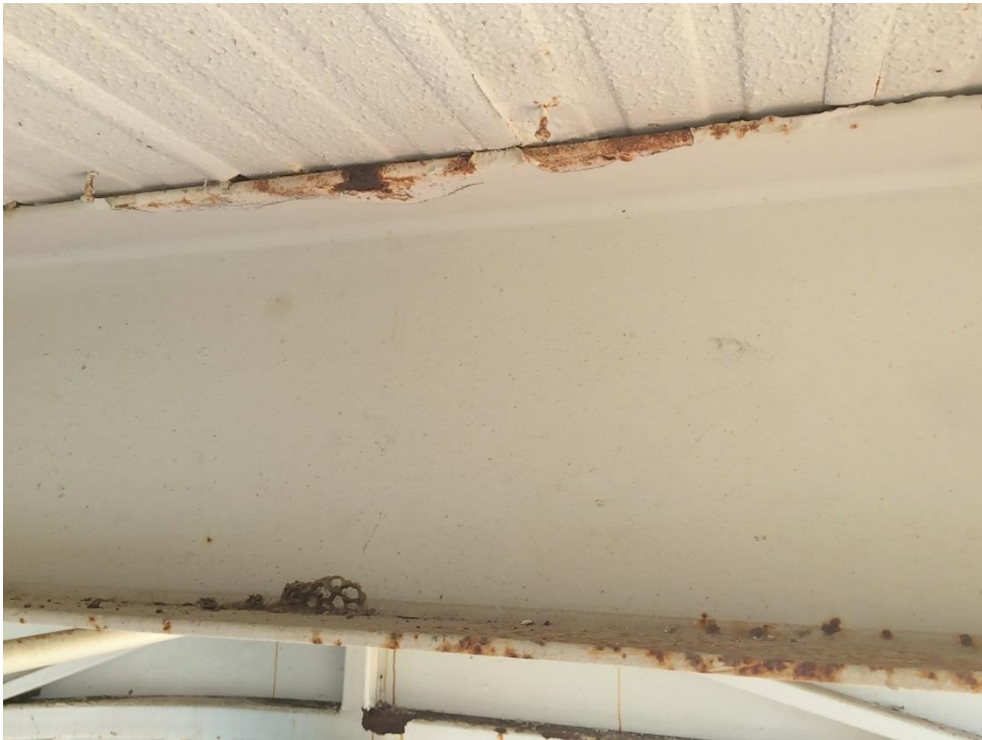
Photo 100 - Minor corrosion to roof beam

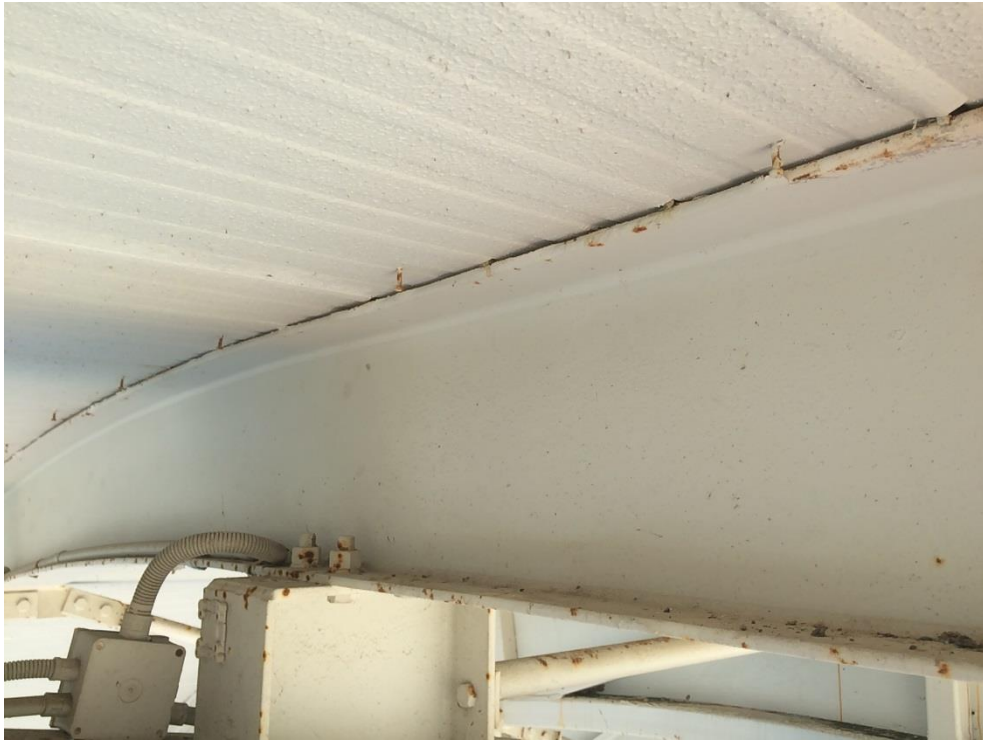
Photo 101 - Minor corrosion to roof beam

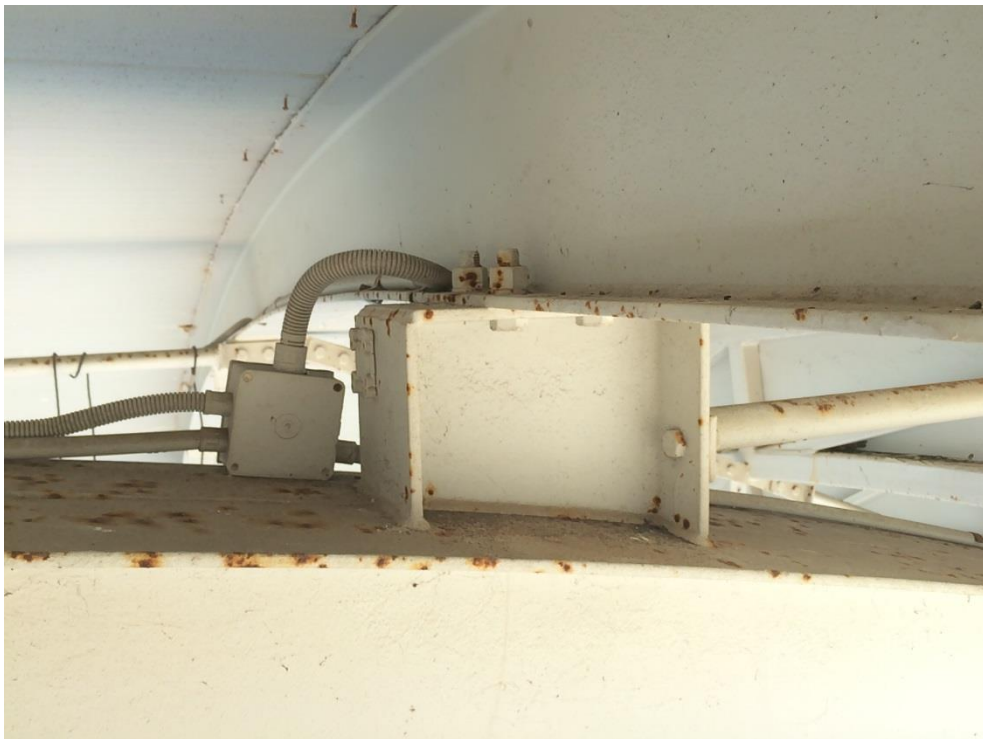
Photo 102 - Minor corrosion to roof beam

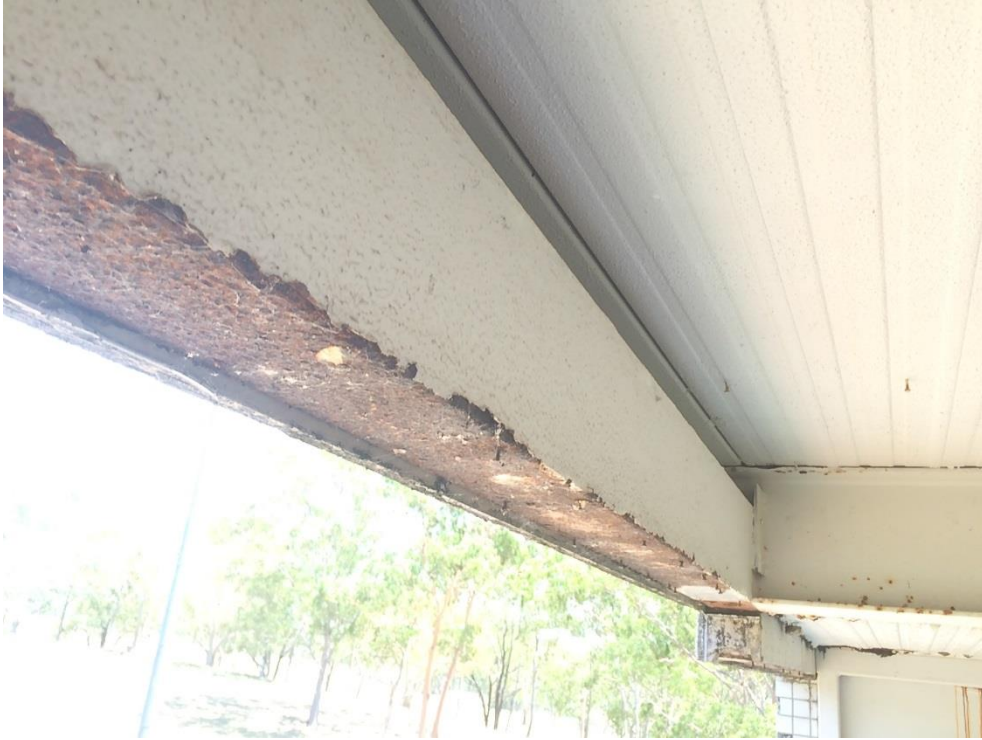
Photo 105 - Heavy corrosion to fascia

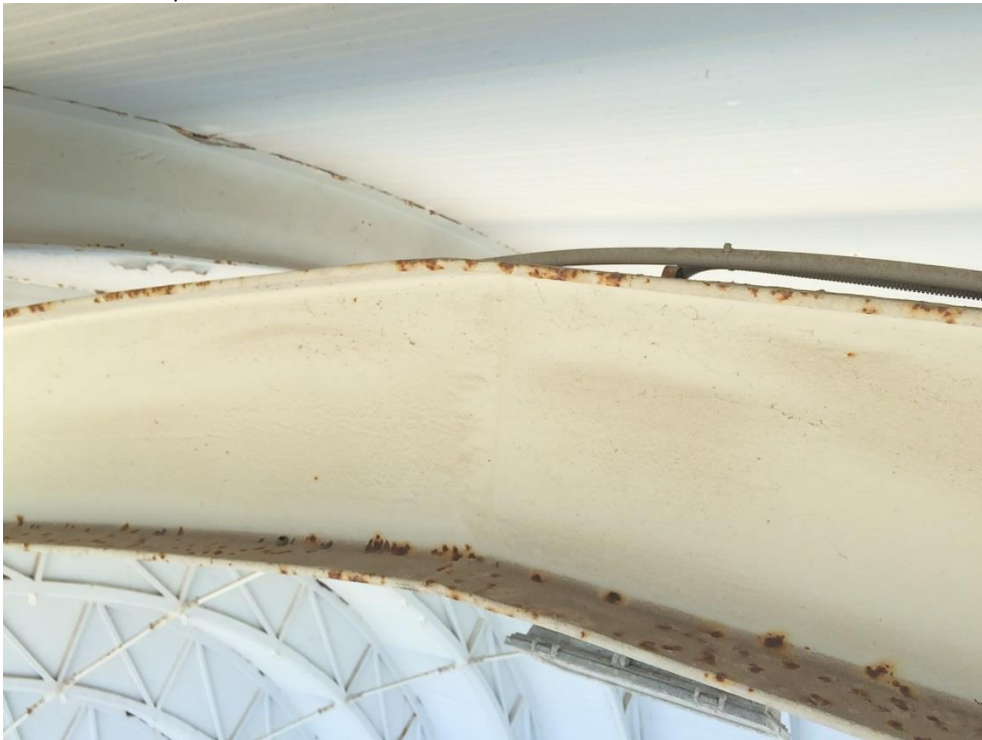
Photo 106 - Minor corrosion to main arch

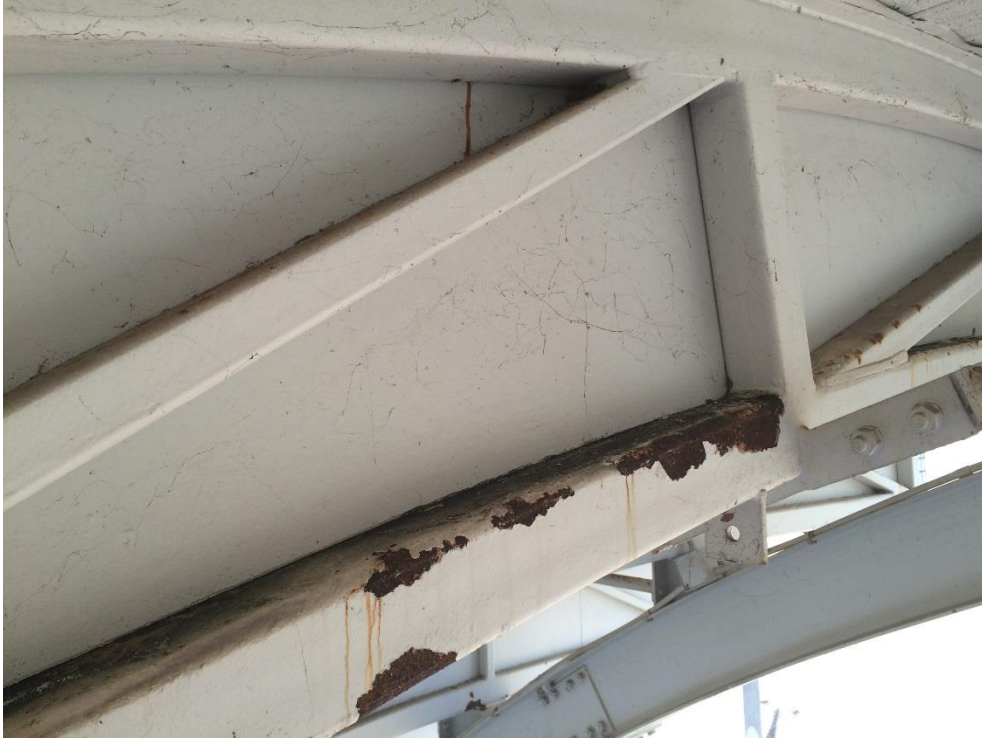
Photo 107 - Minor corrosion to bottom chord

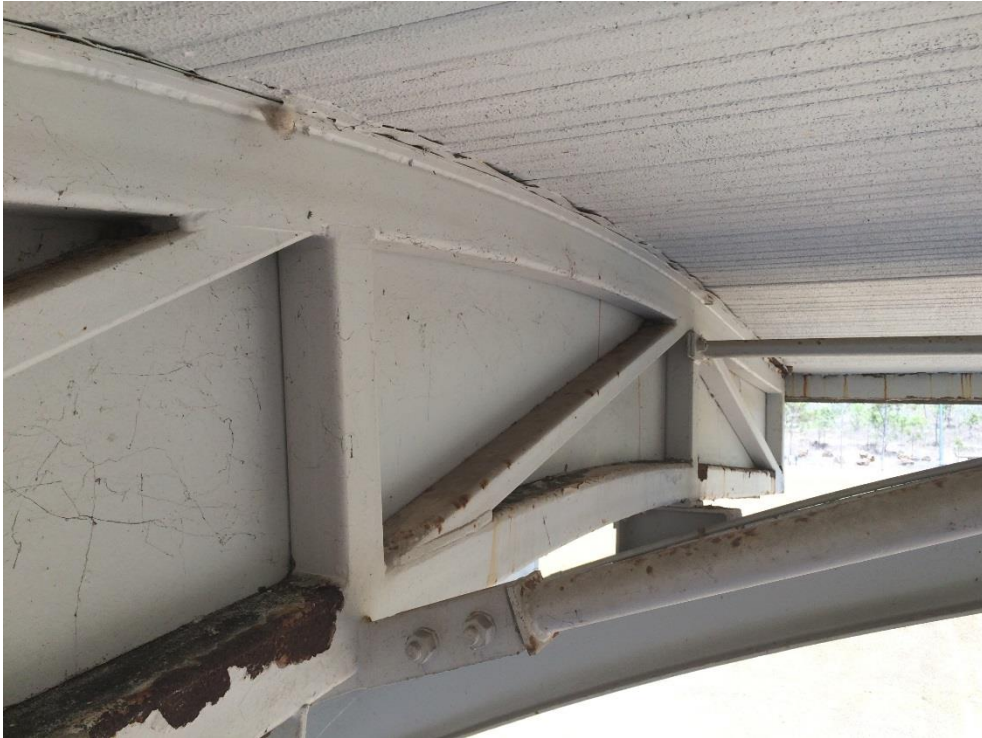
Photo 108 - Minor corrosion to bottom chord

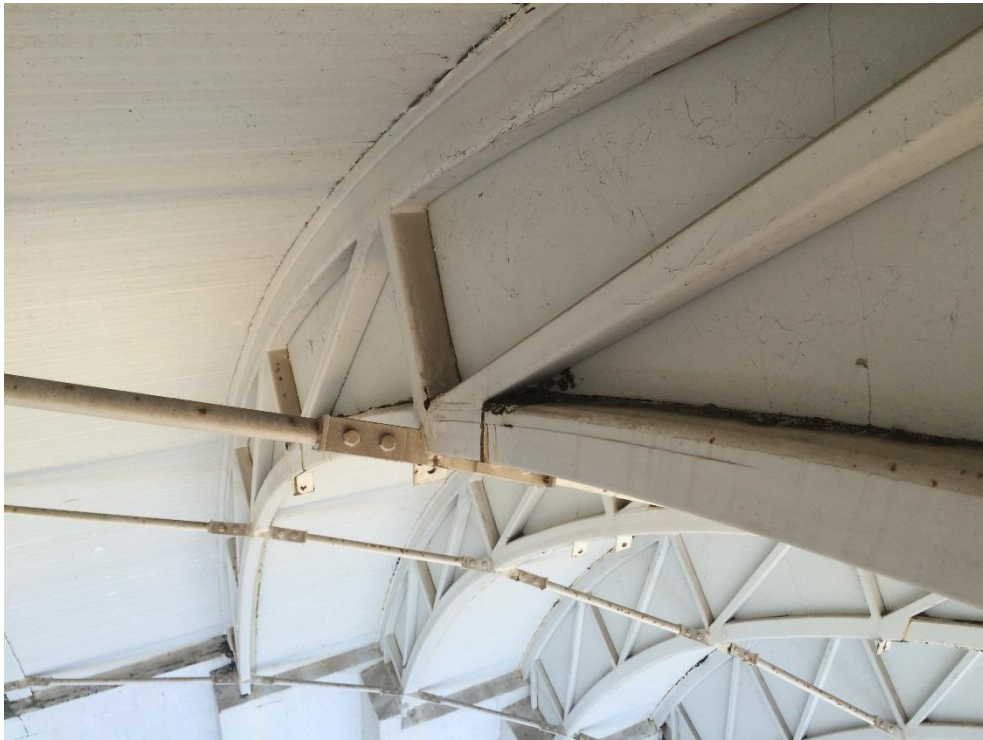
Photo 110 - Minor corrosion to web member

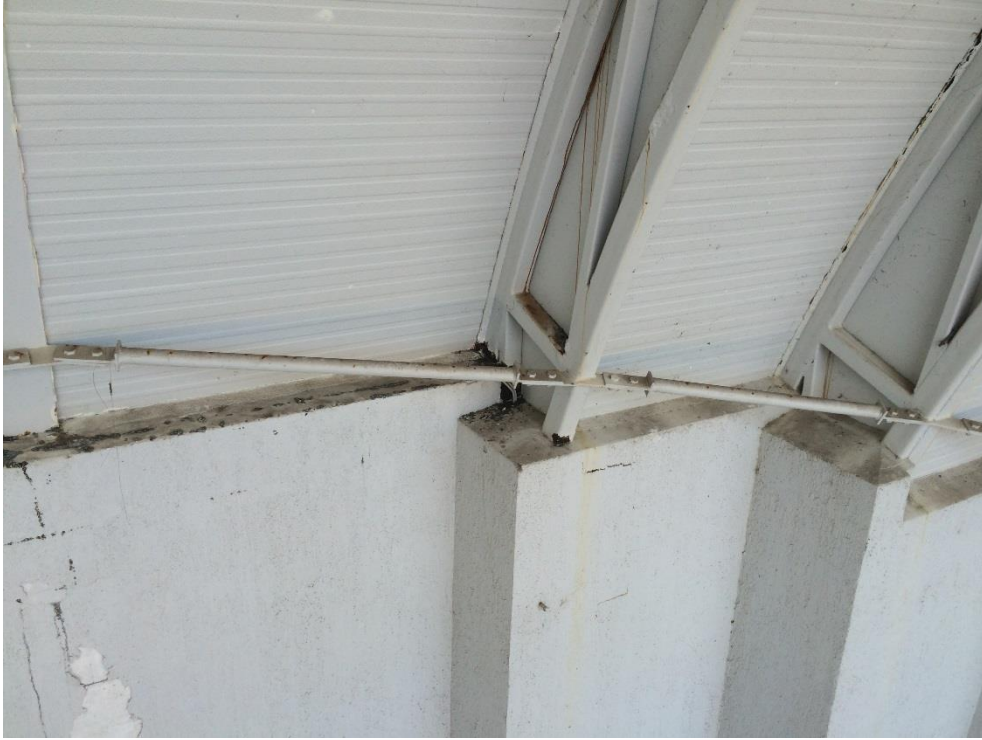
Photo 112 - Heavy corrosion to truss at concrete interface

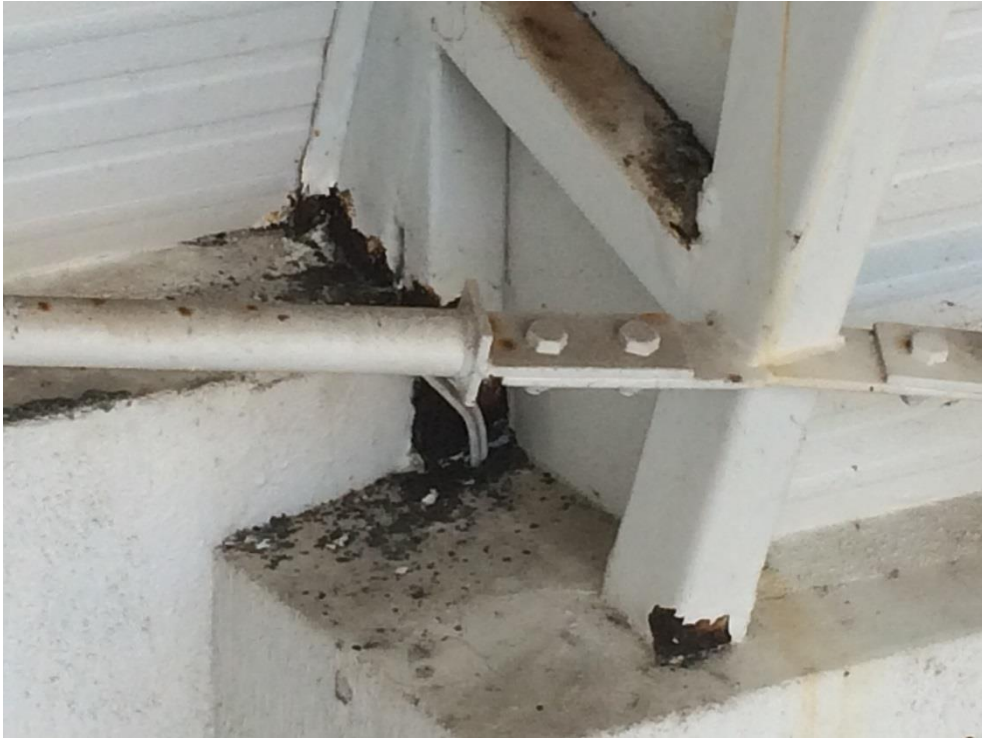
Photo 113 - Heavy corrosion to truss at concrete interface

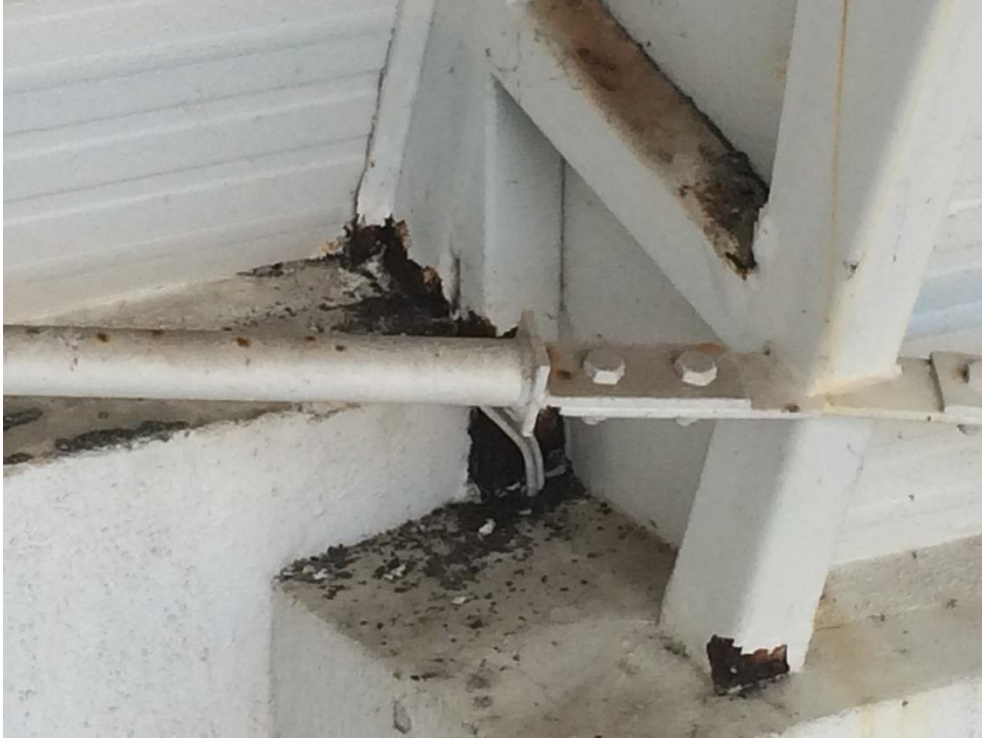
Photo 114 - Heavy corrosion to truss at concrete interface, heavy corrosion to inside corner of tie

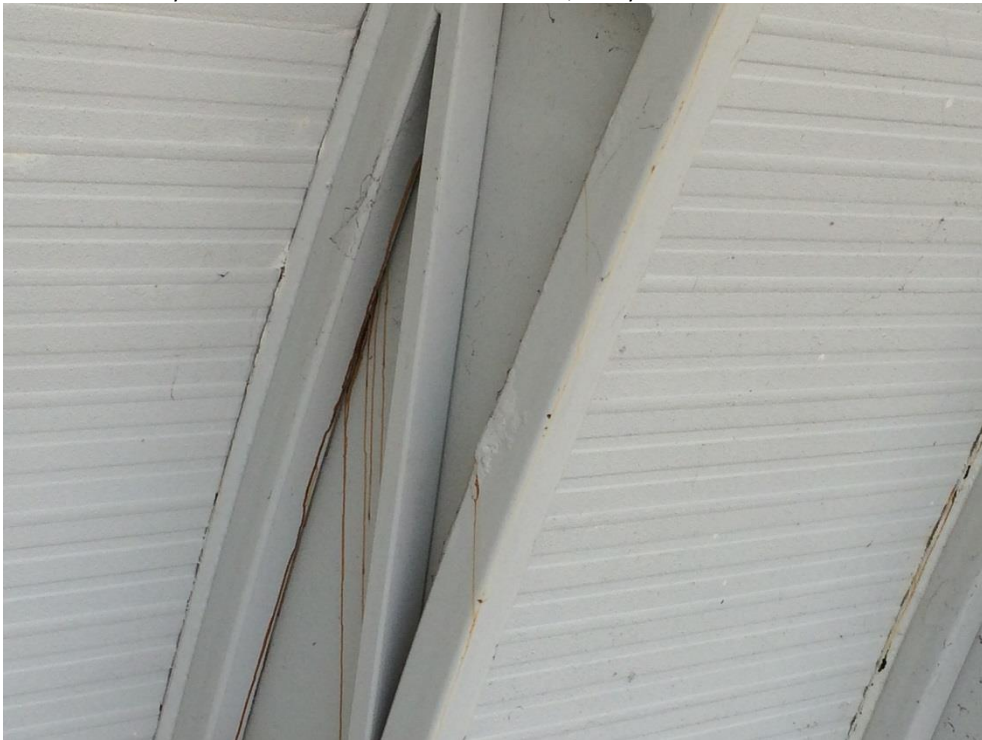
Photo 115 - Heavy corrosion to truss bottom chord, paint peeling off

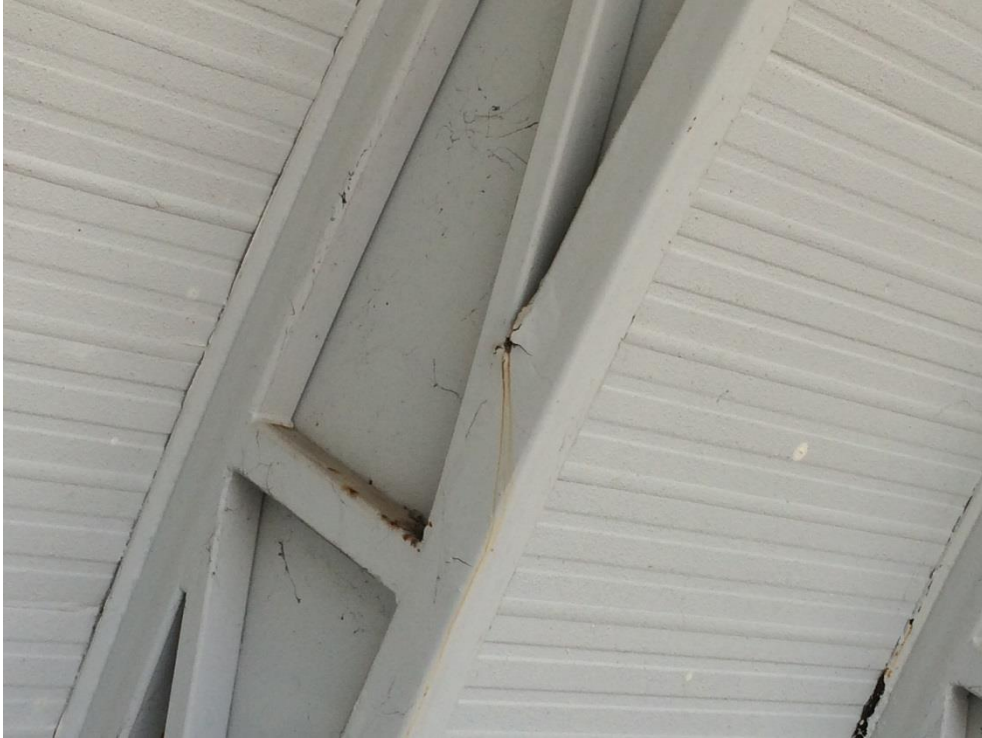
Photo 116 - Heavy corrosion to truss bottom chord, paint peeling off

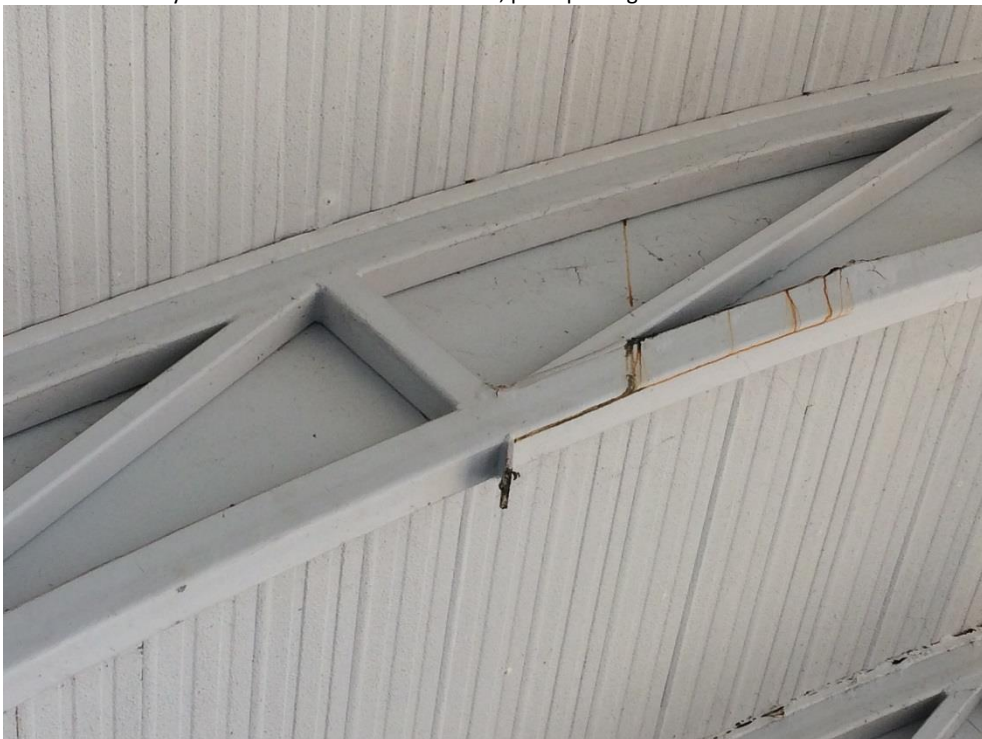
Photo 117 - Heavy corrosion to truss bottom chord, paint peeling off

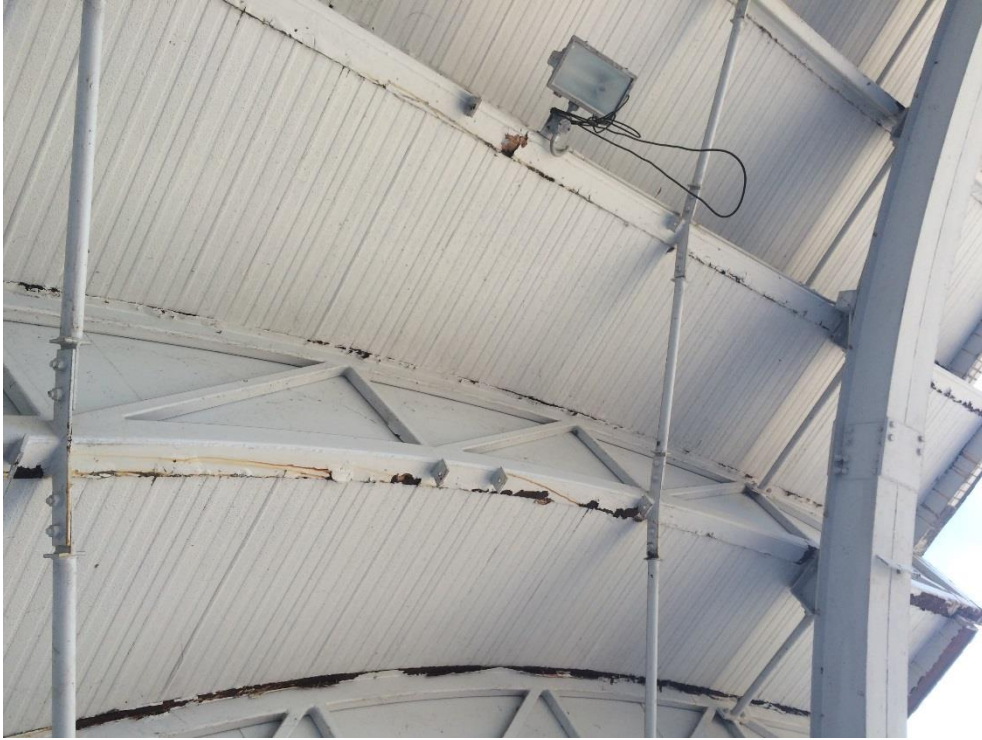
Photo 124 - Minor corrosion to truss top and bottom plate

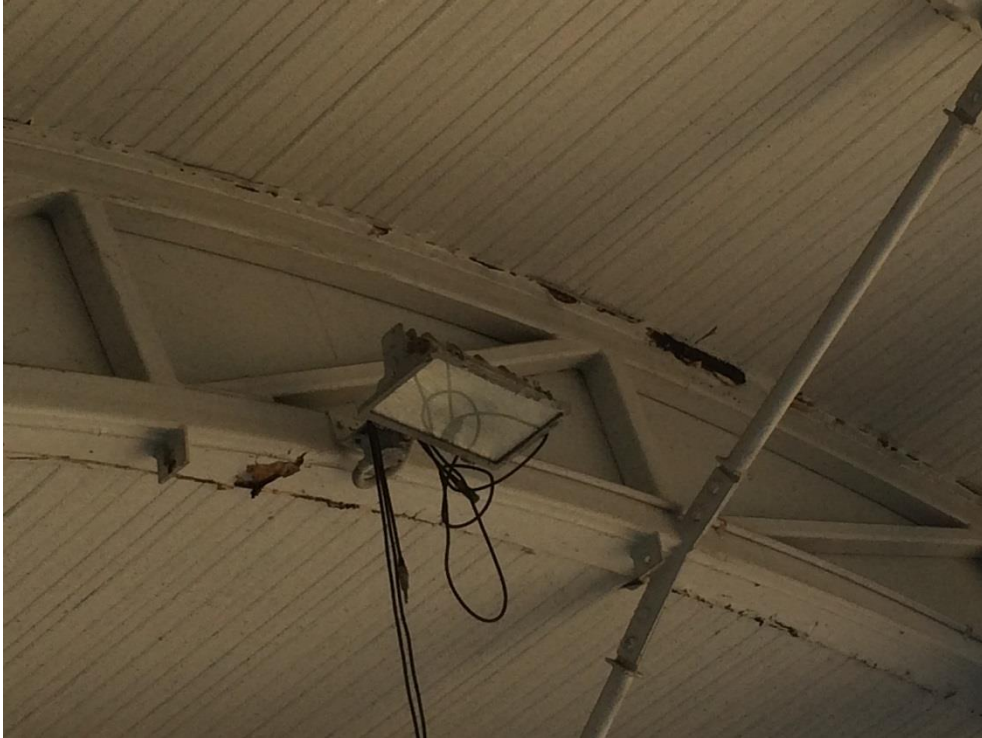
Photo 128 - Minor corrosion to truss top and bottom plate

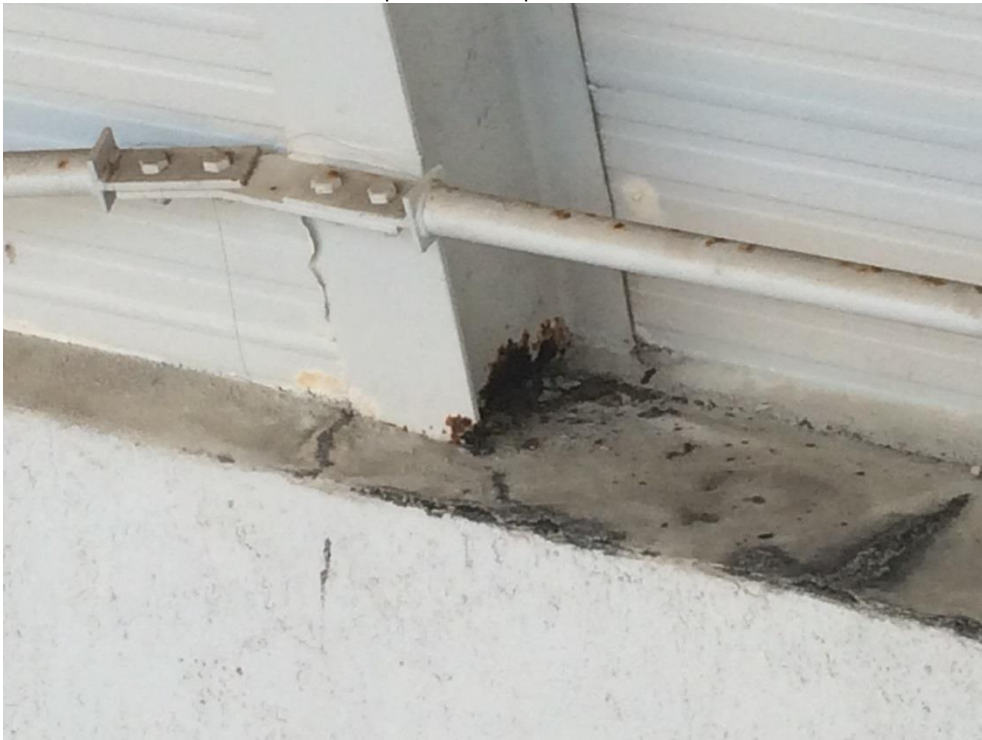
Photo 129 - Heavy corrosion to web of roof beam

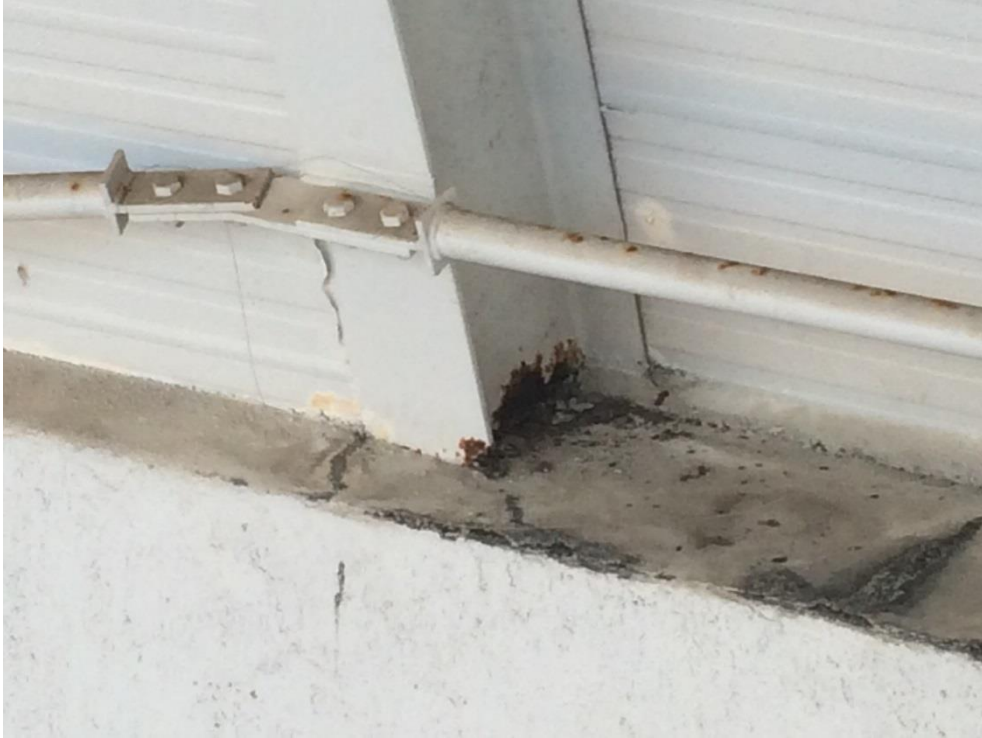
Photo 130 - Heavy corrosion to web of roof beam

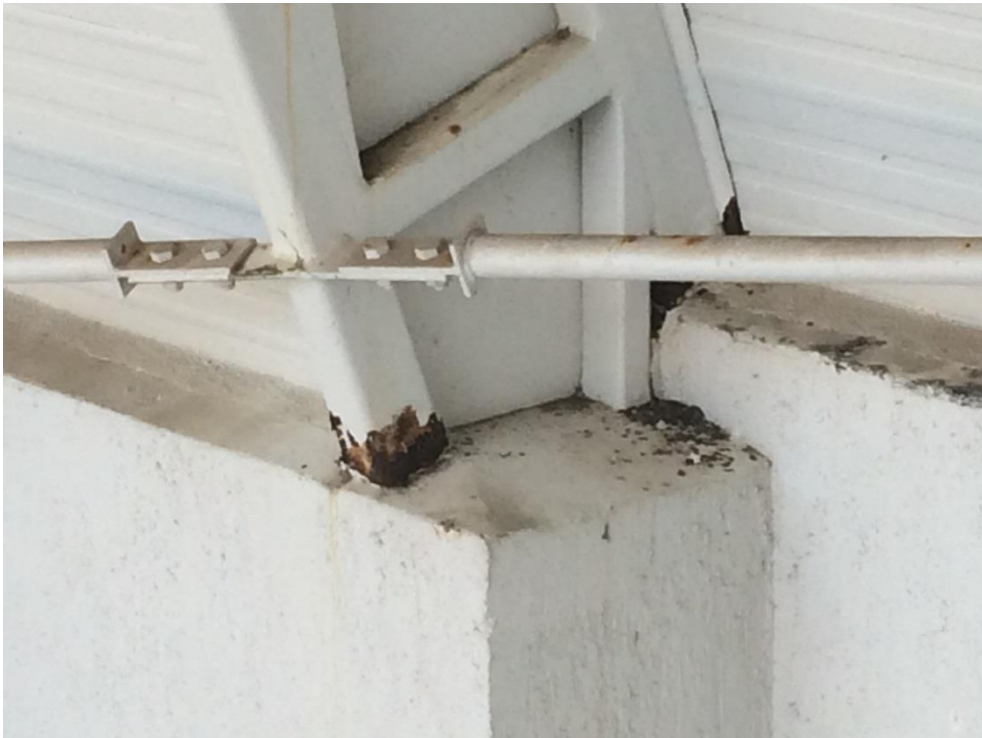
Photo 131 - Heavy corrosion to bottom chord of truss at concrete interface

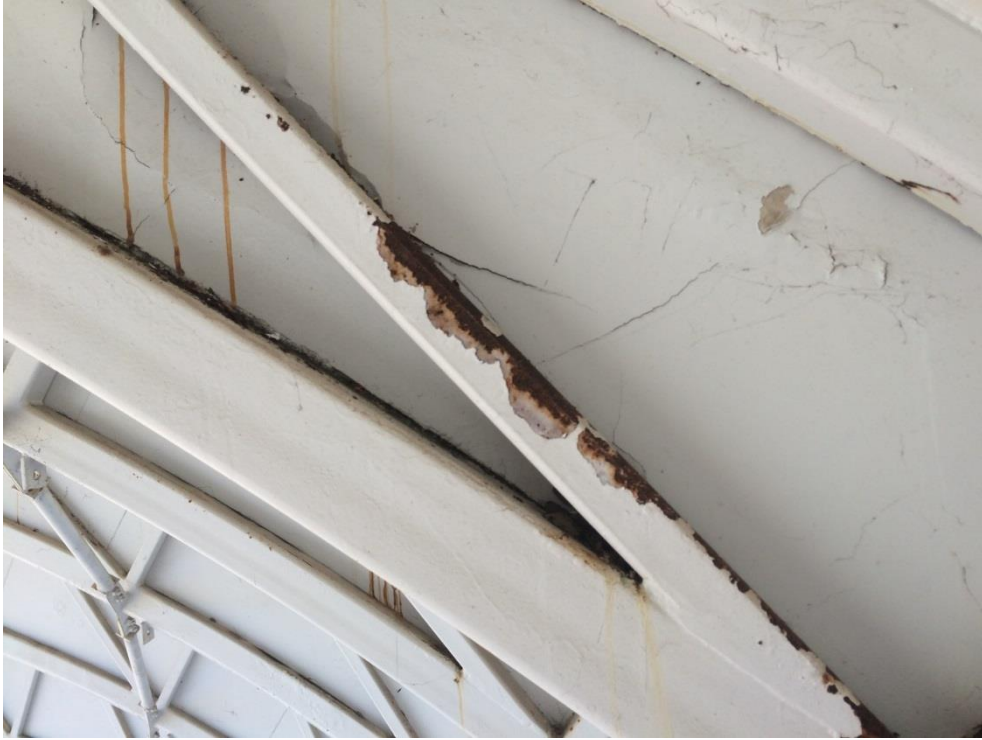
Photo 134 - Minor corrosion to web of truss

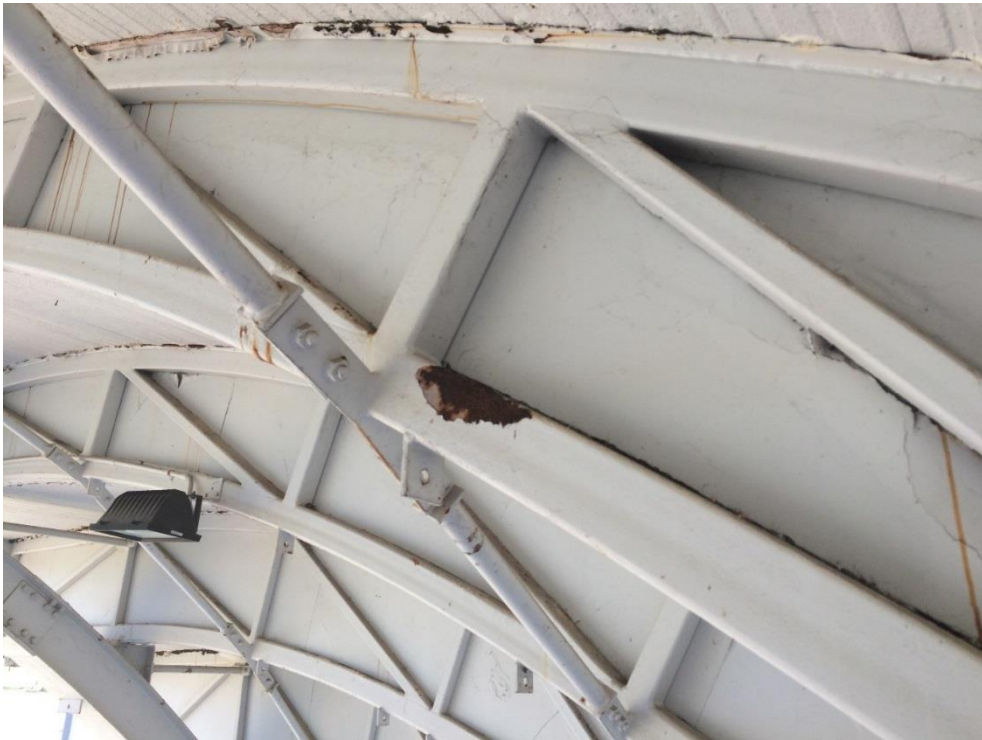
Photo 135 - Minor corrosion to bottom chord

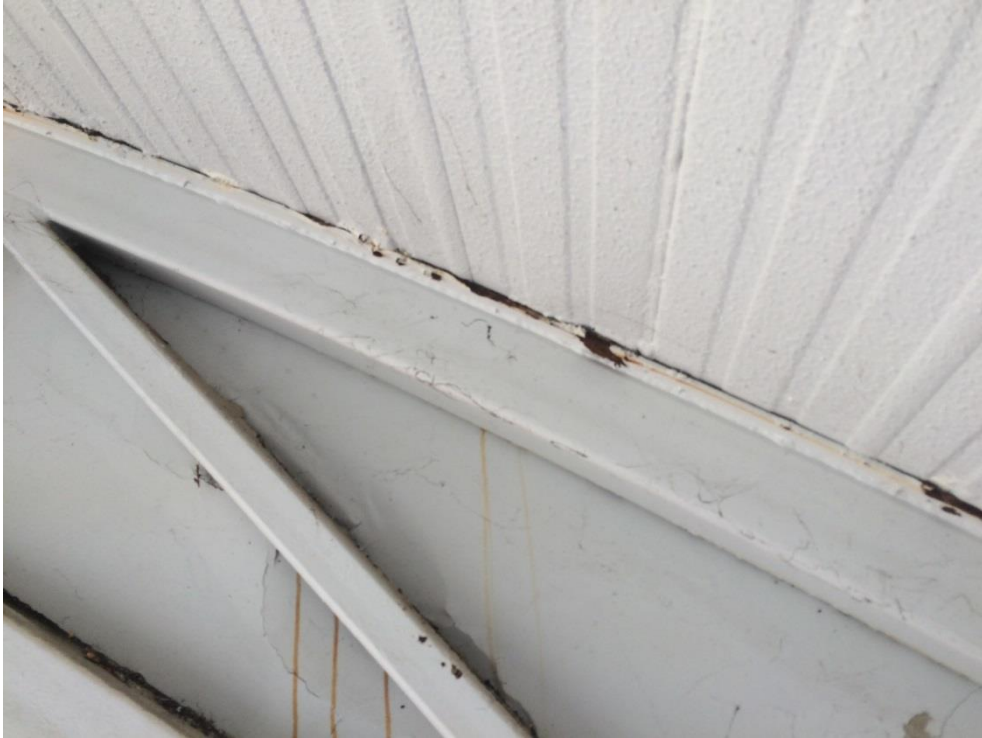
Photo 136 - Heavy corrosion to top plate

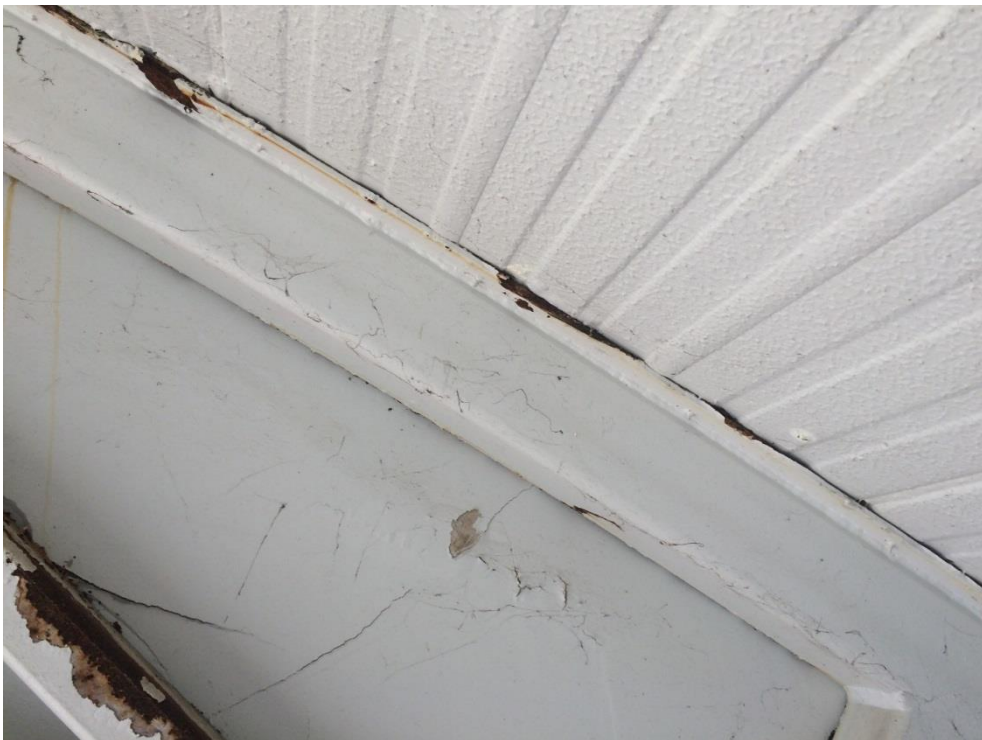
Photo 137 - Heavy corrosion to top plate

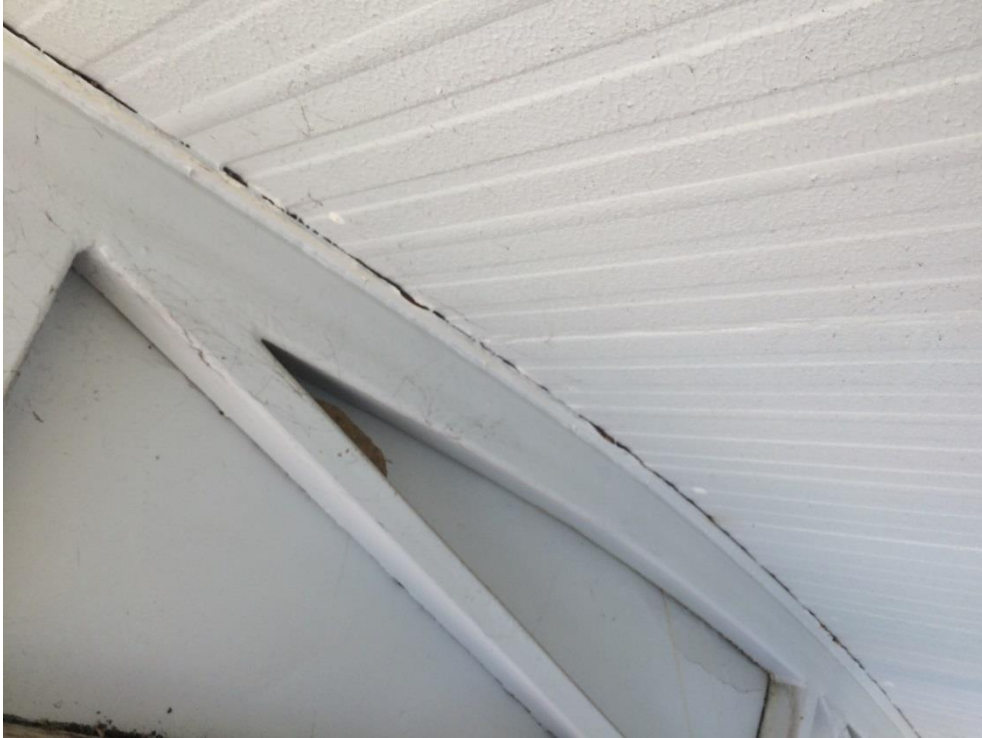
Photo 138 - Heavy corrosion to top plate

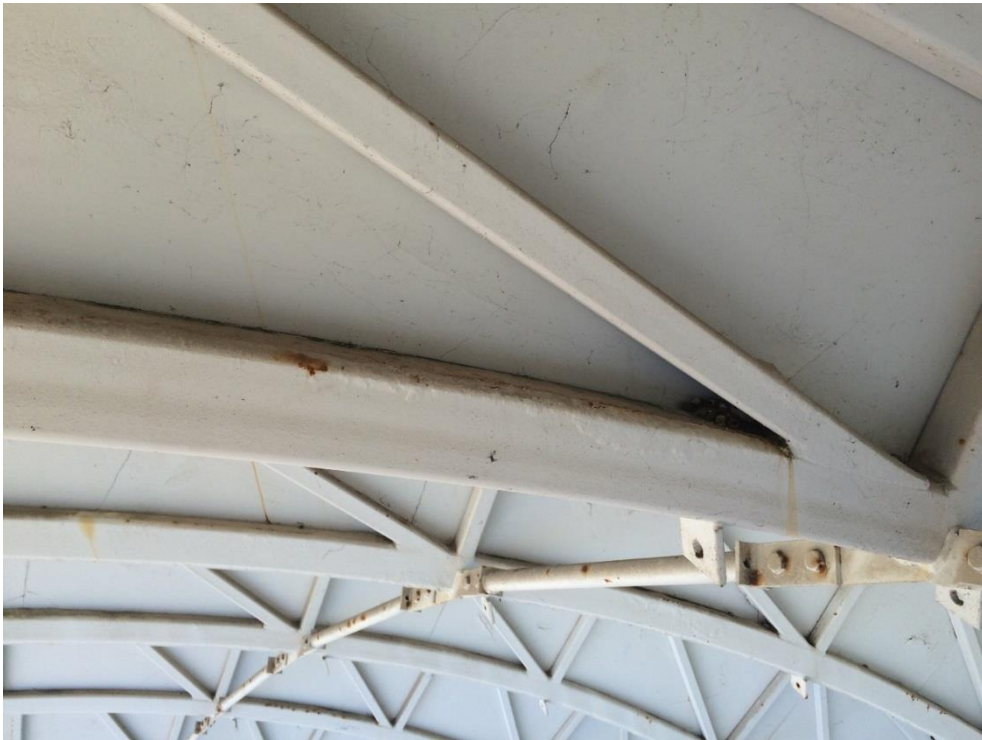
Photo 139 - Minor corrosion to bottom chord of truss

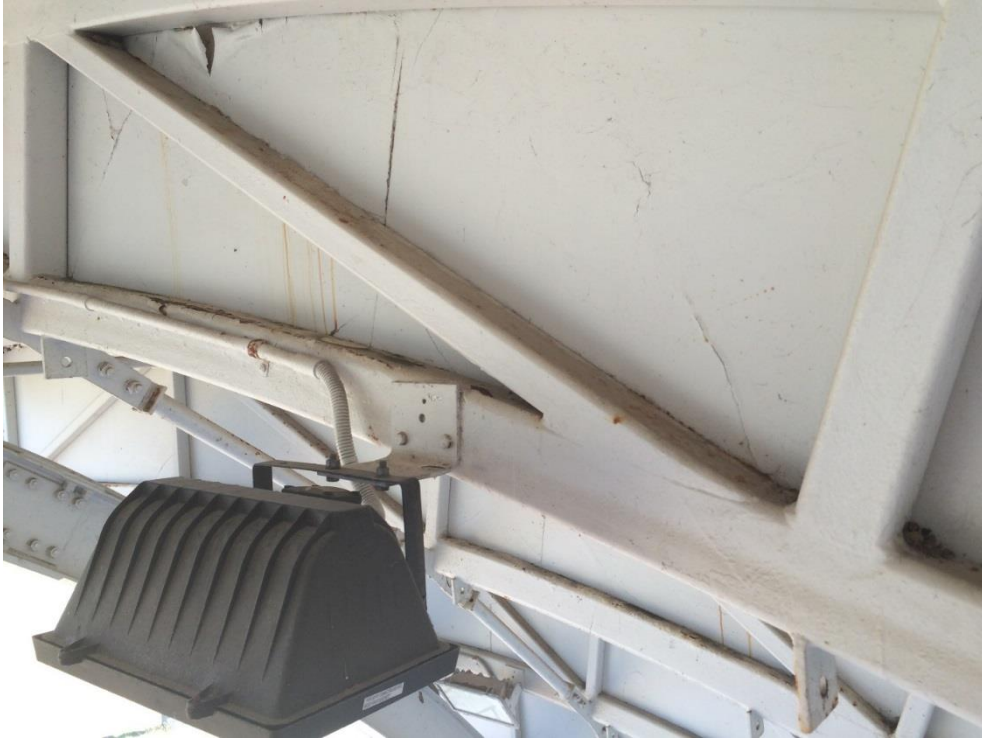
Photo 140 - Minor corrosion to bottom chord of truss

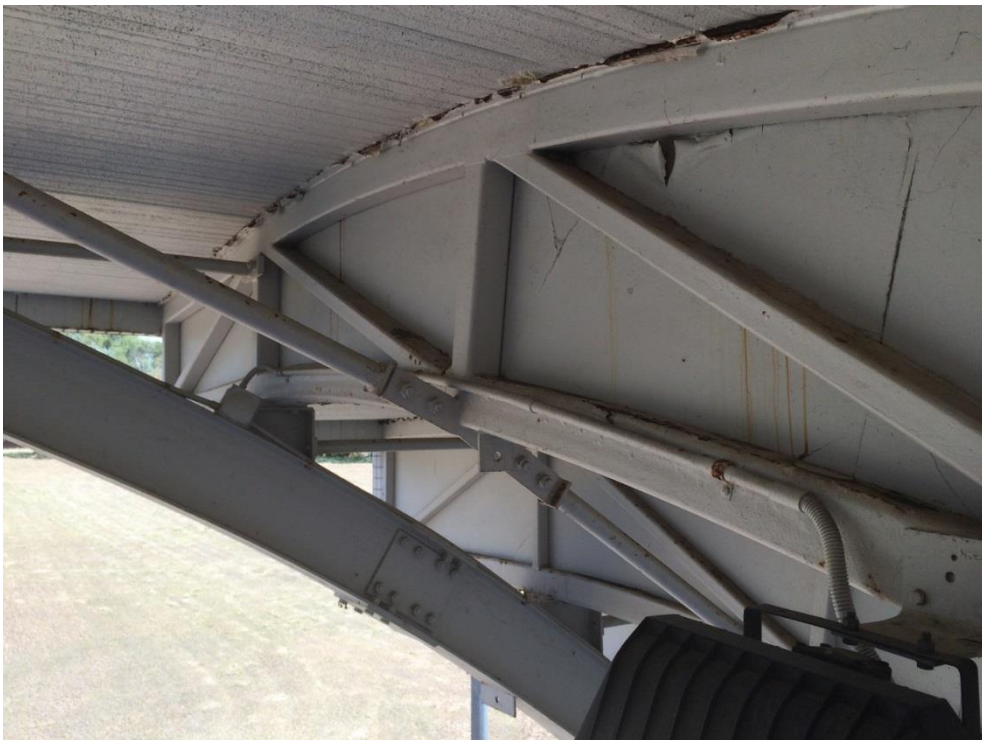
Photo 141 - Minor corrosion to bottom chord of truss and top plate

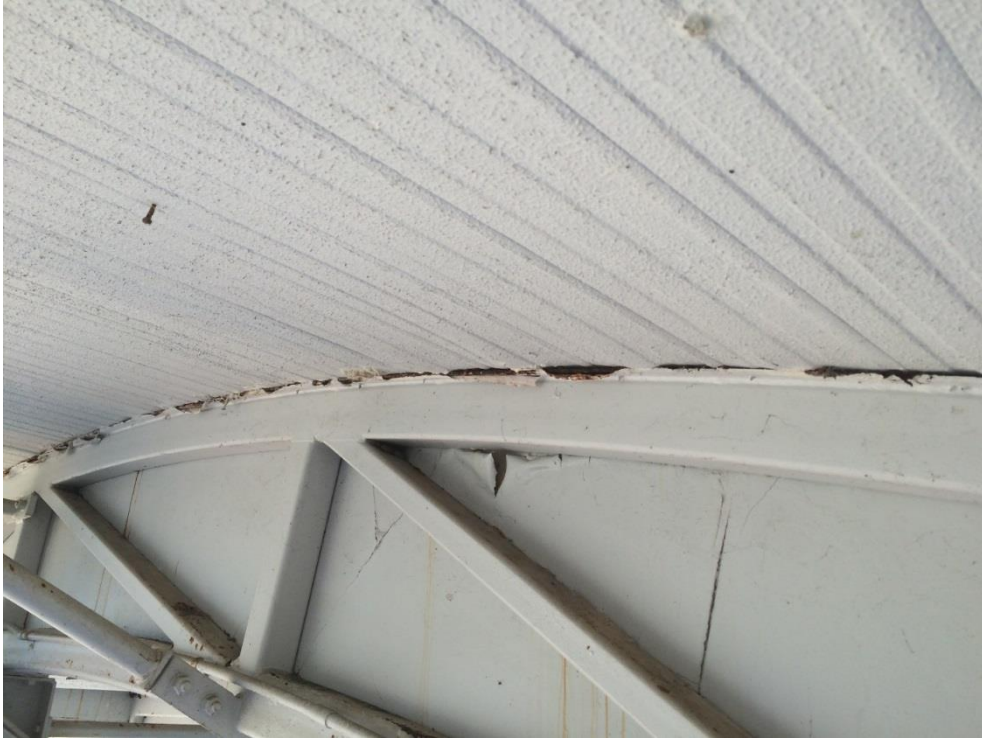
Photo 142 - Minor corrosion to top plate
