Music Bowl Structural Assessment

24 November 2014

R14265

Prepared for Rockhampton Regional Council

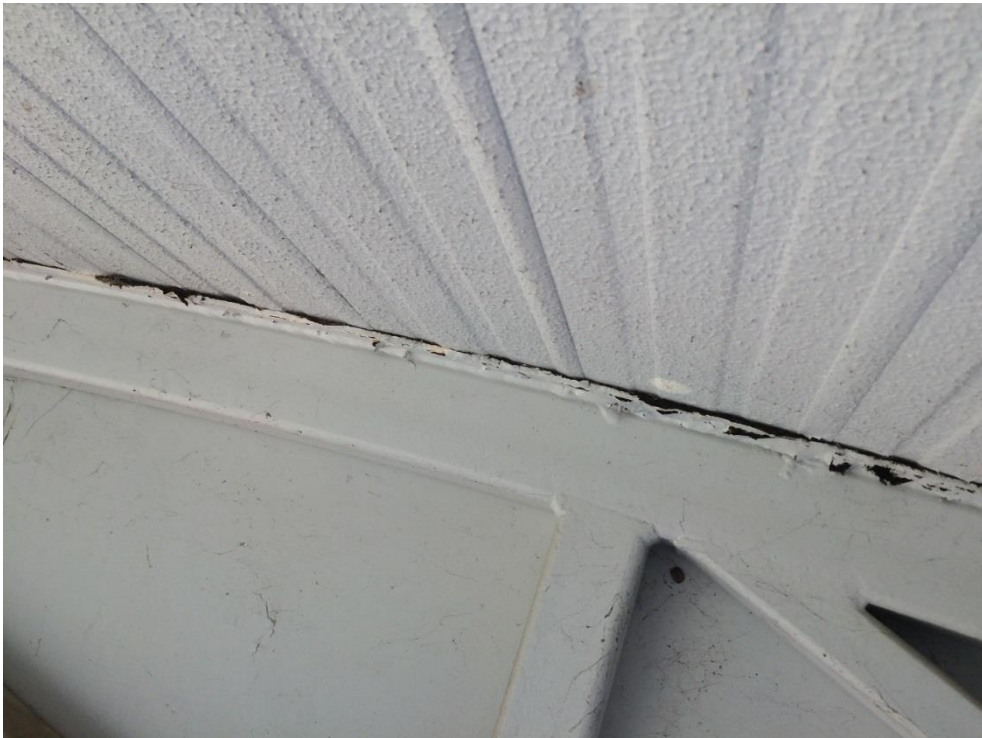
Photo 143 - Minor corrosion to top plate

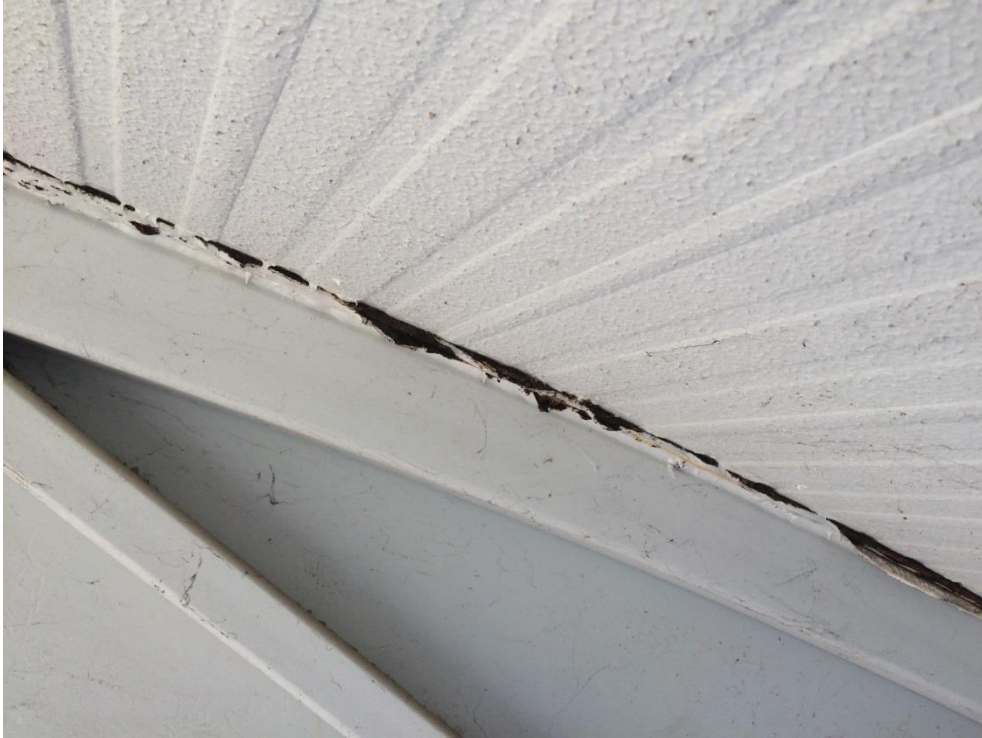
Photo 144 - Minor corrosion to top plate

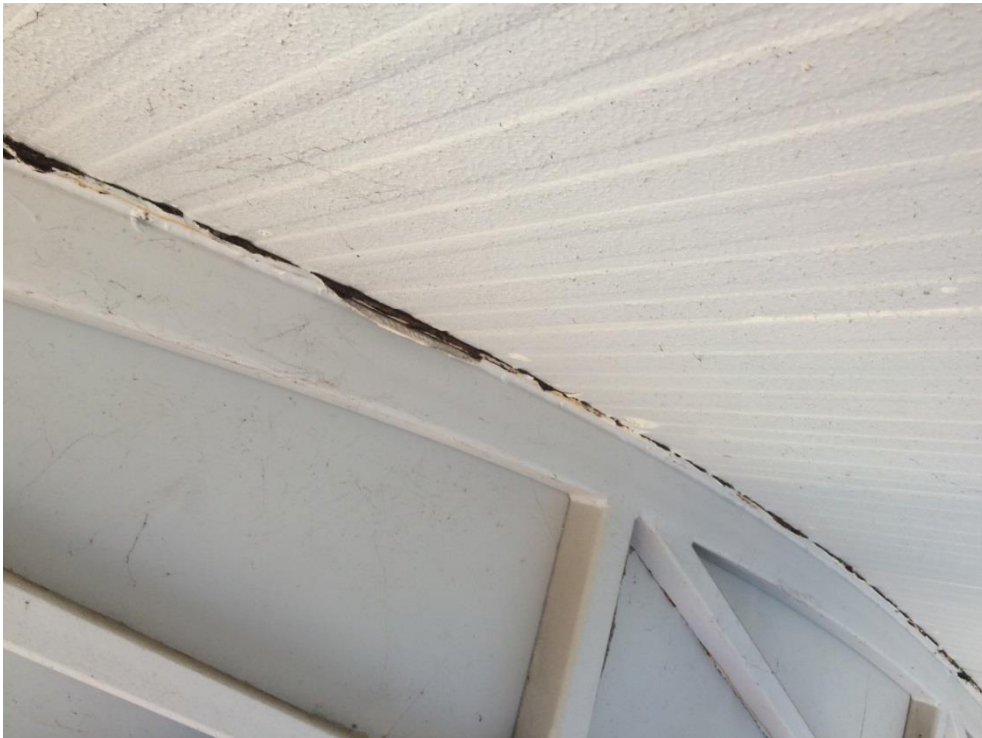
Photo 145 - Minor corrosion to top plate

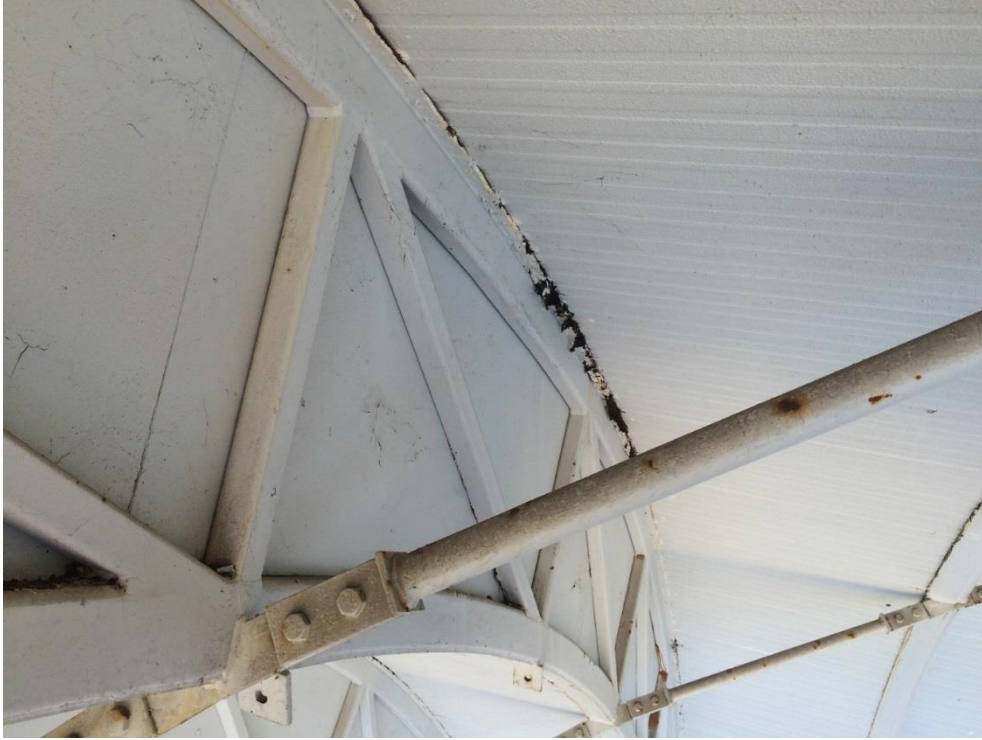
Photo 146 - Heavy corrosion to top plate

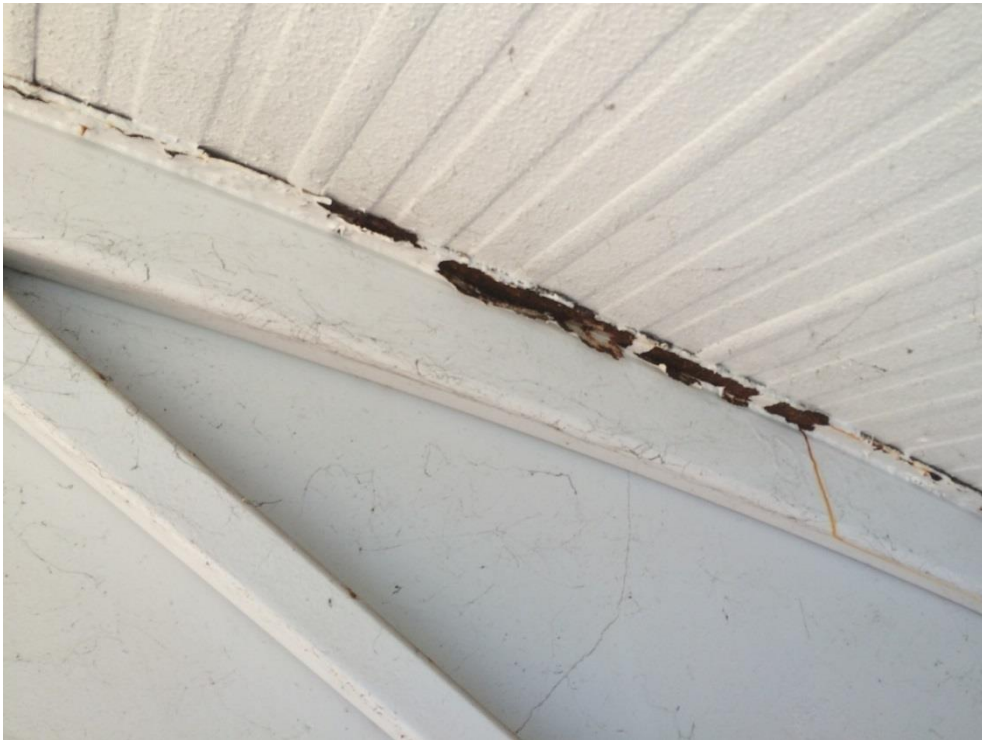
Photo 147 - Heavy corrosion to top plate

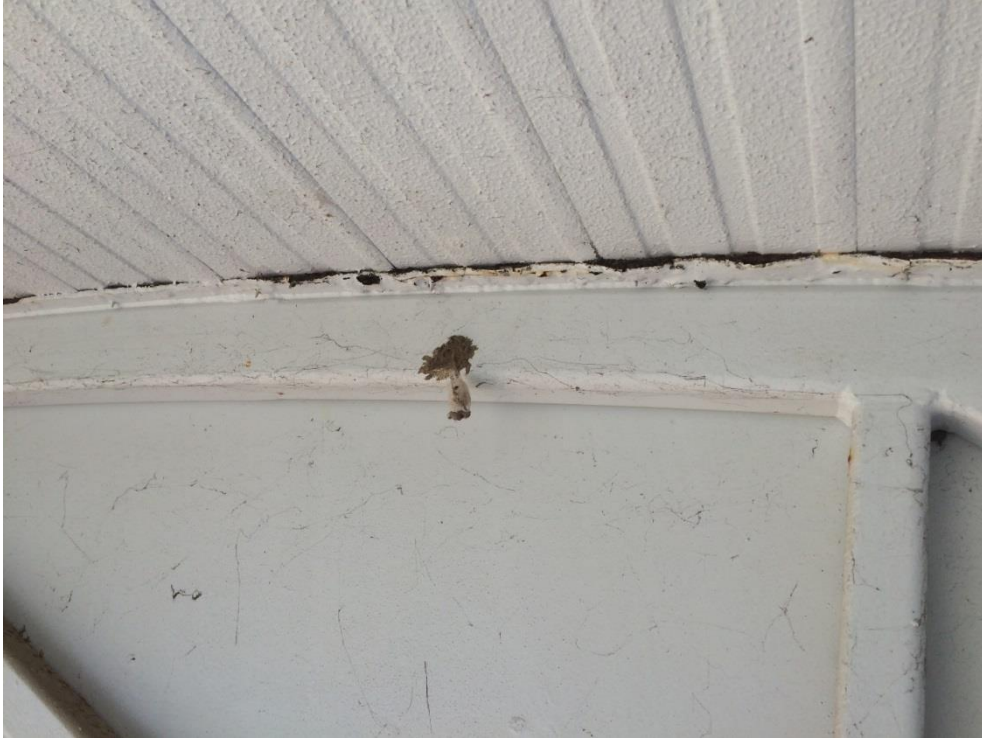
Photo 148 - Heavy corrosion to top plate

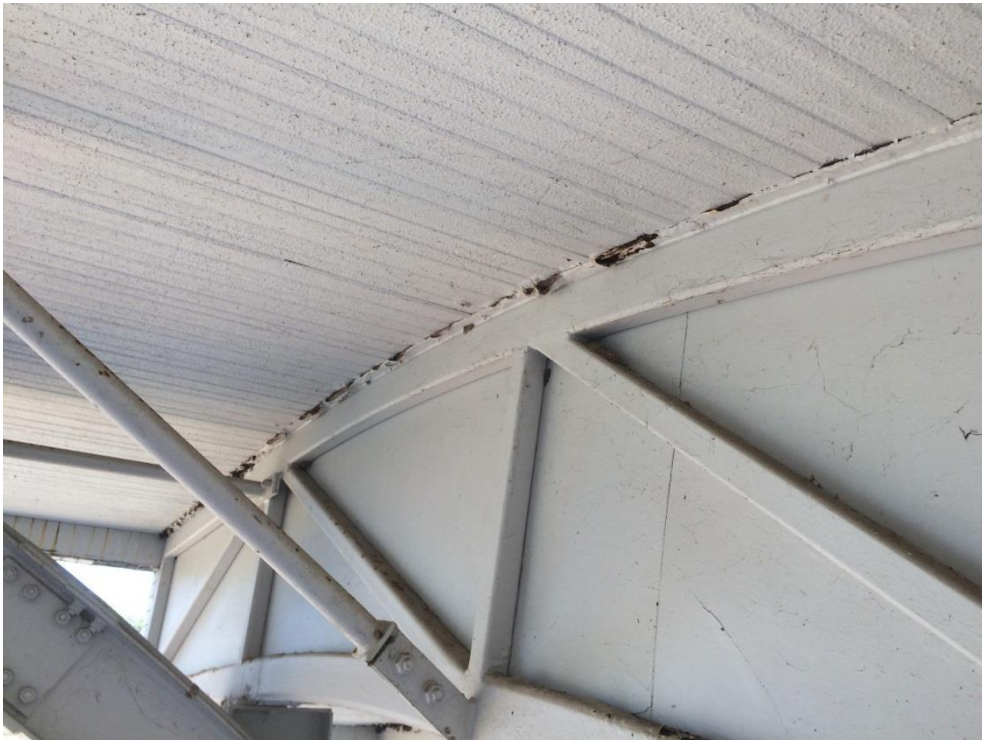
Photo 149 - Heavy corrosion to top plate

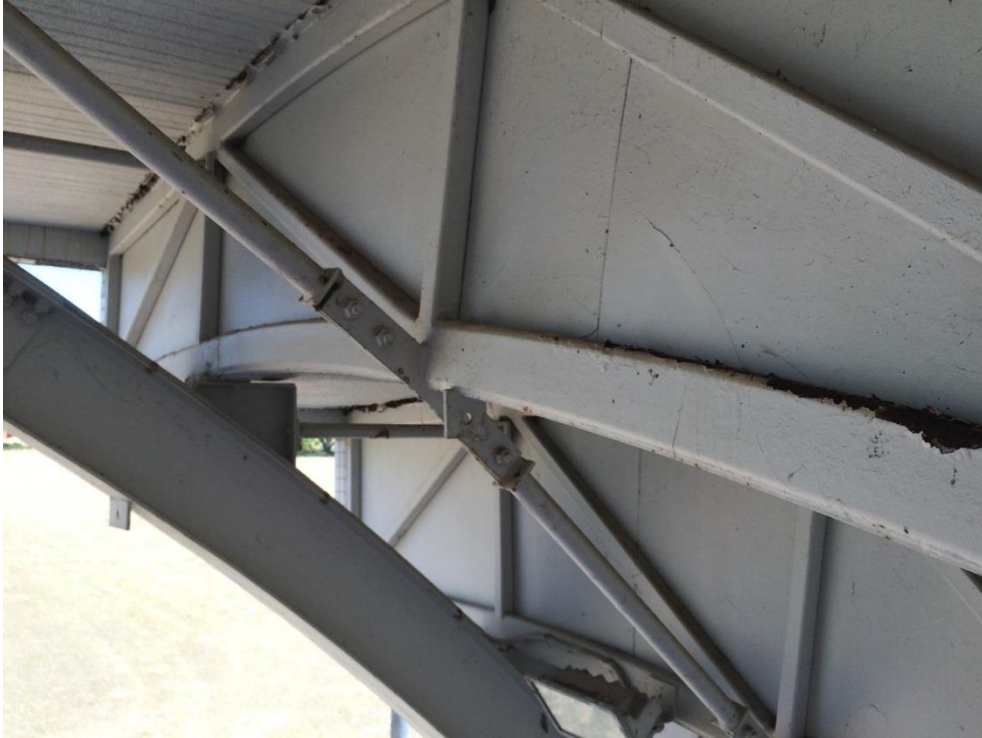
Photo 150 - Heavy corrosion to bottom chord

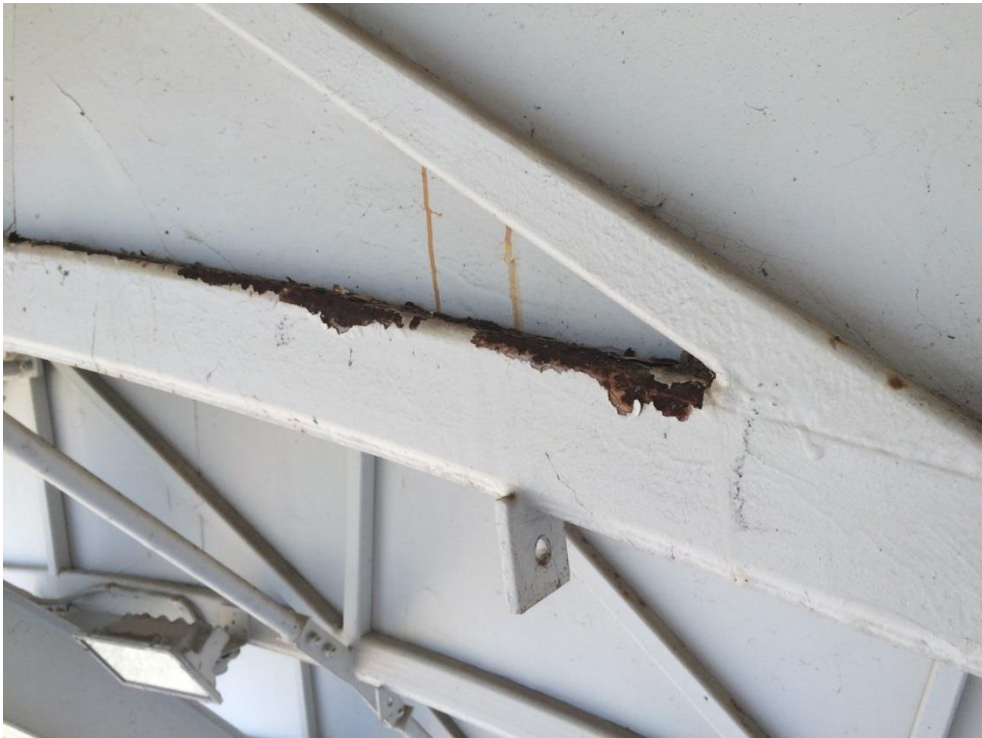
Photo 151 - Heavy corrosion to bottom chord

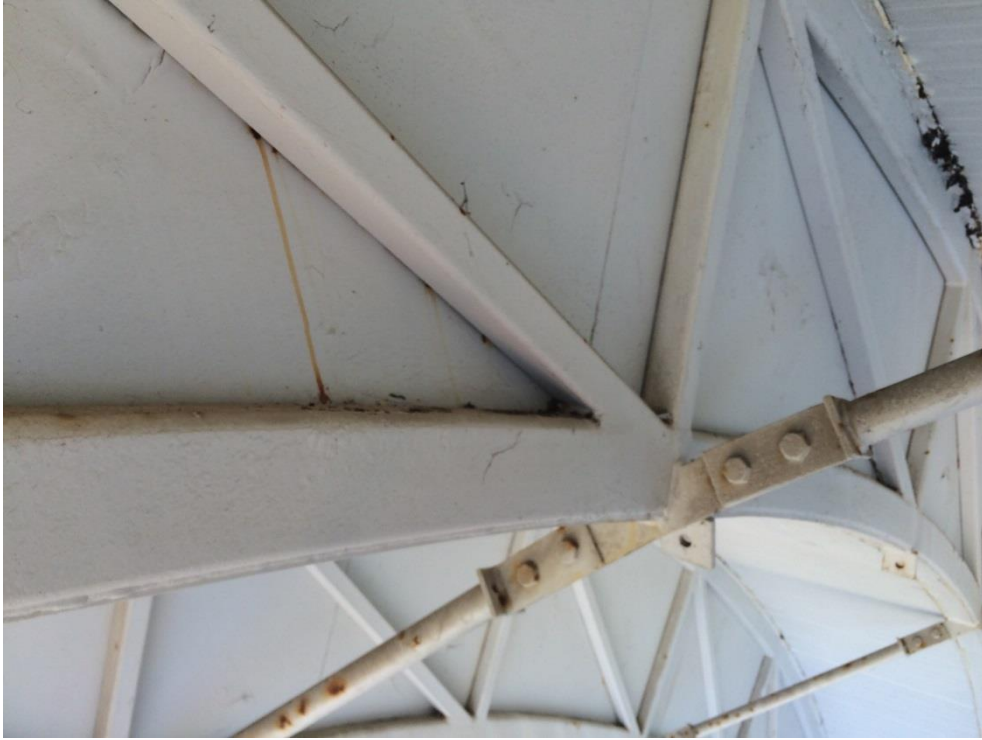
Photo 152 - Minor corrosion to bottom chord

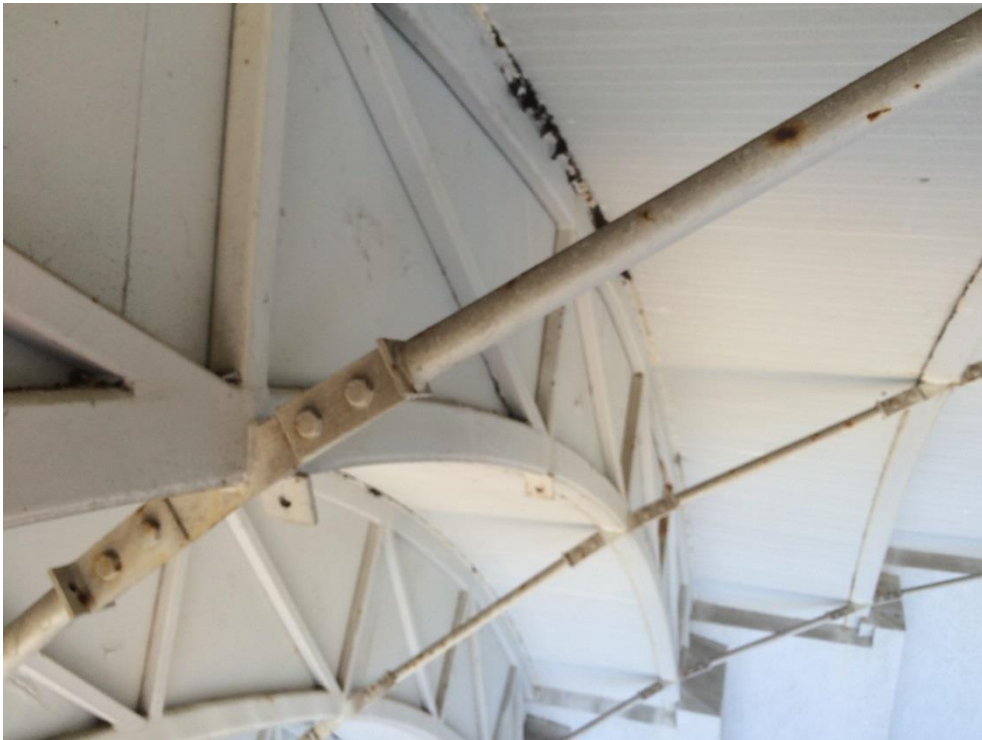
Photo 153 - Minor corrosion to top plate

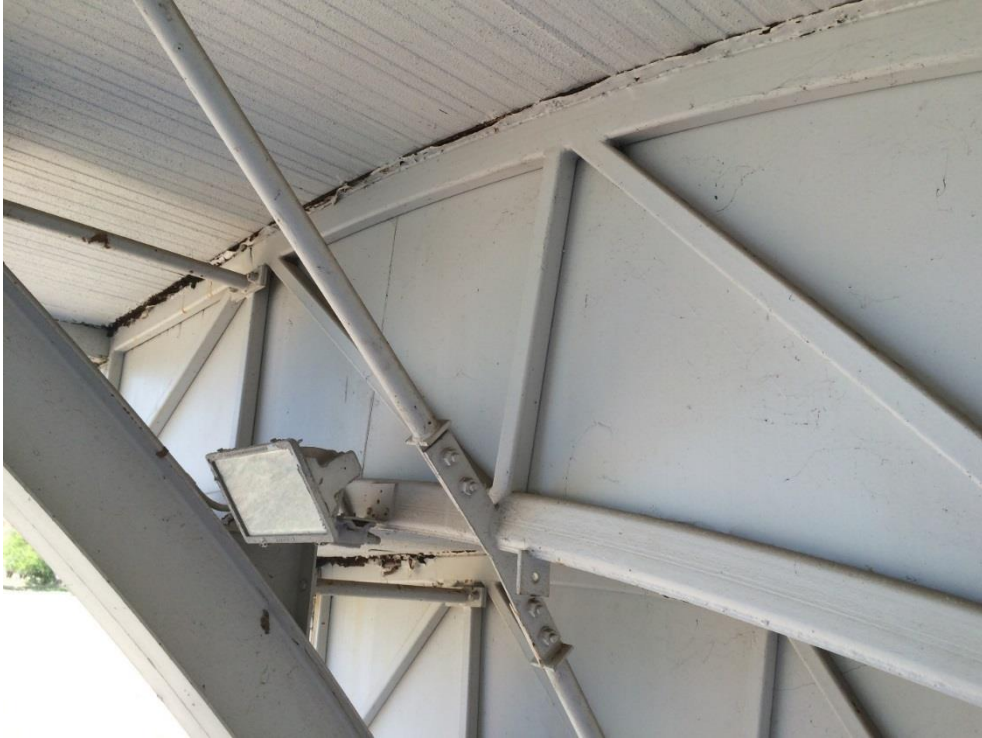
Photo 154 - Minor corrosion to top plate

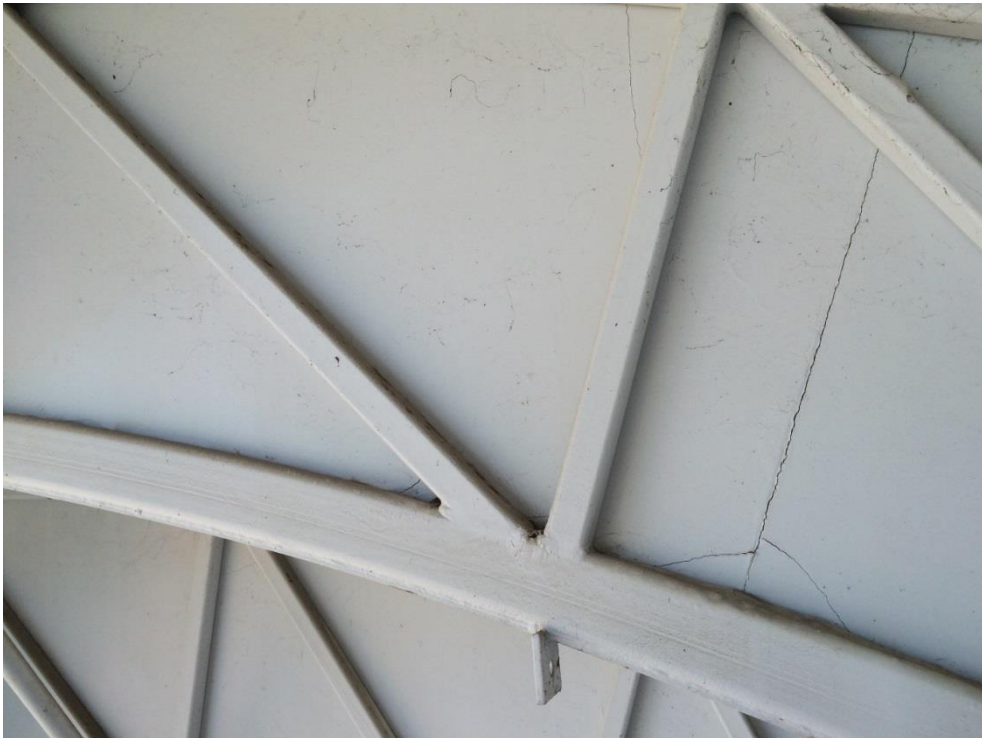
Photo 155 - Minor corrosion to bottom chord

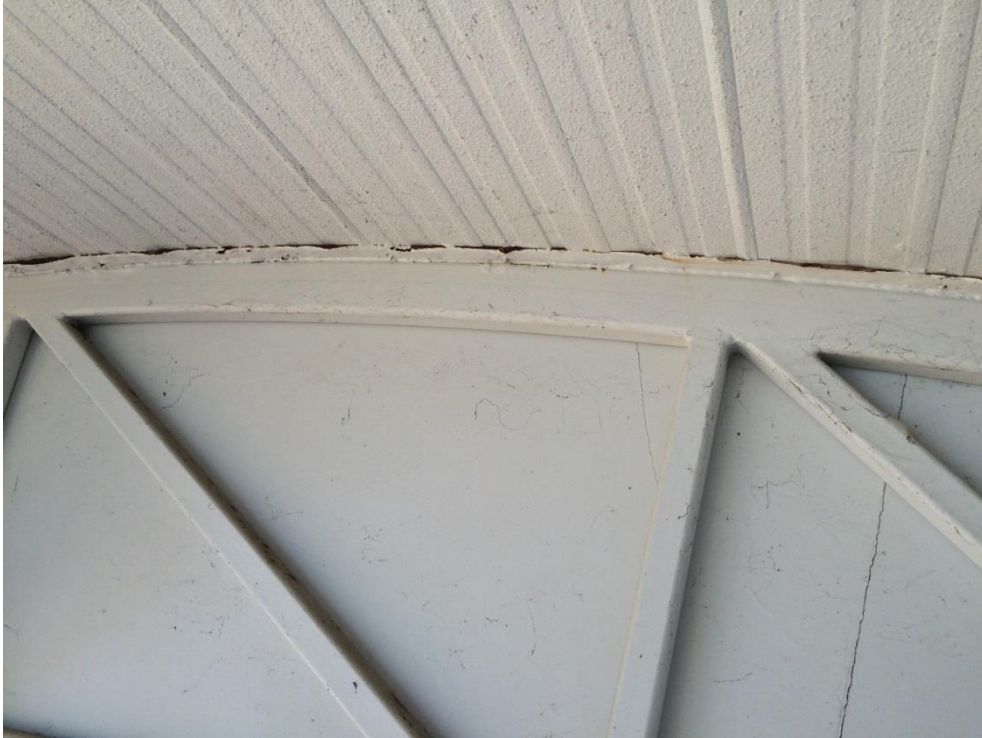
Photo 156 - Minor corrosion to top plate

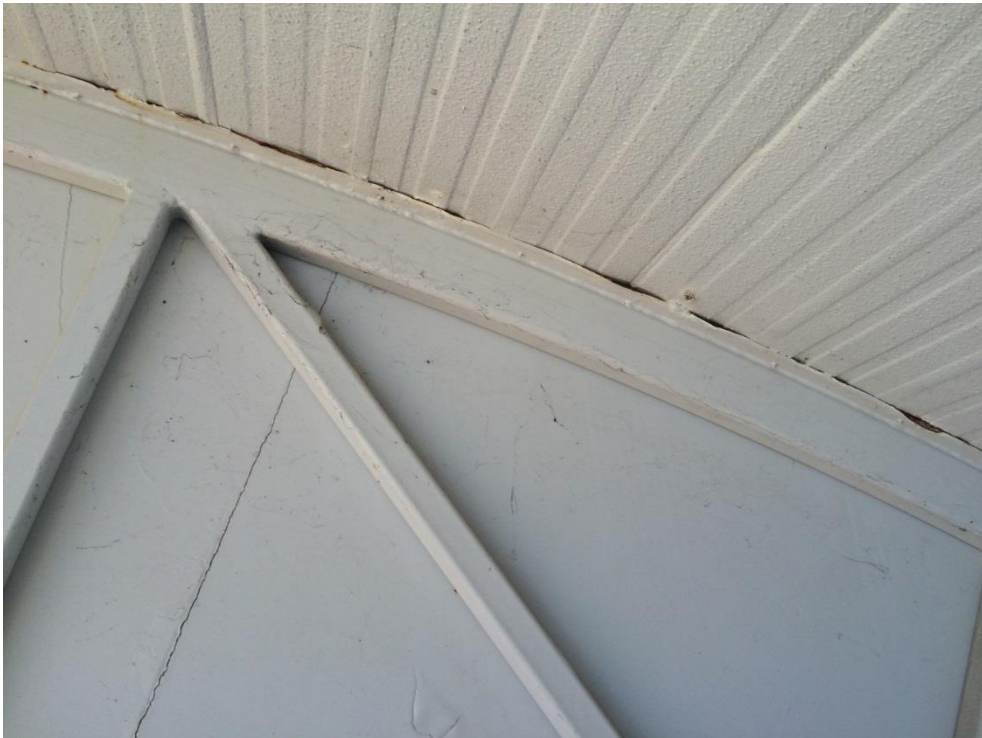
Photo 157 - Minor corrosion to top plate

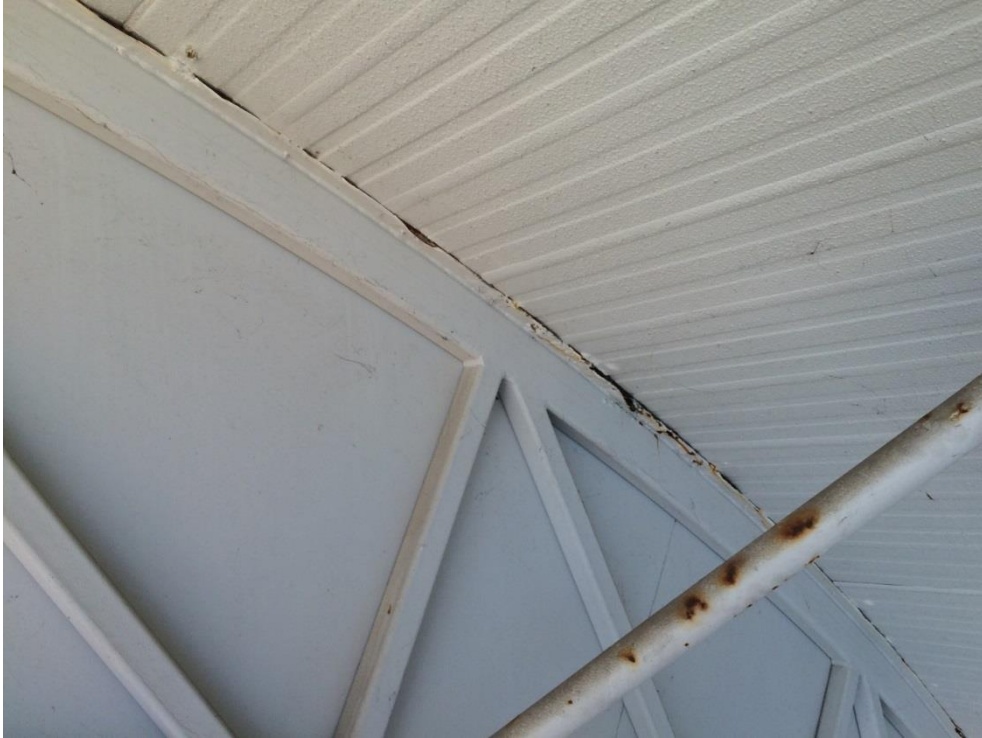
Photo 158 - Minor corrosion to top plate

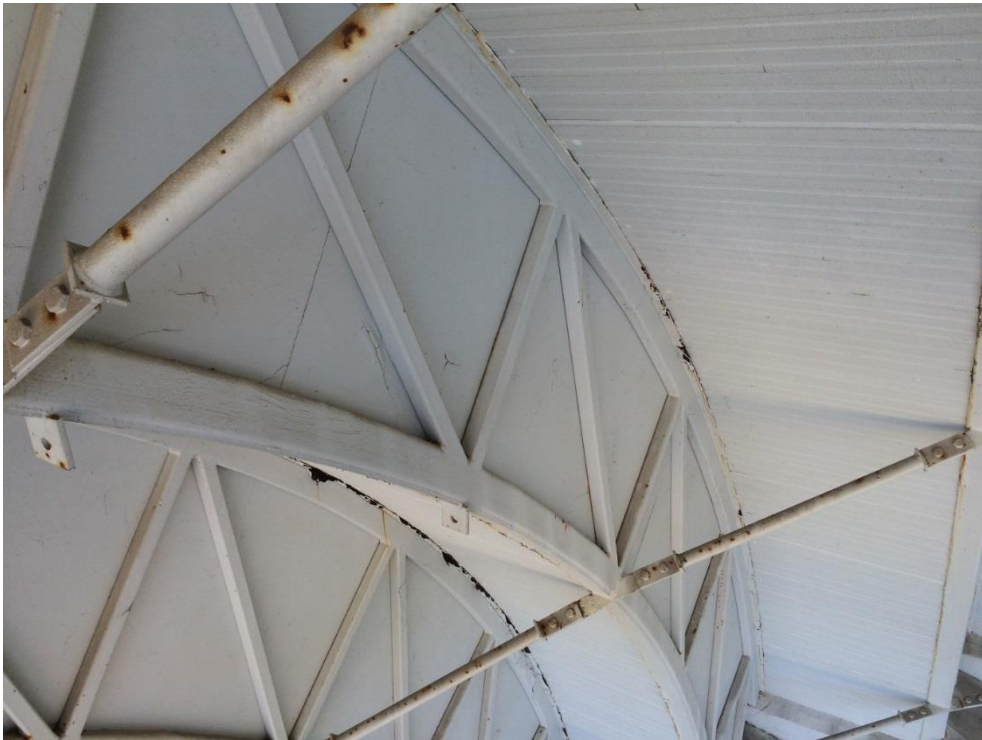
Photo 159 - Minor corrosion to top plate

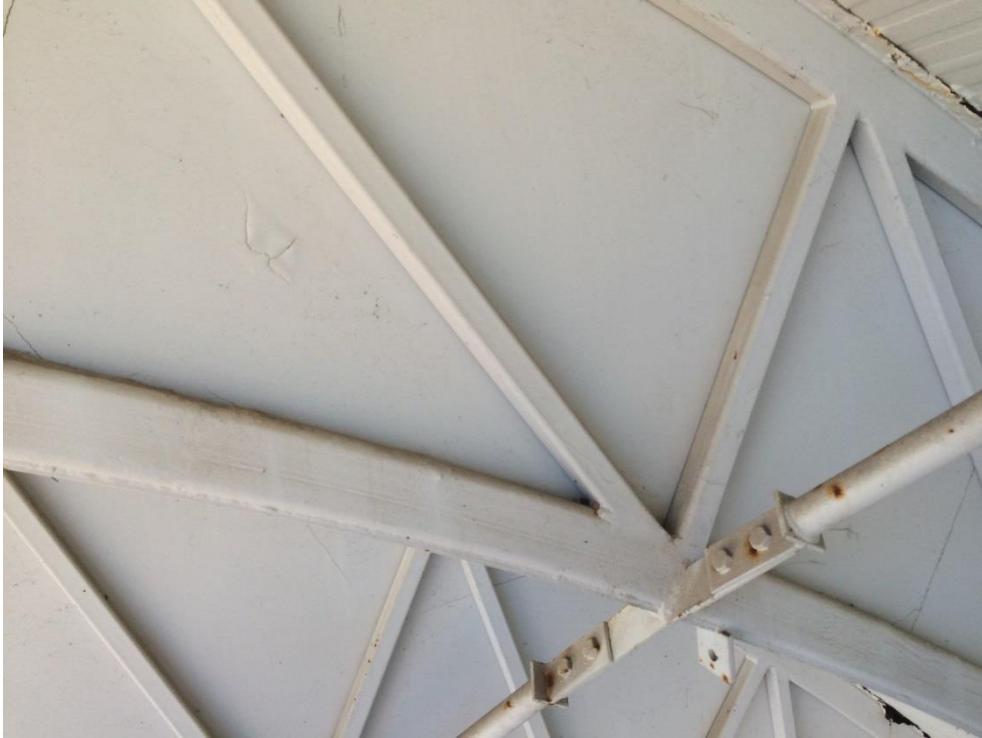
Photo 160 - Minor corrosion to bottom chord

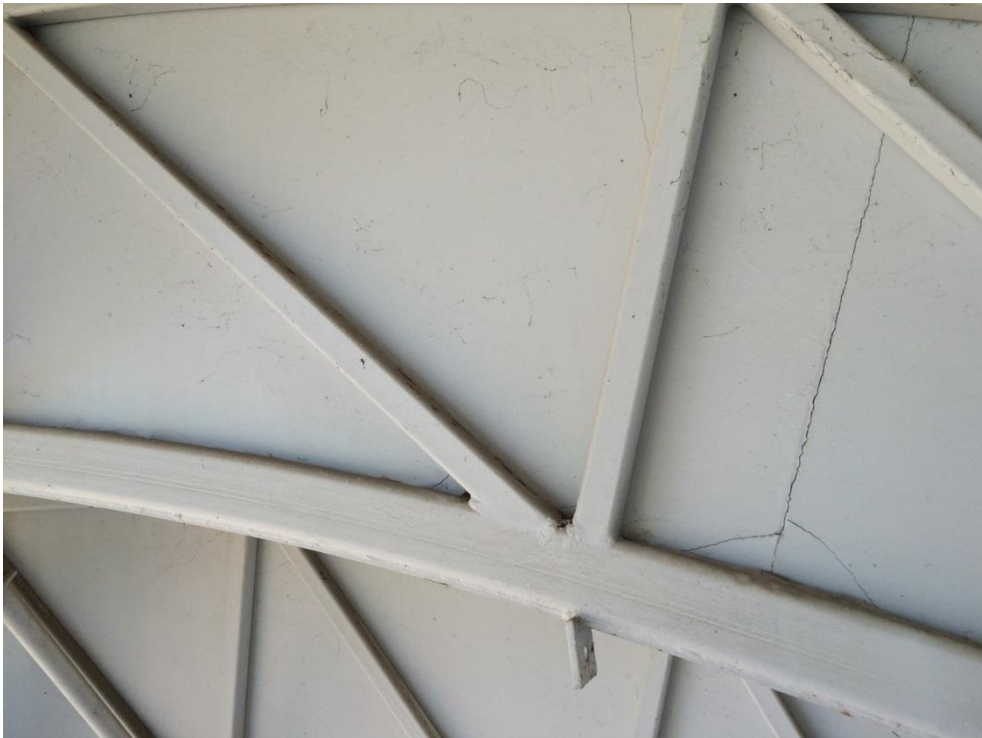
Photo 161 - Minor corrosion to bottom chord

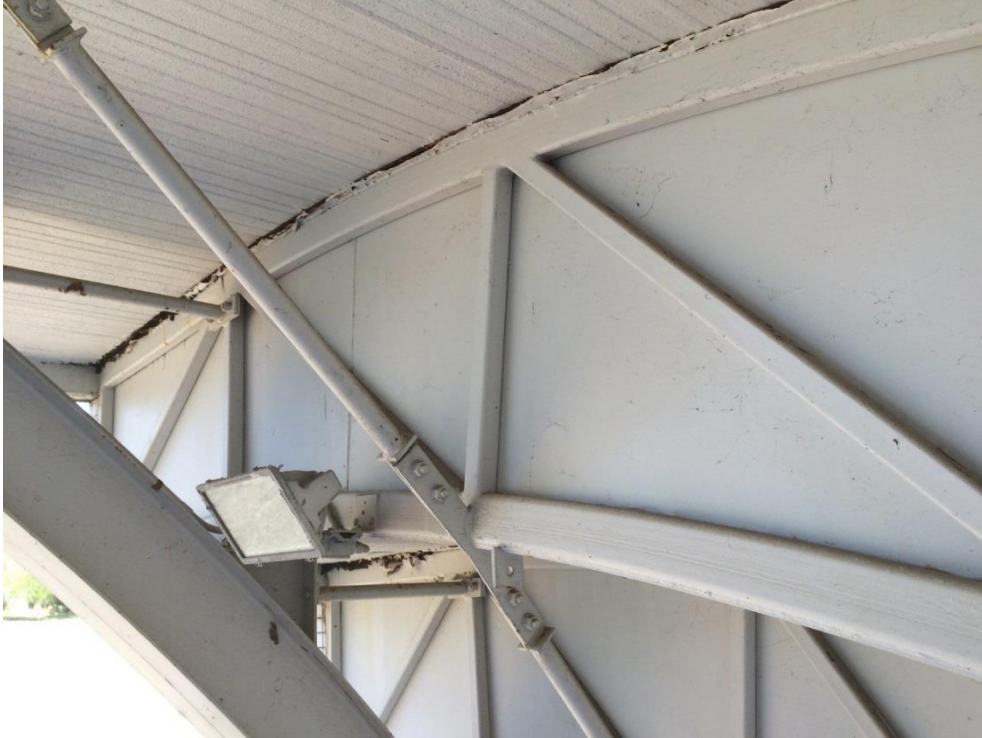
Photo 162 - Minor corrosion to top plate

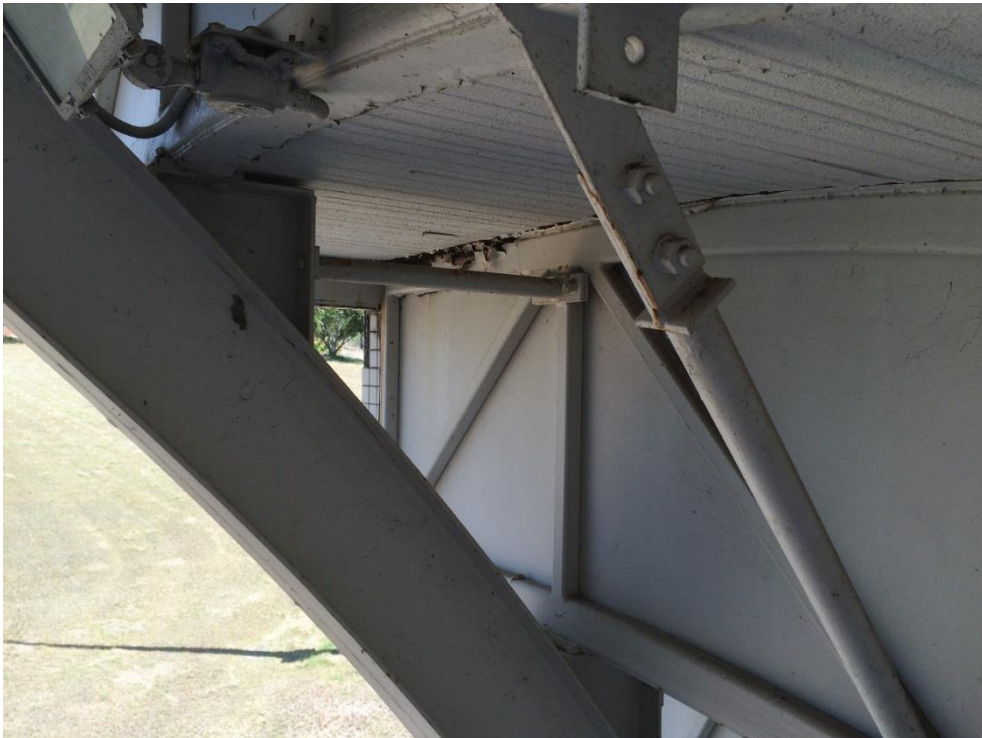
Photo 163 - Minor corrosion to bottom plate

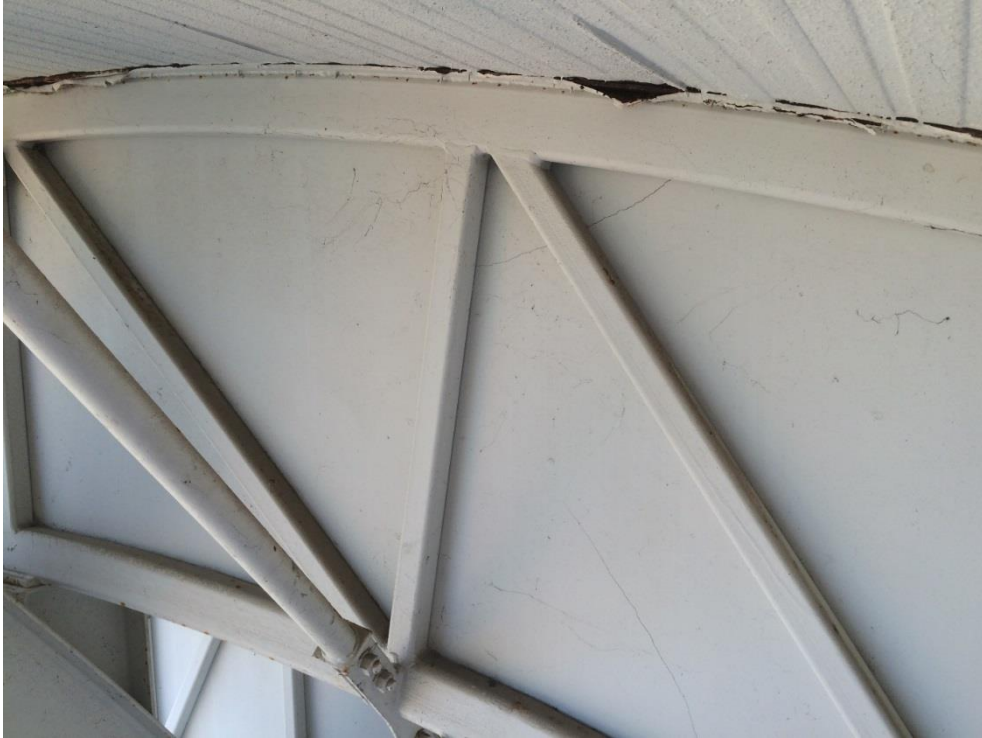
Photo 164 - Minor corrosion to top plate

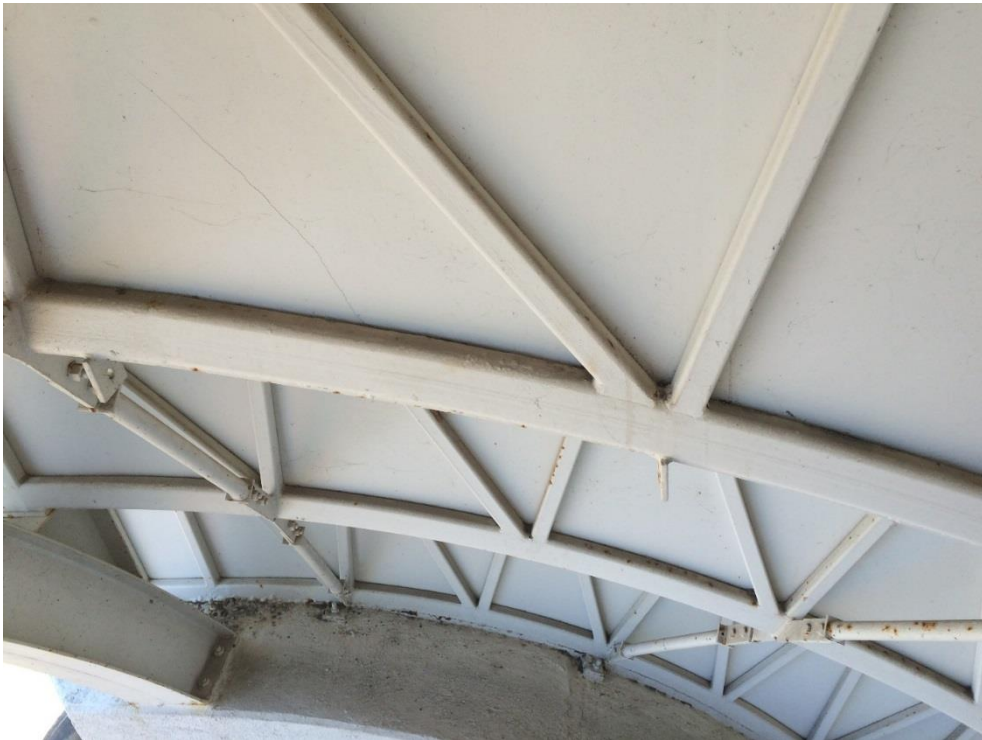
Photo 165 - Minor corrosion to bottom plate

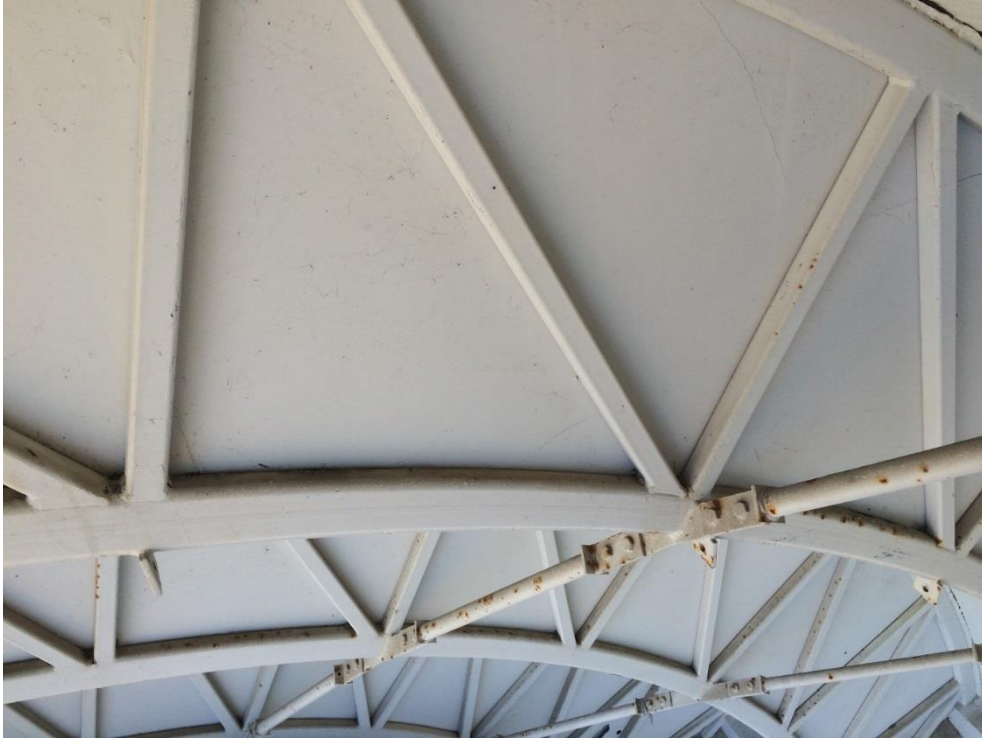
Photo 166 - Minor corrosion to bottom chord

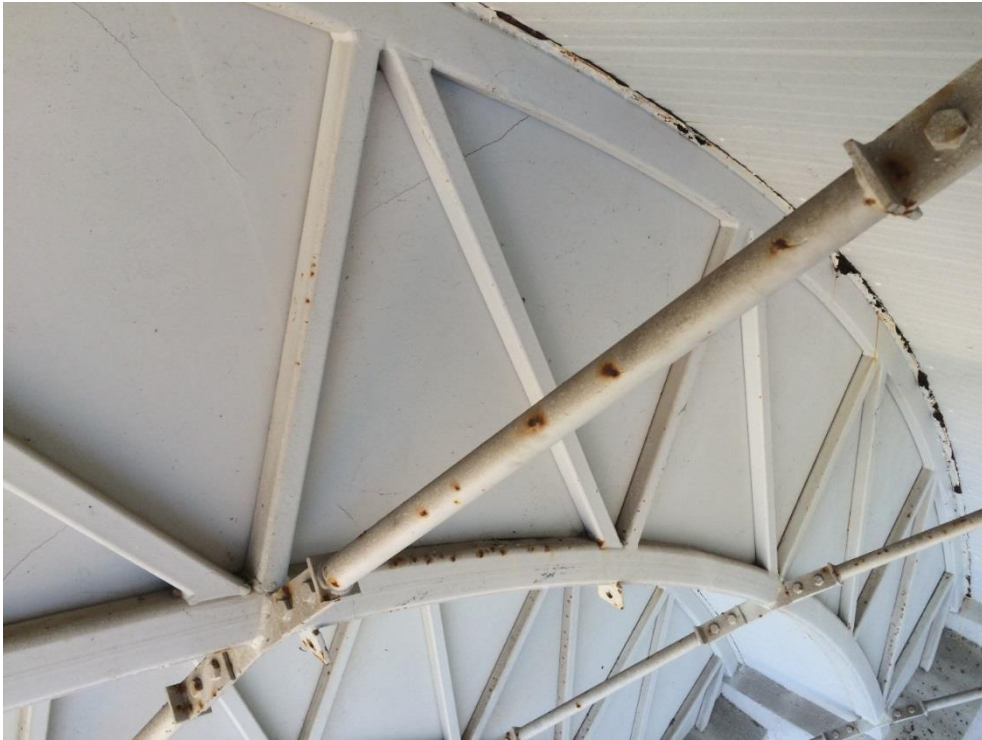
Photo 167 - Minor corrosion to bottom chord

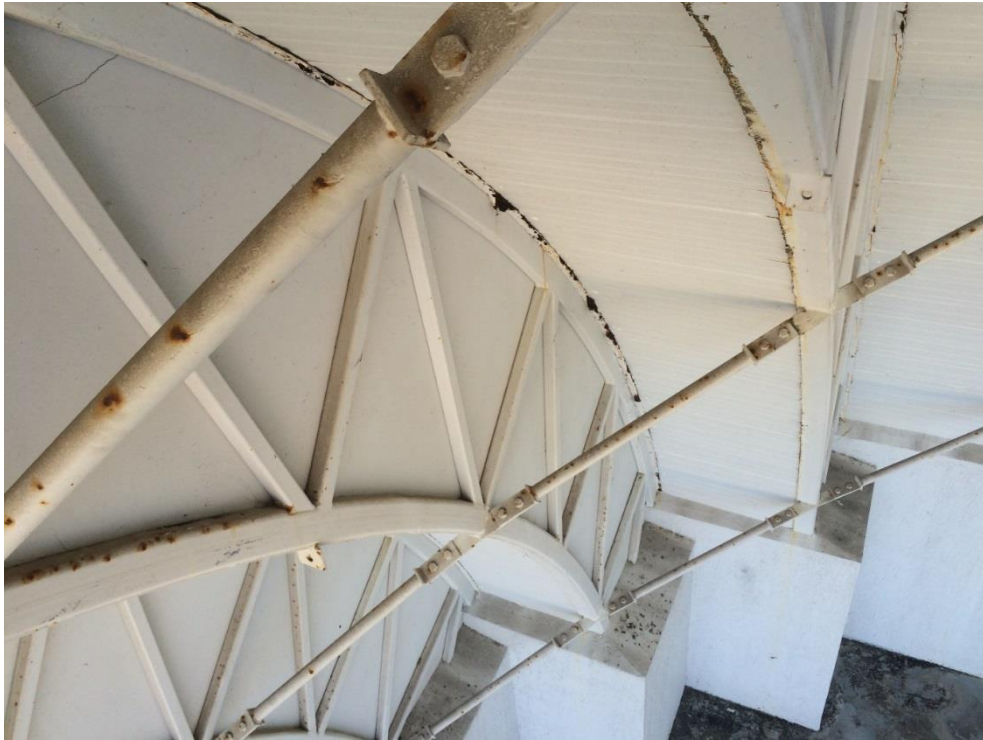
Photo 168 - Minor corrosion to bottom plate and top plate

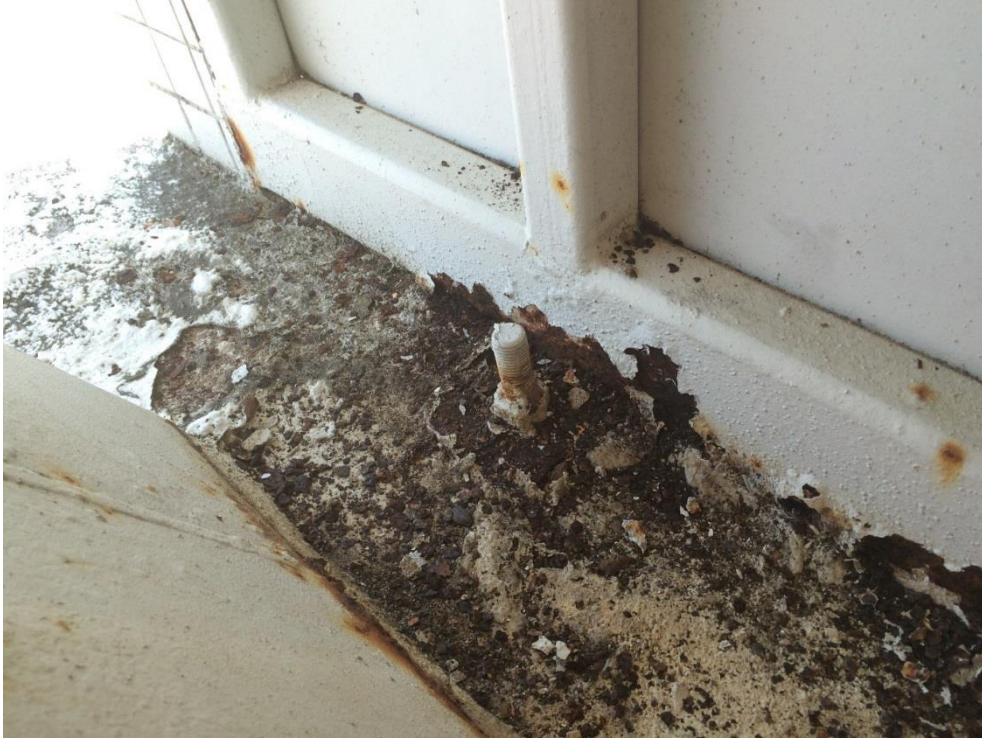
Photo 172 - Heavy corrosion to tab plate and nut

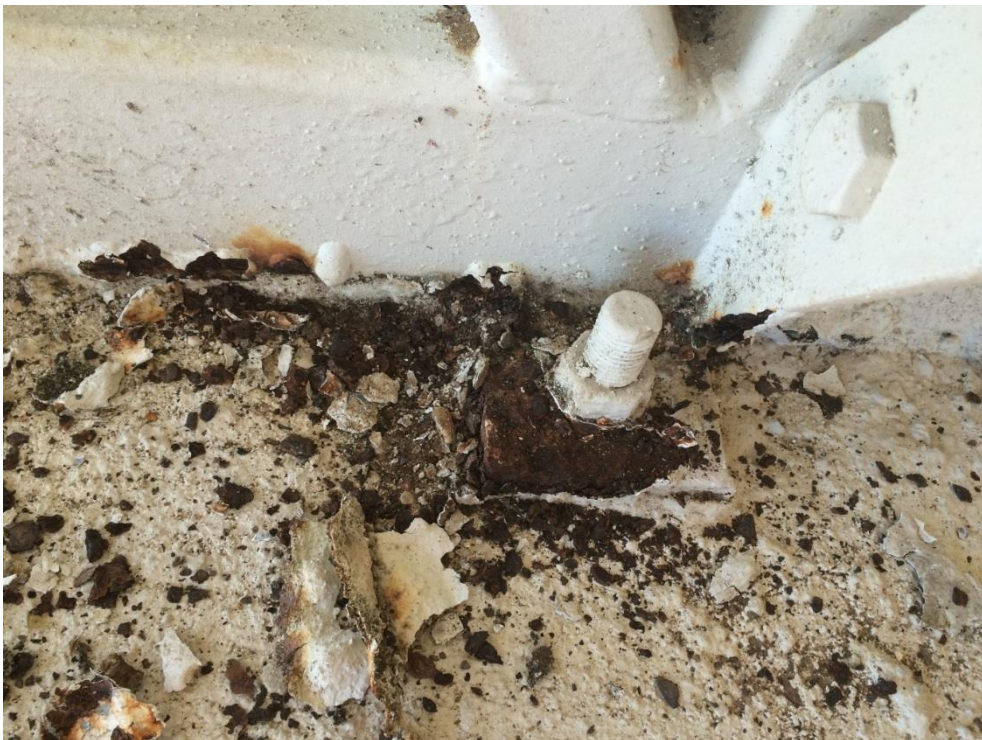
Photo 173 - Heavy corrosion to tab plate and nut

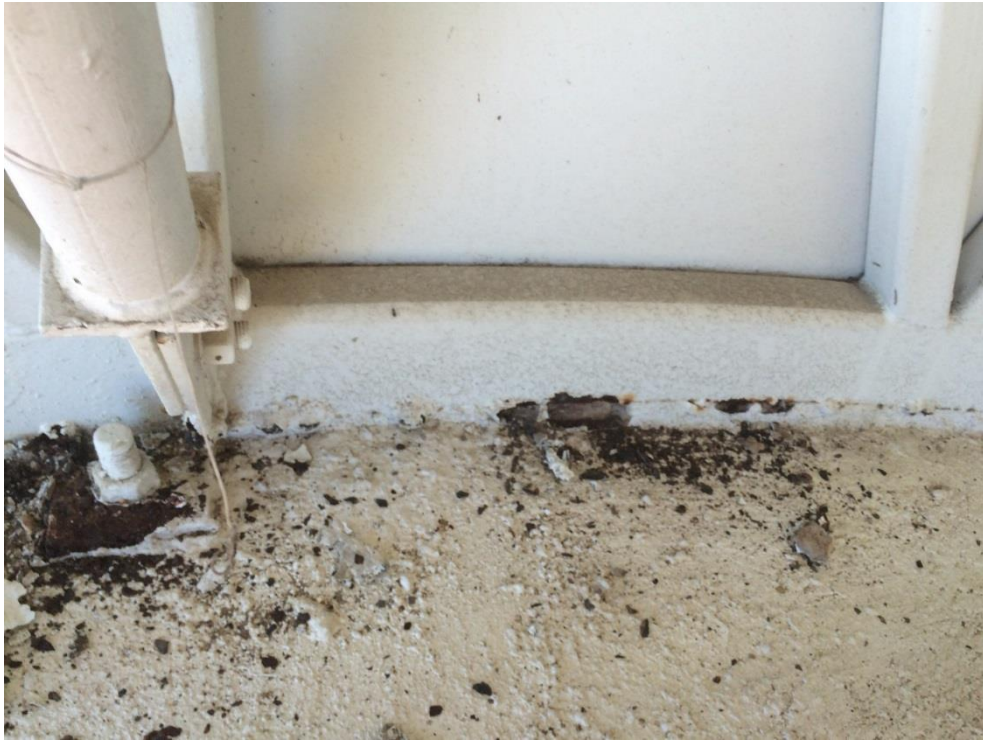
Photo 174 - Heavy corrosion to the side of bottom chord

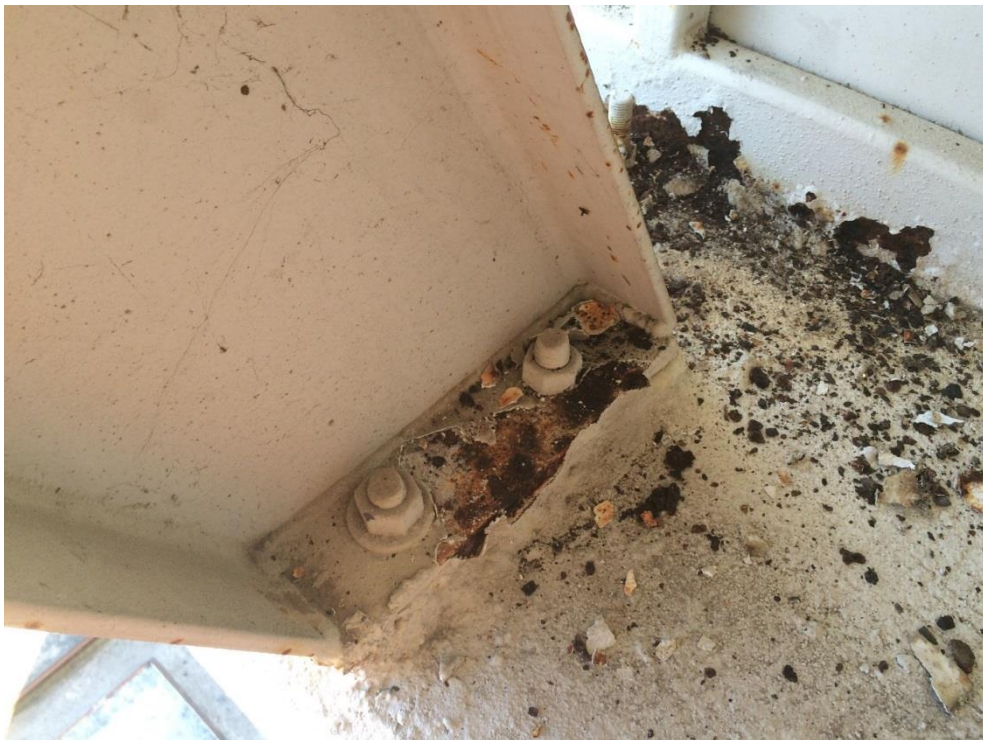
Photo 175 - Minor corrosion to main arch base plate

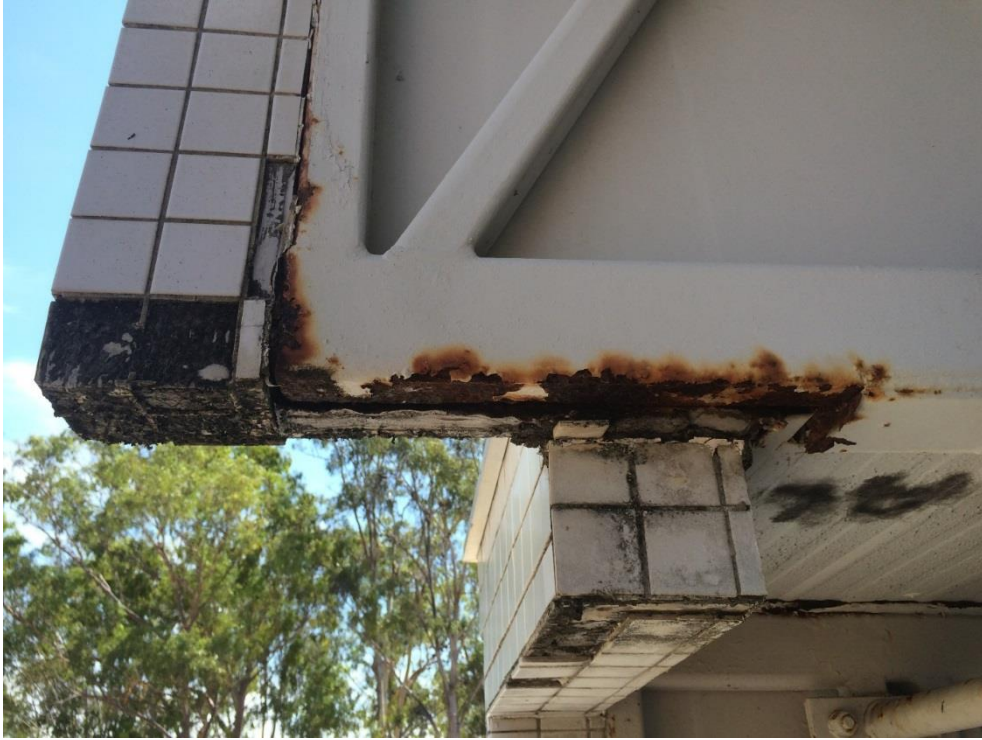
Photo 176 - Heavy corrosion to bottom chord at front face of soundshell
