Music Bowl Structural Assessment

24 November 2014

R14265

Prepared for Rockhampton Regional Council

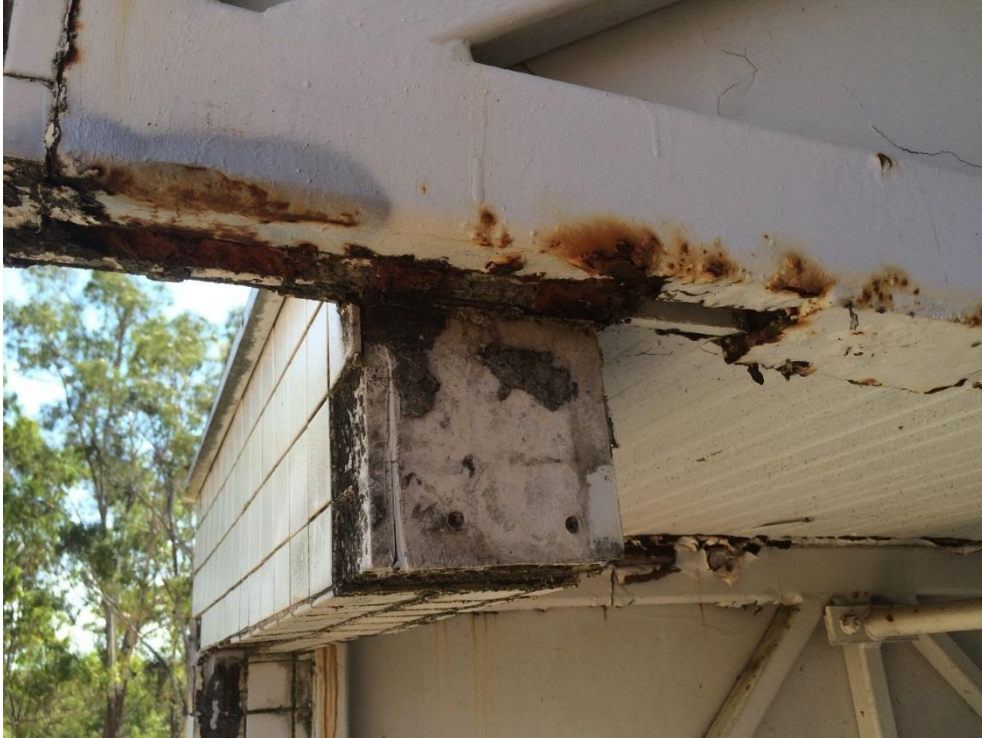
Photo 178 - Heavy corrosion to bottom chord at front face of soundshell

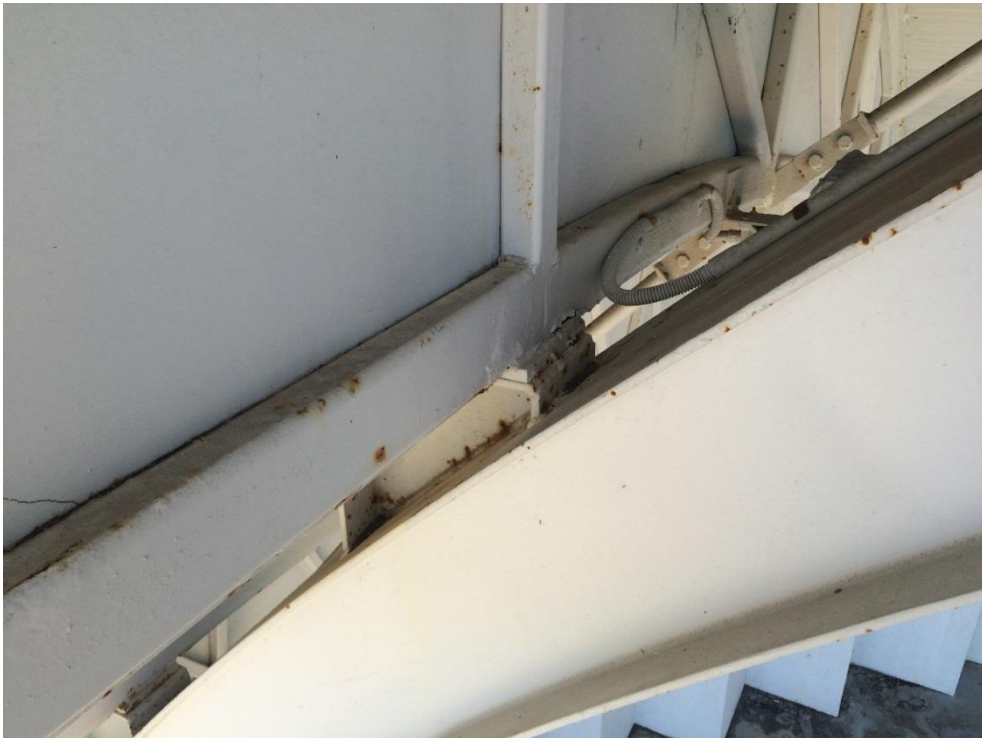
Photo 179 - Minor corrosion to bottom chord of truss

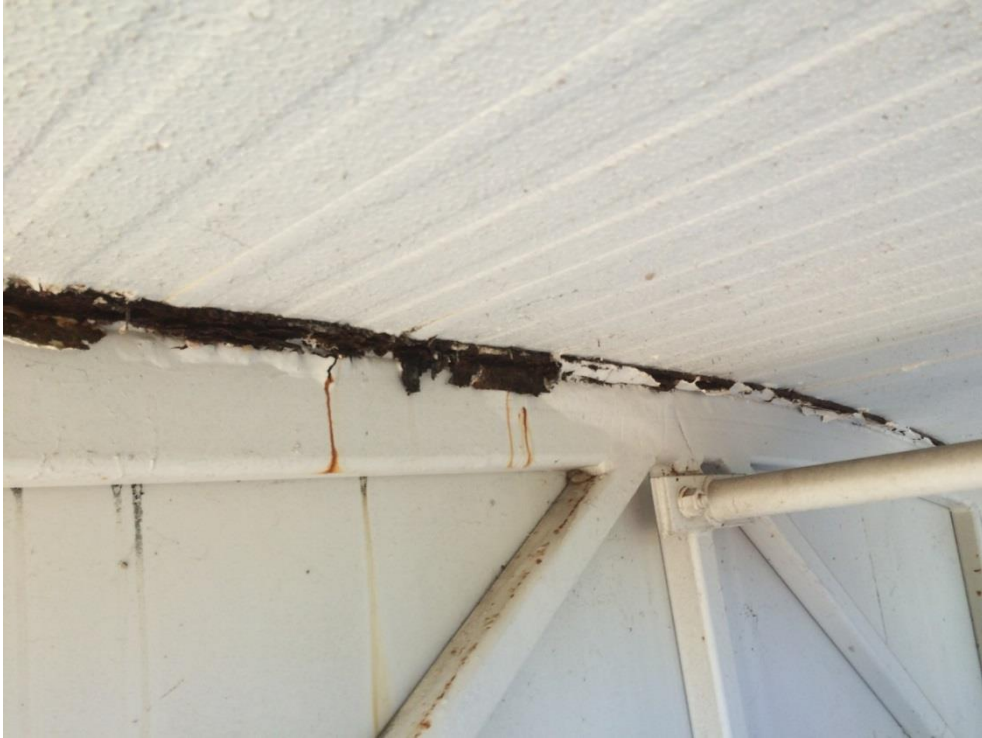
Photo 180 - Heavy corrosion to top plate and top chord of truss

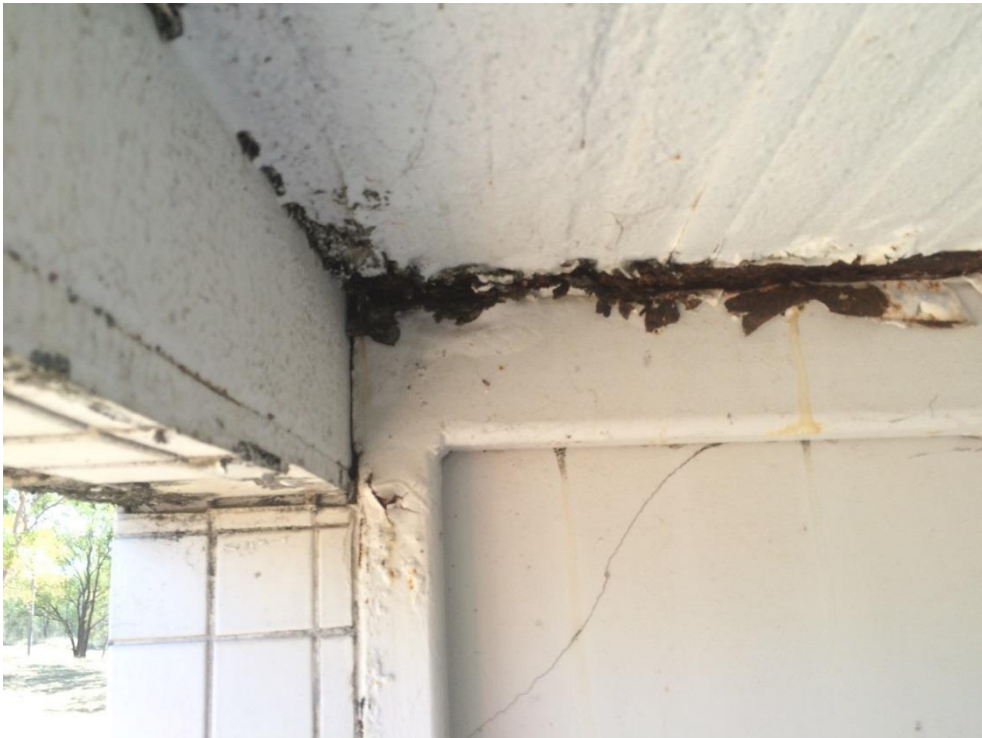
Photo 181 - Heavy corrosion to top plate and top chord of truss

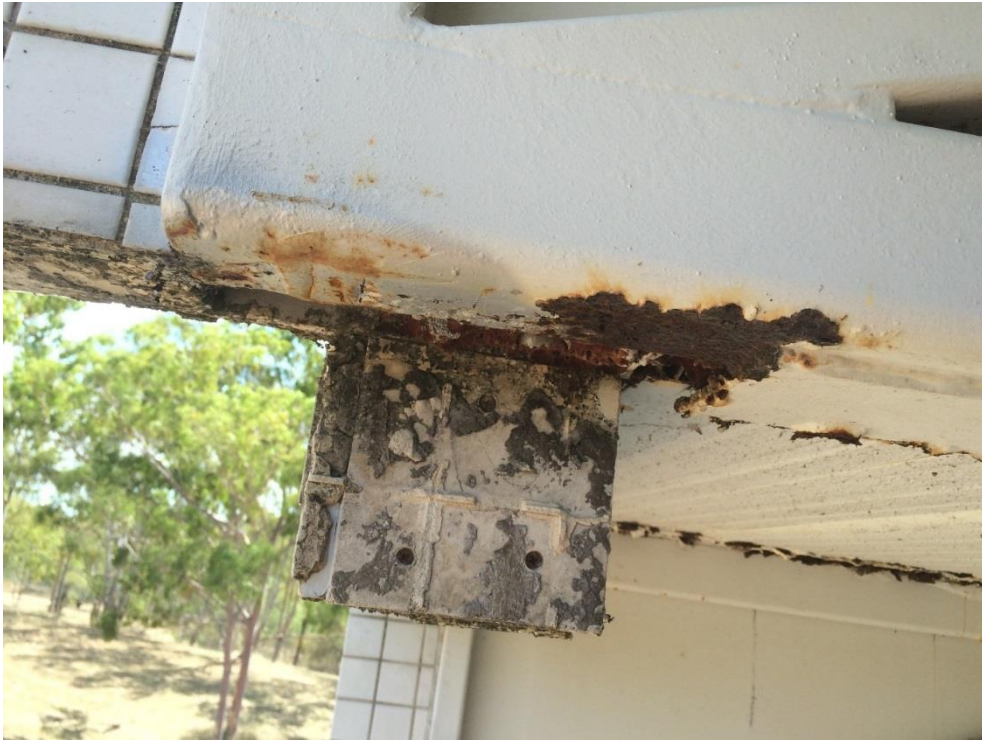
Photo 186 - Heavy corrosion to bottom chord at front face of soundshell

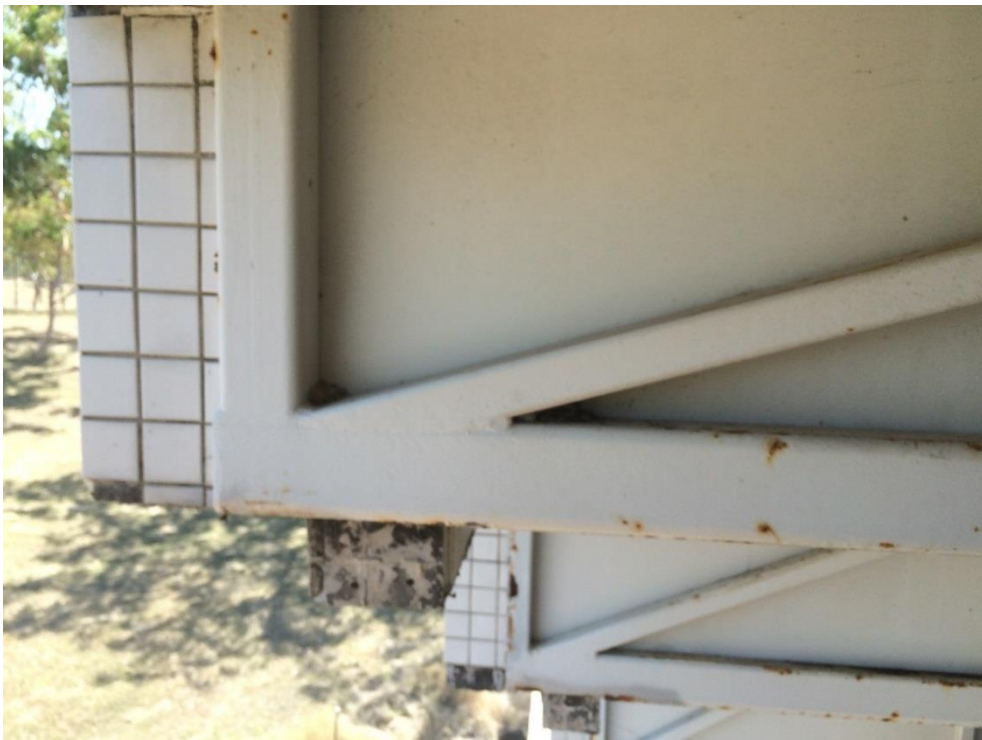
Photo 187 - Minor corrosion to bottom chord

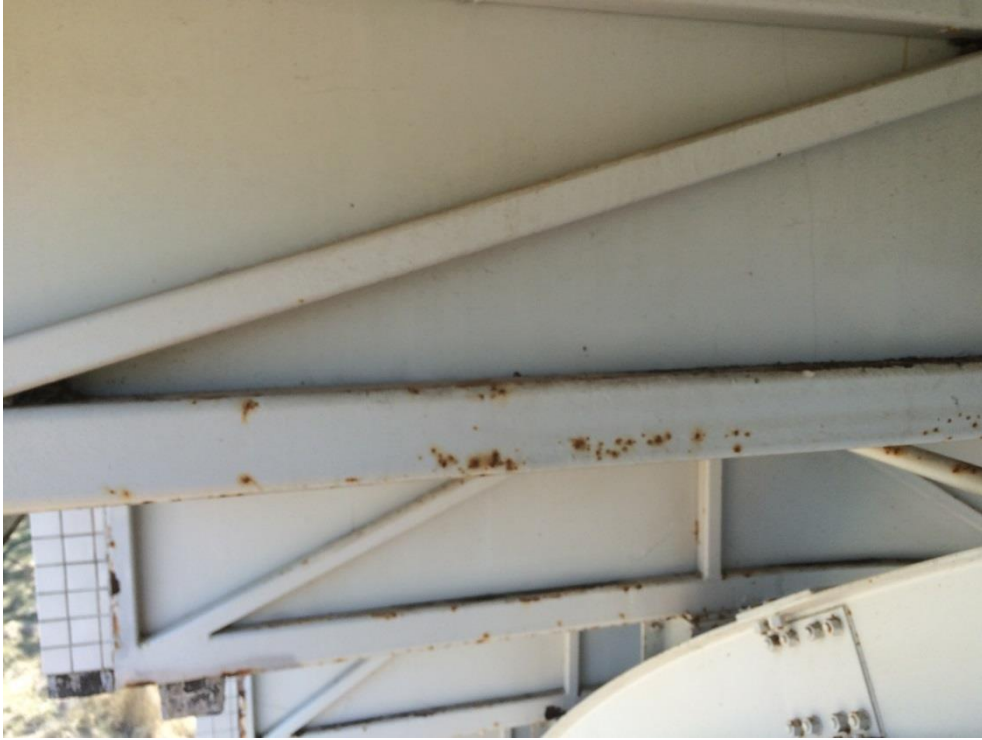
Photo 188 - Minor corrosion to bottom chord

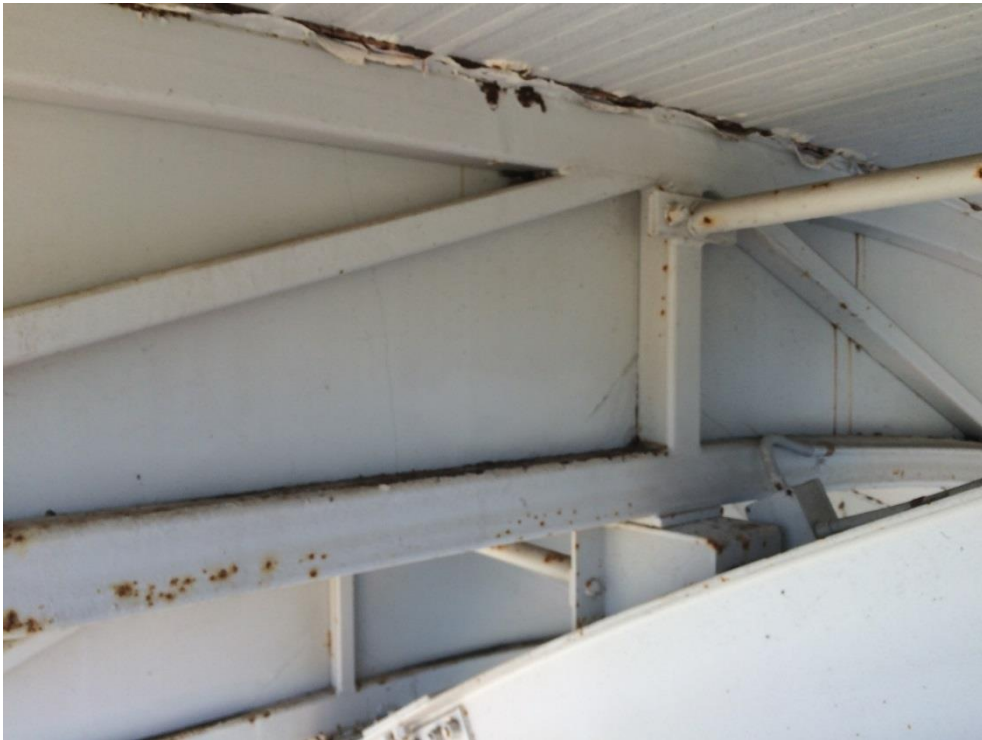
Photo 189 - Minor corrosion to bottom chord

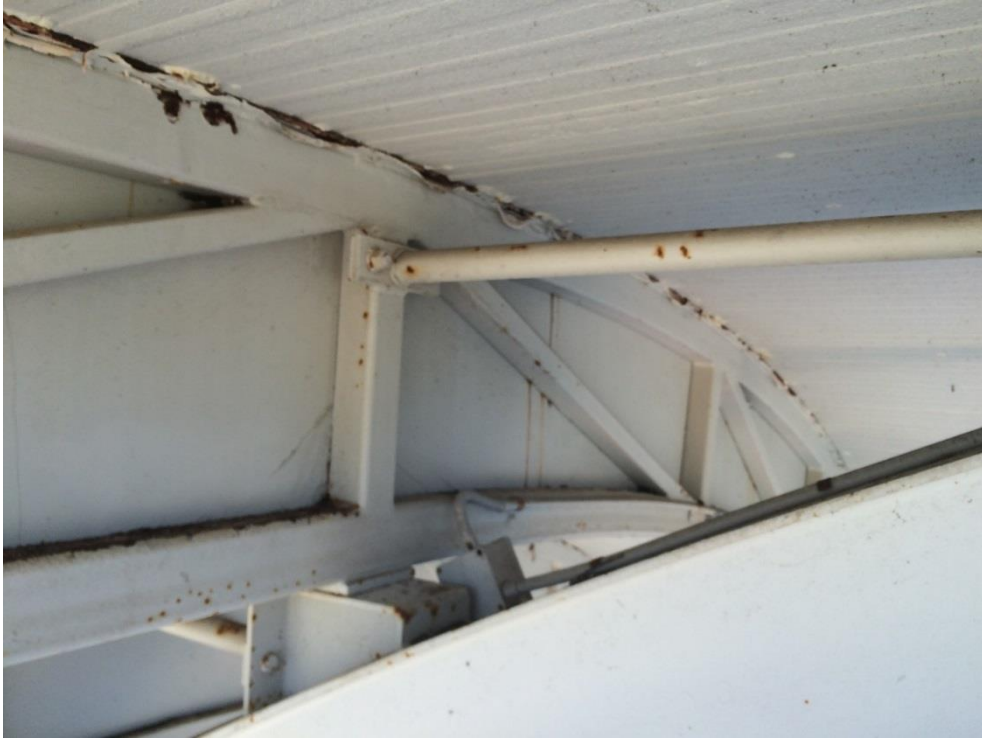
Photo 190 - Minor corrosion to bottom chord

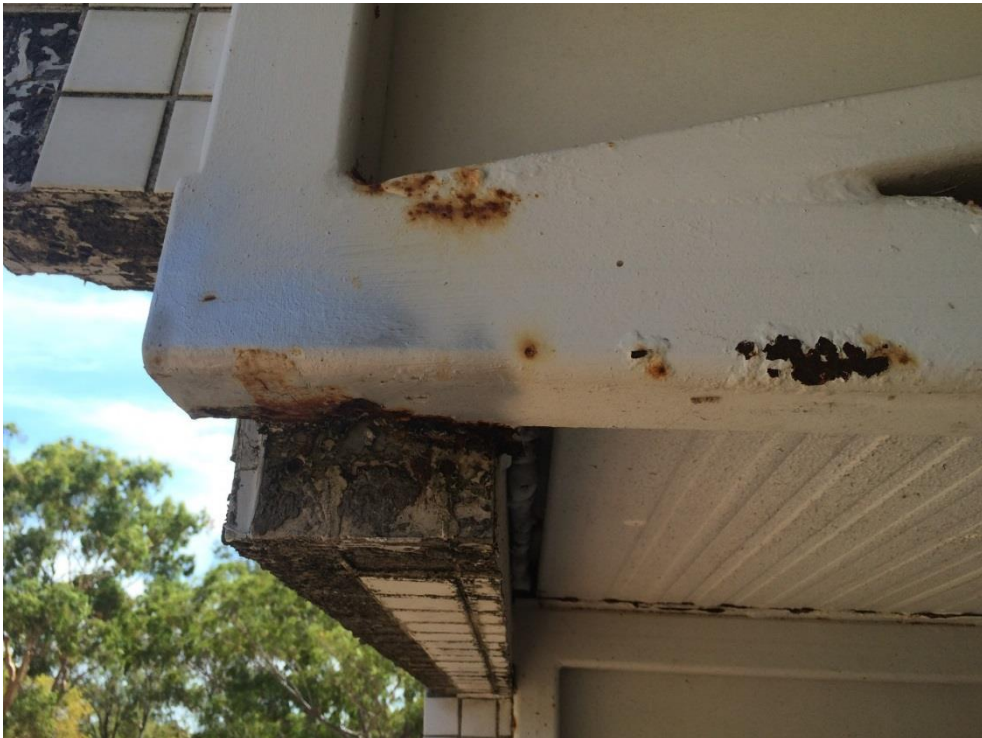
Photo 191 - Minor corrosion to bottom chord at front face of soundshell

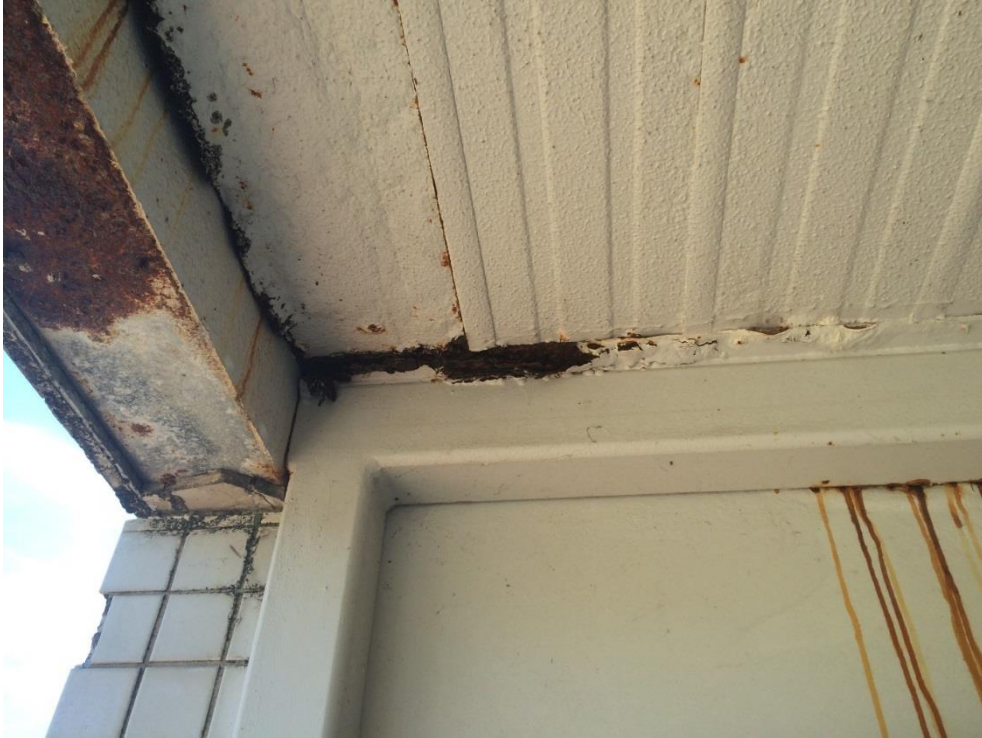
Photo 192 - Heavy corrosion to top plate, minor corrosion to metal formwork, heavy corrosion to fascia

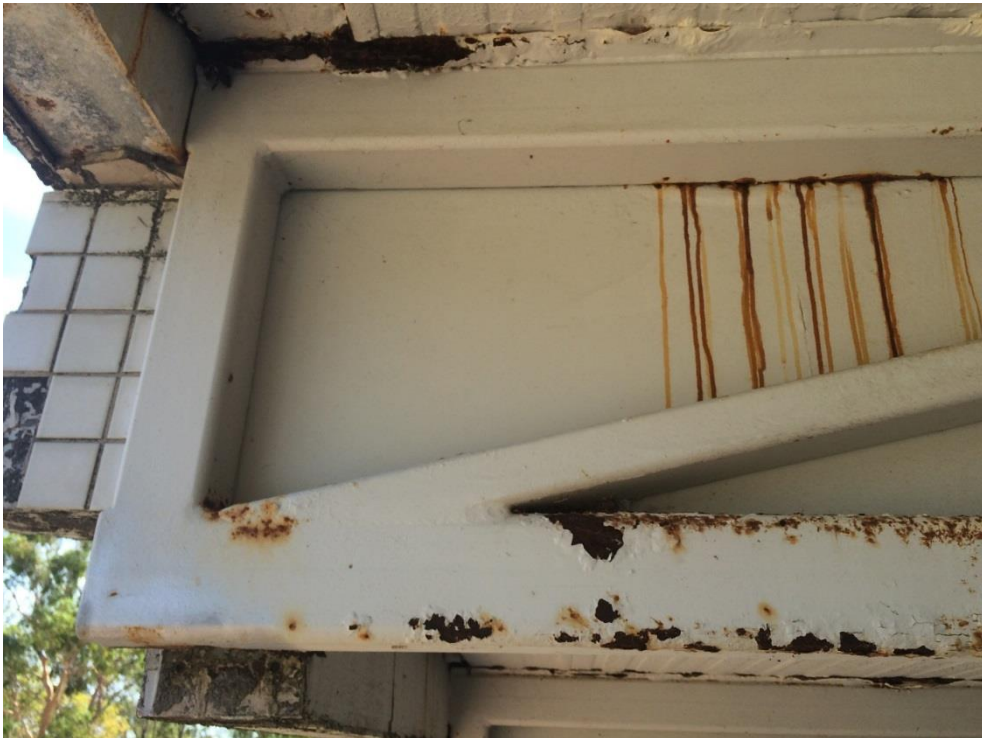
Photo 193 - Heavy corrosion to top plate and bottom chord

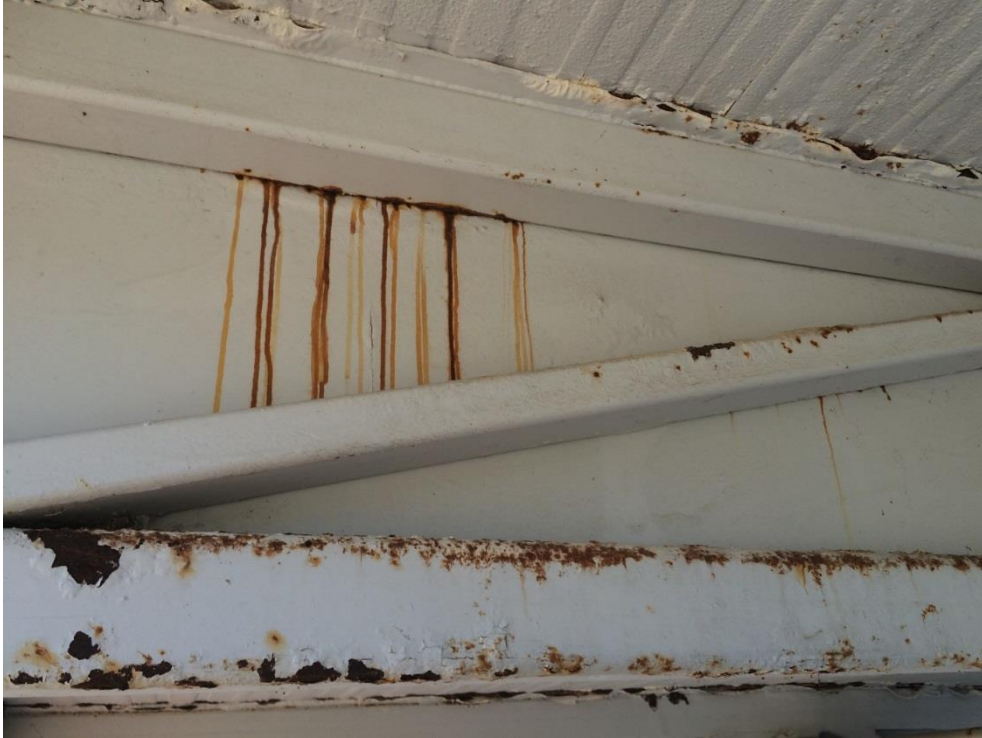
Photo 194 - Heavy corrosion to top plate and bottom chord

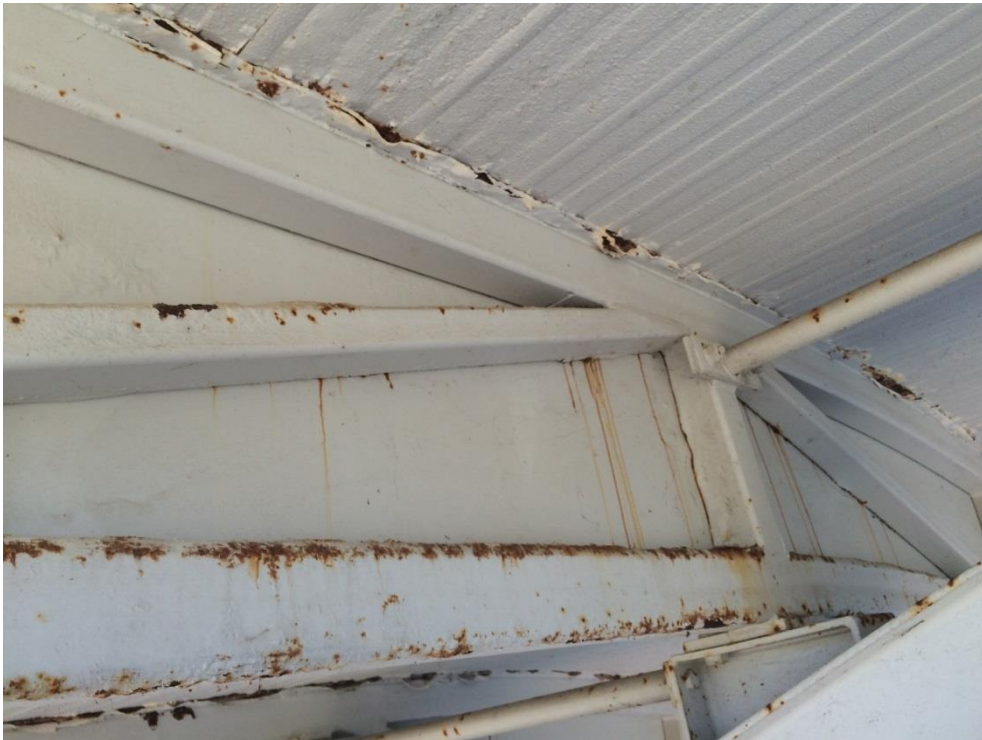
Photo 195 - Heavy corrosion to top plate and bottom chord

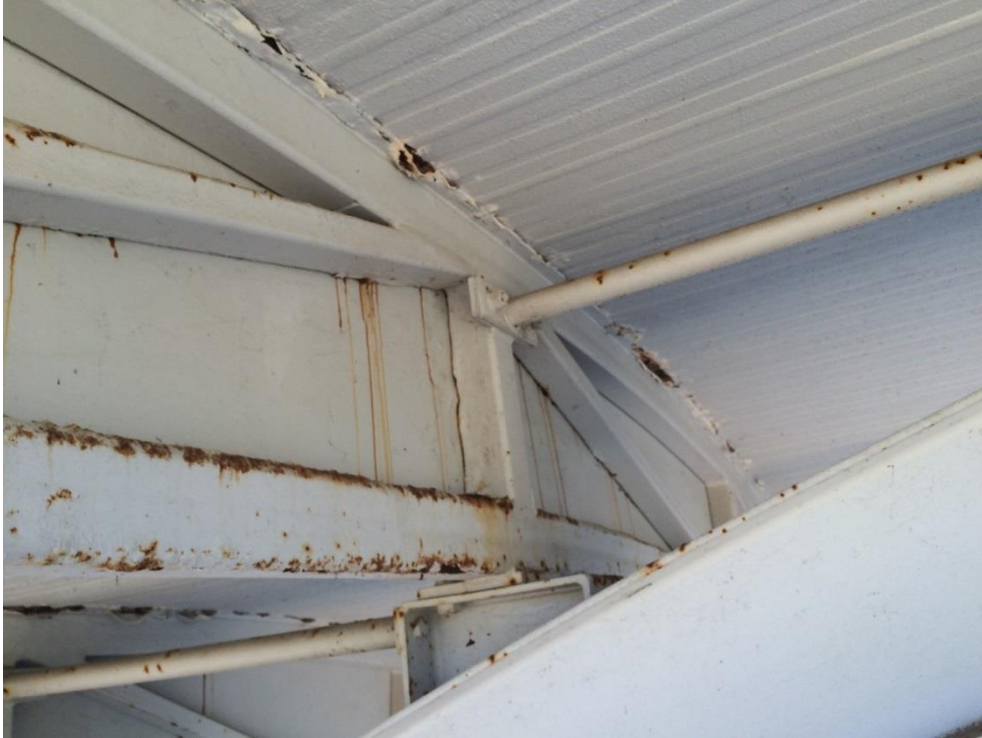
Photo 196 - Heavy corrosion to top plate and bottom chord

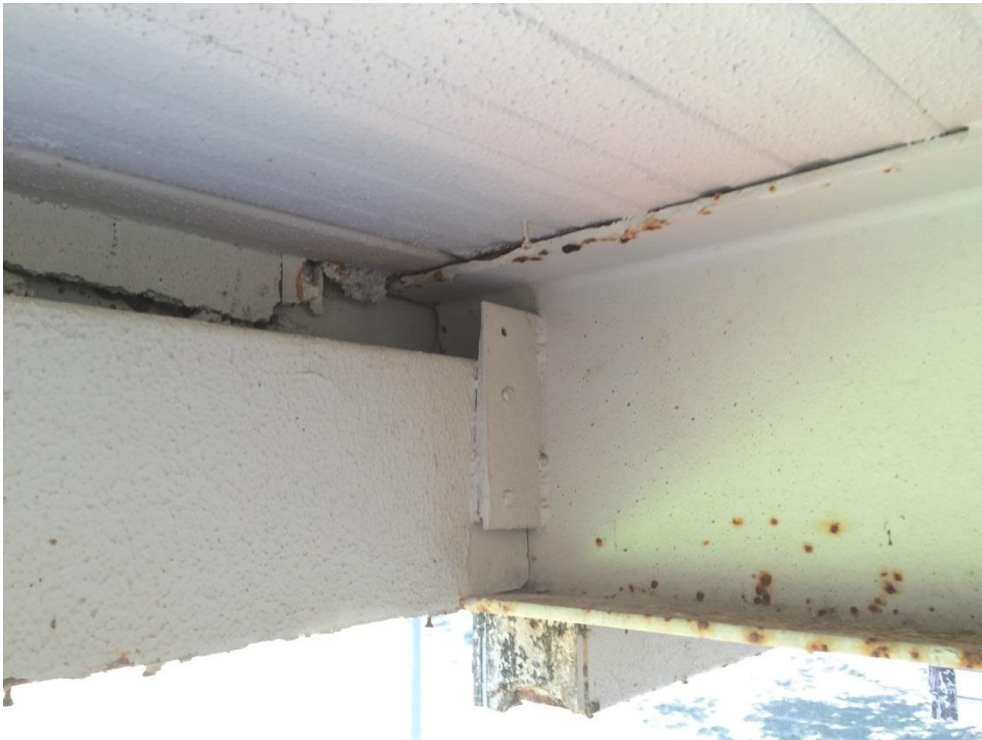
Photo 197 - Minor corrosion to roof beam

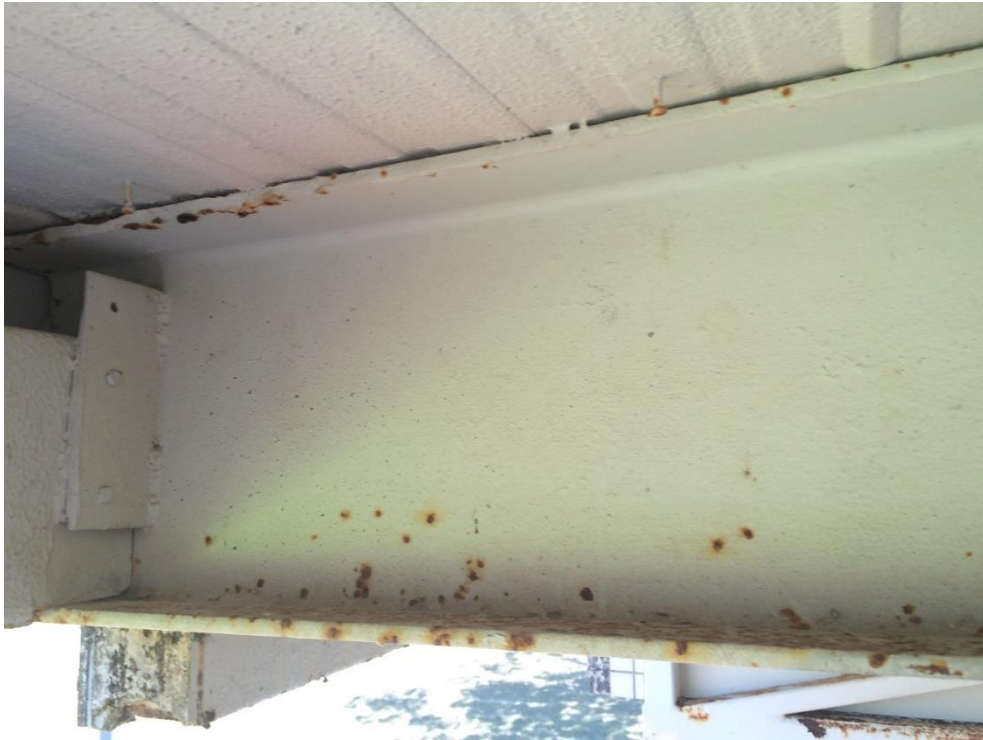
Photo 198 - Minor corrosion to roof beam

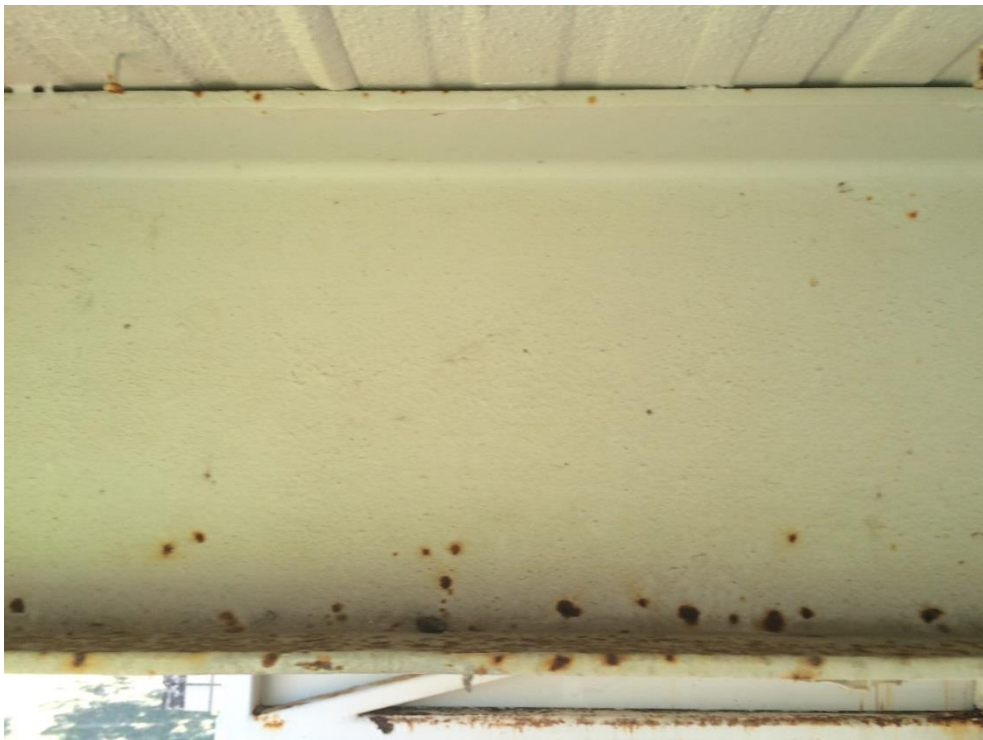
Photo 199 - Minor corrosion to roof beam

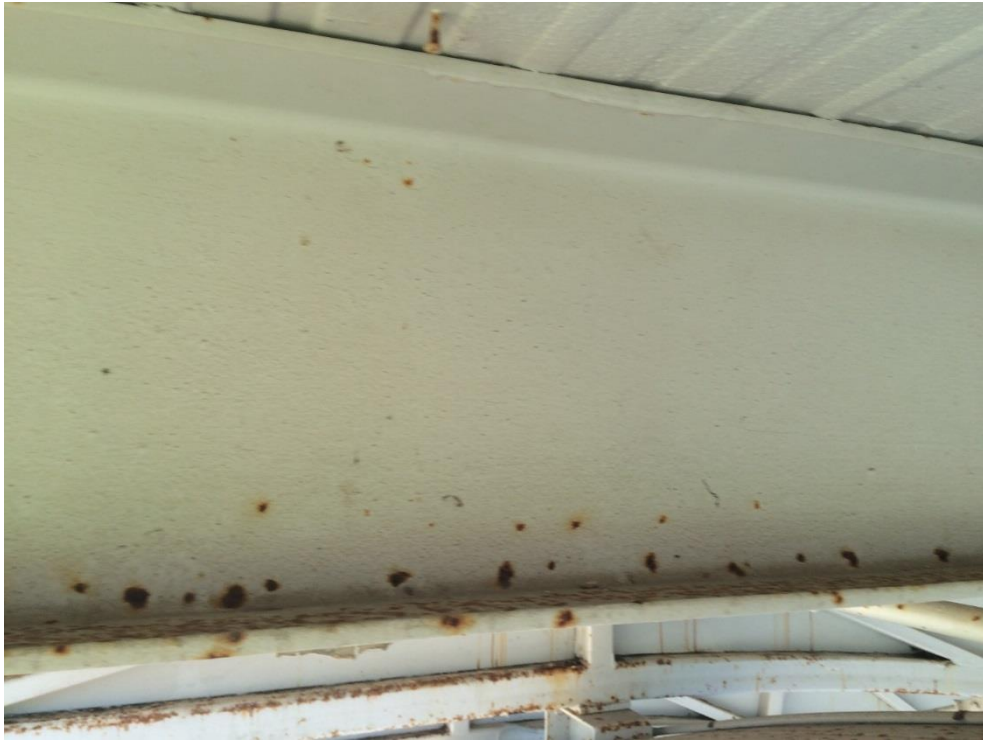
Photo 200 - Minor corrosion to roof beam

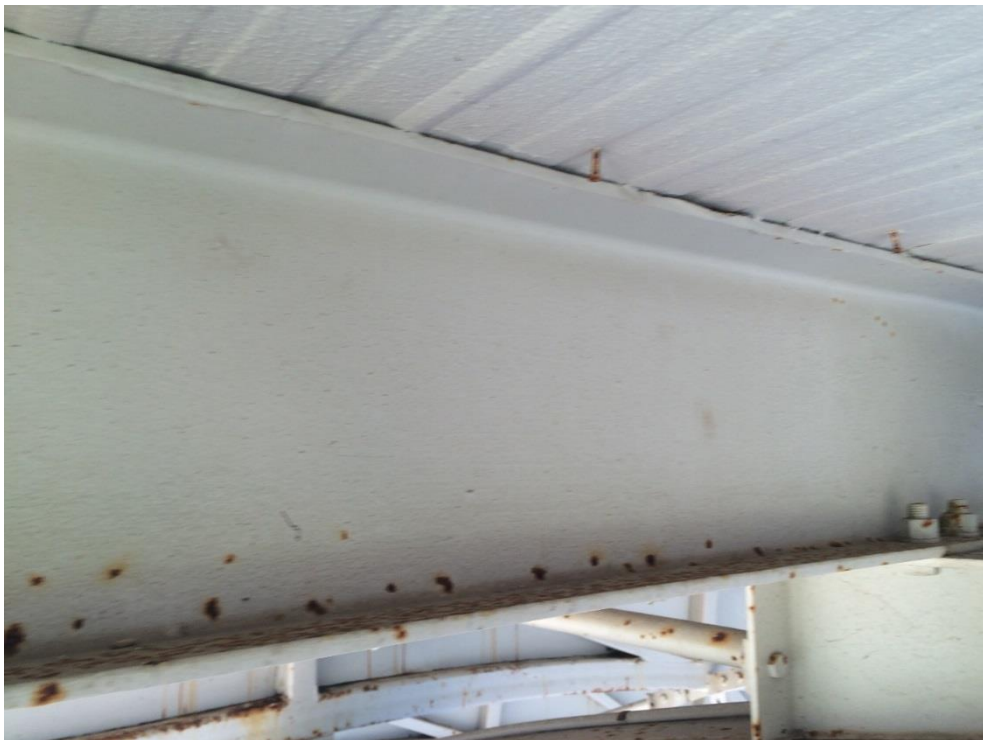
Photo 201 - Minor corrosion to roof beam

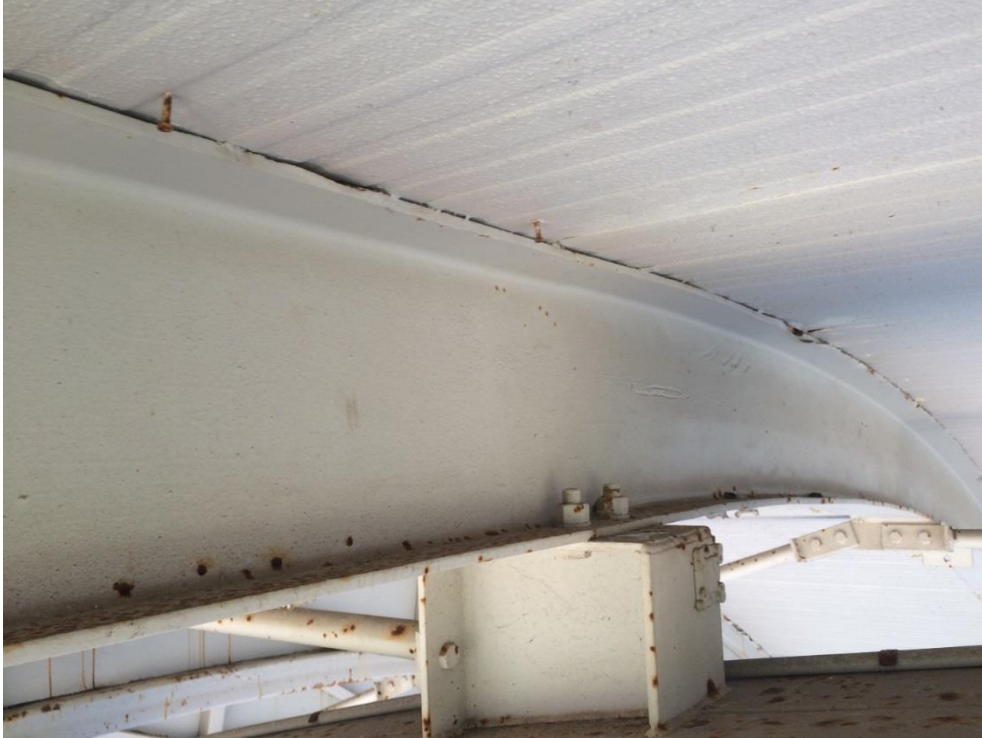
Photo 202 - Minor corrosion to roof beam

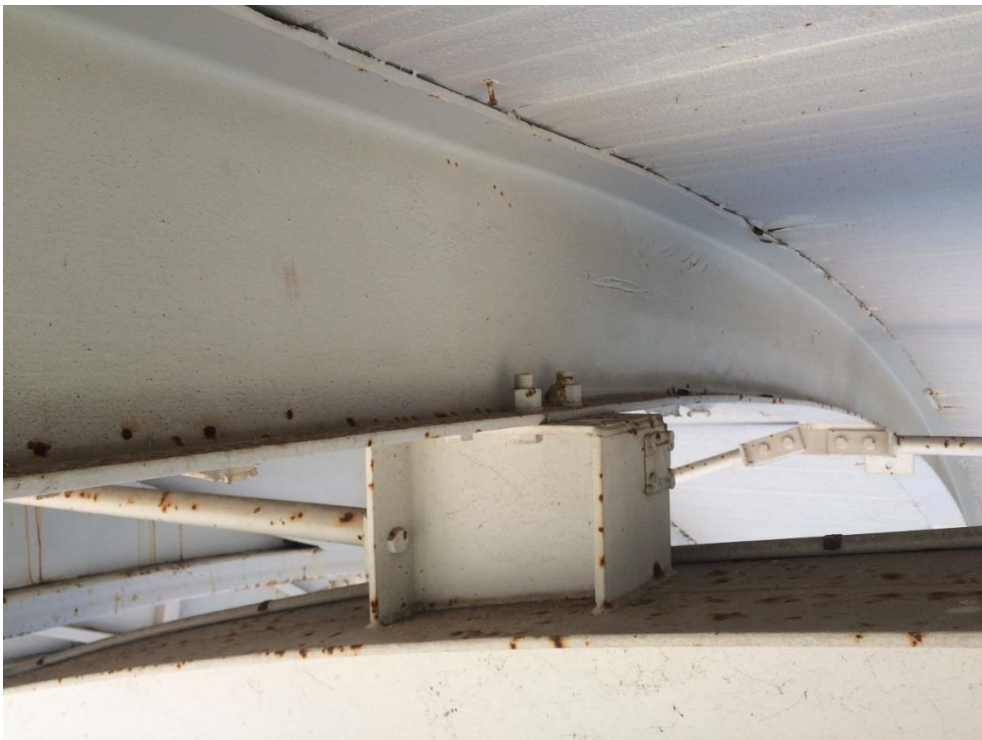
Photo 203 - Minor corrosion to roof beam

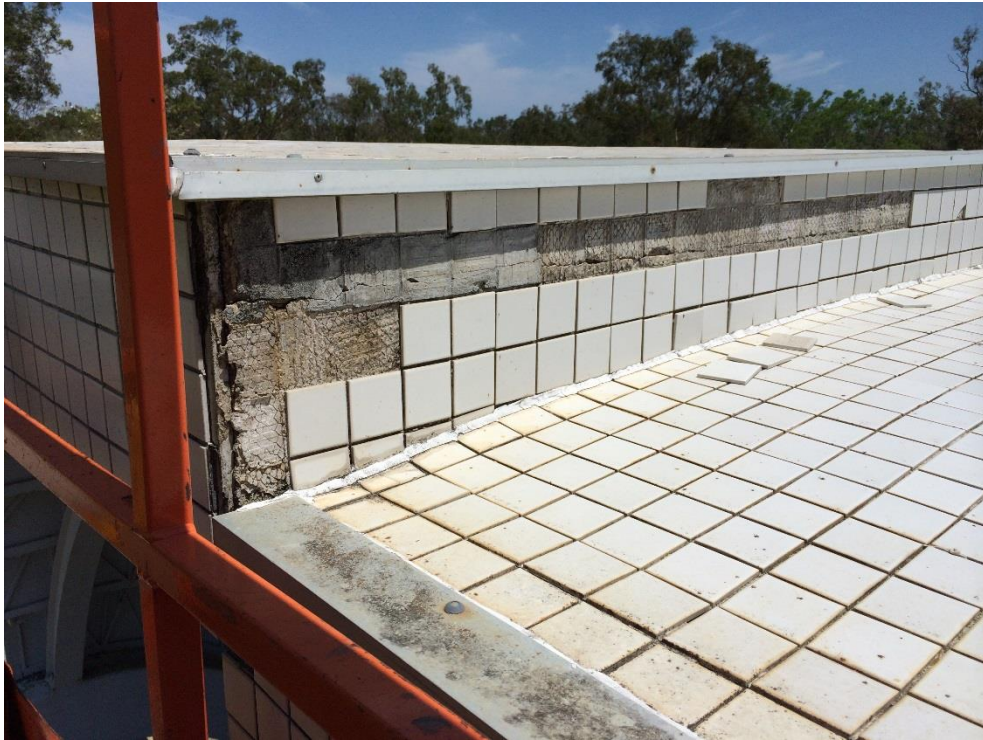
Photo 204 - Tiles missing from vertical surface, aluminium edge capping, evidence of water staining adjacent edge capping

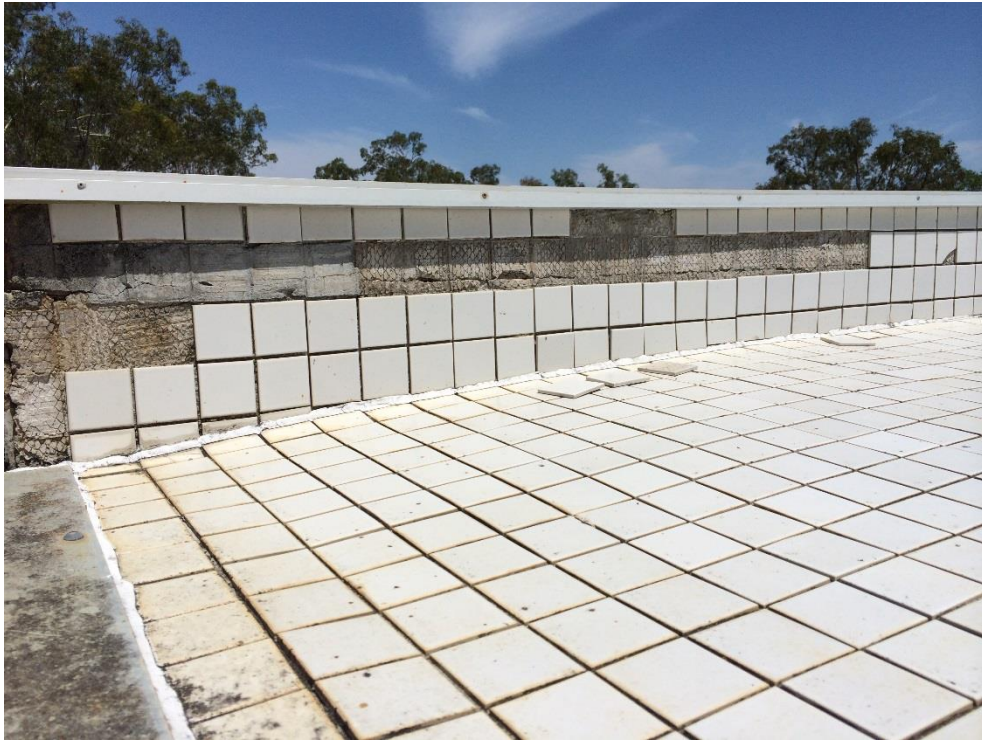
Photo 206 - Tiles missing from vertical surfaces, Horizontal tiled surface at top of sound shell. Evidence of water ponding on horizontal surface

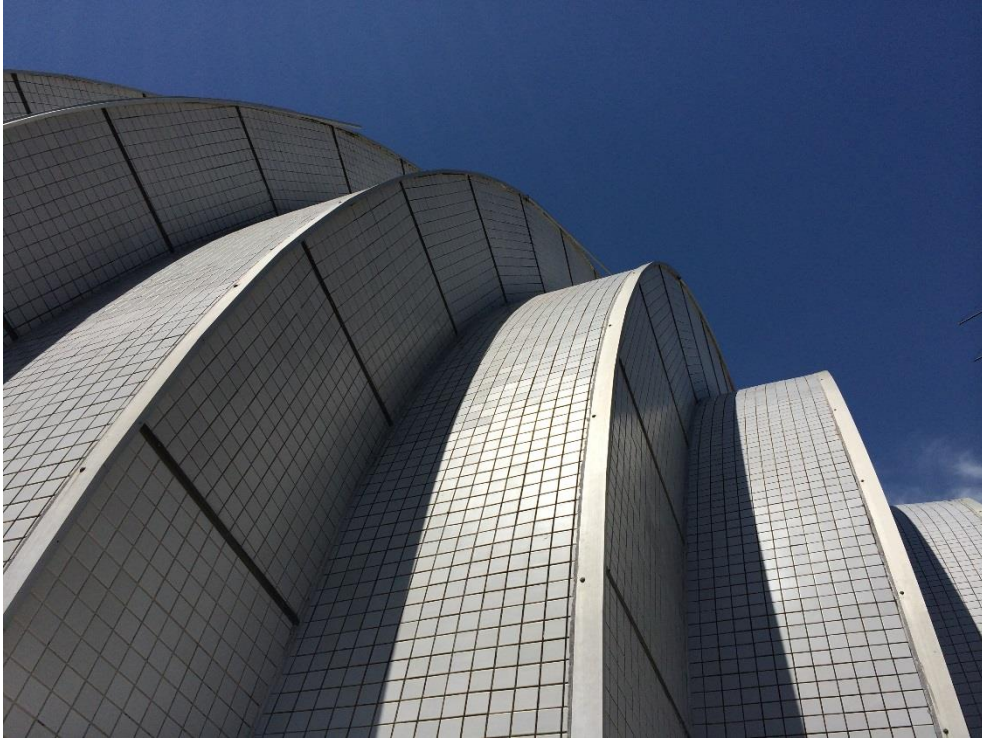
Photo 210 - Rear surface of sound shell, some aluminium edge capping coming loose on curved surfaces

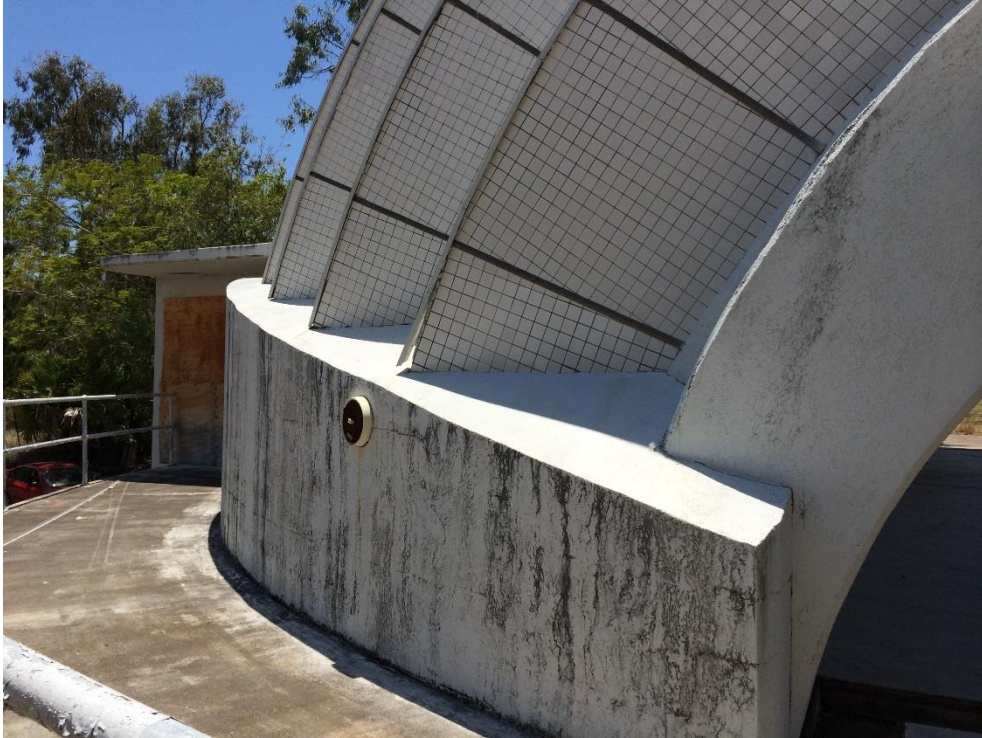
Photo 212 - Rear lower surface of sound shell meeting blockwork plinth. Aluminium capping coming loose

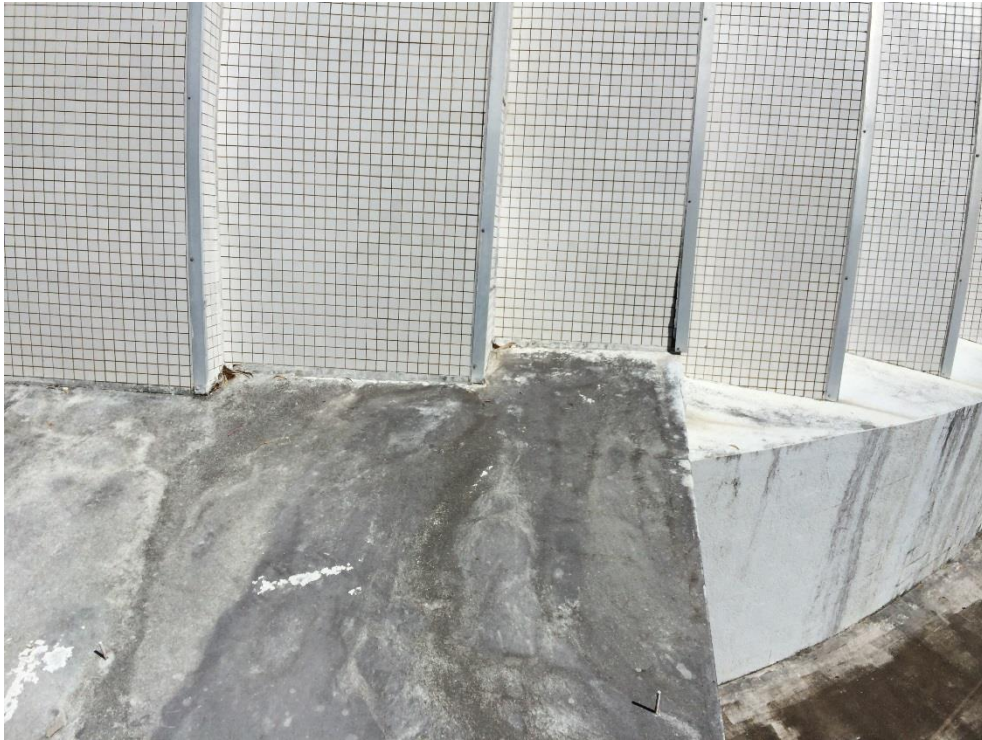
Photo 216 - Rear of sound shell, junction of tiled cladding, aluminium capping coming loose

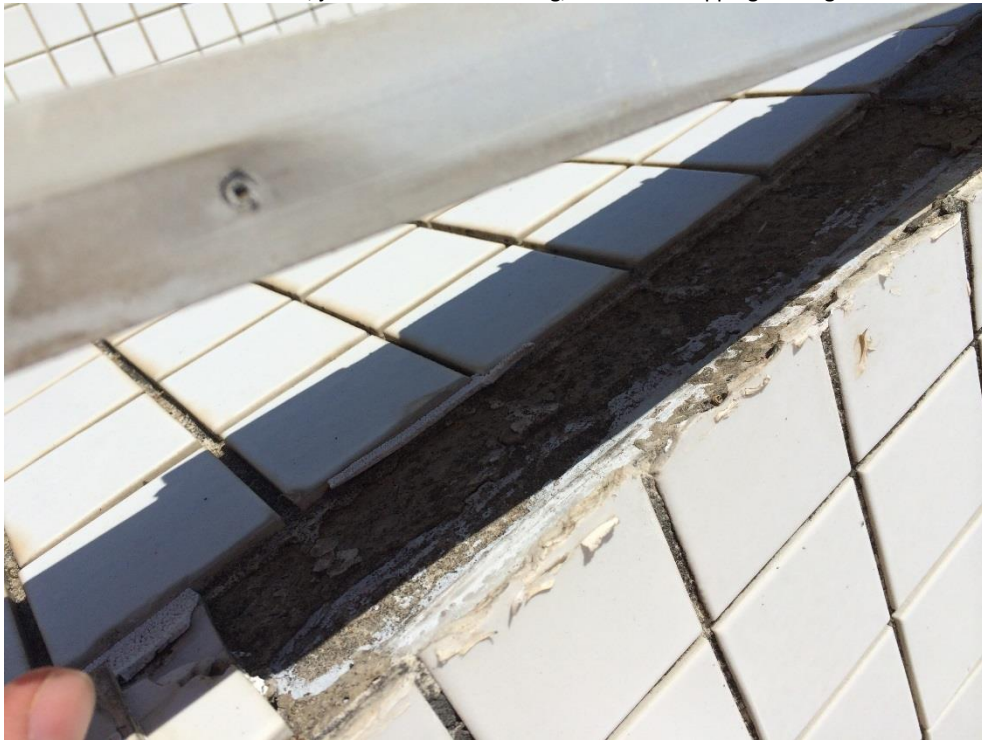
Photo 217 - Detail photo at loose aluminium cladding

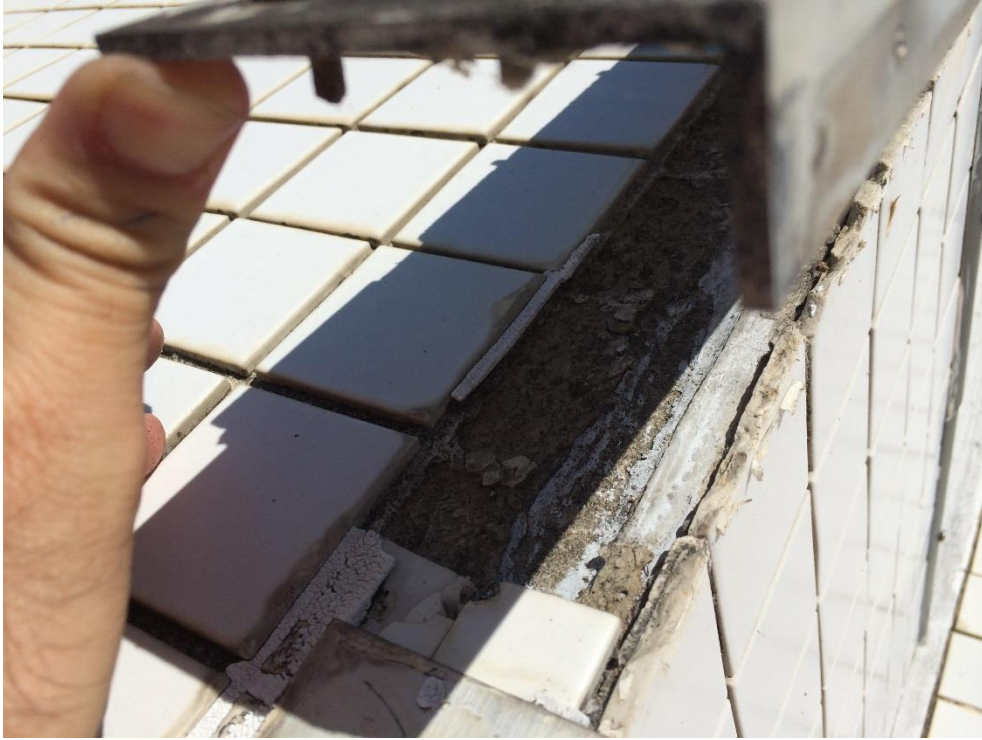
Photo 218 - Detail photo at loose aluminium cladding

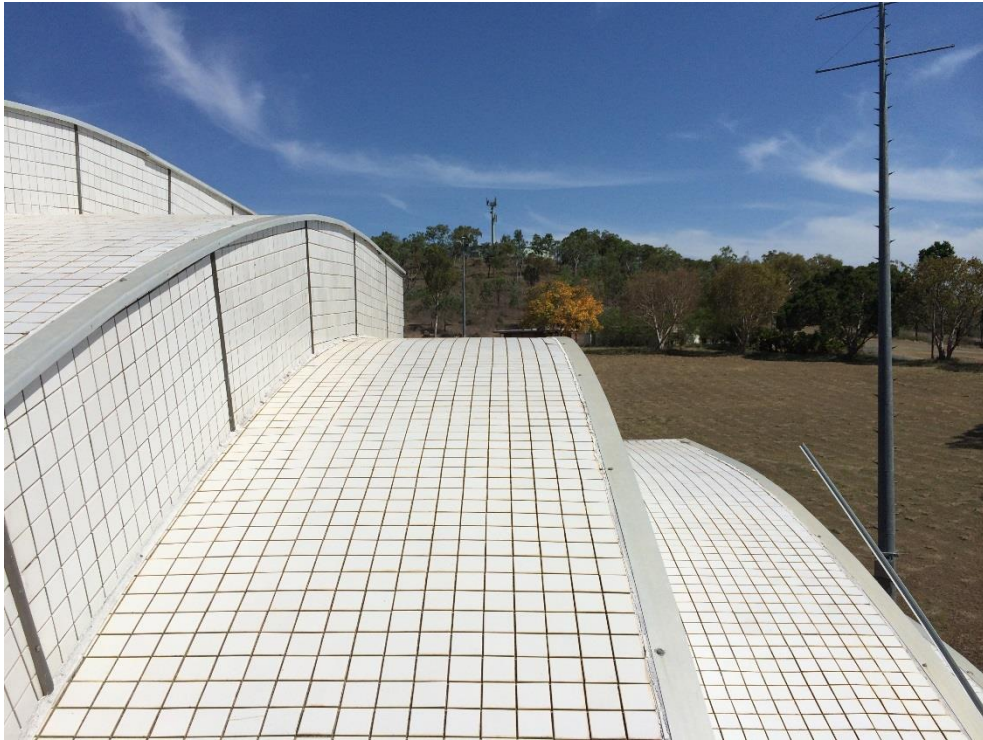
Photo 220 - Loose aluminium capping on rear of sound shell

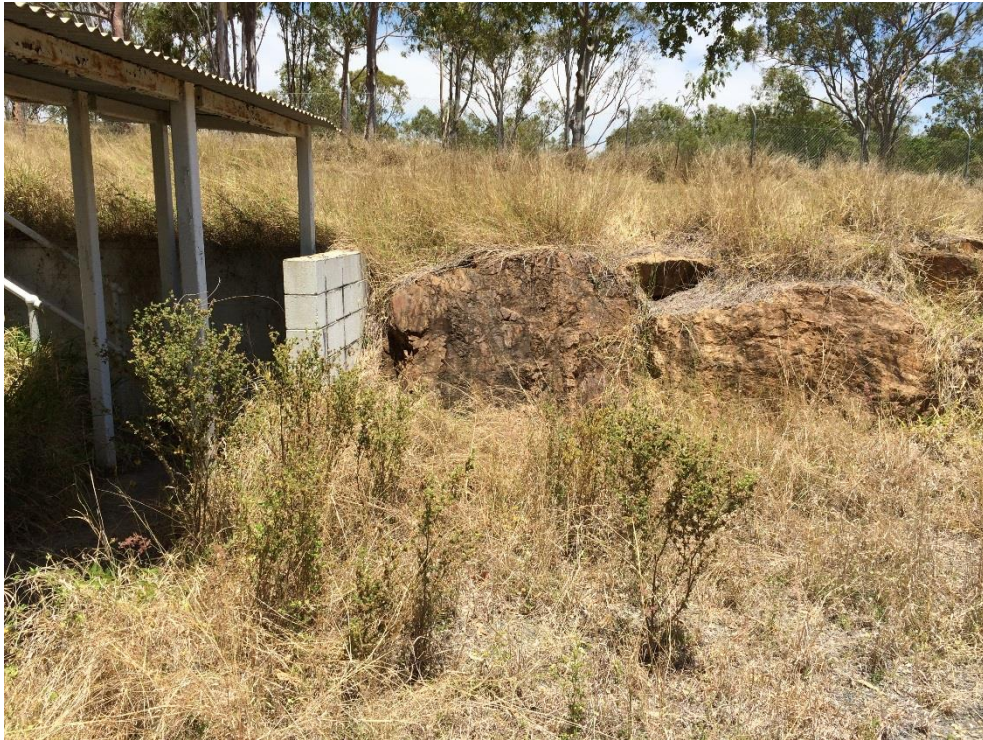
Photo 220 - Overgrown vegetation, boulder wall adjacent covered stairs
