Music Bowl Structural Assessment

24 November 2014

R14265

Prepared for Rockhampton Regional Council

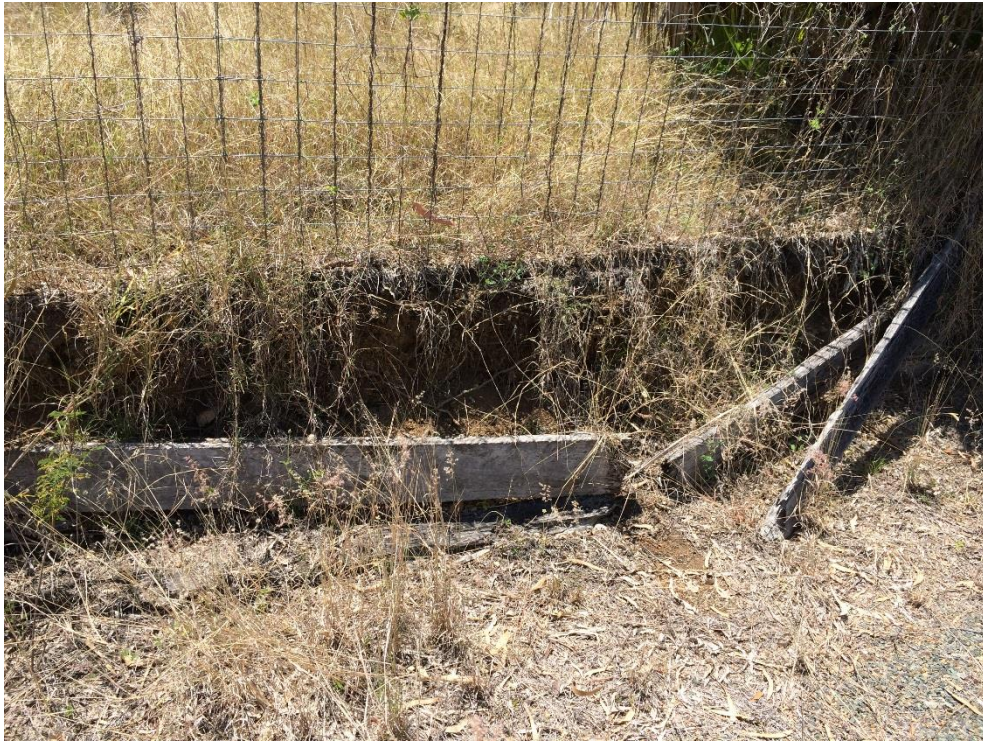
Photo 224 - Timber retaining wall, rotted and collapsed

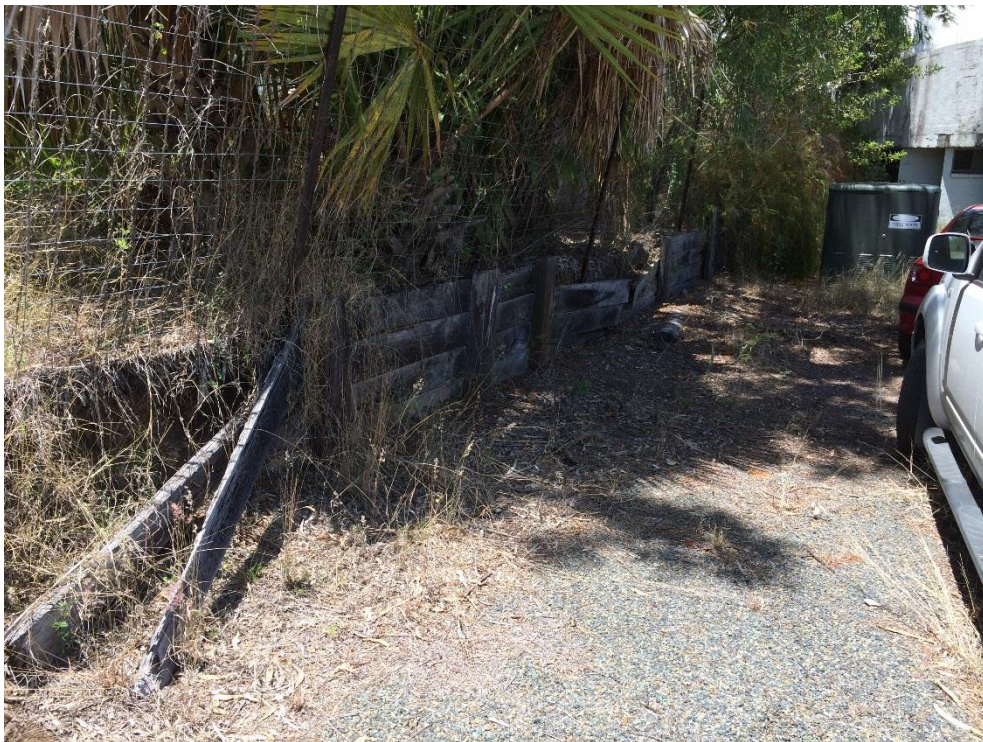
Photo 225 - Timber retaining wall, rotted and collapsed

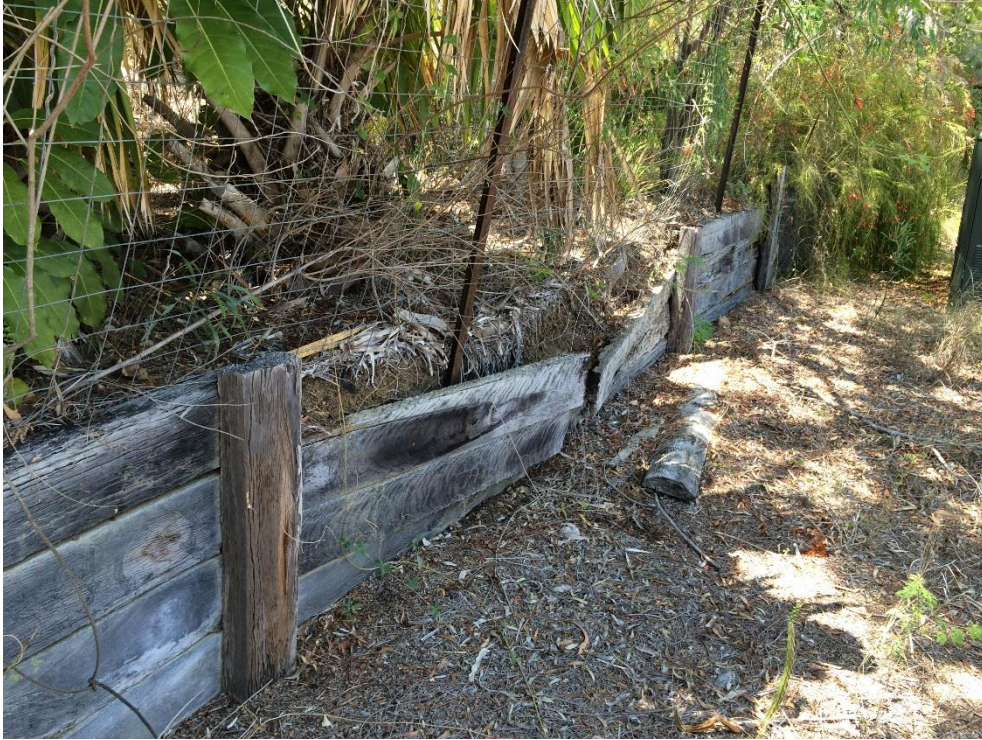
Photo 226 - Timber retaining wall, rotted and collapsed

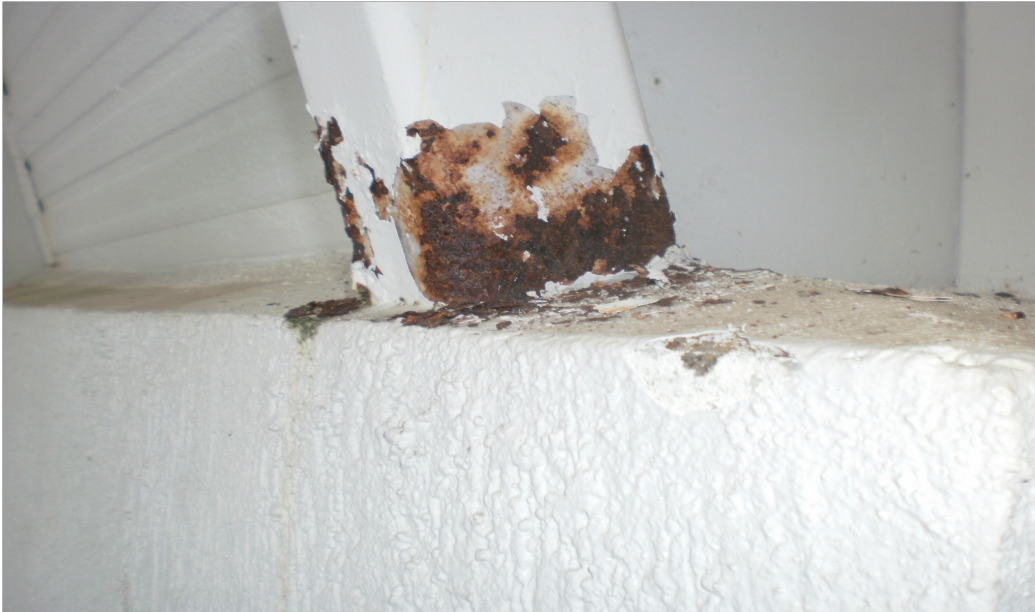
The structural steel to the sound shell is rusted to a lot of the surfaces under the roof of the shell due to the roof leaking at the roof to wall junctions. Refer photo 1 to 4. The steel frame work for the covered walk ways is also covered in surface rust. Refer photo 11.

Rusted Structural Steel (photo 2)

To repair this building is going to be a major task as you would need to remove all of the tiles and tile substrate to the roof structure, then assess the rusted steel members, replace and treat any rusted steel members and reconstruct the shell roof. You would also need to water proof the complete roof, retile the roof and repaint all previously painted surfaces.

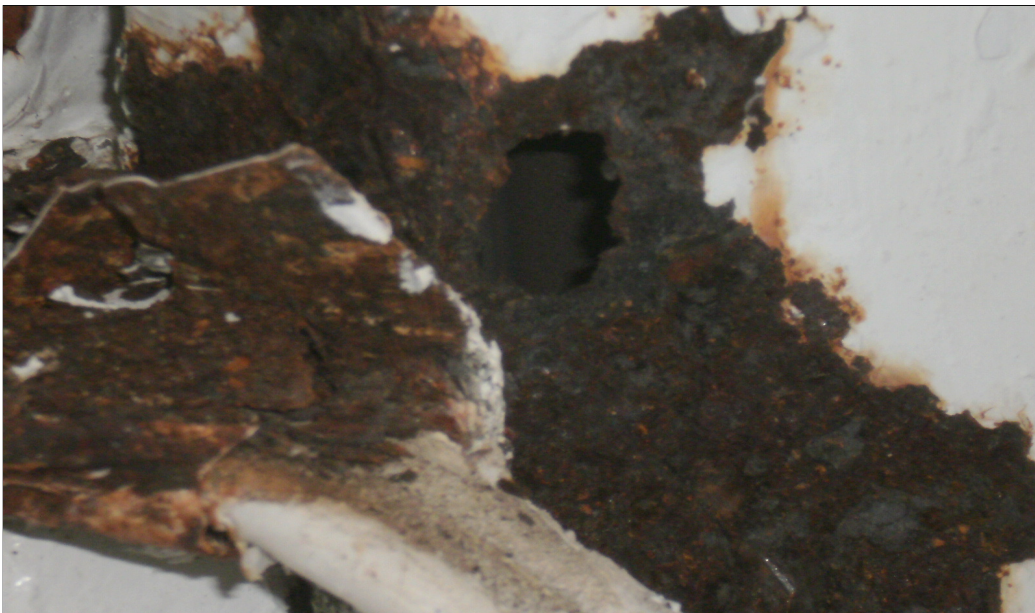
Rusted Structural Steel (photo 3)

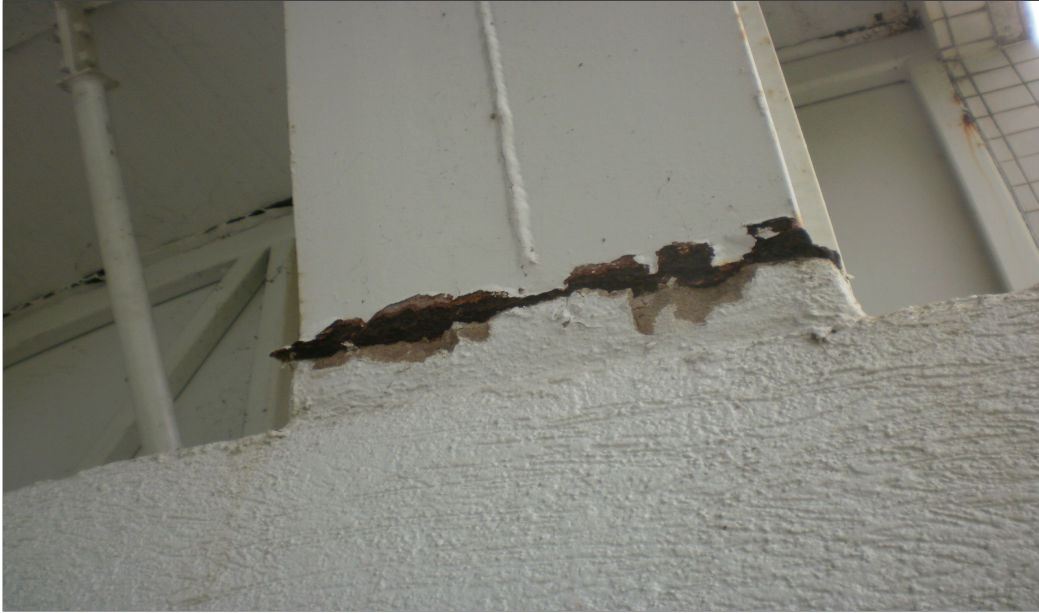
Rusted Structural Steel (photo 4)

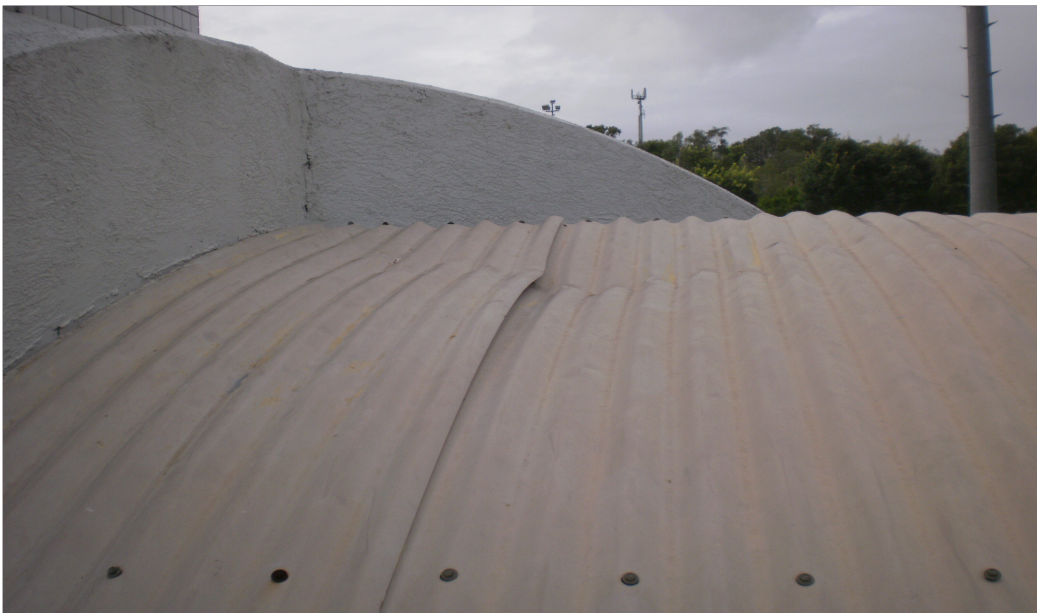
The tiles to the roof of the sound shell are missing at various locations refer photo 10. The colour bond roof sheeting to the covered walkways is also damaged refer photo 8 and 9. The metal roof finishing flashing is loose and falling off most of the roof refer photo 5 and 6.

Damaged roofing iron to covered walk way (photo 9)
