Project No. 18154-001-Rev0

SLOPE STABILITY ASSESSMENT FOR PROPOSED RESIDENCE 11 KILKENNY COURT, KAWANA

SOILS INVESTIGATION

11 Kilkenny Court, Kawana

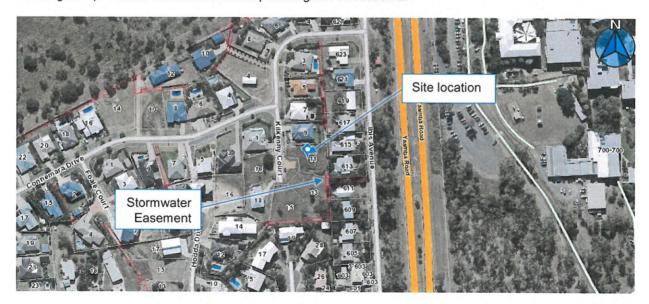
Text Figure 1: 2016 image of surrounds (courtesy RRC)

Site photos and available contour information indicate that the ground surface slope is generally linear and slightly convergent, and therefore surface water may be concentrated slightly towards the south-eastern corner of the site. It should be noted, however, that this may be affected locally by the more recent construction of retaining walls. However, surface runoff is expected to follow the overall ground surface contours towards the south-east, and drain well from the site considering the positive gradients, and only moderately permeable immediate subsurface materials (gravelly clayey sand). A stormwater easement is noted to begin within the site in the south-east corner, and drain to the south (Ref. RCC mapping, Text Figure 1), which may aid in providing a pathway for surface/stormwater.

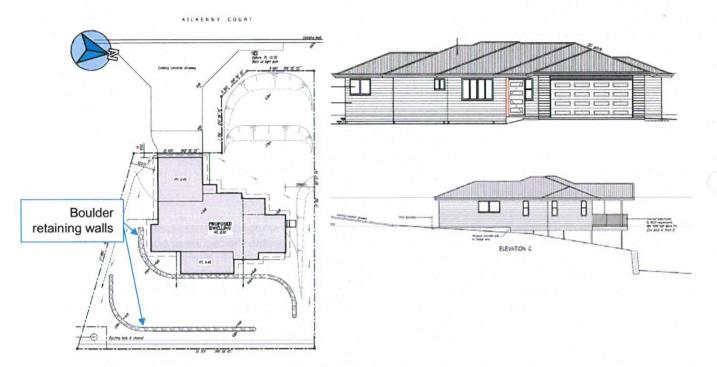
Text Figure 2: Design drawings extracts: layout; and west and south elevations (courtesy Gill Kerr Planning & Drafting)

The shape of the original natural ground surface was linear and slightly convergent. The contours indicate a relatively consistent slope of around 13° (23 %) towards the east/south-east is present on site. Two retaining walls (Ref. Text Figure 2) were present on site at the time of the investigation, which have created a gently sloping terrace to the east of the site.

It is apparent from aerial photos that a driveway consisting of small pavers and concrete was present to the western boundary, and that retaining walls were present within the eastern (downslope) part of the block. Notes or detailed photos of the condition of structures on site, or on adjacent blocks, were not provided to Tectonic by CQ prior to this assessment.

No details have been provided as to the condition of retaining walls currently on site, and if greater than 1 m height, it is recommended that the engineer certification is sighted. Future retaining structures greater than 1 m high shall be founded as described in Section 4.4 below, and would also require engineer design and certification of construction.

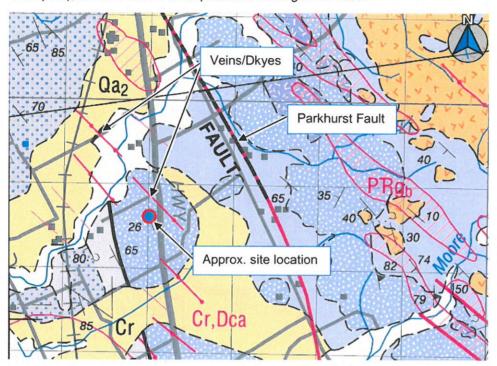
Text Figure 3: Extract from Rockhampton Geology Map

Available geological information indicates that the site is underlain by the Permian age Lakes Creek Formation (stippled blue shading) comprising "siltstone and lithic sandstone." The Parkhurst Fault is mapped around 1.5 km to the east of the site, and several intrusive features, noted to be veins or dykes (pink lines with spots), are also shown to be prevalent in the general area.

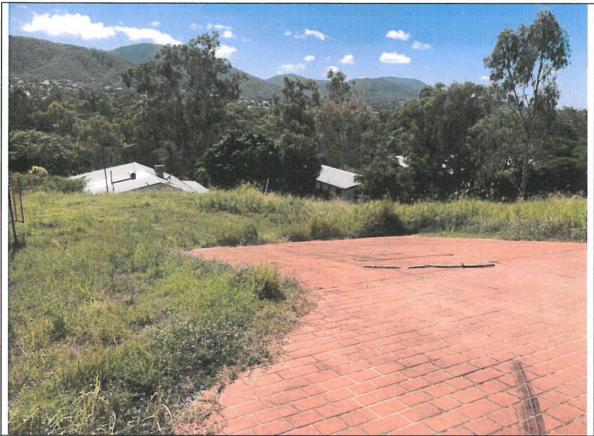
Figure 1 Proposed construction site

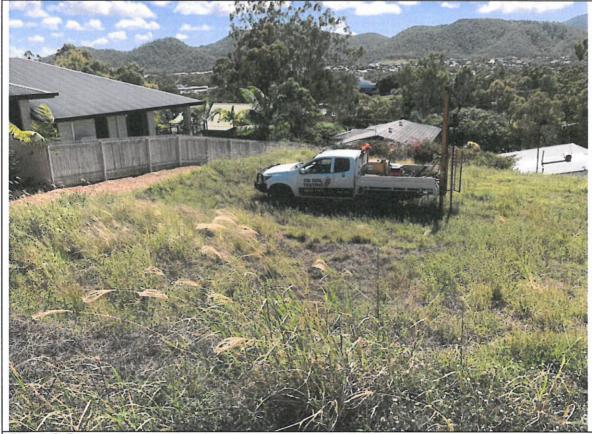
Figure 2 Proposed construction site
