Edenbrook Estate  
Edenbrook Drive,  
Parkhurst

Reconfiguration Plan  
Stage 1  
(47 Lots + Balance)

8066-11-ROL A

**ALEXANDRA STREET EXT.**  
BELMONT DR TO EDENBROOK DR (PARKHURST)  
ROADWORKS CONSTRUCTION  
WORKING PLAN - CONTROL LINE 1 - SHEET 3 OF 4

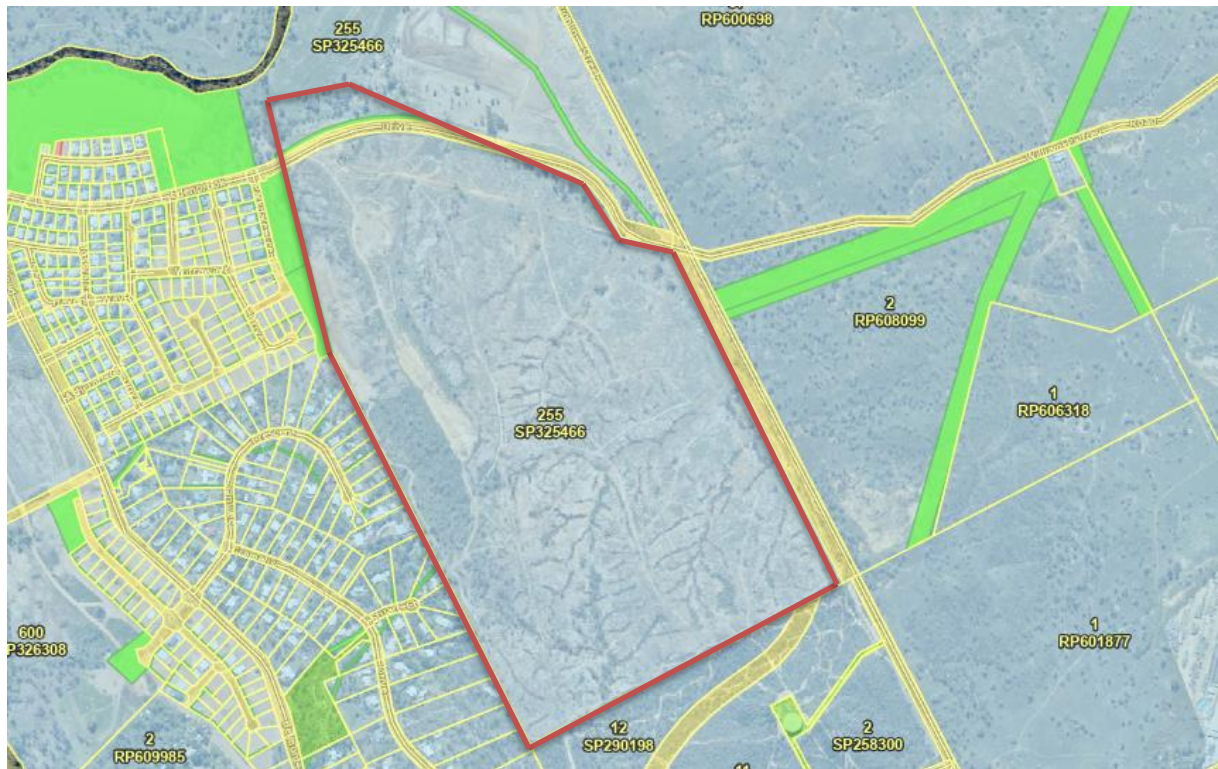
Figure 1: Site Location.

The development site is described as Lot 255 on SP325466, which encompasses both the northern and southern sides of Edenbrook Drive, Parkhurst (refer to Figure 1).

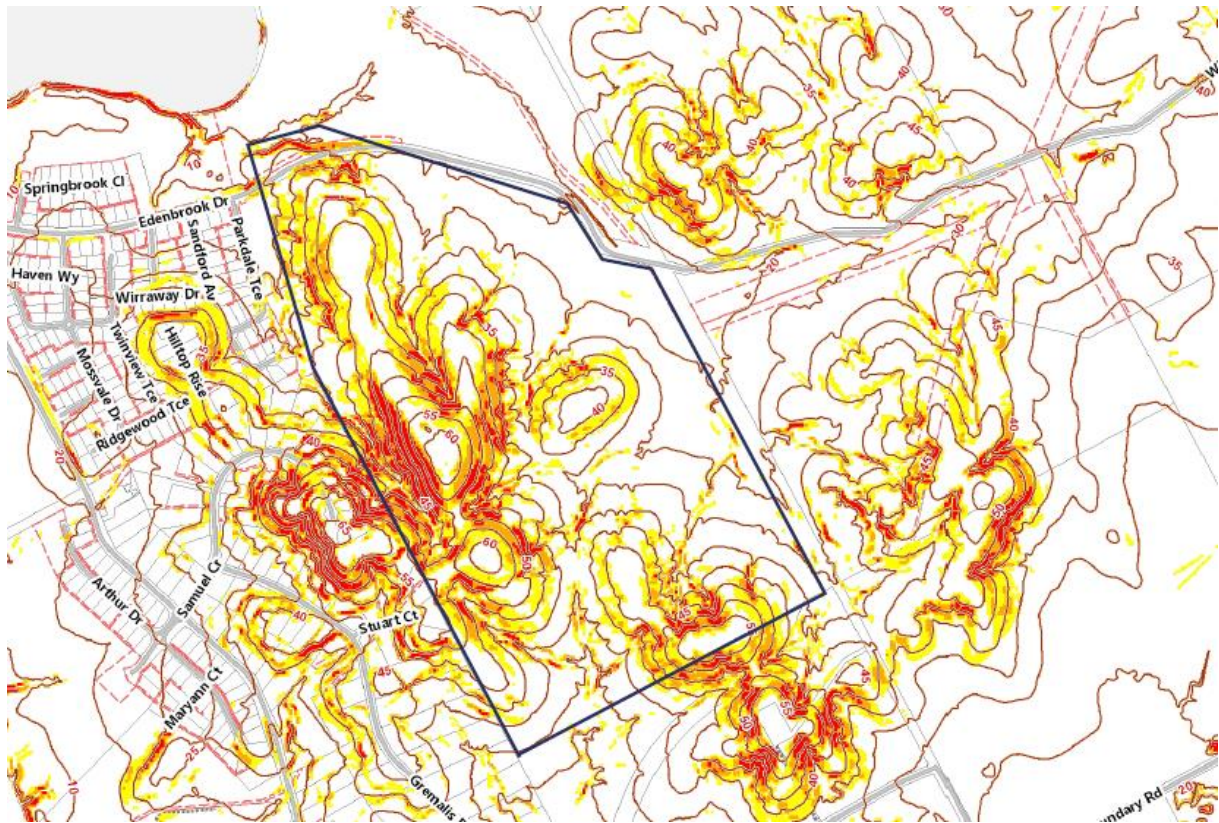
**Figure 4: RRC Steep Land Overlay.**

RCC's Steep Land Overlay identifies land with a slope of 15% or greater as being land potentially susceptible to landslide. Reference to the steep land overlay map (Figure 4), typically the moderately sloping side slopes of the spurs, and steeply sloping re-entrants are identified as steep land.

It should be noted that the steep land overlay map is a broad scale indication of the potential landslide susceptibility based on topography alone, and does not consider other factors such as regional geology or evidence of past instability.
