**CQ SOIL
TESTING**

AS2870 Site Classification, Site-Specific Landslide Susceptibility Risk Assessment and Slope Stability Analysis

SITE ADDRESS: Lot 57 (SP217337)
24 Reddy Drive, Norman Gardens QLD 4701

Job Number: CQ18152

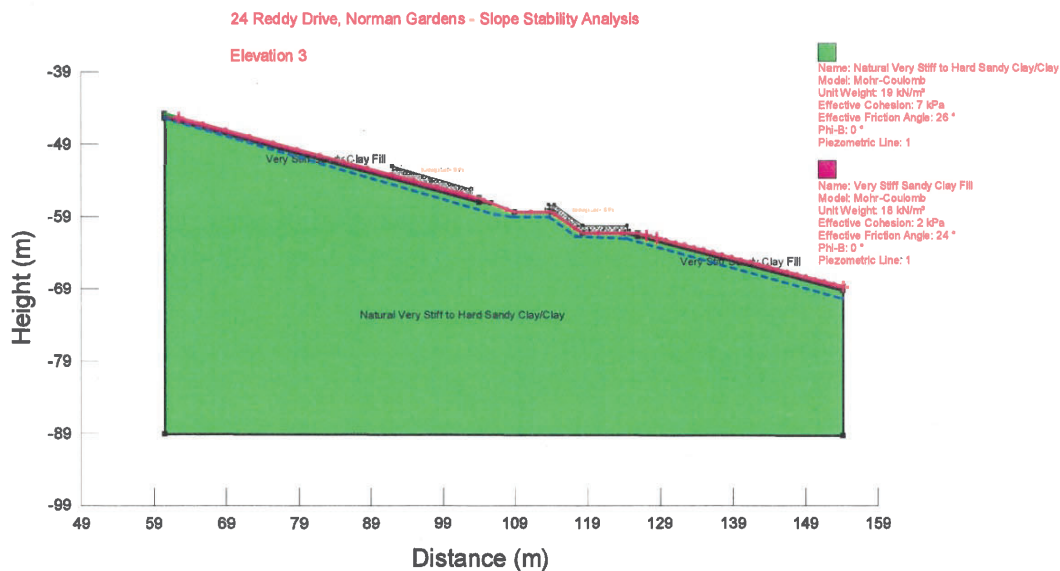
Figure 1: Elevation 3 Model Adopted in this Slope Stability Analysis.

Model adopted in this stability analysis is presented below.

The results of the slope stability analysis with groundwater conditions are presented in Table 5 below.

Analysis Area	Analysis Condition	Long Term Factor of Safety (FOS) Achieved	Required Long Term FOS by "Geotechnical Stability Assessment Guidelines"
Elevation 3	Existing/Proposed Slope Geometry with Surcharge Load and Appropriate Groundwater – Global Stability	1.51 (>1.50) (Drawing 1)	1.50

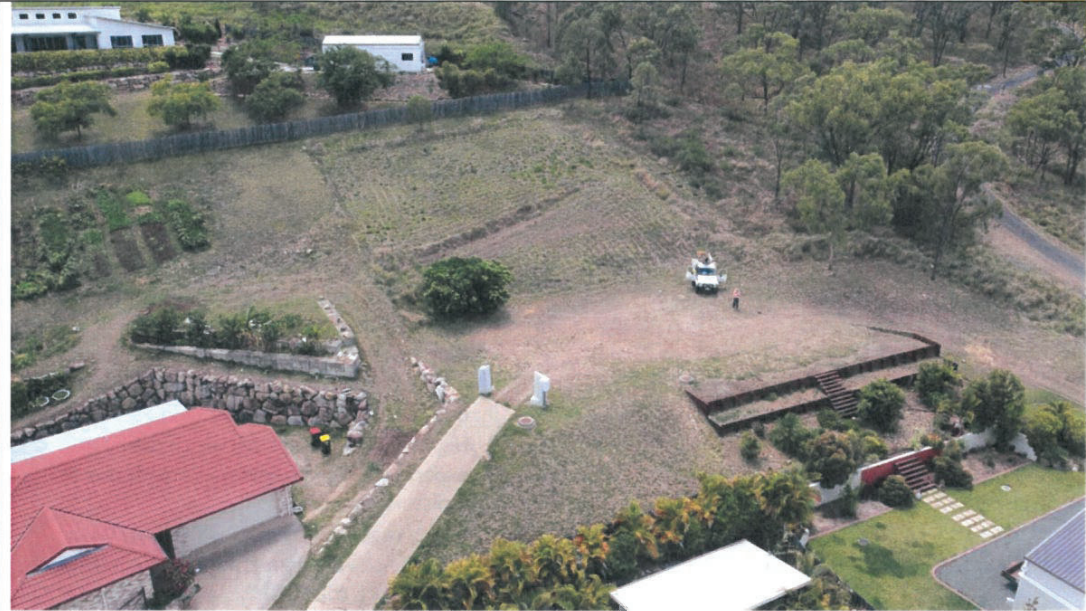
Image 1: Proposed construction site

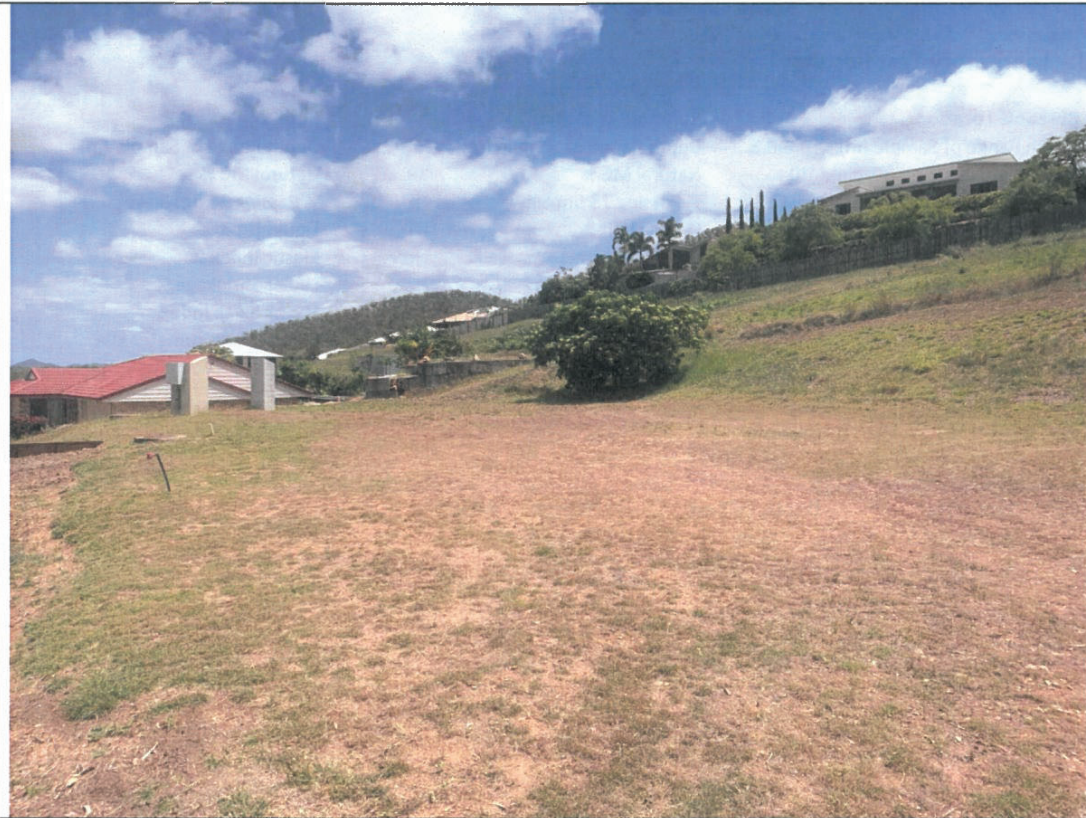
Image 2: Proposed construction site
