Edenbrook Estate
Edenbrook Drive,
Parkhurst

Reconfiguration Plan
Stage 1
(46 Lots + PUL + Balance)

scale
1:2000 @ A3
sheet no.
1 of 1
plan no.
8066-01-ROL

DRAWN	ASC	DATE	05/22
DESIGN	ASC	DATE	05/22
EDENBROOK DEVELOPMENTS			
EASTERN PRECINCT STAGES 1 -6			
ROL ENGINEERING SUBMISSION			
STORM WATER MANAGEMENT			
Q100 FLOOD INUNDATION AREA			
FILE NO	G2201-02-ROL7.DWG		
JOB NO	PRJ-0131		
SCALE	0 1:1500 HORIZ. 25	AT	A3 SIZE
DRAWING NUMBER	PRJ-0131-ROL12		ISSUE SHEET NO 3 12

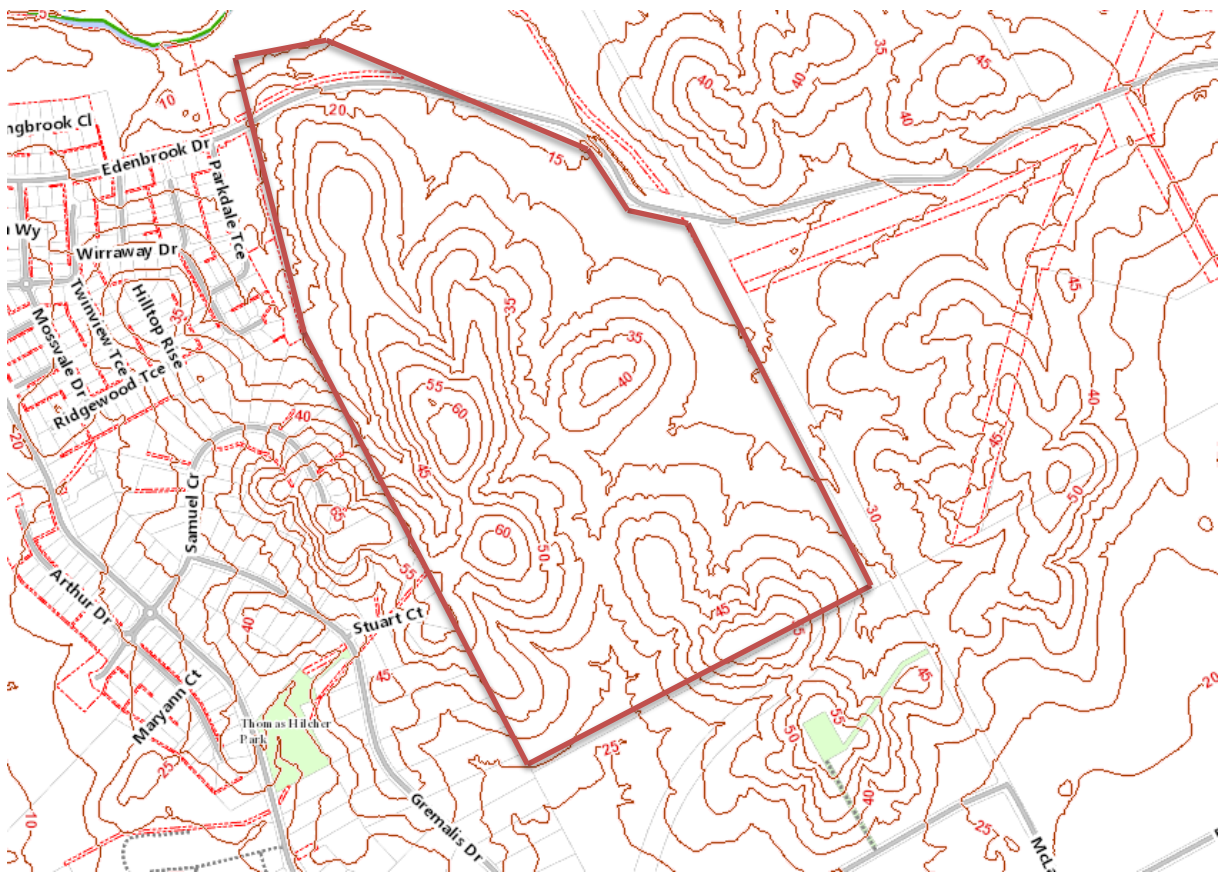
Figure 3: RRC Contour Mapping.

Reference to RCC's online contour mapping, the site is dominated by two prominent topographical features of high relief with a saddle connecting the two along the western part of the site. An elongated spur runs off to the north, with a number of smaller moderately sloping (between 10° and 15°) spurs running off to the north-east, to the east and to the south. A knoll is located atop of a spur towards the eastern part of the site. Steep (between 15° and 20°) re-entrants are located between the spurs. The site is also dominated by a second feature of high relief along the southern boundary of the site. As the site extends to the north-east, it generally flattens out.

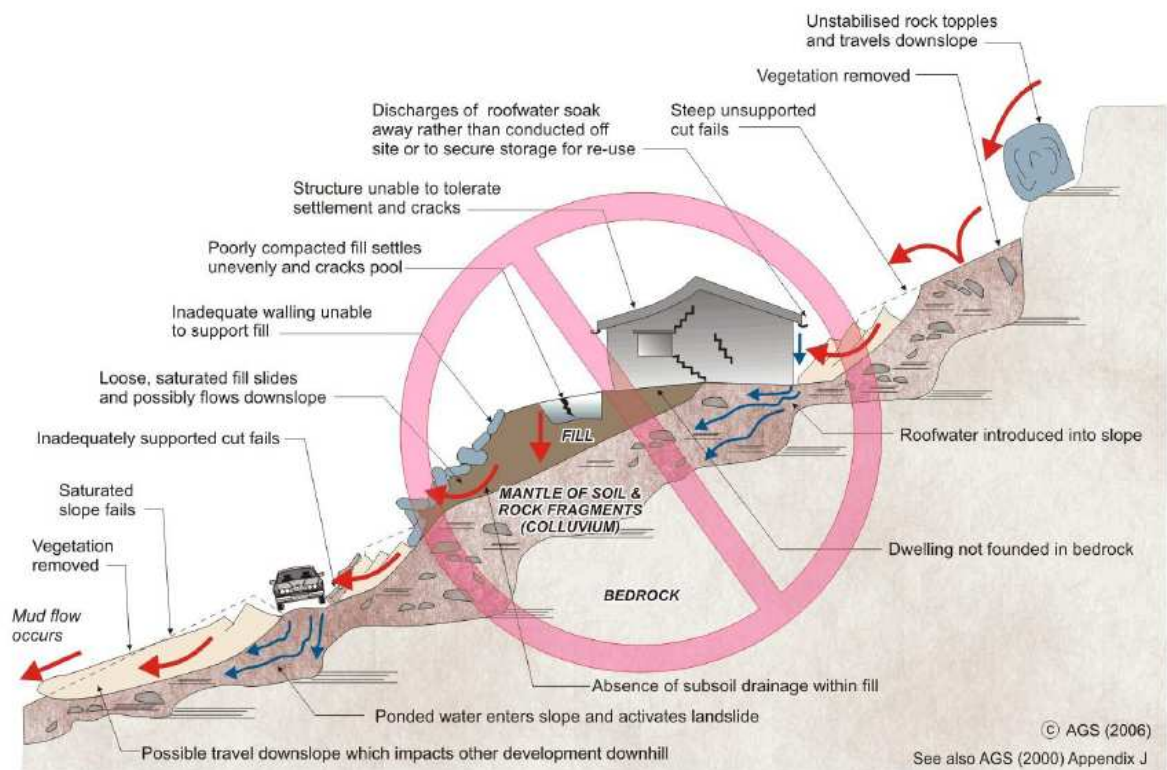
EXAMPLES OF **POOR** HILLSIDE PRACTICE

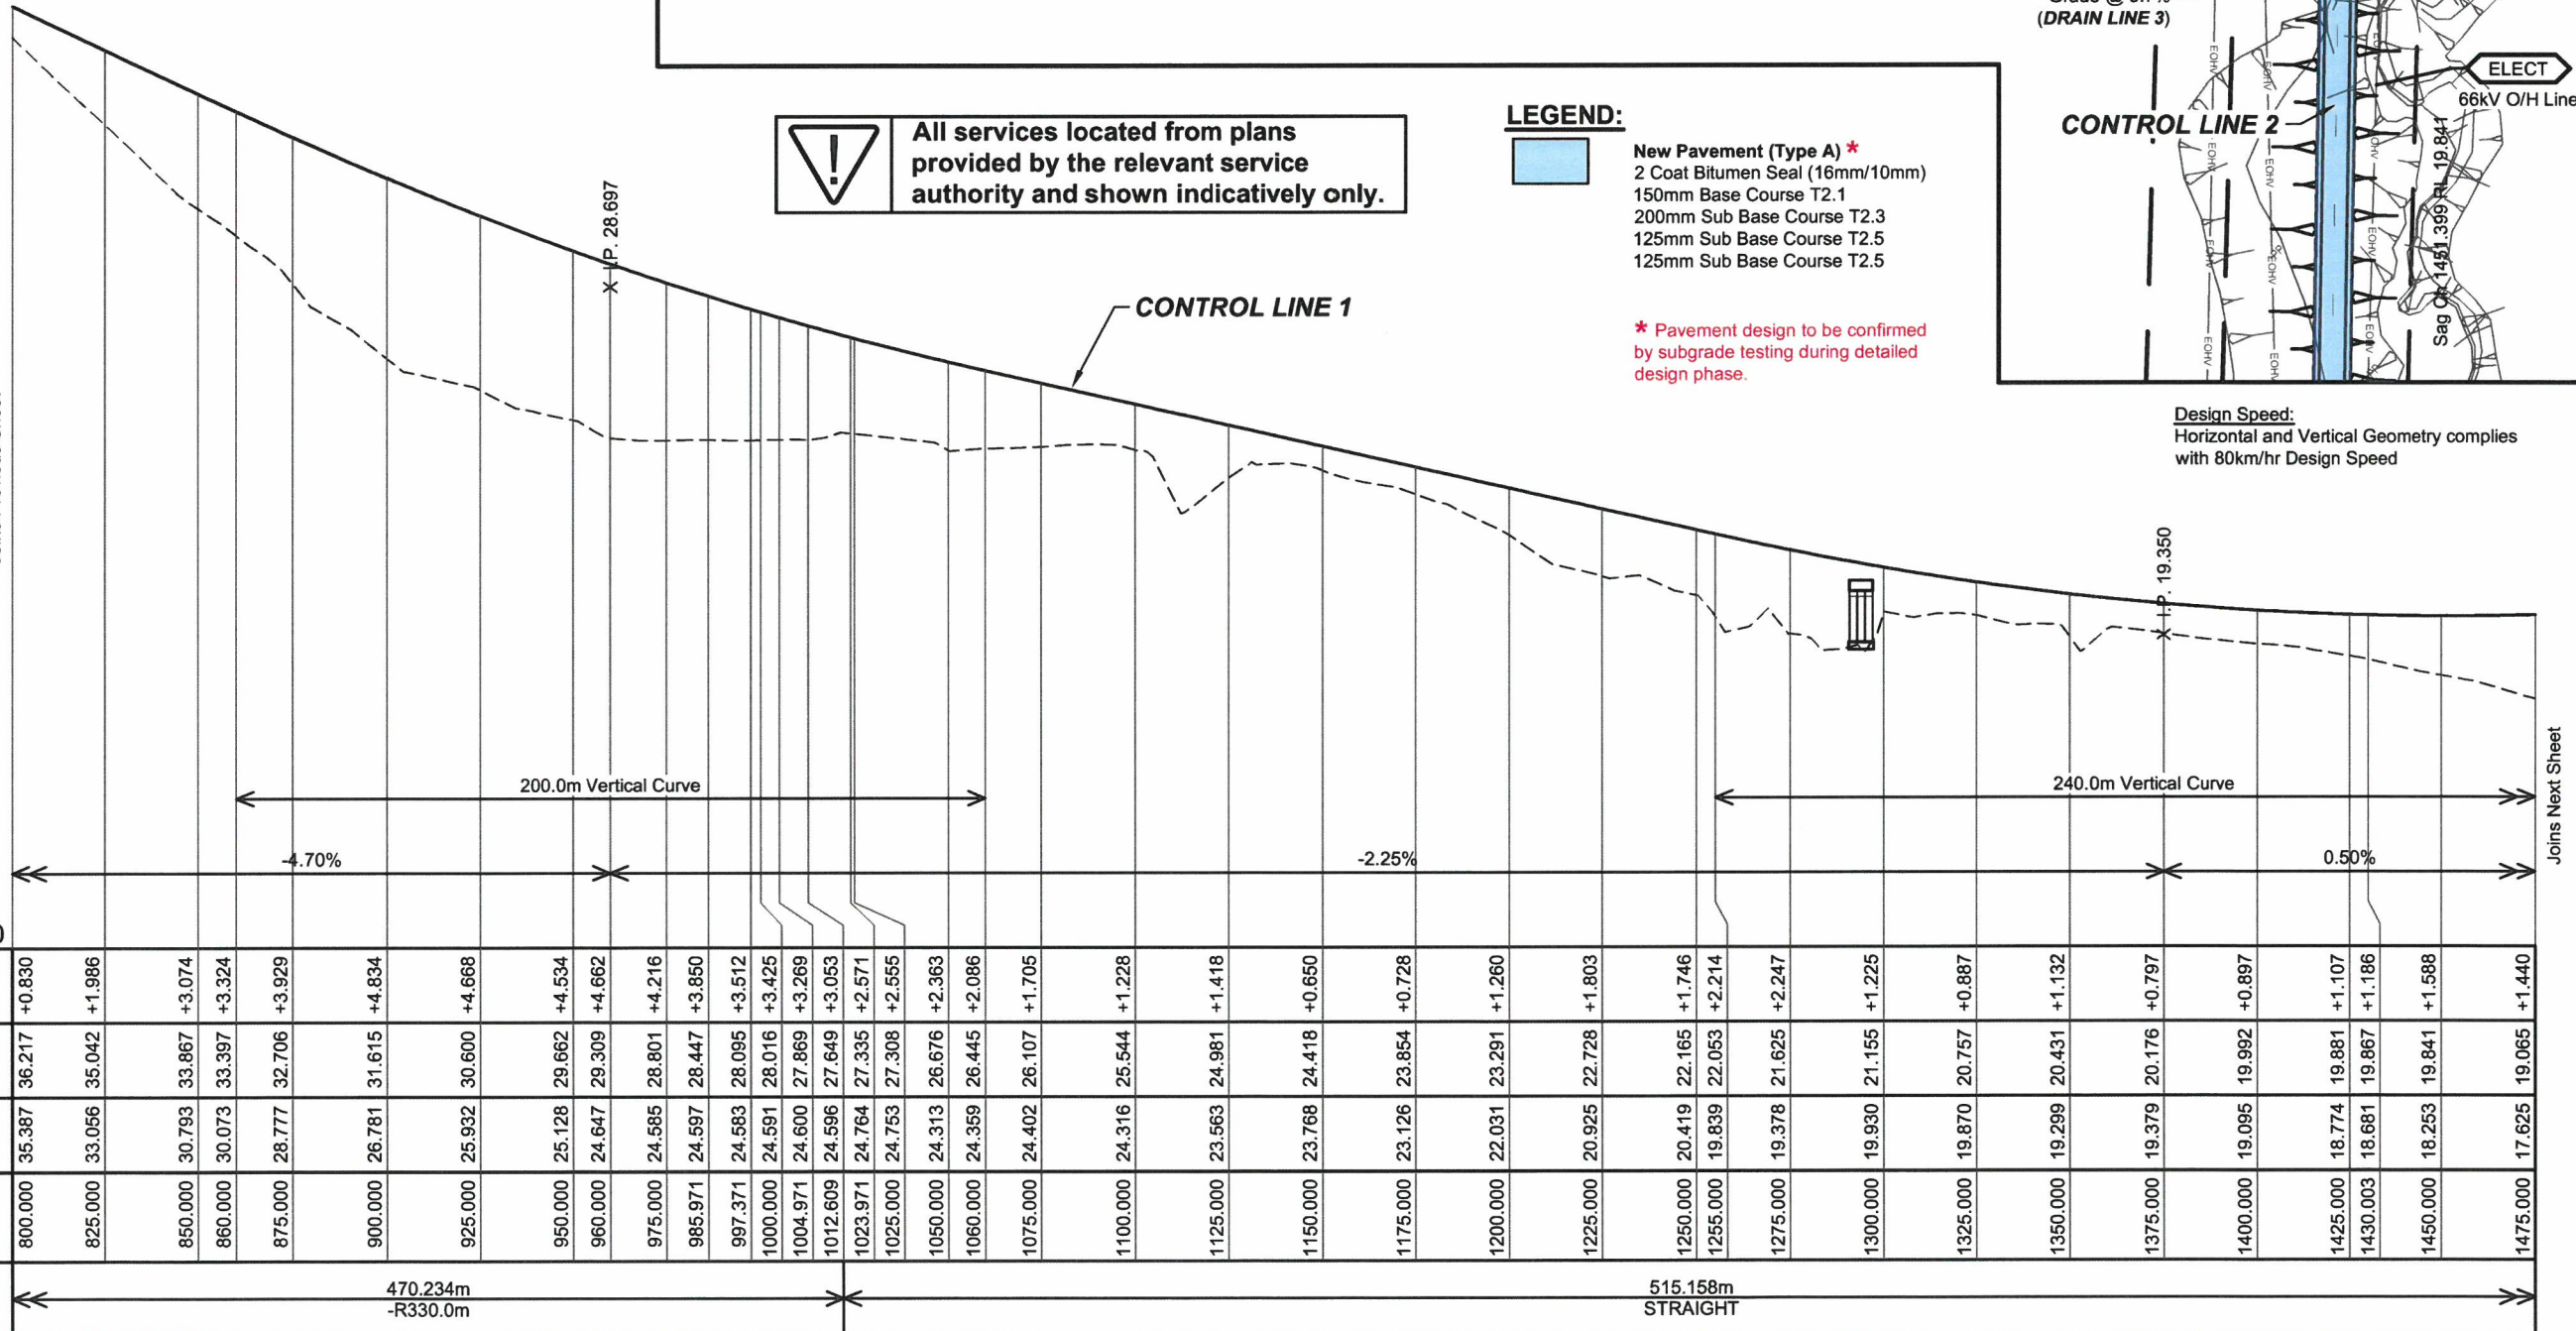
CUT / FILL	+0.830	+1.986		+3.074	+3.324	+3.929		+4.834		+4.668		+4.534	+4.662	+4.216	+3.850	+3.512	+3.425	+3.269	+3.053	+2.571	+2.555	+2.363	+2.086	+1.705		+1.228		+1.418			+0.650		+0.728		+1.260			+1.803			+1.746	+2.214	+2.247		+1.225			+0.887		+1.132		+0.797			+0.897			+1.107	+1.186	+1.588			+1.440					
DESIGN SURFACE	36.217	35.042		33.867	33.397	32.706		31.615		30.600		29.662	29.309	28.801	28.447	28.095	28.016	27.869	27.649	27.335	27.308	26.676	26.445	26.107		25.544		24.981			24.418			23.854		23.291			22.728			22.165	22.053	21.625			21.155			20.757			19.992			19.881	19.867	19.841			19.065							
EXISTING SURFACE	35.387	33.056		30.793	30.073	28.777		26.781		25.932		25.128	24.647	24.585	24.597	24.583	24.591	24.600	24.596	24.764	24.753	24.313	24.359	24.402		24.316		23.563			23.768			23.126		22.031			20.925			20.419	19.839	19.378			19.930			19.870			19.299			18.774	18.681	18.253			17.625

ALEXANDRA STREET EXT.
BELMONT DR TO EDENBROOK DR (PARKHURST)
ROADWORKS CONSTRUCTION
WORKING PLAN - CONTROL LINE 1 - SHEET 3 OF 4
