Report on Geotechnical Stability Assessment

> Proposed Subdivision Edenbrook Estate (Precinct 2) Edenbrook Drive, Parkhurst

> > Prepared for Hartecs Group Pty Ltd

Project 213255.00 May 2022

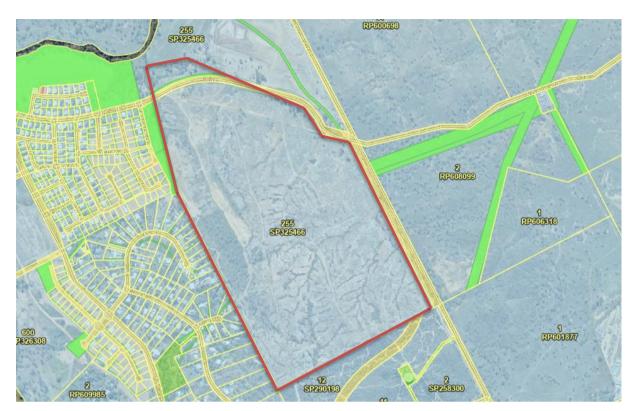
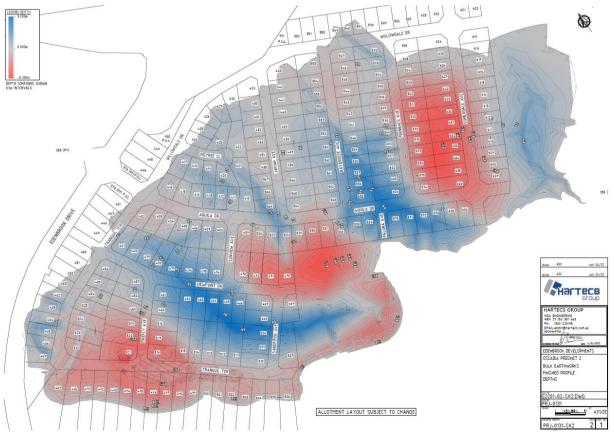
Figure 2: Proposed earthworks for a proportion of the overall site.

It is further understood that the proposed earthworks for a portion of the overall site will consist of bulk excavations up to approximately 7 m in height along the ridgeline and spurs, and filling up to approximately 9 m in the low lying re-entrants between the spurs (refer to Figure 2); generally creating relatively flat and level building platforms, some locally increasing up to approximately 15%. It is anticipated that similar earthworks will be required for the remainder of the site.

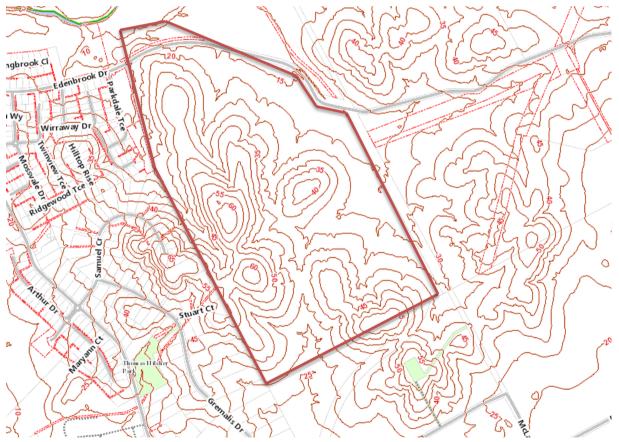
Figure 3: RRC Contour Mapping.

Reference to RCC's online contour mapping, the site is dominated by two prominent topographical features of high relief with a saddle connecting the two along the western part of the site. An elongated spur runs off to the north, with a number of smaller moderately sloping (between 10° and 15°) spurs running off to the north-east, to the east and to the south. A knoll is located atop of a spur towards the eastern part of the site. Steep (between 15° and 20°) re-entrants are located between the spurs. The site is also dominated by a second feature of high relief along the southern boundary of the site. As the site extends to the north-east, it generally flattens out.

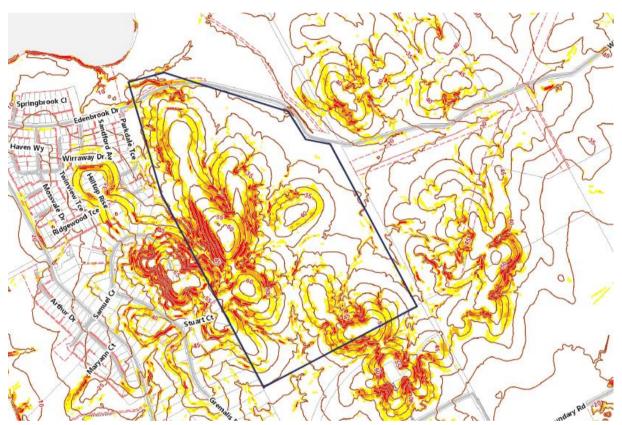
Figure 4: RRC Steep Land Overlay.

RCC's Steep Land Overlay identifies land with a slope of 15% or greater as being land potentially susceptible to landslide. Reference to the steep land overlay map (Figure 4), typically the moderately sloping side slopes of the spurs, and steeply sloping re-entrants are identified as steep land.

It should be noted that the steep land overlay map is a broad scale indication of the potential landslide susceptibility based on topography alone, and does not consider other factors such as regional geology or evidence of past instability.
