Edenbrook Estate
Edenbrook Drive, Parkhurst

Reconfiguration Plan
Stage 3
(42 Lots + PUL + Balance)

scale
1:2000 @ A3
sheet no.
1 of 1
plan no.
8066-13-ROL

Project 213255.00
May 2022

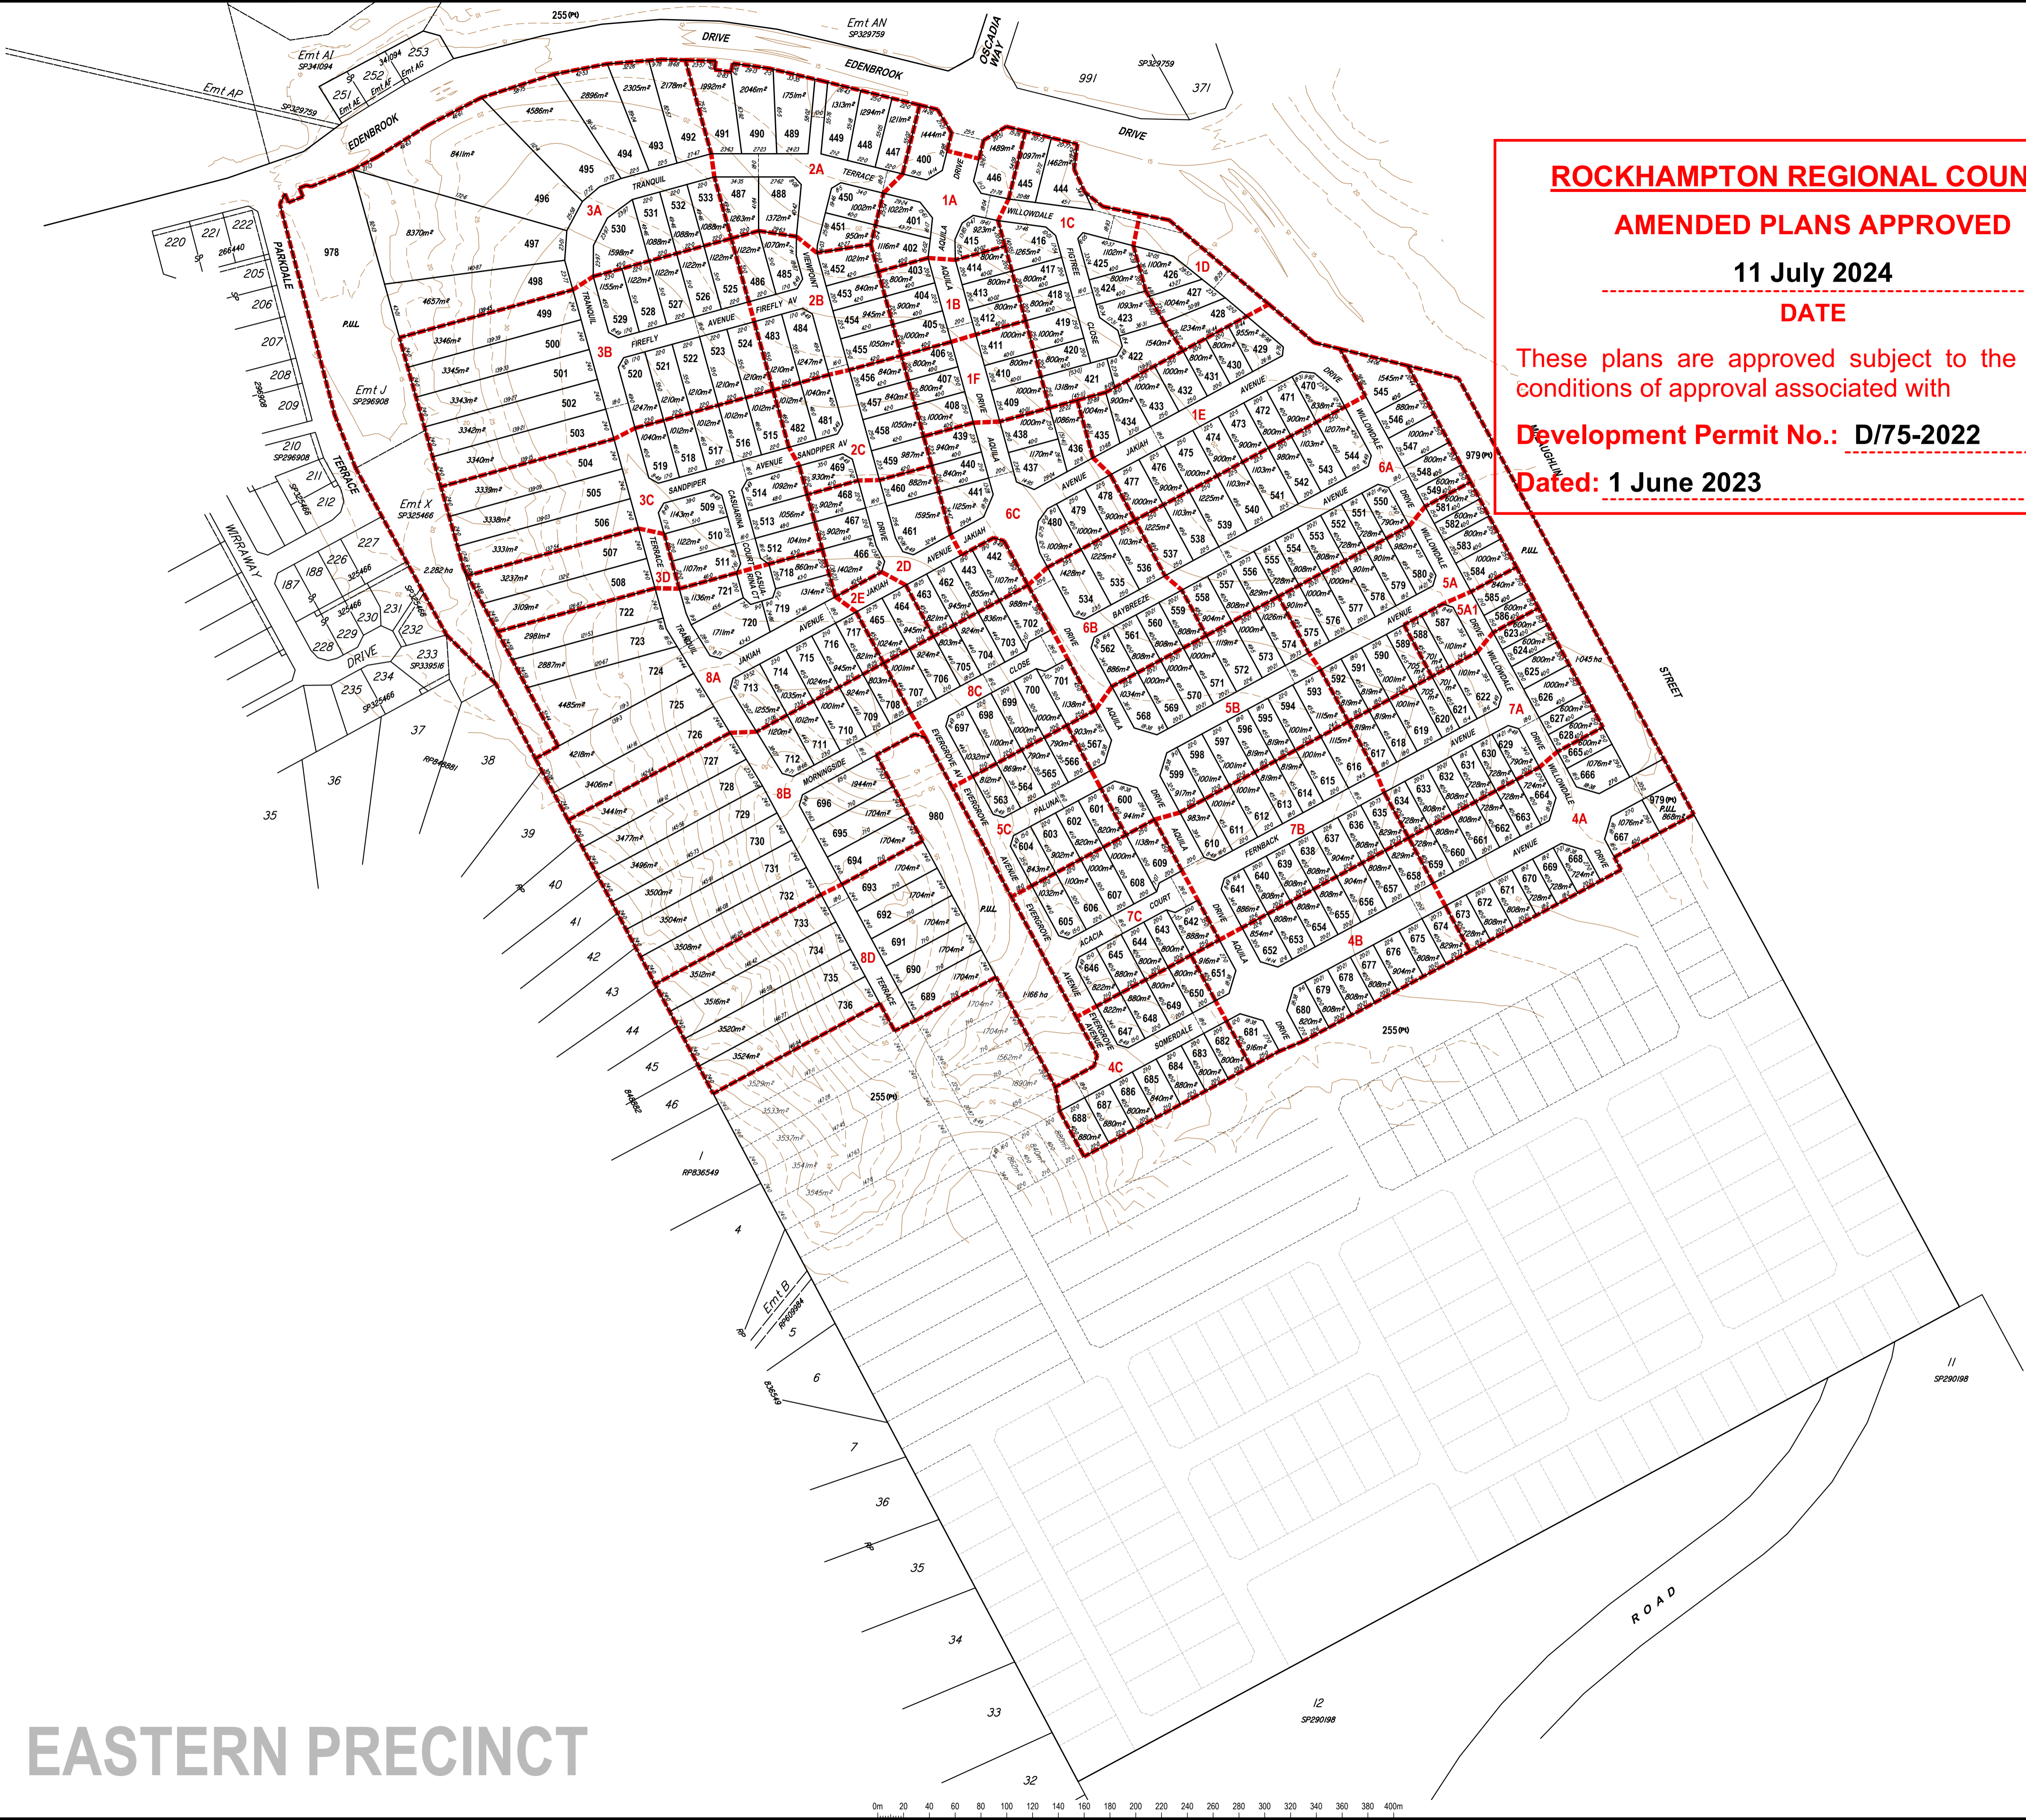
Staging

Stage Number	Lots
Stage 1	47
Stage 2	36
Stage 3	42
Stage 4	42
Stage 5	42
Stage 6	38
Stage 7	42
Stage 8	48
Total	337

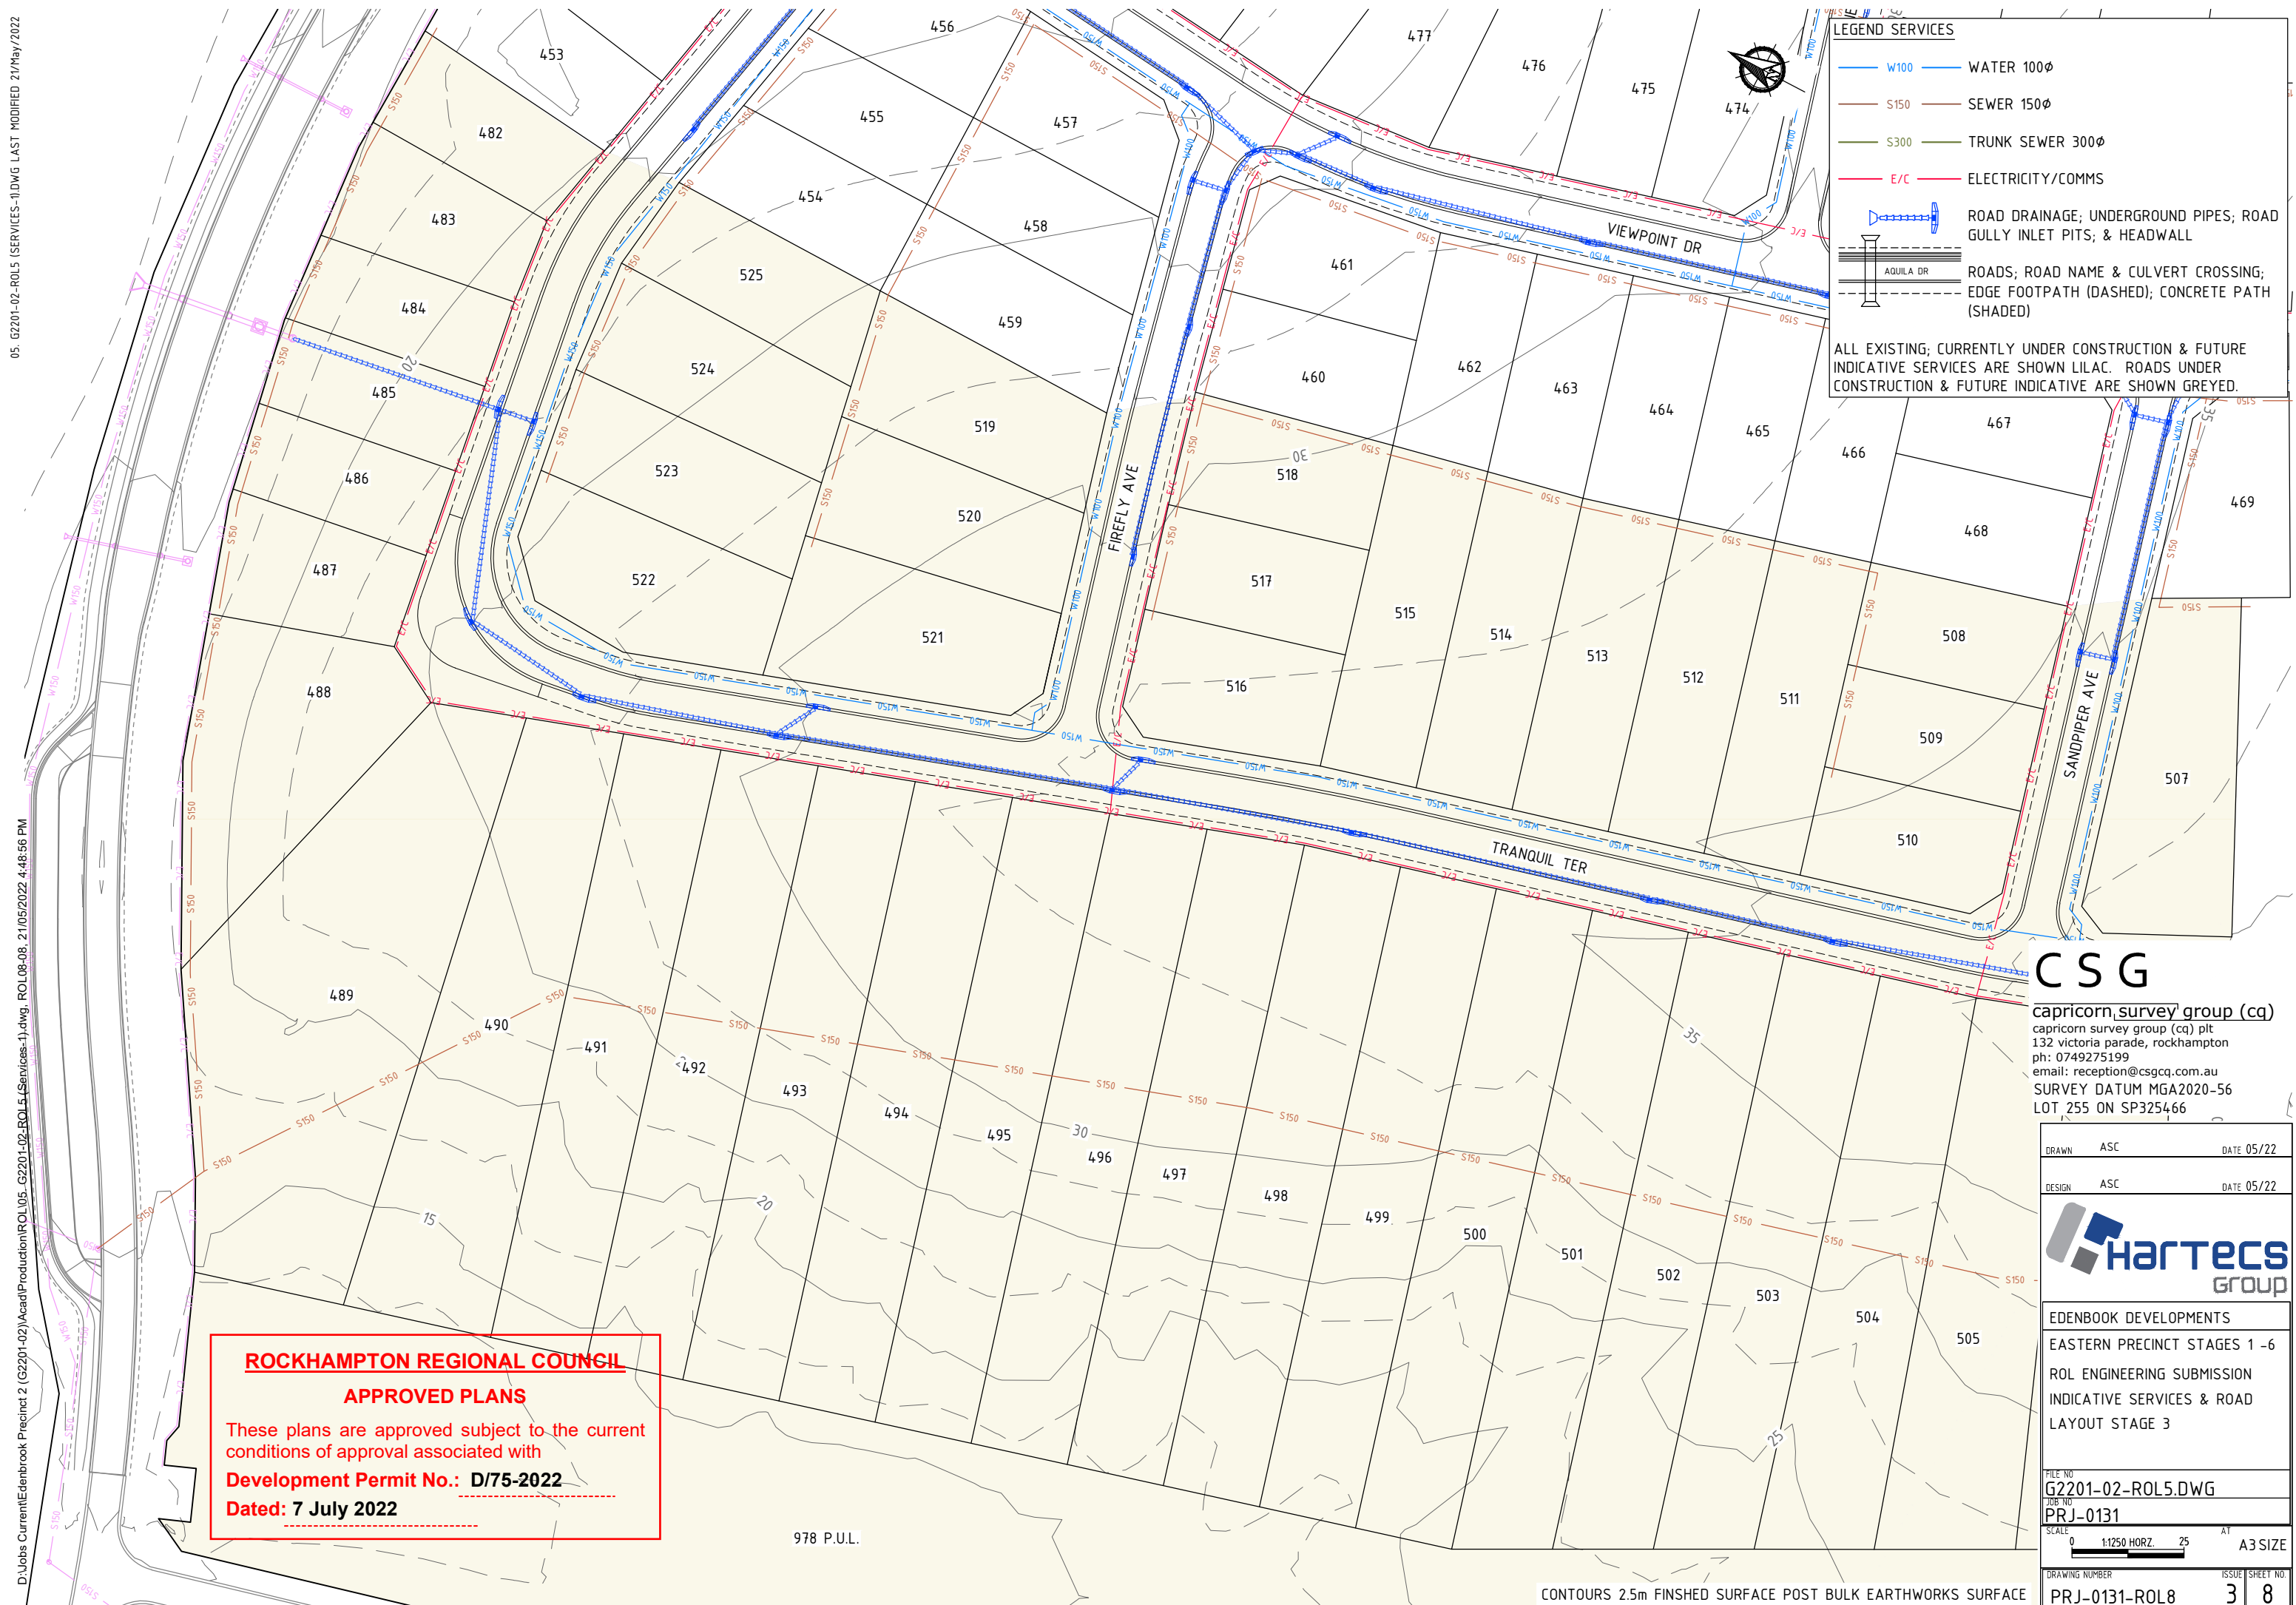
LEGEND SERVICES

- W100 WATER 100Ø
- S150 SEWER 150Ø
- S300 TRUNK SEWER 300Ø
- E/C ELECTRICITY/COMMS
- ROAD DRAINAGE; UNDERGROUND PIPES; ROAD GULLY INLET PITS; & HEADWALL
- AQUILA DR
- ROADS; ROAD NAME & CULVERT CROSSING; EDGE FOOTPATH (DASHED); CONCRETE PATH (SHADED)

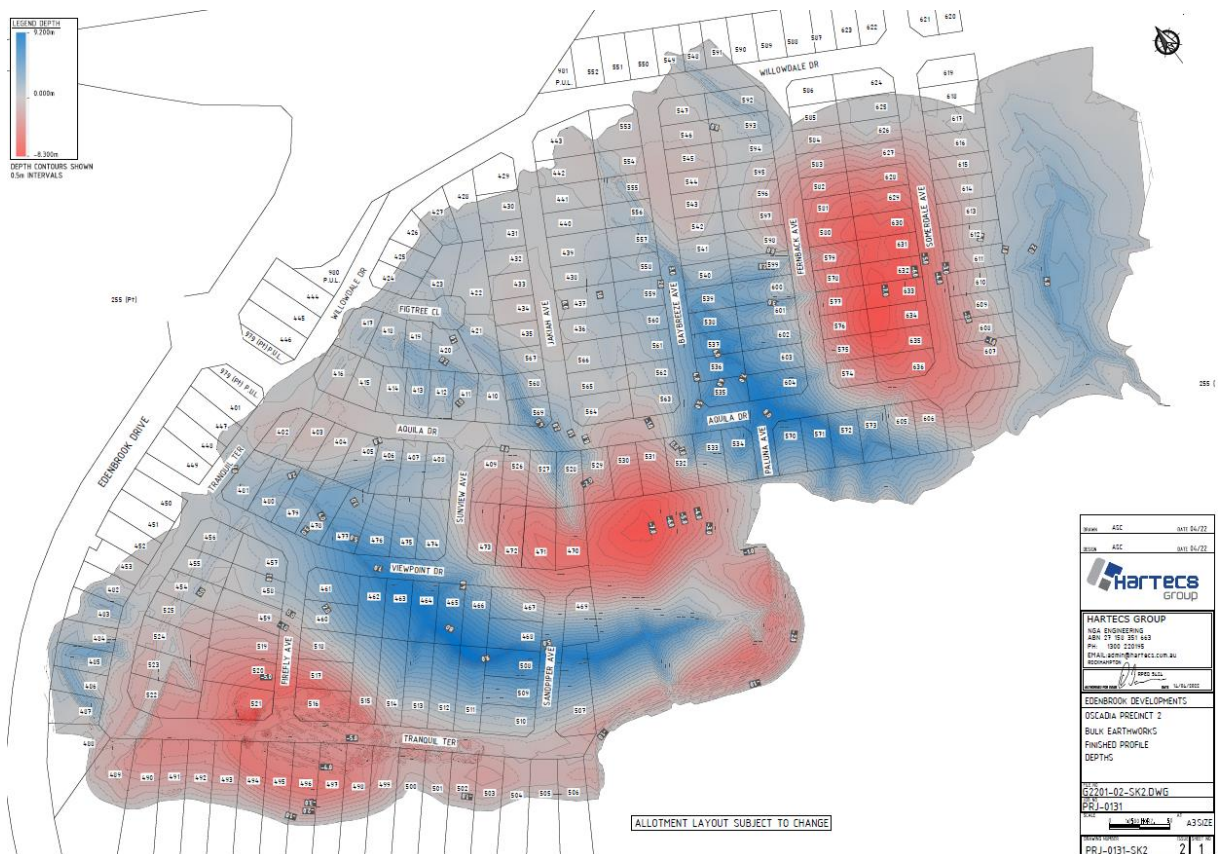
Figure 2: Proposed earthworks for a proportion of the overall site.

It is further understood that the proposed earthworks for a portion of the overall site will consist of bulk excavations up to approximately 7 m in height along the ridgeline and spurs, and filling up to approximately 9 m in the low lying re-entrants between the spurs (refer to Figure 2); generally creating relatively flat and level building platforms, some locally increasing up to approximately 15%. It is anticipated that similar earthworks will be required for the remainder of the site.

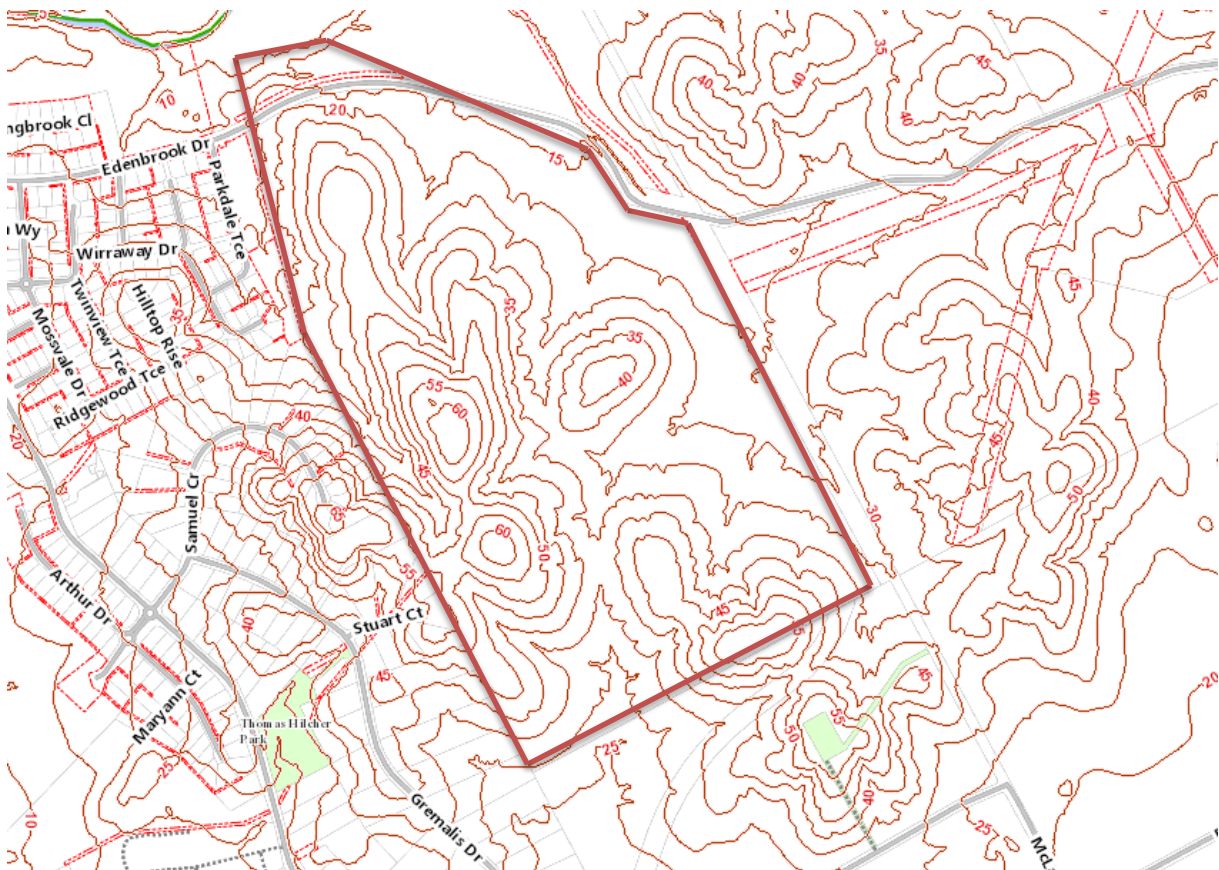
Figure 3: RRC Contour Mapping.

Reference to RCC's online contour mapping, the site is dominated by two prominent topographical features of high relief with a saddle connecting the two along the western part of the site. An elongated spur runs off to the north, with a number of smaller moderately sloping (between 10° and 15°) spurs running off to the north-east, to the east and to the south. A knoll is located atop of a spur towards the eastern part of the site. Steep (between 15° and 20°) re-entrants are located between the spurs. The site is also dominated by a second feature of high relief along the southern boundary of the site. As the site extends to the north-east, it generally flattens out.

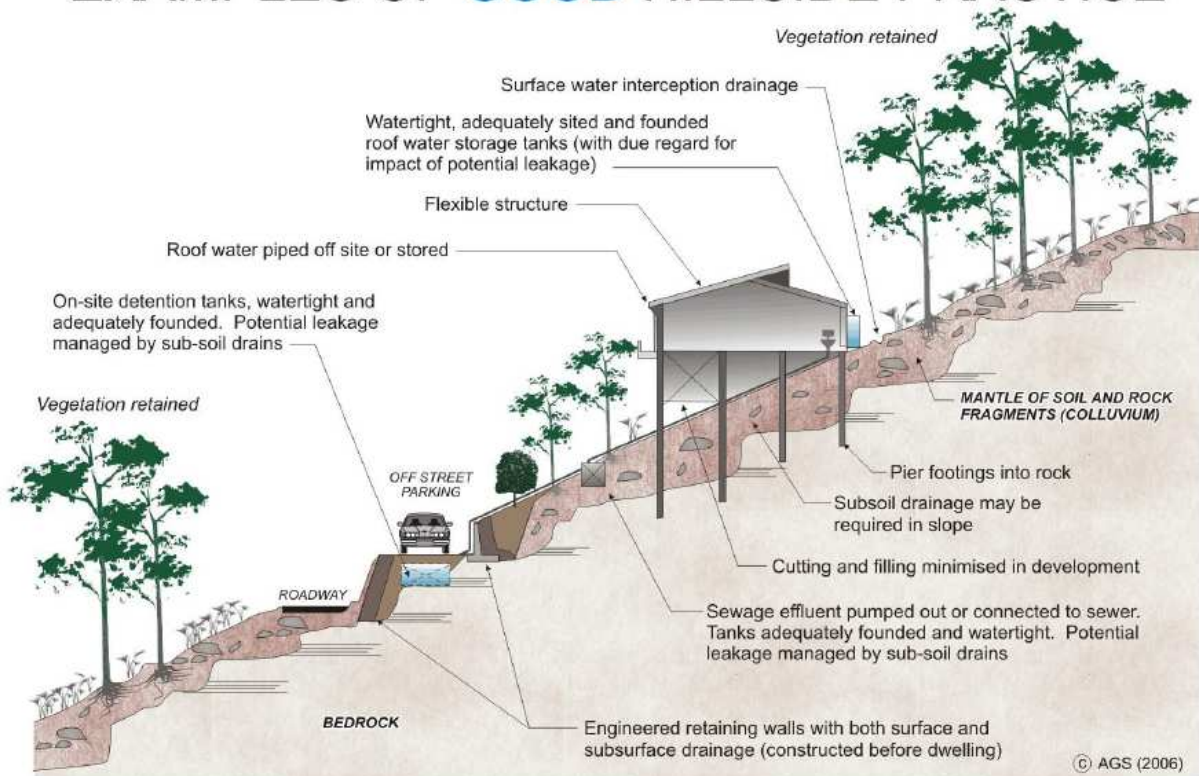
EXAMPLES OF **GOOD** HILLSIDE PRACTICE
