**Edenbrook Estate**  
**Edenbrook Drive,**  
**Parkhurst**

**Reconfiguration Plan**  
**Stage 6**  
**(44 Lots + Balance)**

EDENBOOK DEVELOPMENTS			
EASTERN PRECINCT STAGES 1 - 6			
ROL ENGINEERING SUBMISSION			
ALLOTMENT LAYOUT & STAGING			
FILE NO G2201-02-ROL2.DWG			
JOB NO PRJ-0131			
SCALE 0 1:3000 HORZ. 60		AT A3 SIZE	
DRAWING NUMBER PRJ-0131-ROL2		ISSUE 3	SHEET NO 2

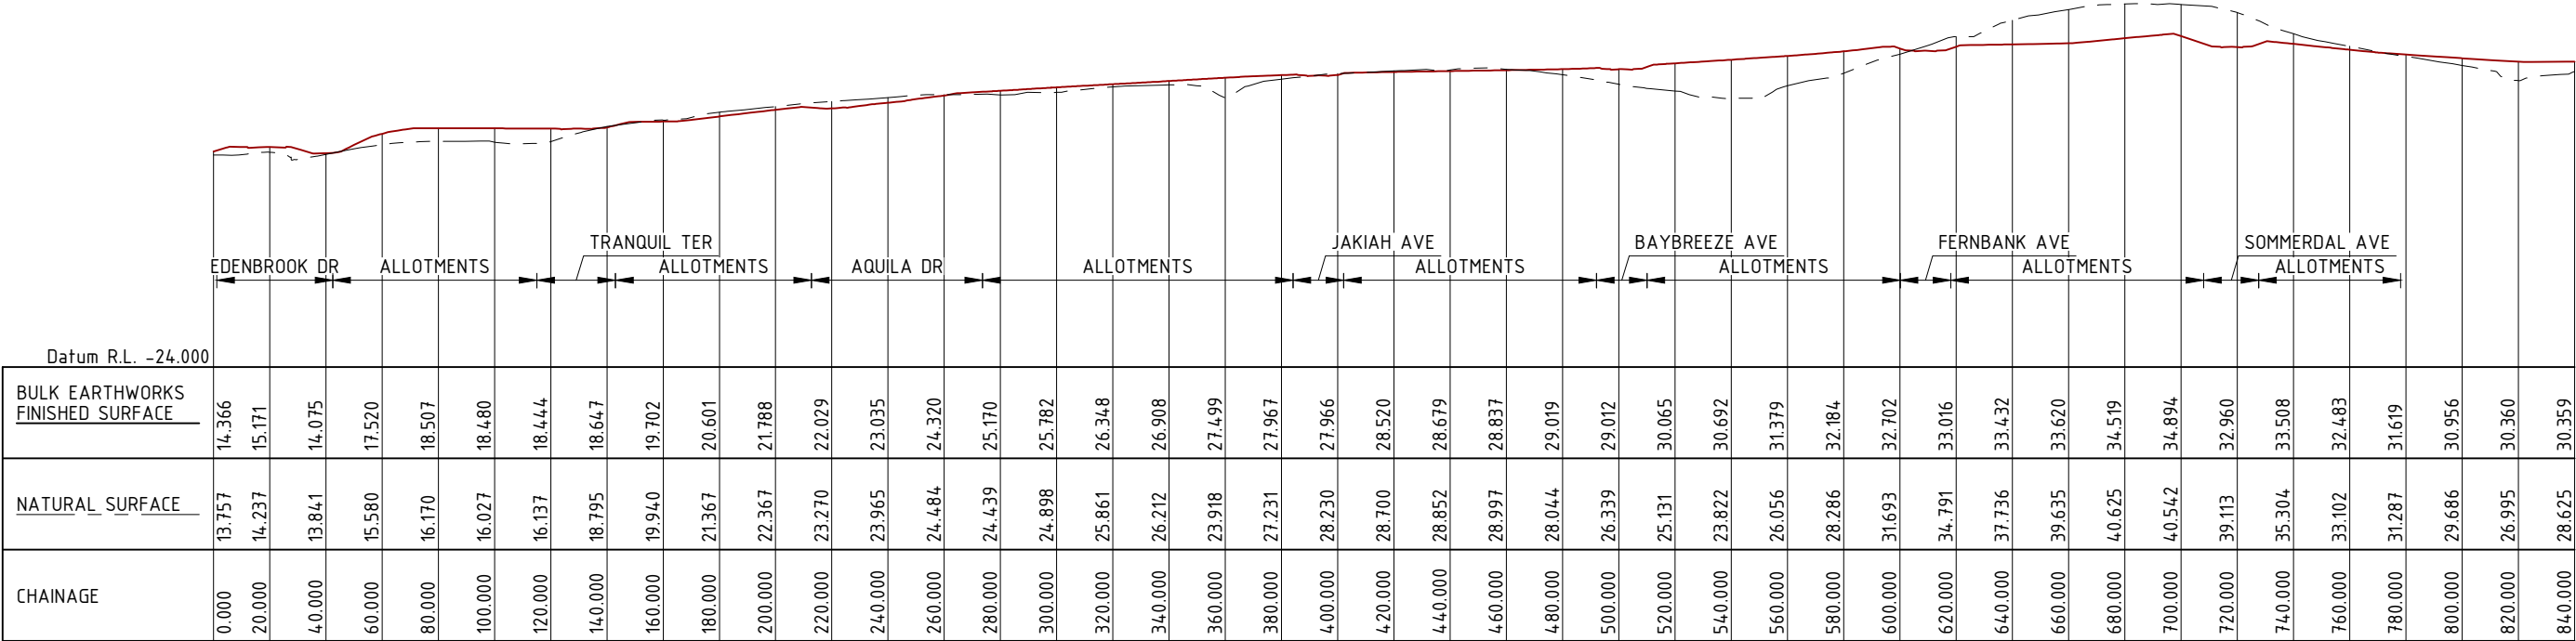
Scale Horizontal 1:2500 Vertical 1:1250 SITE SECTION A

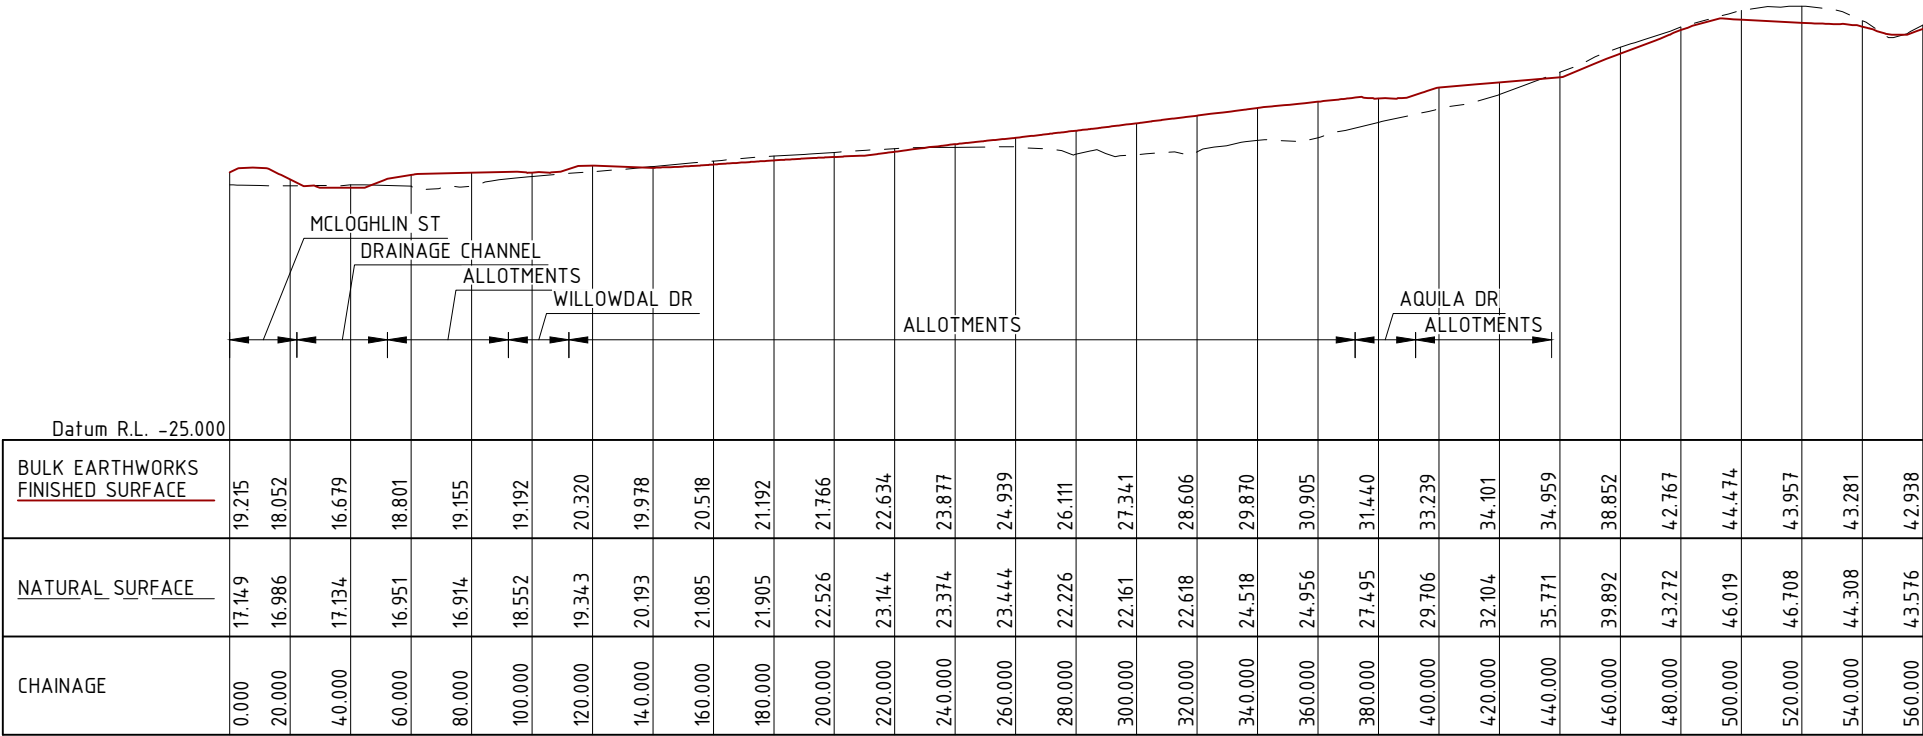
Scale Horizontal 1:2500 Vertical 1:1250 SITE SECTION B

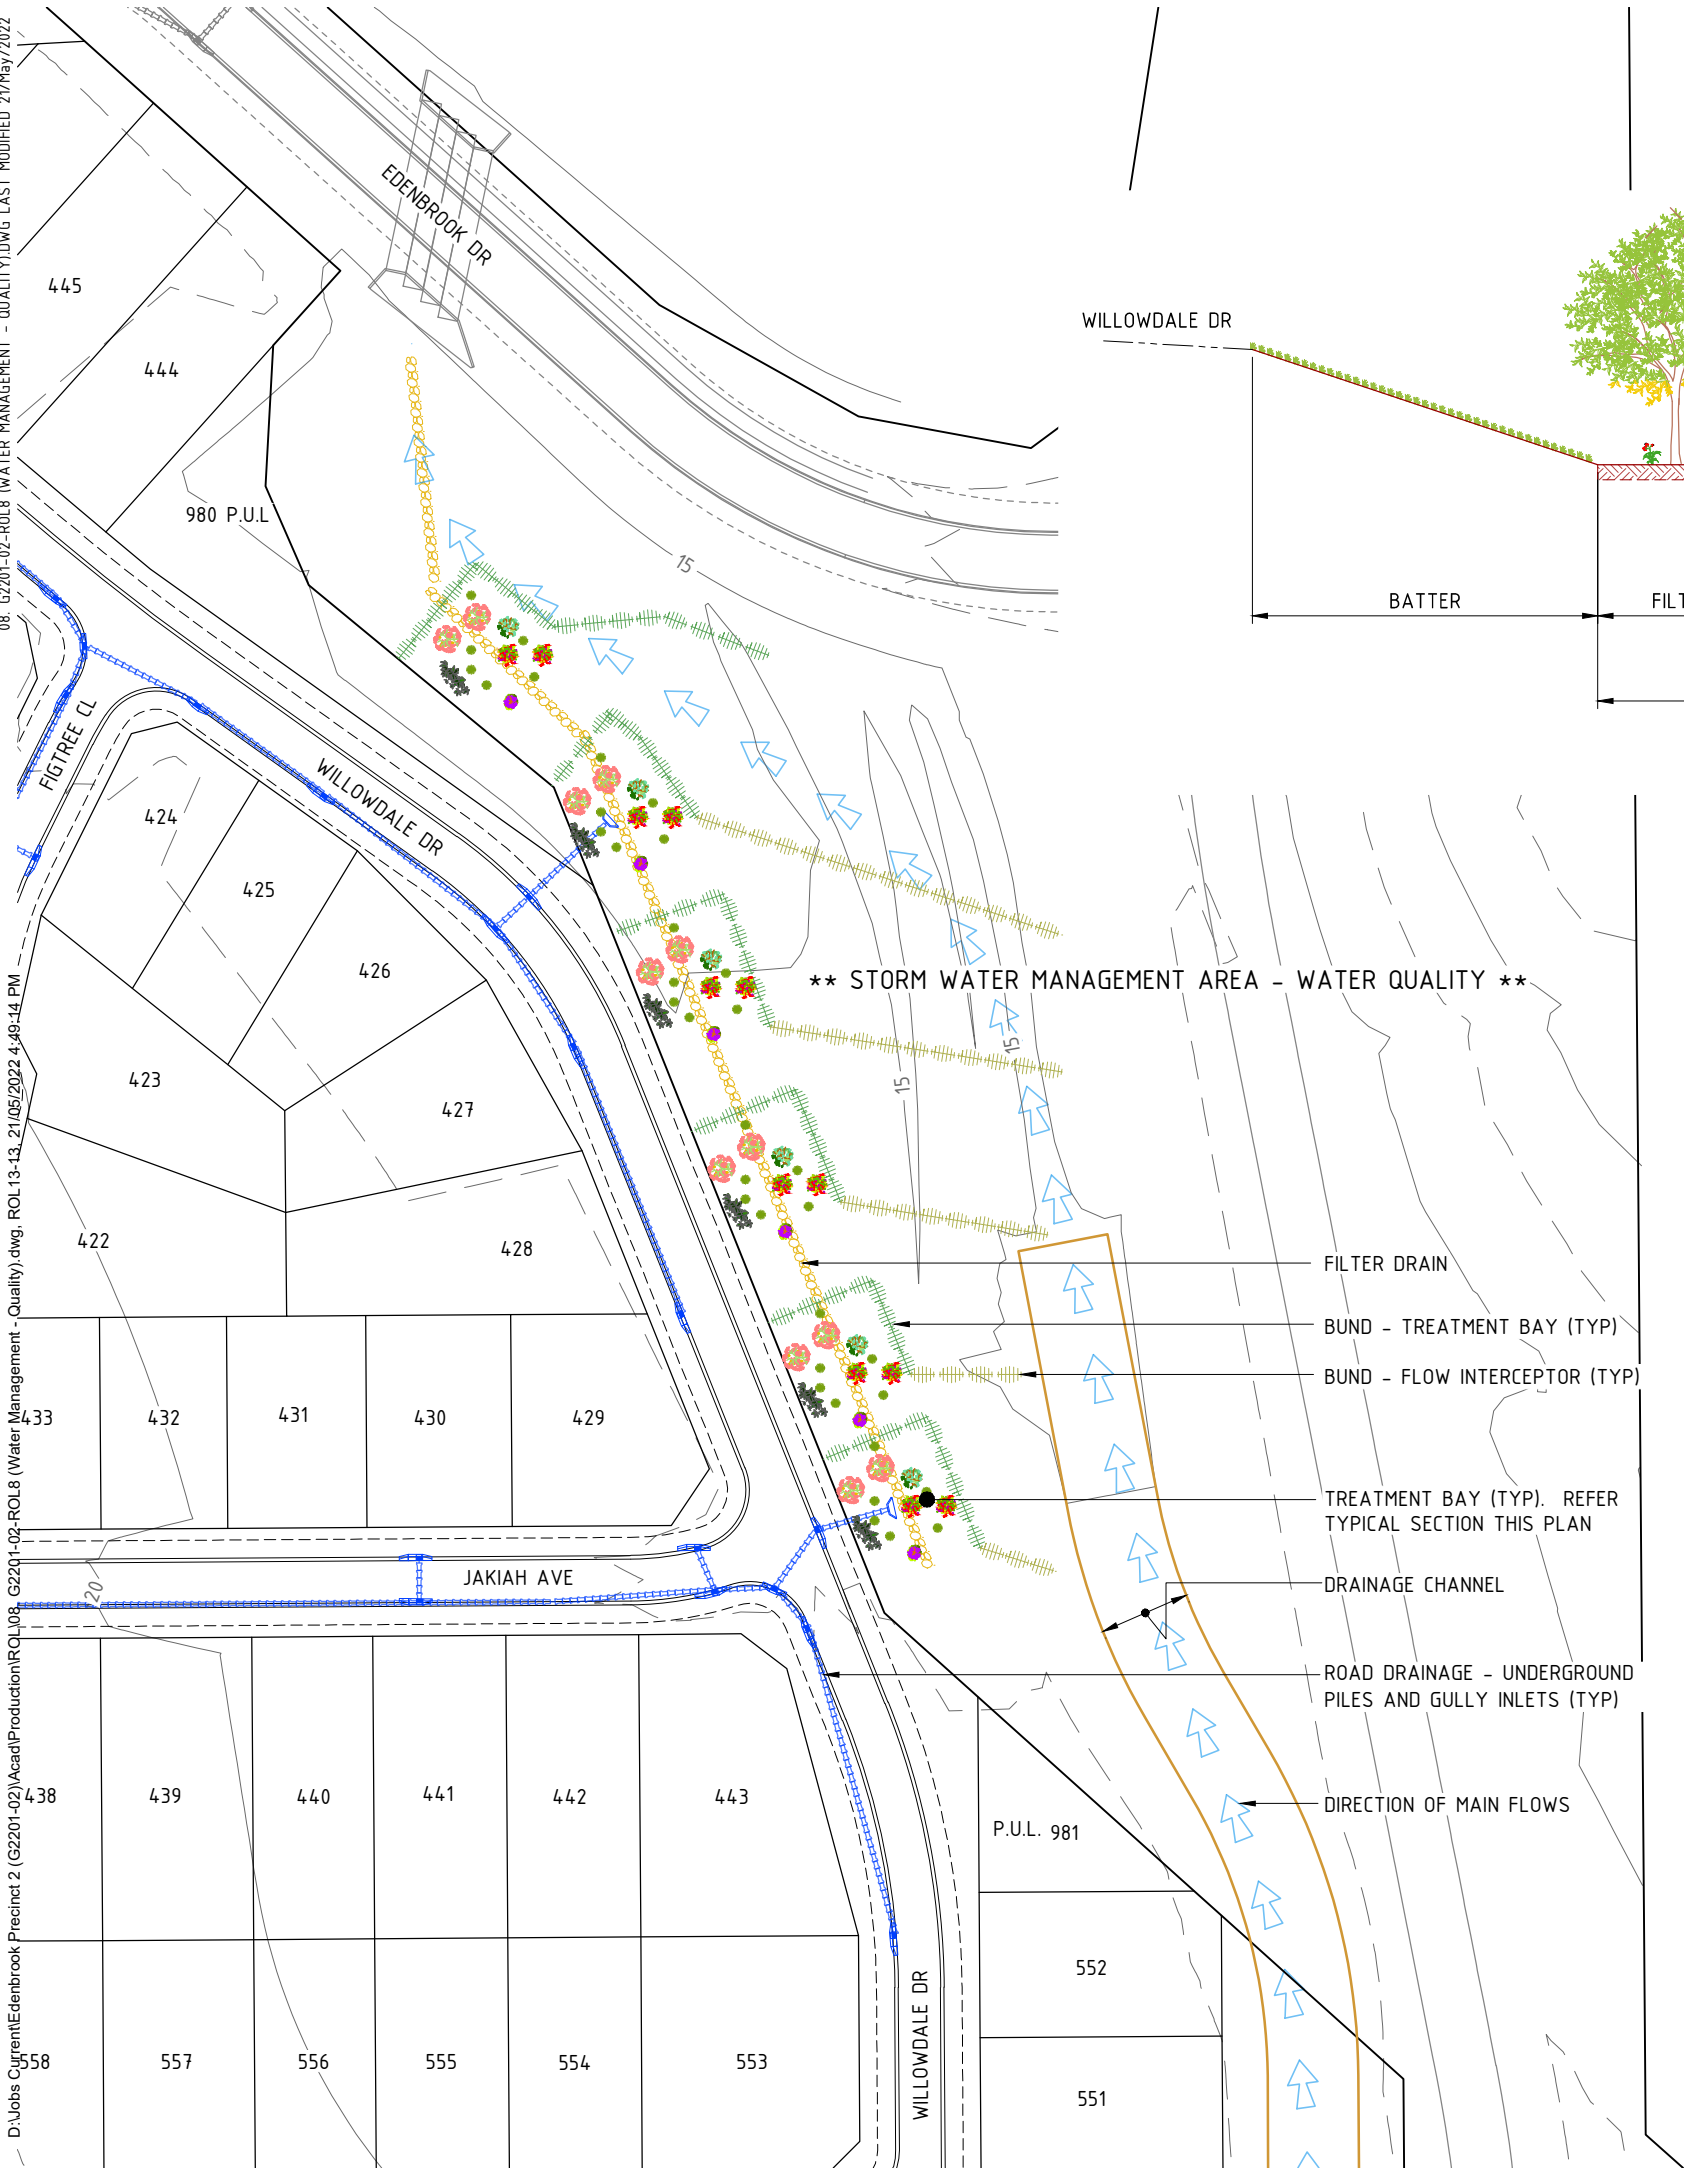
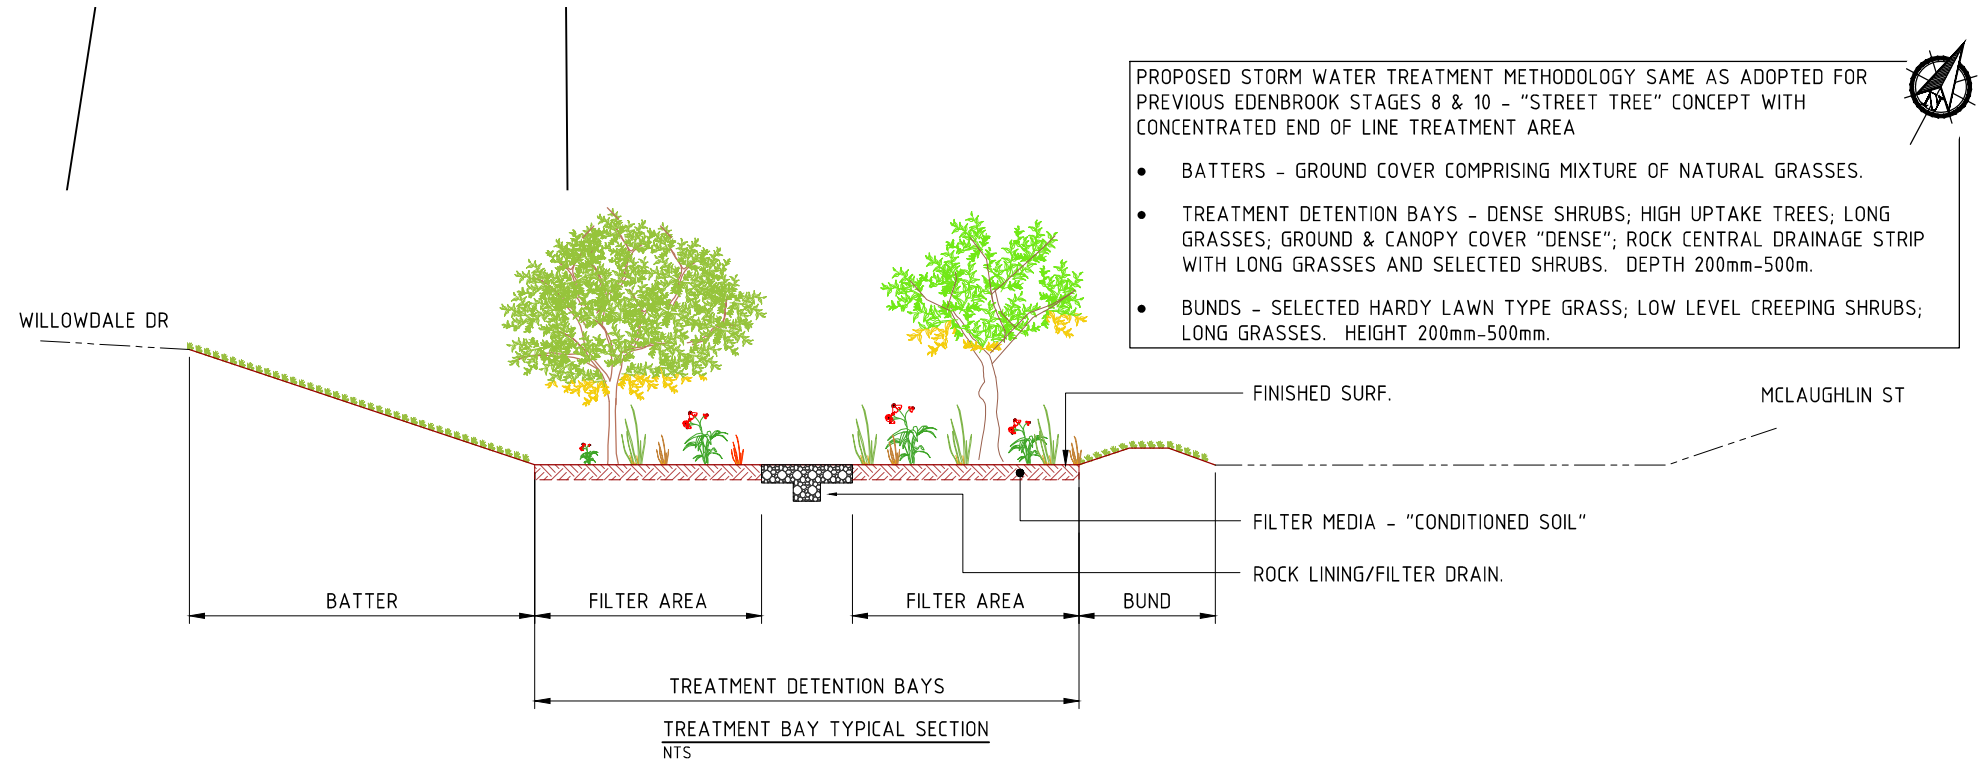
- PROPOSED STORM WATER TREATMENT METHODOLOGY SAME AS ADOPTED FOR PREVIOUS EDENBROOK STAGES 8 & 10 - "STREET TREE" CONCEPT WITH CONCENTRATED END OF LINE TREATMENT AREA
- BATTERS - GROUND COVER COMPRISING MIXTURE OF NATURAL GRASSES.
  - TREATMENT DETENTION BAYS - DENSE SHRUBS; HIGH UPTAKE TREES; LONG GRASSES; GROUND & CANOPY COVER "DENSE"; ROCK CENTRAL DRAINAGE STRIP WITH LONG GRASSES AND SELECTED SHRUBS. DEPTH 200mm-500m.
  - BUNDS - SELECTED HARDY LAWN TYPE GRASS; LOW LEVEL CREEPING SHRUBS; LONG GRASSES. HEIGHT 200mm-500mm.

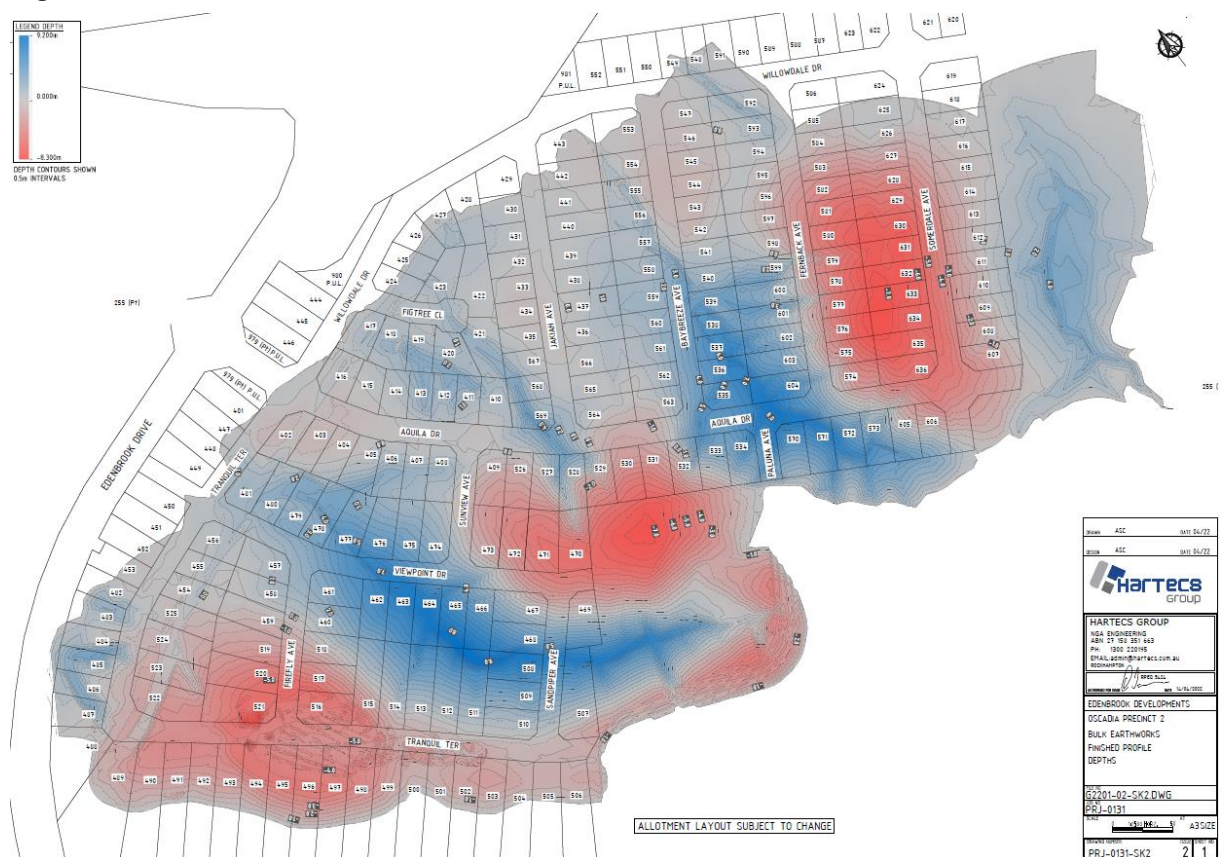
**Figure 2: Proposed earthworks for a proportion of the overall site.**

It is further understood that the proposed earthworks for a portion of the overall site will consist of bulk excavations up to approximately 7 m in height along the ridgeline and spurs, and filling up to approximately 9 m in the low lying re-entrants between the spurs (refer to Figure 2); generally creating relatively flat and level building platforms, some locally increasing up to approximately 15%. It is anticipated that similar earthworks will be required for the remainder of the site.
