# PRECINCT 2

**Edenbrook Estate**  
Edenbrook Drive,  
Parkhurst

**Reconfiguration Plan**  
**Stage 5**  
(35 Lots + Balance)

**Lot 255 on SP325466**

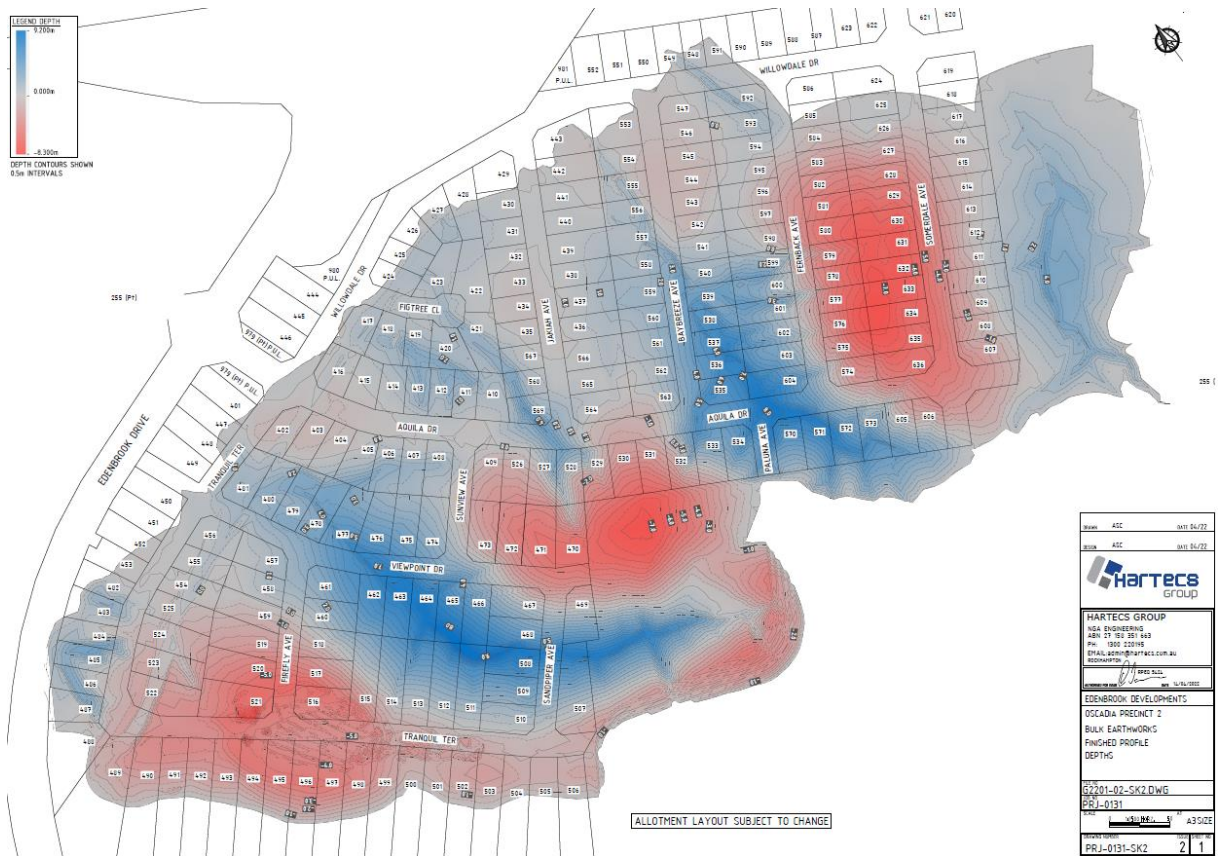
Figure 2: Proposed earthworks for a proportion of the overall site.

It is further understood that the proposed earthworks for a portion of the overall site will consist of bulk excavations up to approximately 7 m in height along the ridgeline and spurs, and filling up to approximately 9 m in the low lying re-entrants between the spurs (refer to Figure 2); generally creating relatively flat and level building platforms, some locally increasing up to approximately 15%. It is anticipated that similar earthworks will be required for the remainder of the site.

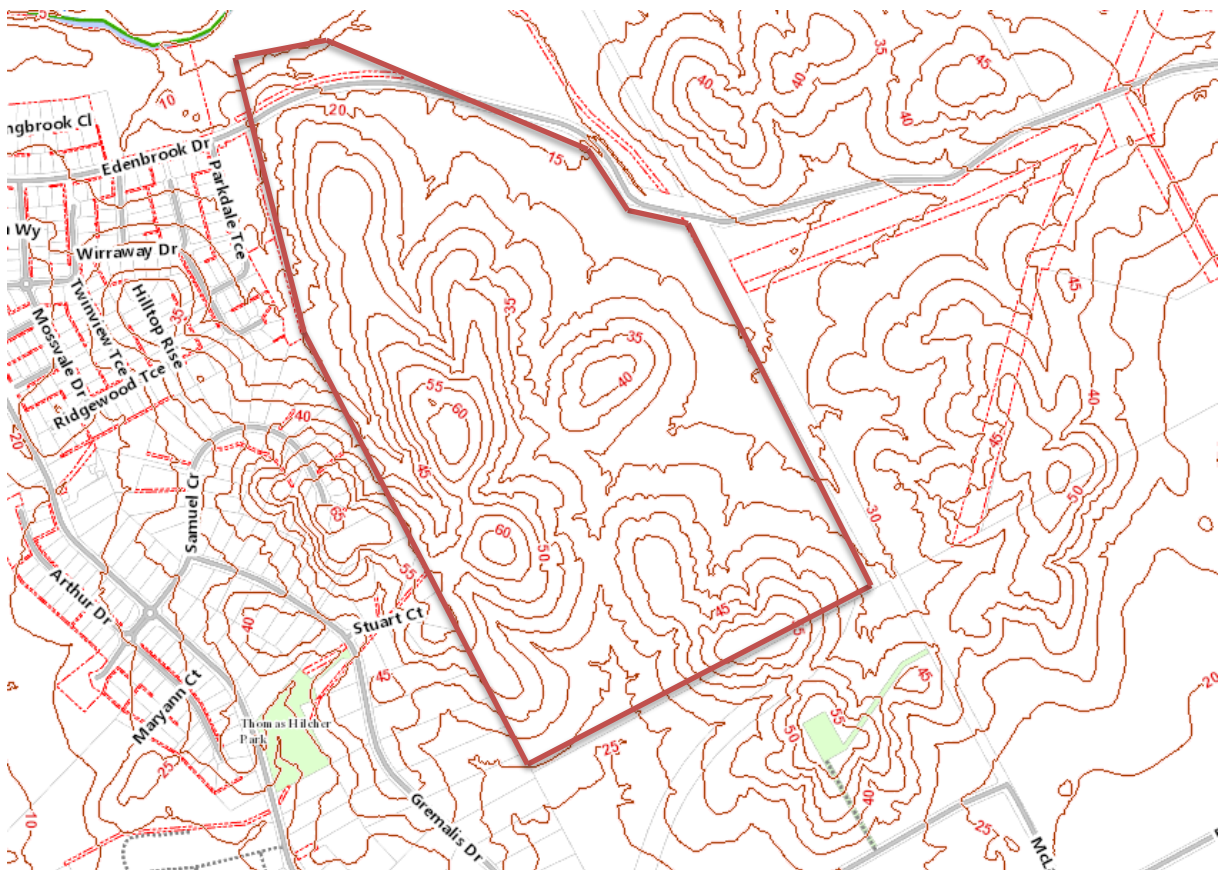
Figure 3: RRC Contour Mapping.

Reference to RCC's online contour mapping, the site is dominated by two prominent topographical features of high relief with a saddle connecting the two along the western part of the site. An elongated spur runs off to the north, with a number of smaller moderately sloping (between 10° and 15°) spurs running off to the north-east, to the east and to the south. A knoll is located atop of a spur towards the eastern part of the site. Steep (between 15° and 20°) re-entrants are located between the spurs. The site is also dominated by a second feature of high relief along the southern boundary of the site. As the site extends to the north-east, it generally flattens out.
