~	<u> </u>			PROPOSED DWELLING	this dra
SNOIS	0N0				FOR M & P HICKEY	
	<u>IS</u>				AT 229 GERMAN STREET	
	Ы					
	ľ	No.	DESCRIPTION	DATE

REVISIONS		DESCRIPTION	DATE	PROPOSED DWELLING FOR M & P HICKEY AT 229 GERMAN STREET NORMAN GARDENS	this drawi Eleva
LLL.	No.	DESCRIPTION	DATE

CONCLUSIONS AND RECOMMENDATIONS

2 Site Location

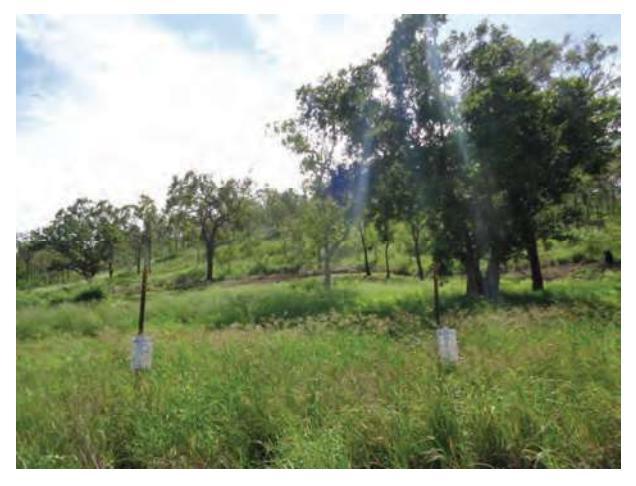
The sloping surface was generally planar in shape with a minor gully developing approximately half-way down the slope towards the southern boundary of the proposed allotment 2 block. Firebreaks have been constructed along the proposed common access as indicated on Vision Surveys Drawing No: 16025-PP-01 Rev C dated 03/02/2017, allowing access to the sites from a gated entrance. The existing slopes were measured onsite to range between 27-37%.

Plate 1: View of the site from German Street to the North

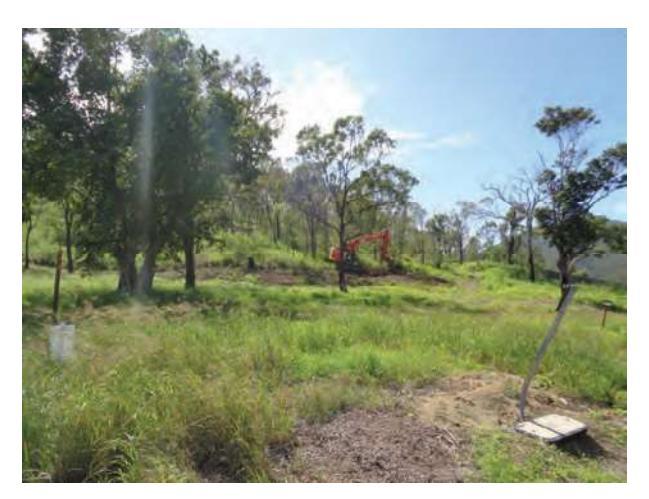
Plate 2: View of the site from German Street to the North-East

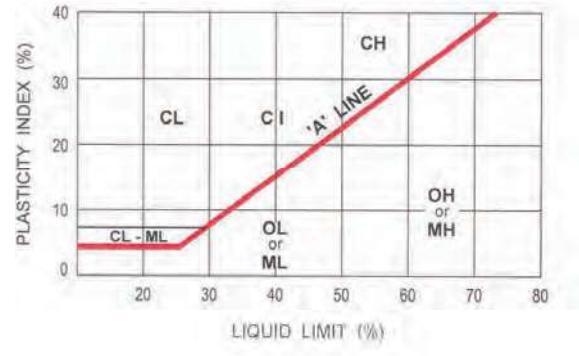
PLASTICITY CHART FOR CLASSIFICATION OF FINE GRAINED SOILS

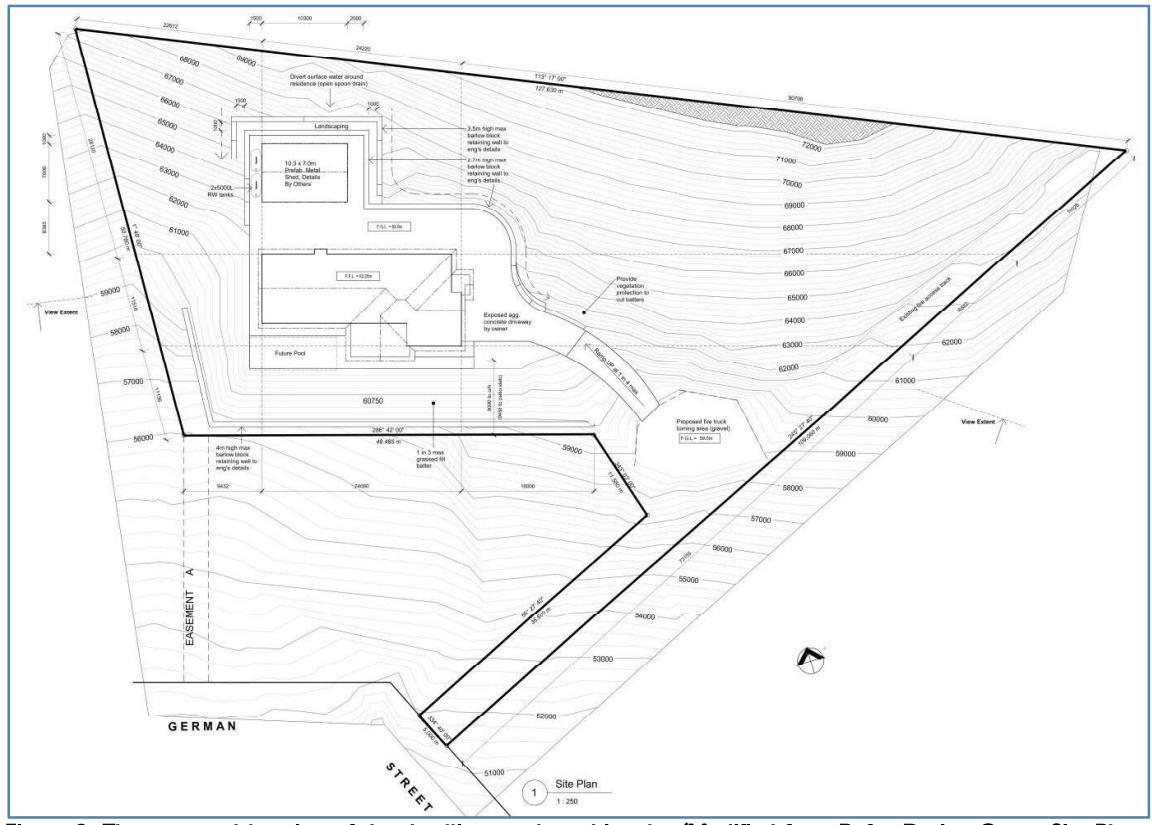
Figure 2. The proposed location of the dwelling on the subject lot (Modified from Rufus Design Group Site Plan Drawing 201005).

The location of the proposed dwelling is provided in **Appendix** and an extract is provided in **Figure 2**.

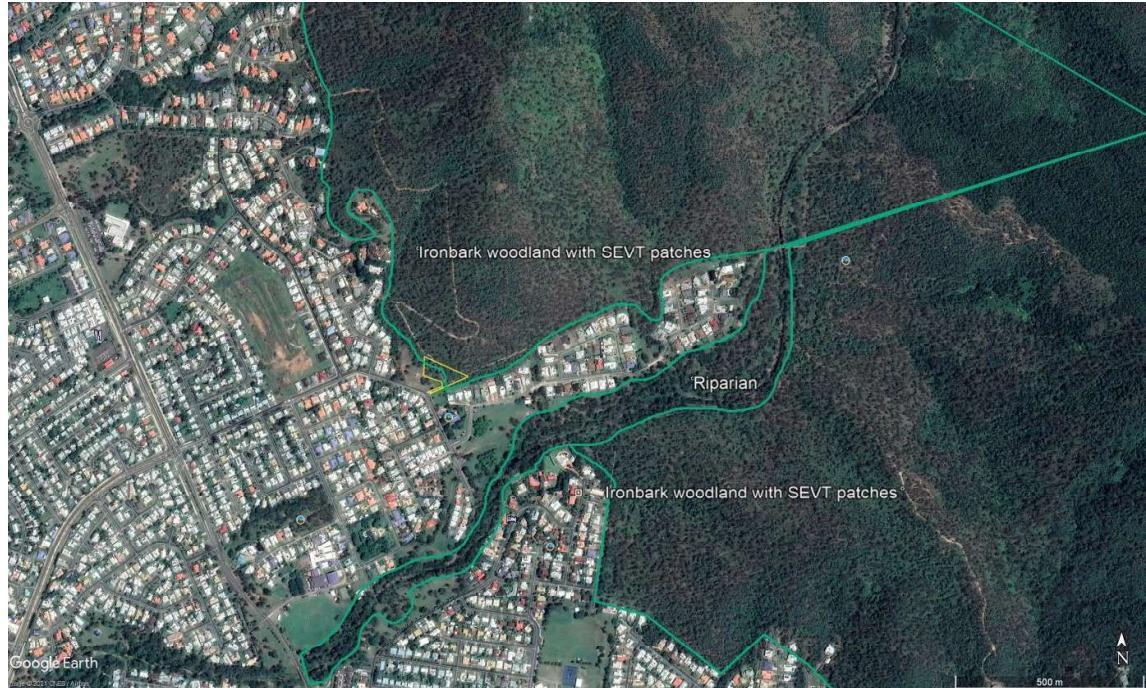
Figure 3. Location of vegetation types in relation to the proposed dwelling site on 12.95.

Vegetation communities in the near area consist of ironbark woodlands with patches of semievergreen vine thicket in gullies and the Moore's Creek riparian area with a mixture of low flammability rainforest species and more fire prone sclerophyll species. See **Figure 3** for the location of vegetation types in relation to the dwelling site.

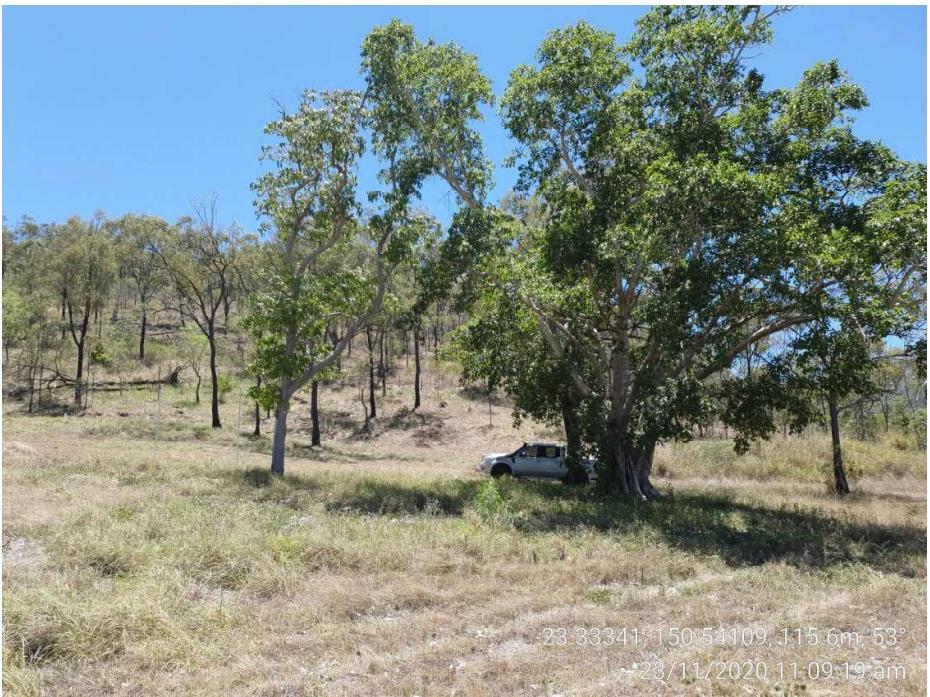
Figure 4. A narrow area of grasslands greater than 30cm in height located downslope from the dwelling.

There were two vegetation types presenting a bushfire hazard. These were; A narrow area of grasslands greater than 30cm in height located downslope from the dwelling (Figure 4); and; Grassy to shrubby ironbark woodlands at northwest, north and northeast aspects. The location of these vegetation types are indicated in Figure

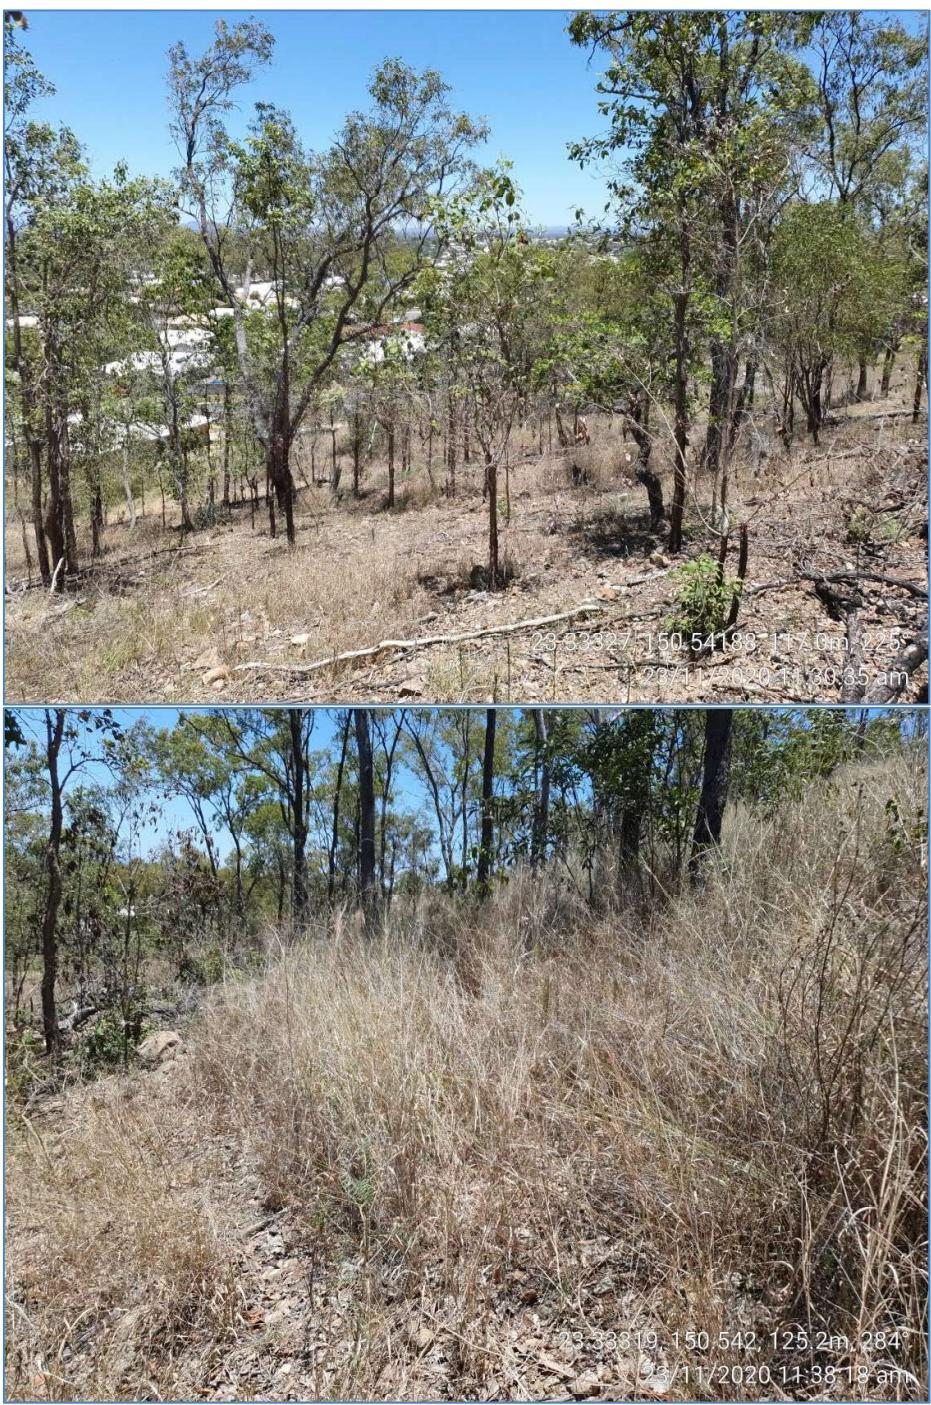
Figure 5. Grassy to shrubby woodland upslope from the proposed dwelling location. Surface fuels were variable between sparse grasses and scattered patches of dense grasses and shrubs (largely lantana).

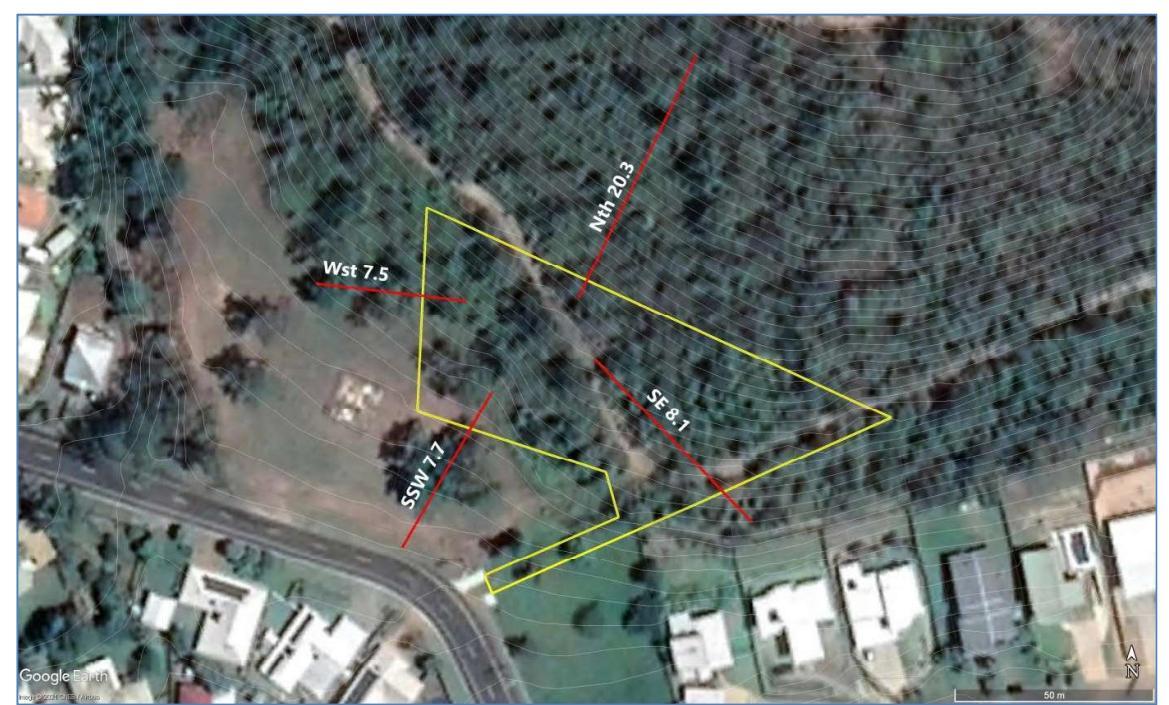
Figure 6. One metre contours over 35SP285391. The driveway is indicated by the grey line.

Aspect	Degree of slope
N	20.3*
SE	8.1
SSW	7.7
W	7.5

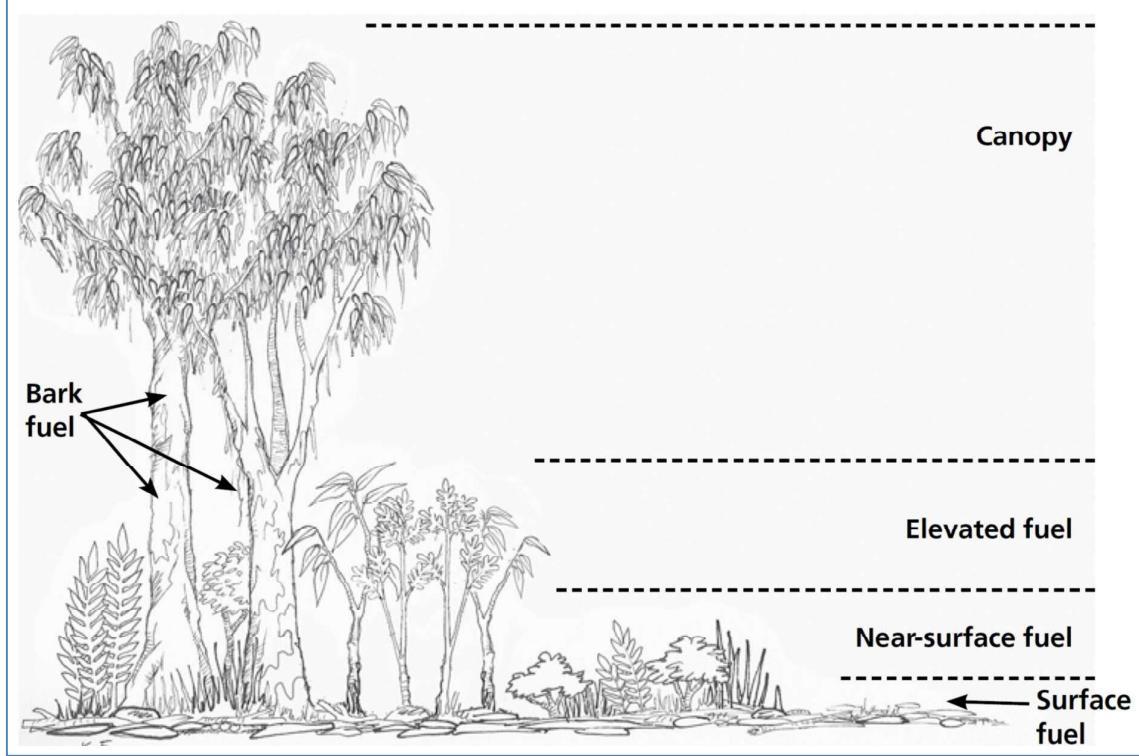
Figure 7. A diagram of various layers of vegetation hazard used in the BAL calculation for surface fuels (taken from Hines et. al., 2010).

Figure 7 provides a classification of vegetation layers as levels of potential fuel. Hazard ratings are given with respect to Hines *et. al.* (2010). Hines *et. al.* provides an assessment of fuel hazard on a 5 step scale from low, moderate, high, very high to extreme. These hazard ratings with respect to a vegetation layer provides an estimate of tons/ha of fuel load for that layer.

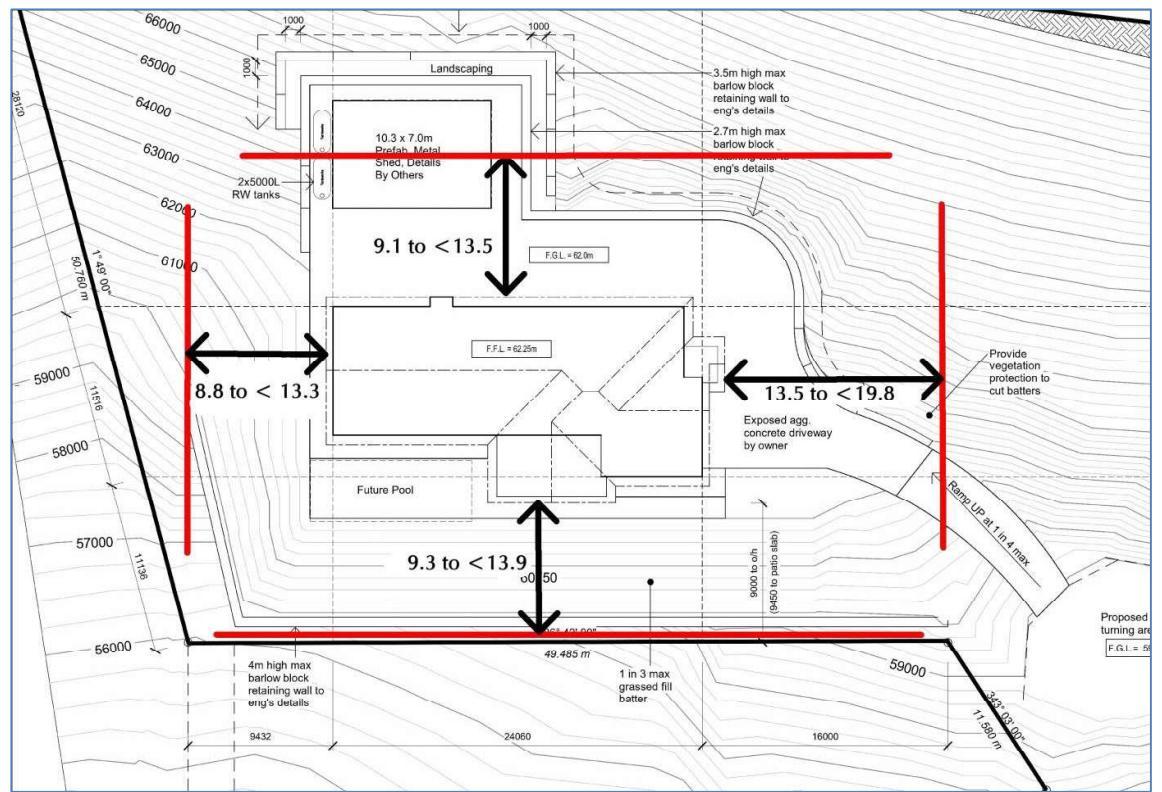
Figure 8. APZ distance ranges at each surface of the proposed dwelling to comply with AS3959: 2018 BAL-19.

Aspect	APZ range (m) for BAL-19	Notes
N	9.1 to <13.5	Retaining wall provides some shielding to radiant heat. Embers likely to circulate in enclosed areas
SE	13.5 to <19.8	Retaining wall provides some shielding to radiant heat. Embers likely to circulate in enclosed areas
SSW	9.3 to <13.9	BAL 12.5 can be used where grasses between the dwelling and German Street are kept to < 30 cm tall.
W	8.8 to < 13.3

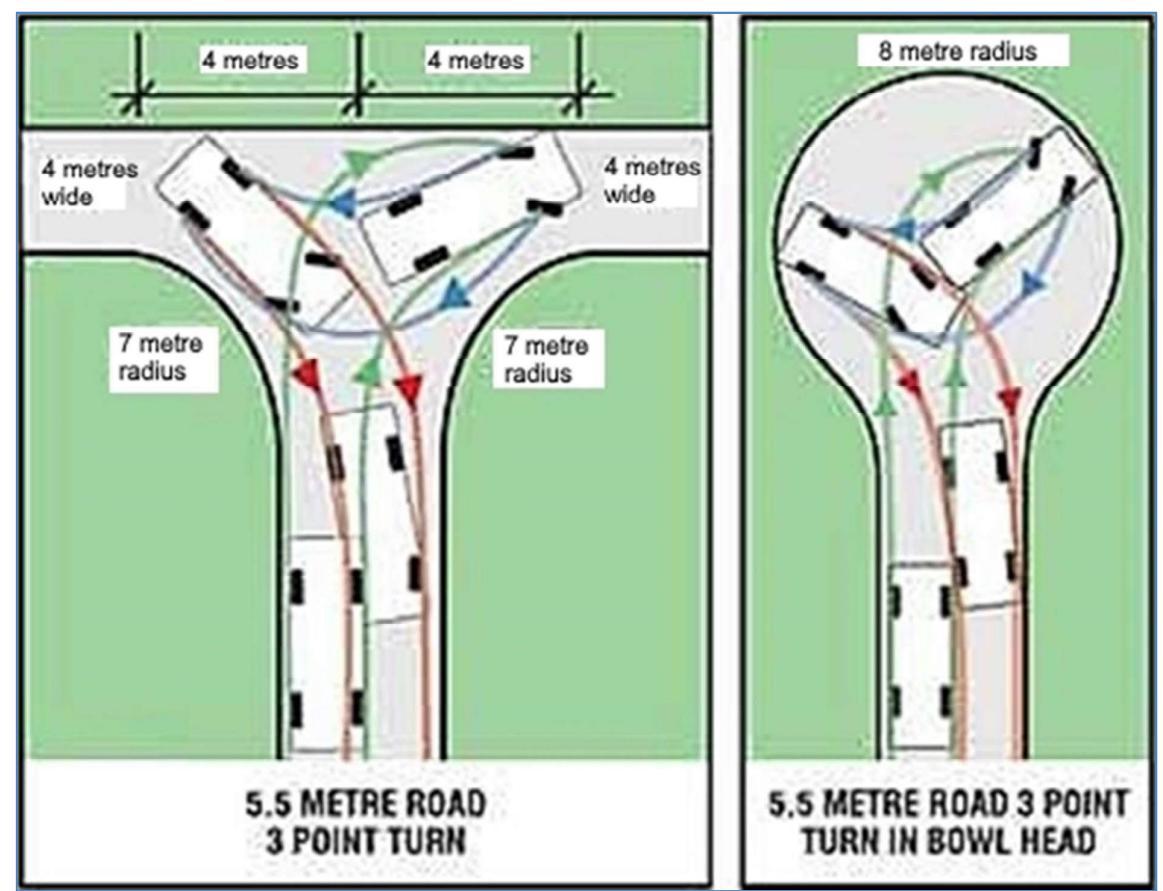
Figure 9. Example turnaround areas (Taken from Building Fire Safety Management Tool & Advisory Notes, State of Queensland (Queensland Fire and Emergency Services) 2015).

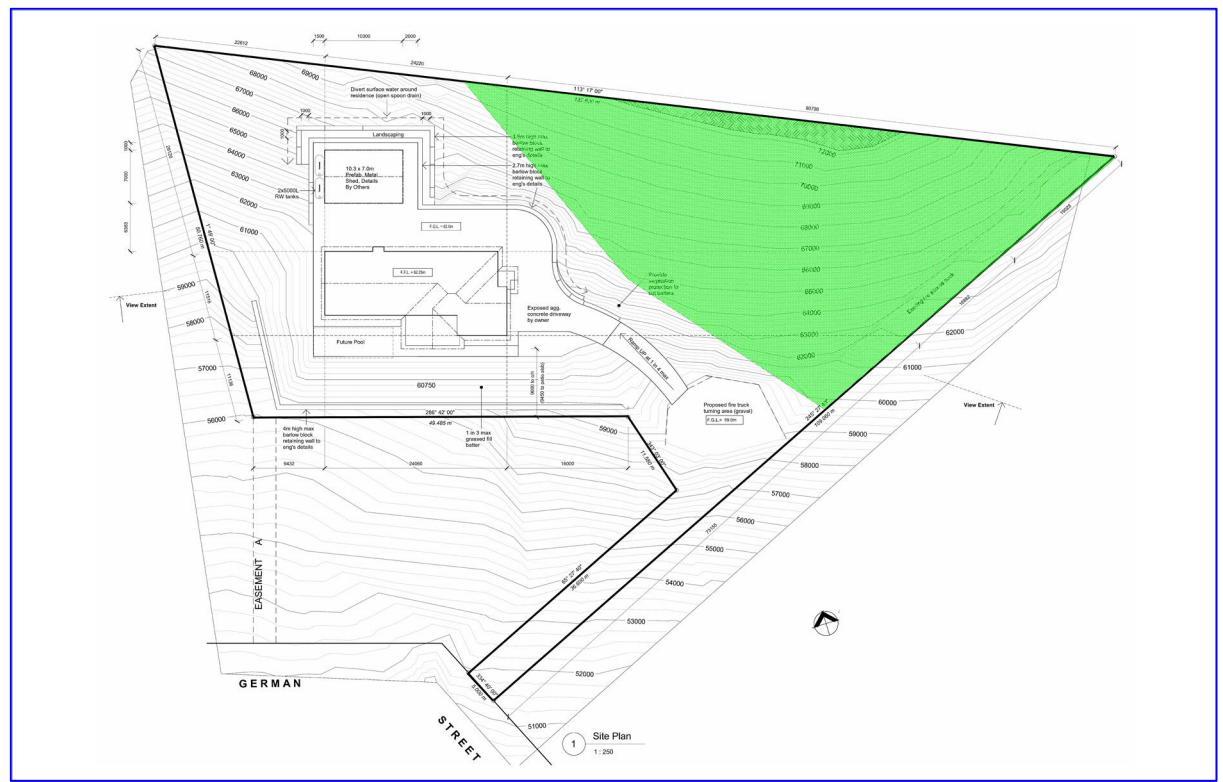
Figure 2. The proposed location of the dwelling on the subject lot with potential areas of vegetation retention shaded green (Modified from Rufus Design Group Site Plan Drawing 201005).

The lot is approximately 4,645 m². **Figure 2** shows the proposed layout and earthworks. The shaded green area in **Figure 2** represents the potential retention of 1,800m² of site vegetation. However, this area does not include any existing tracks and potential clearing along boundary lines for fire management lines.

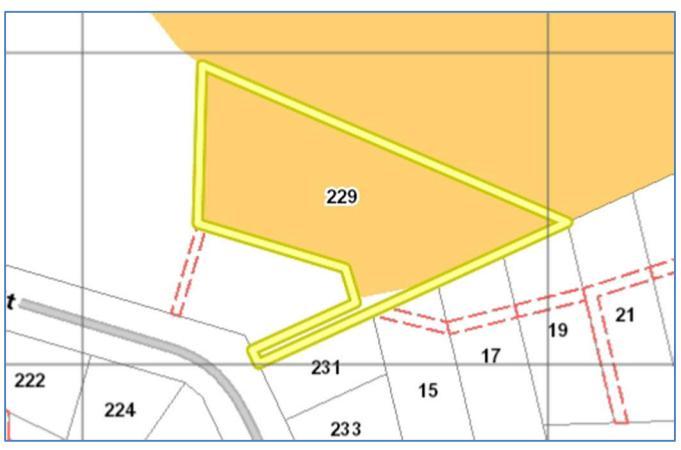
Figure 3. Extent of MLES – High over Lot 35.

A large proportion of the site is identified in the RRC Planning Scheme as an *Environmental management and conservation zone* and as *MLES – High.* See Figure 3 for an extract of the RRC mapping and the Appendix for the full map.
