project
Edenbrook Estate
Edenbrook Drive, Parkhurst

plan of
Reconfiguration Plan
Stage 5
(42 Lots + Balance)

Report on
Geotechnical Stability Assessment

Proposed Subdivision
Edenbrook Estate (Precinct 2)
Edenbrook Drive, Parkhurst

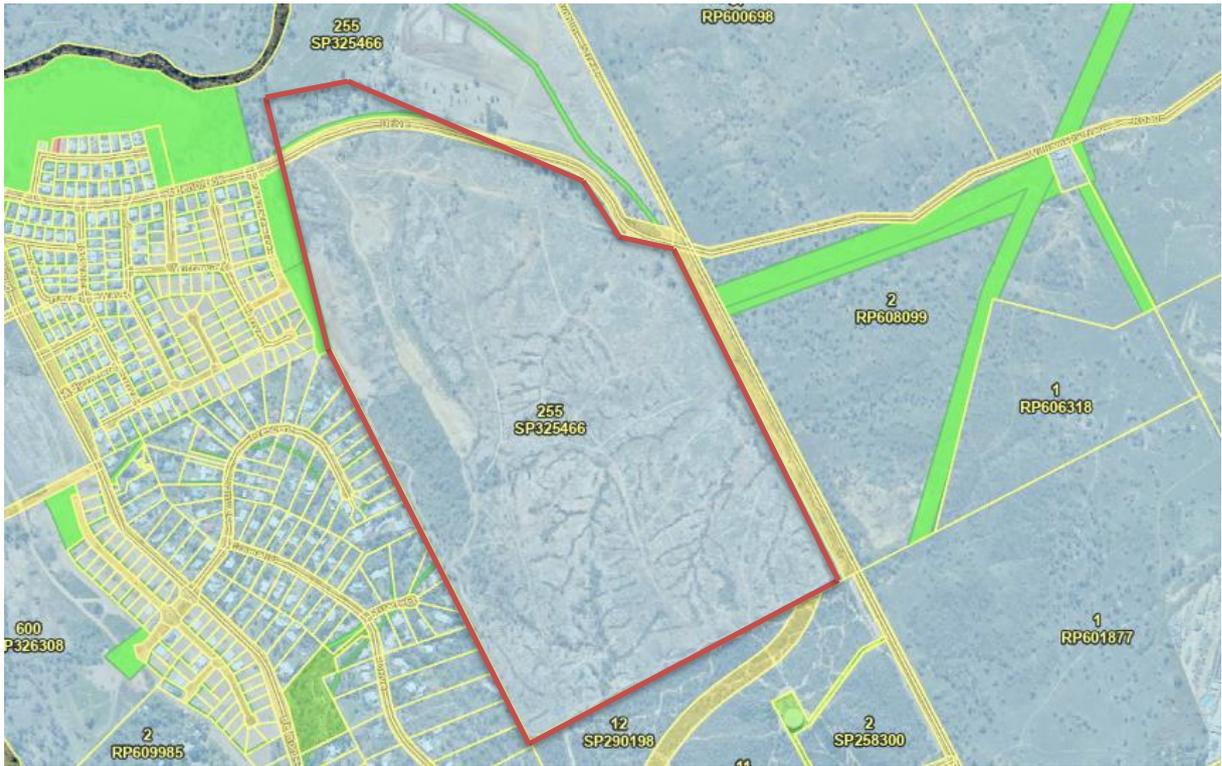
Figure 1: Site Location.

The development site is described as Lot 255 on SP325466, which encompasses both the northern and southern sides of Edenbrook Drive, Parkhurst (refer to Figure 1).

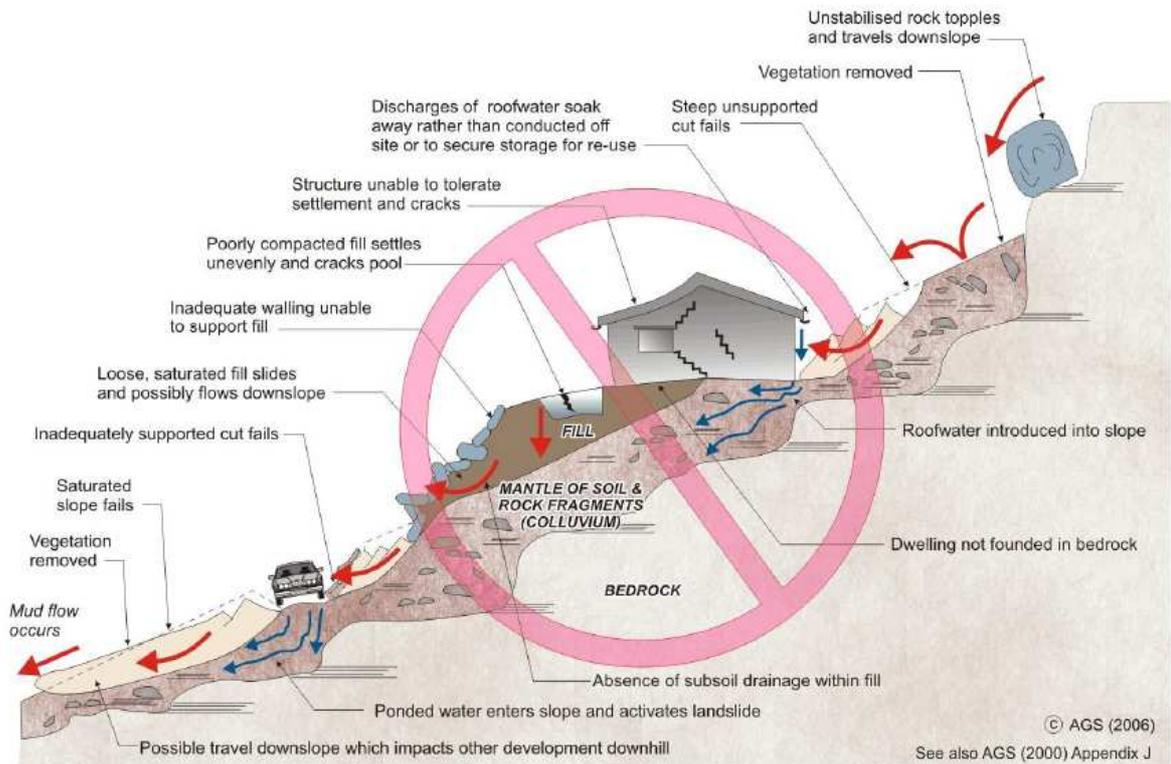
EXAMPLES OF **POOR** HILLSIDE PRACTICE
