Music Bowl Structural Assessment

24 November 2014

R14265

Prepared for Rockhampton Regional Council

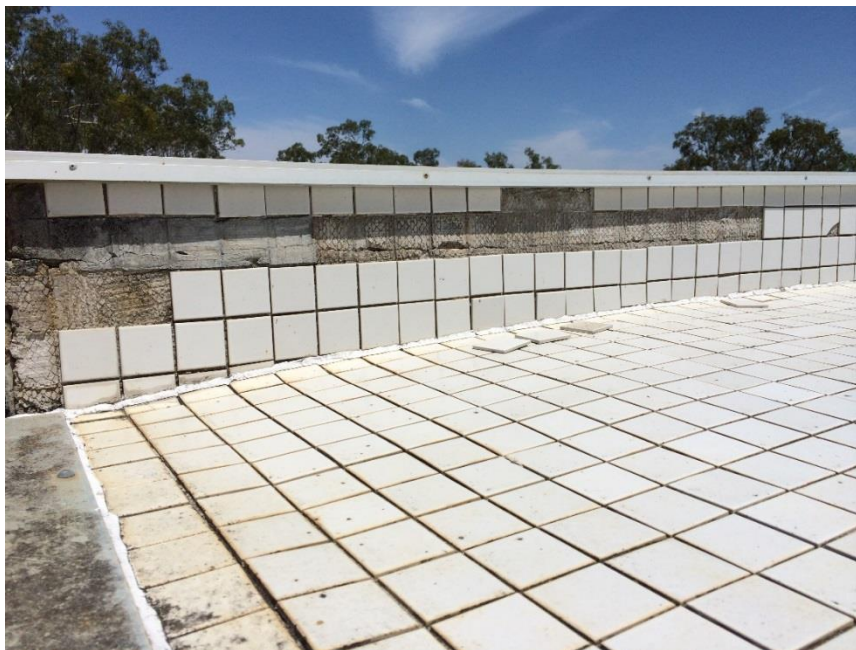
Figure 5 - Horizontal and vertical tiled surfaces

Tiles missing from vertical surfaces. Horizontal tiled surface. Evidence of water ponding adjacent aluminium edge capping.

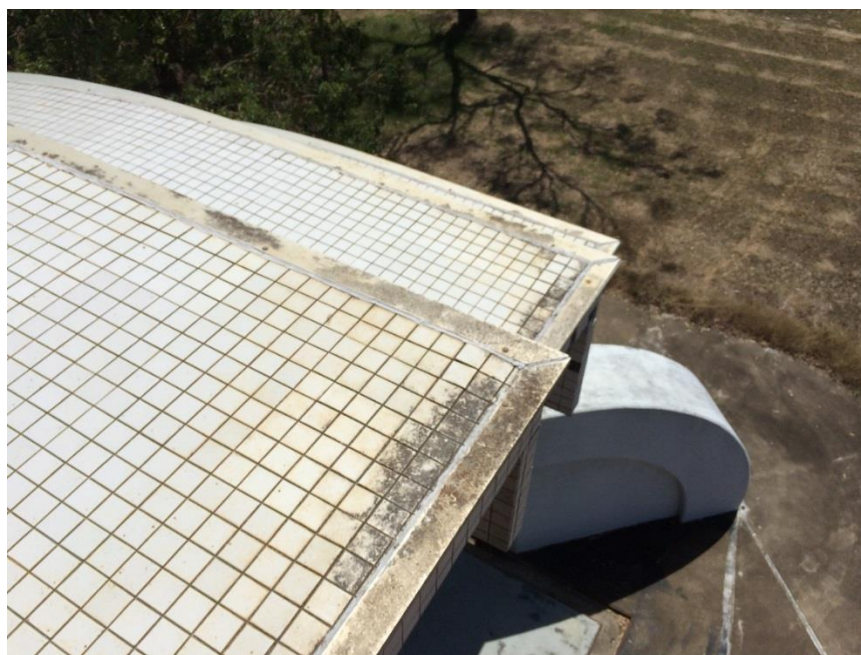
Figure 6 - Tiled Roof (horizontal section)

Horizontal tiled surface with evidence of water ponding adjacent the aluminium edge capping.

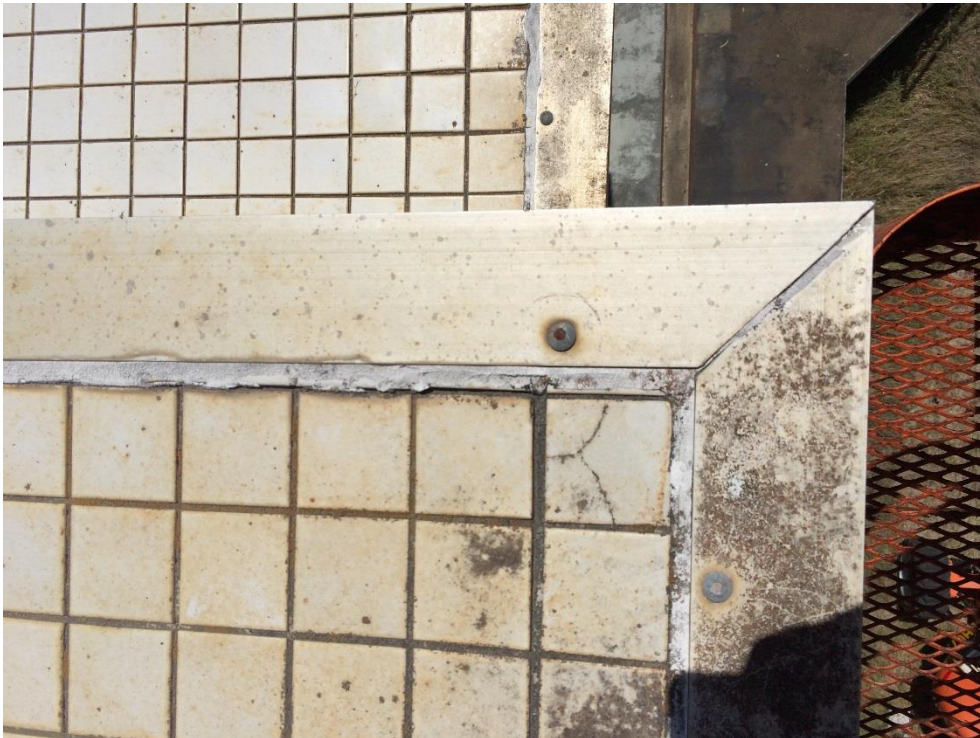
Figure 7 - Edge of horizontal tiled surface (detailed view)

Detailed view of edge horizontal tiled surface with aluminium edge capping and sealant. Evidence of water ponding.

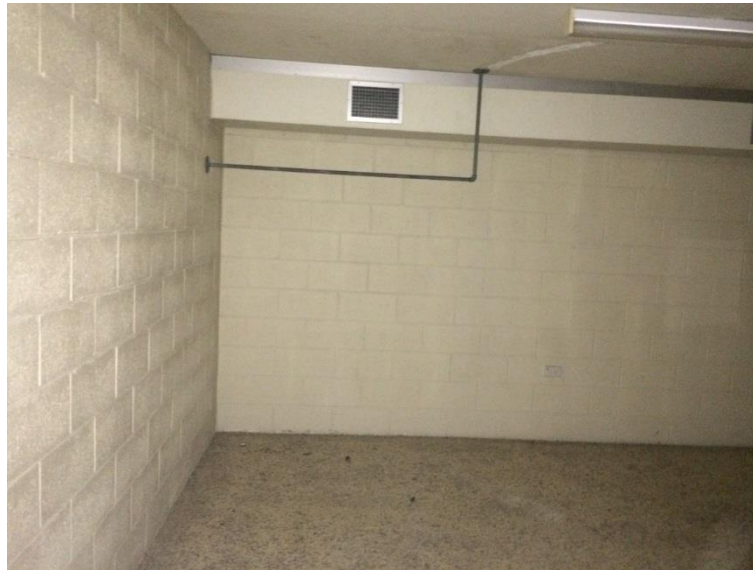
Figure 16 – Substructure

Lower ground floor dressing rooms, structure generally in sound condition

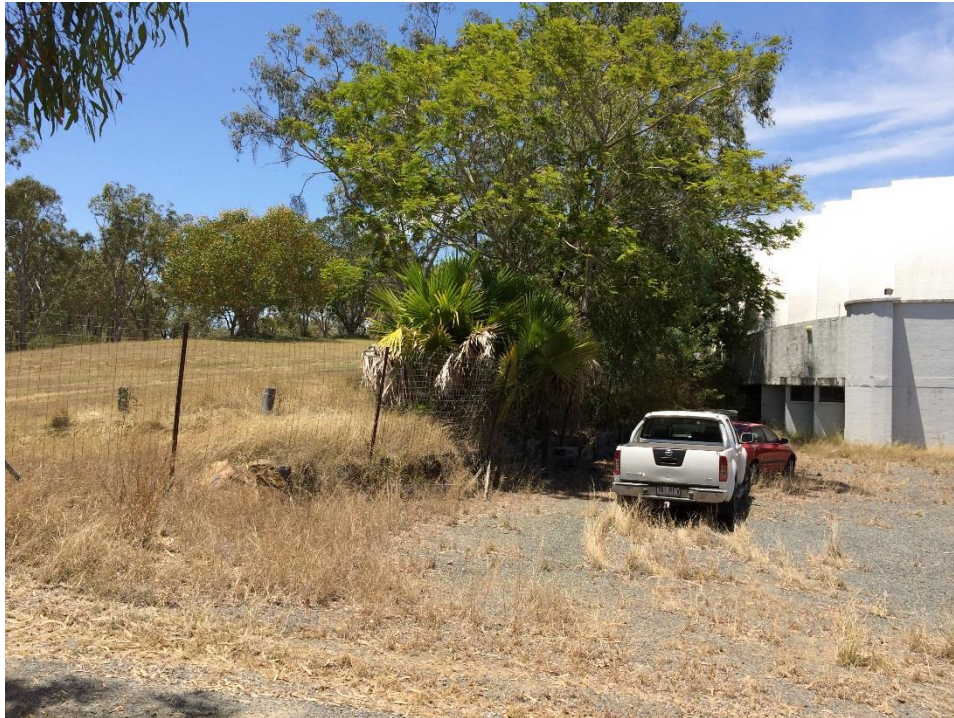
Figure 23 – Landscaping

Landscaping and retaining wall to north east of sound shell

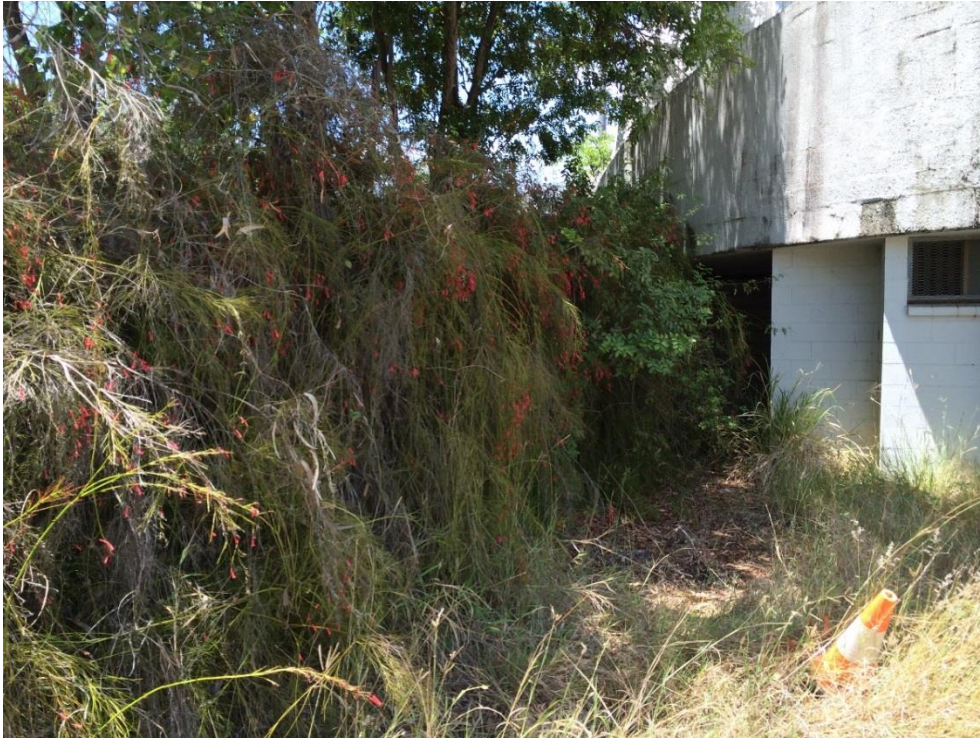
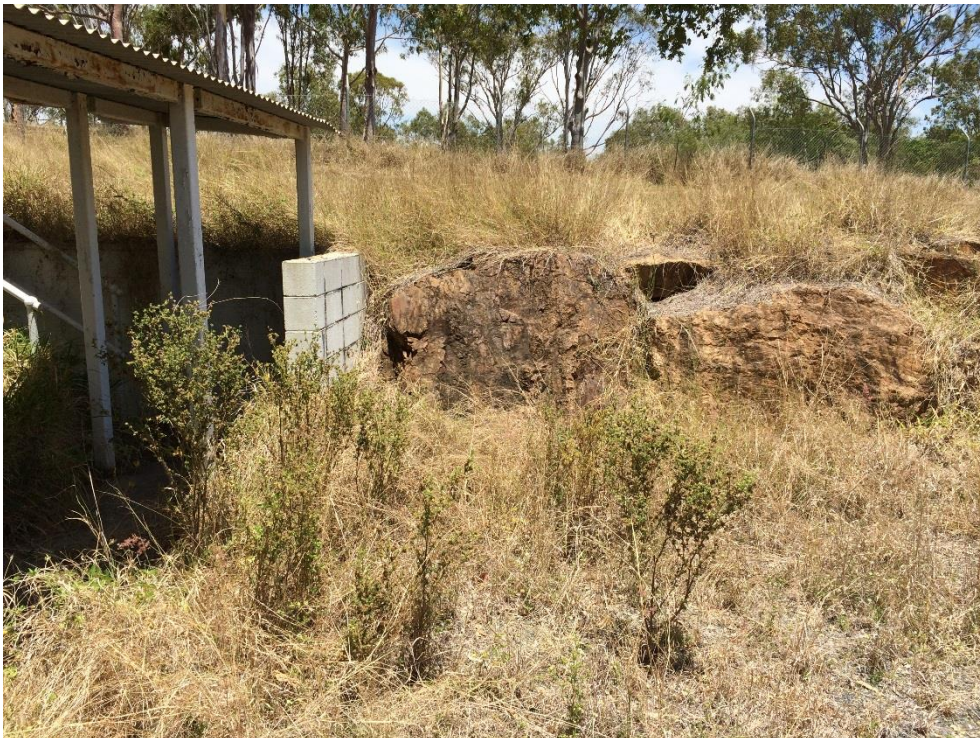
Overgrown vegetation adjacent sound shell. Access to lower ground floor is hindered.

Figure 25 - Overgrown vegetation

Figure 26 - Overgrown vegetation

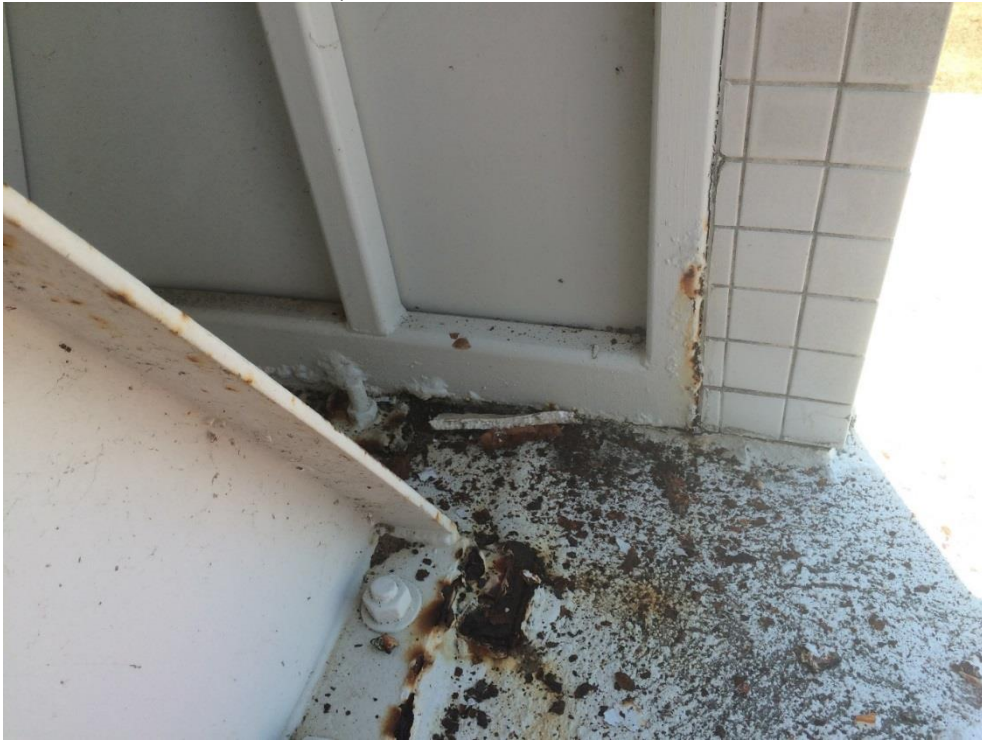
Photo 006 - Corrosion to truss tab plate

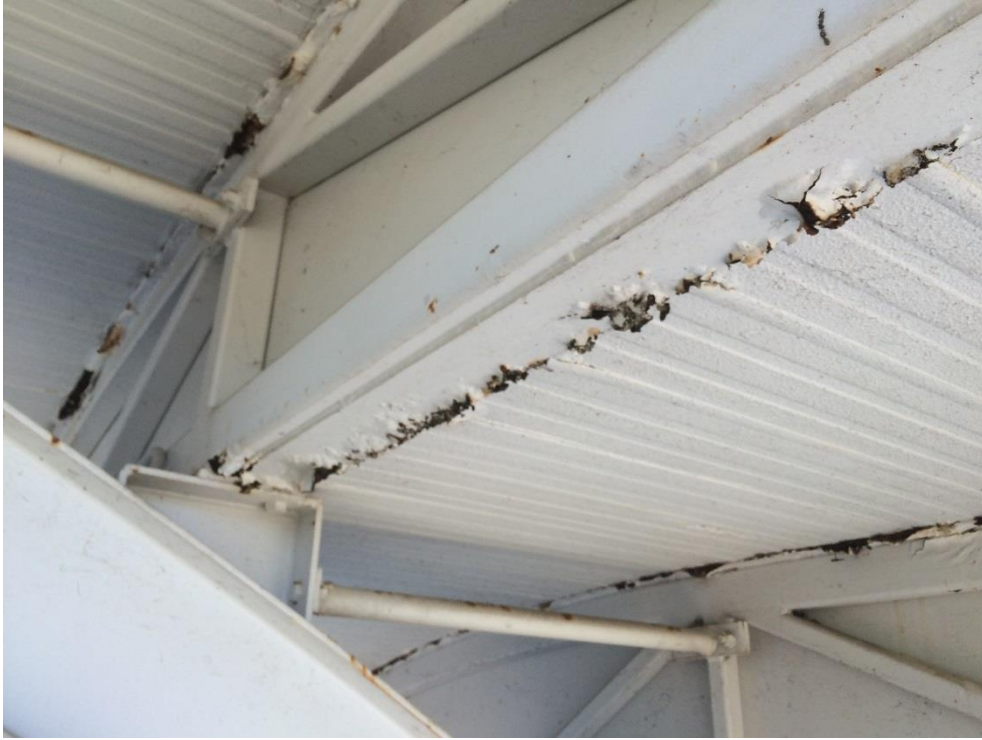
Photo 080 - Minor corrosion to bottom plate

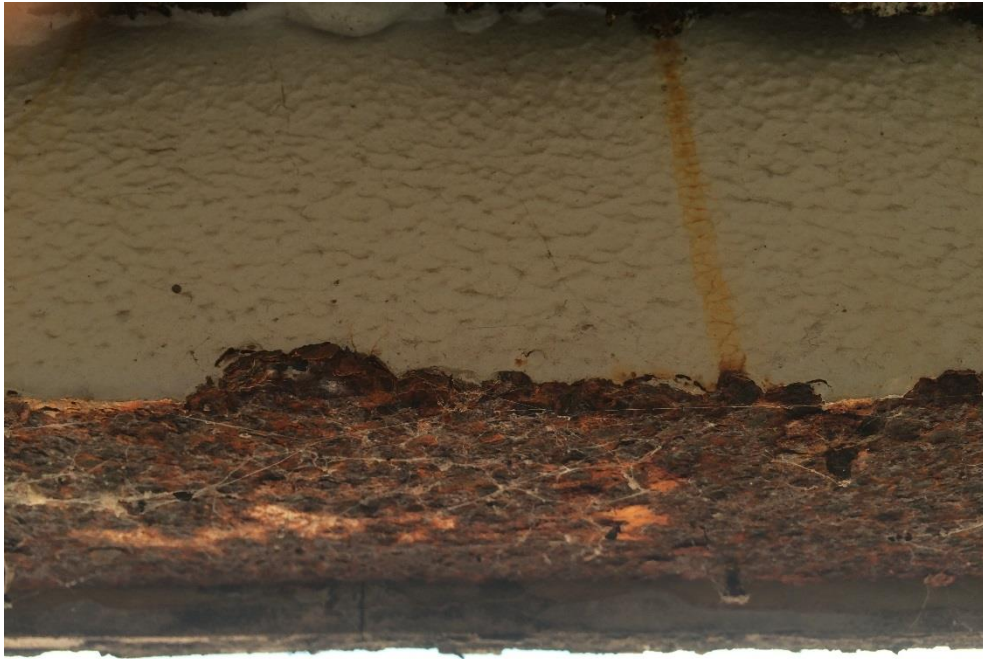
Photo 093 - Heavy corrosion to fascia

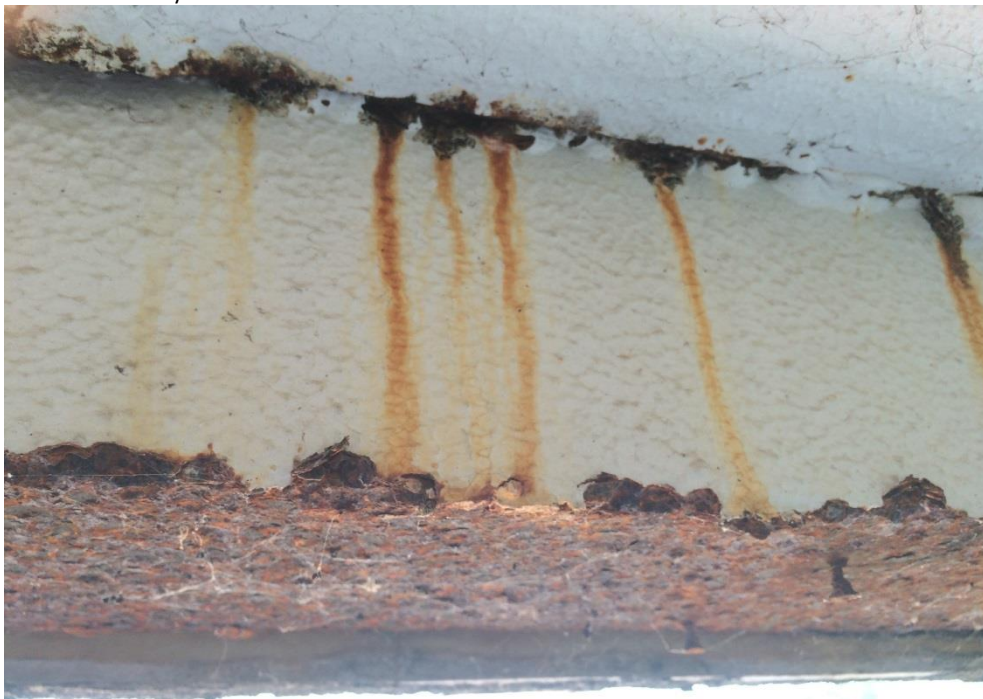
Photo 094 - Heavy corrosion to fascia

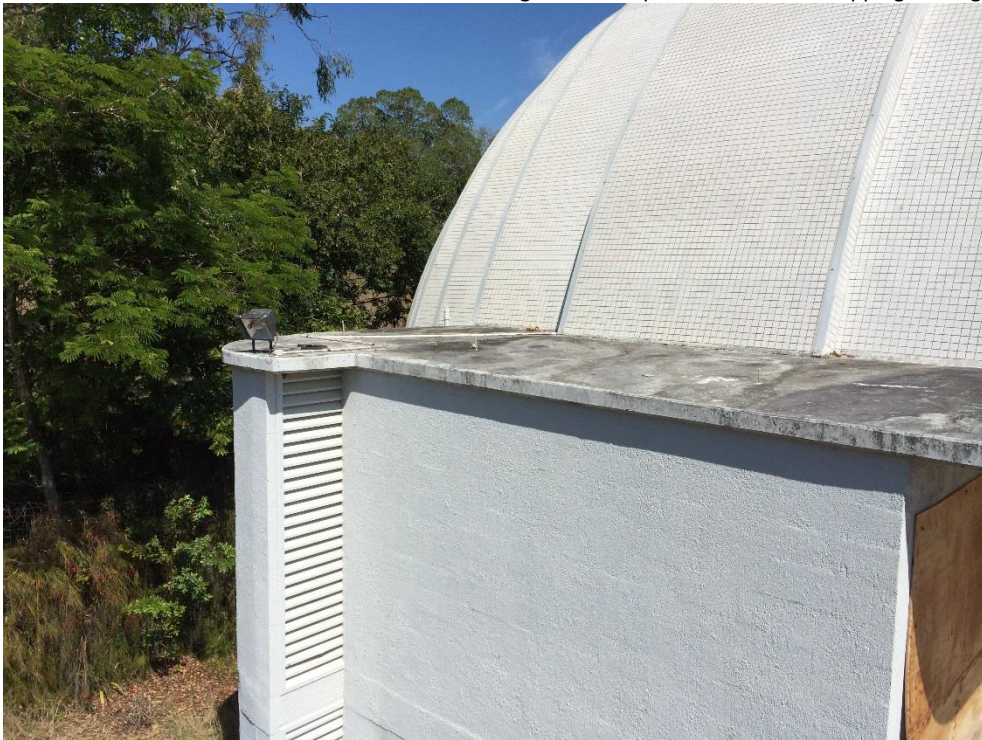
Photo 213 - Rear of sound shell, general photo

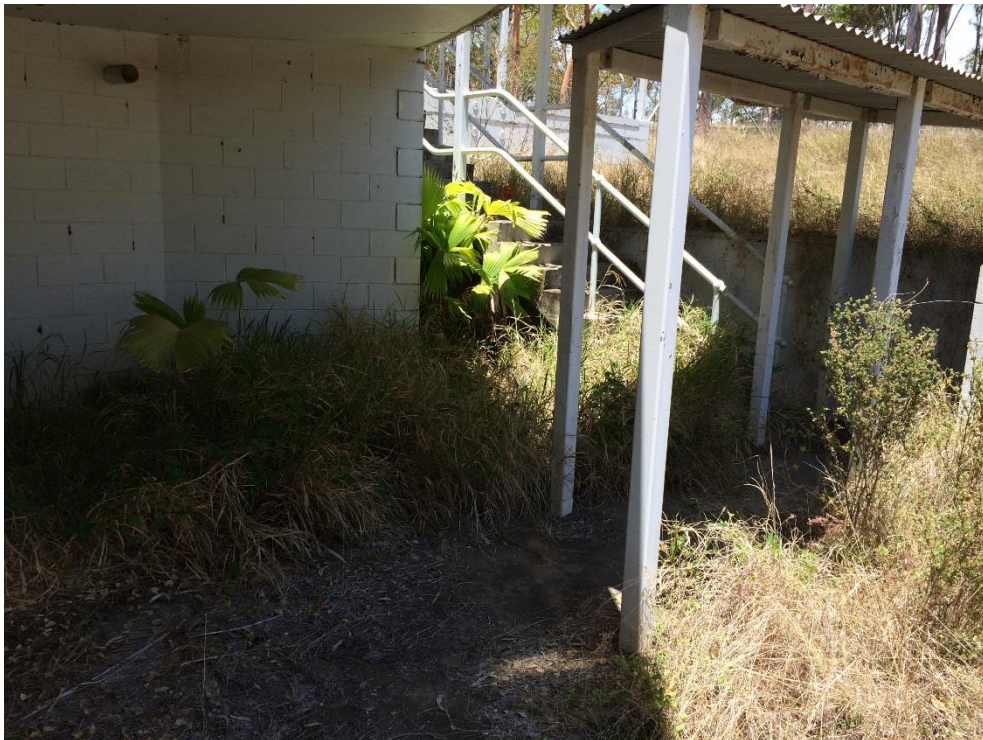
Photo 221 - Overgrown vegetation adjacent covered walkway

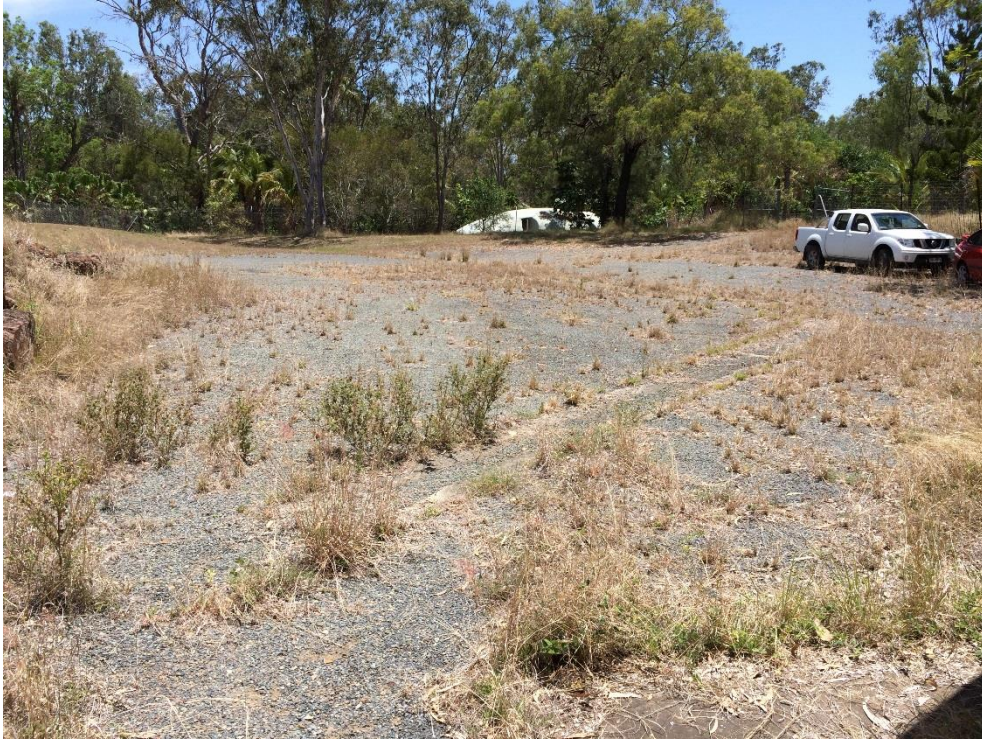
Photo 222 - Loading area at rear, vegetated

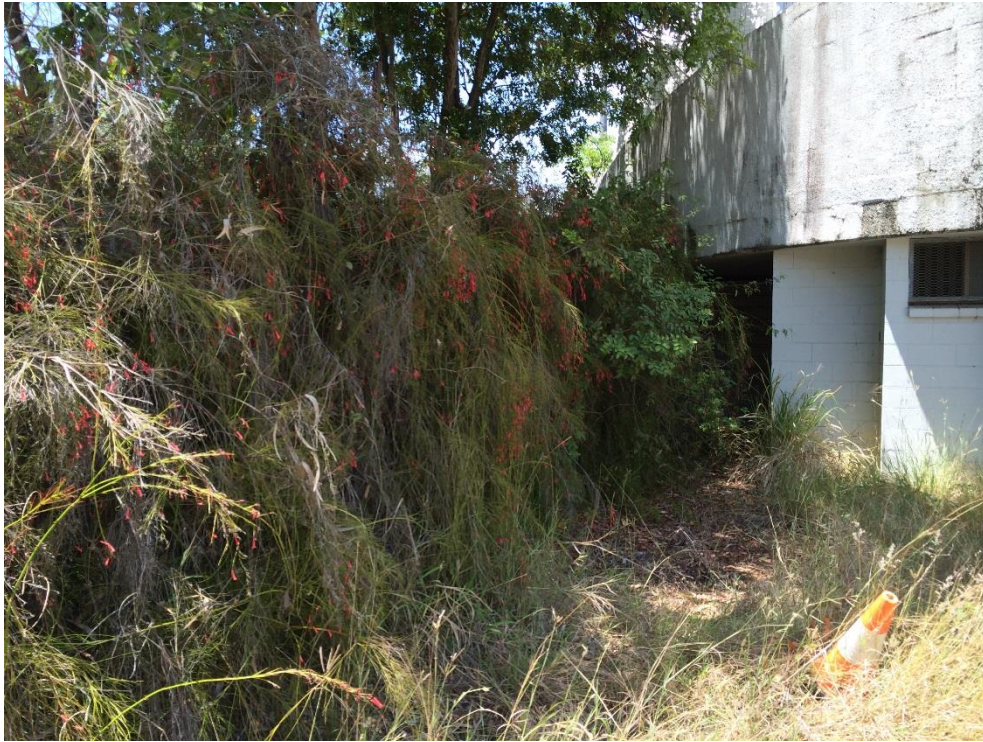
Photo 228 - Overgrown vegetation in landscaped area adjacent sound shell

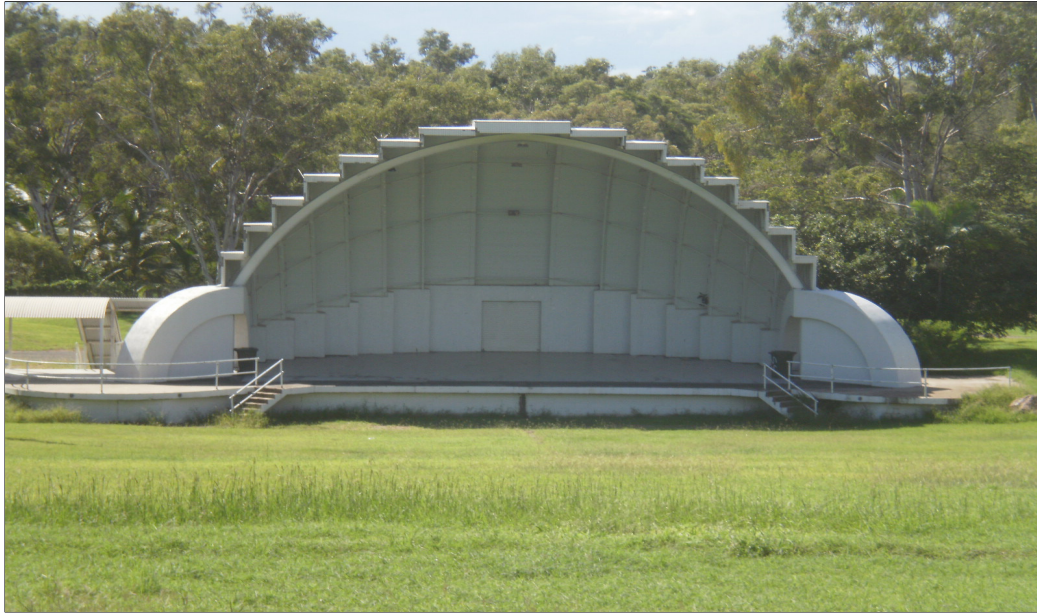
The structural steel to the sound shell is rusted to a lot of the surfaces under the roof of the shell due to the roof leaking at the roof to wall junctions. Refer photo 1 to 4. The steel frame work for the covered walk ways is also covered in surface rust. Refer photo 11.

Rusted Structural Steel (photo 1)

To repair this building is going to be a major task as you would need to remove all of the tiles and tile substrate to the roof structure, then assess the rusted steel members, replace and treat any rusted steel members and reconstruct the shell roof. You would also need to water proof the complete roof, retile the roof and repaint all previously painted surfaces.

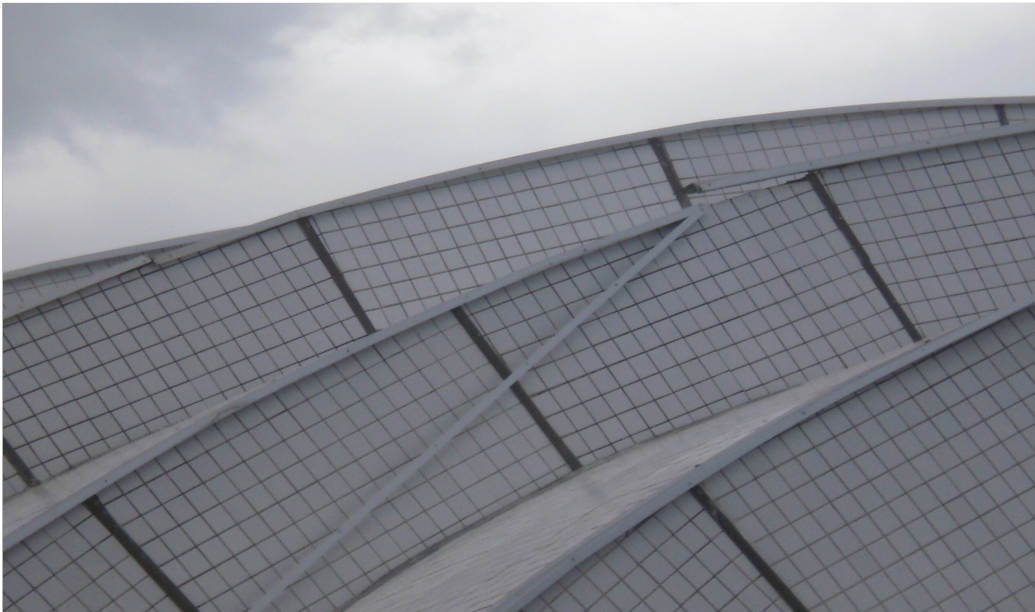
The tiles to the roof of the sound shell are missing at various locations refer photo 10. The colour bond roof sheeting to the covered walkways is also damaged refer photo 8 and 9. The metal roof finishing flashing is loose and falling off most of the roof refer photo 5 and 6.

Metal flashing loose on the roof (photo 6)

Some of the roof flashing is falling off the building or laying on the roof, this should be removed so that it will not cause injury, also some of the roof tiles have fallen off in places this also could cause injury.

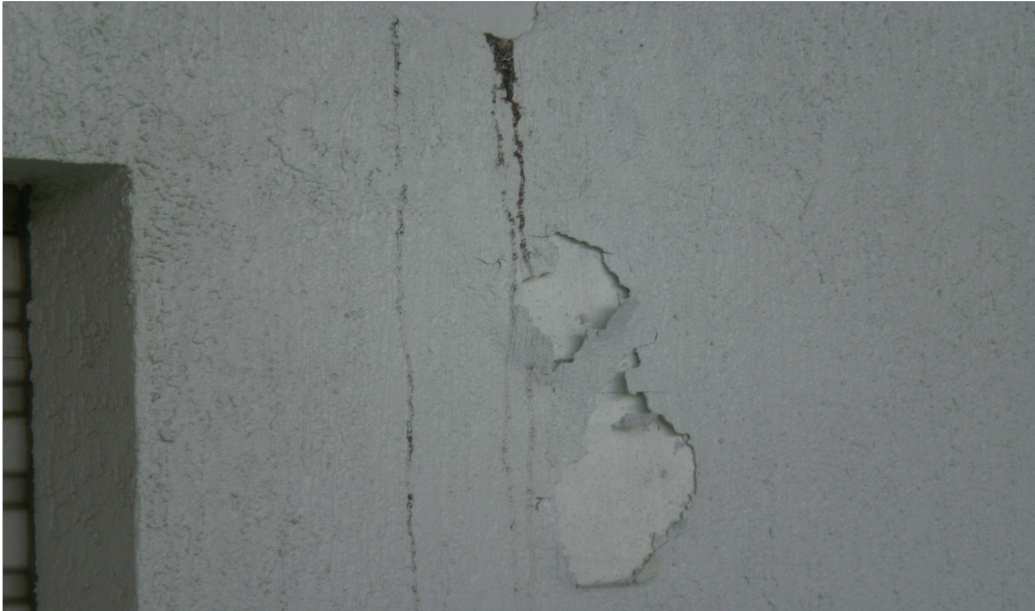
The paintwork to the exterior of the building is faded, marked and in poor condition. The Granosite texture coating is peeling at the back of the stage area refer photo 13 and 14. The interior paint work is also faded and has paint peeling off in the dressing rooms and amenities refer photo 18.

Paintwork in poor condition (Photo 14)

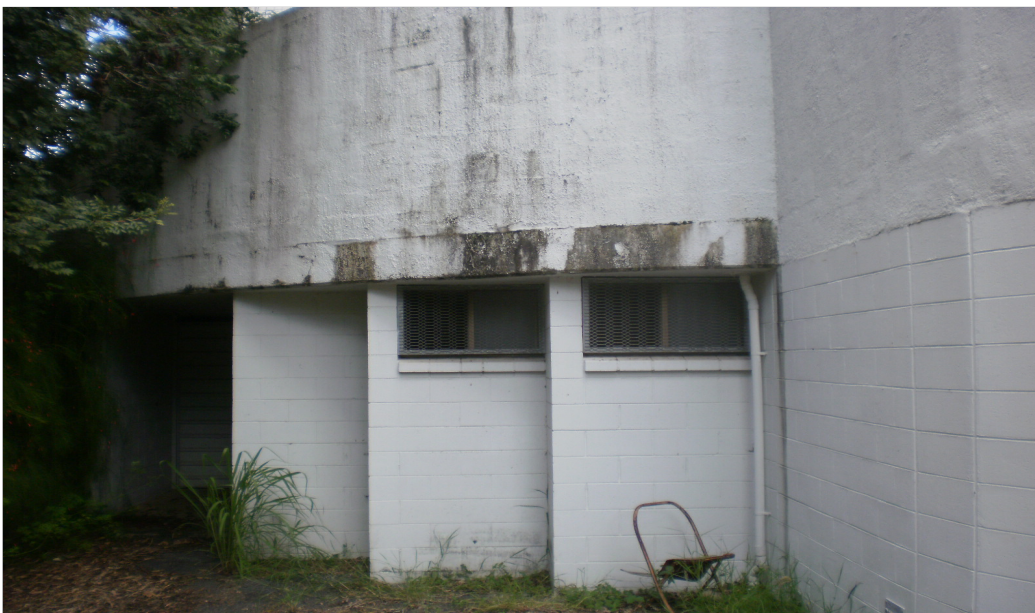
The balustrade has bolts missing on the foot plate on the southern side and sections of balustrade missing or removed on the western side's photo 15, 16 and 17.

Bolts missing to handrail foot plates (photo 15)

The balustrade to the south east side has one rail missing and on the southern and western side there are bolts missing in the foot plates and some of the rails have been removed in the area of the loading ramp this could also be dangerous as no fall protection is provided.

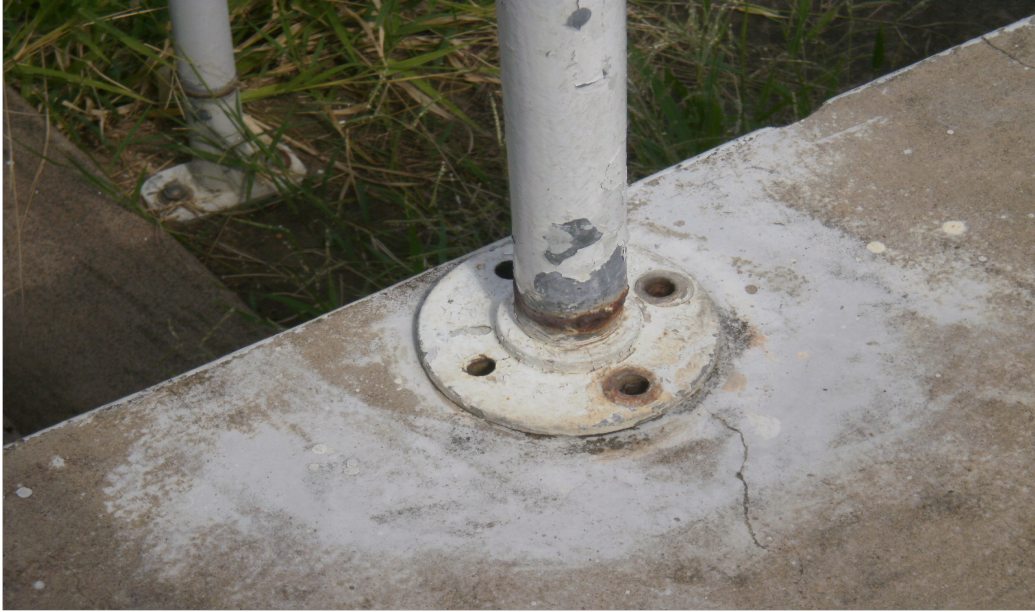
Section of balustrade missing (photo 16)

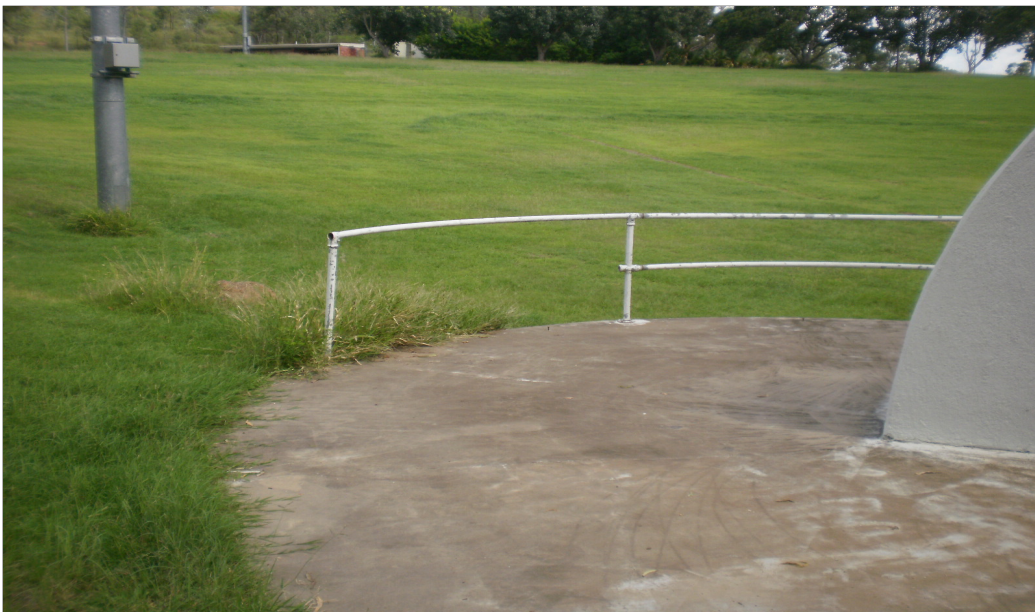
Section of balustrade missing (photo 17)
